BELLEFONTE NUCLEAR PLANT UNITS 1 AND 2 - TUBE LEAKS IN COMPONENT COOLING
WATER HEAT EXCHANGERS - BLRD-50-438/83-15, BLRD-50-439/83-11 - FIRST
INTERIM REPORT

BELLEFONTE NUCLEAR PLANT UNITS 1 AND 2
TUBE LEAKS IN COMPONENT COOLING WATER HEAT EXCHANGERS
SUPPLIED BY BABCOCK AND WILCOX
BLRD-50-438/83-15, BLRD-50-439/83-11
NCR 2174
10 CFR 50.55(e)
FIRST INTERIM RPEORT

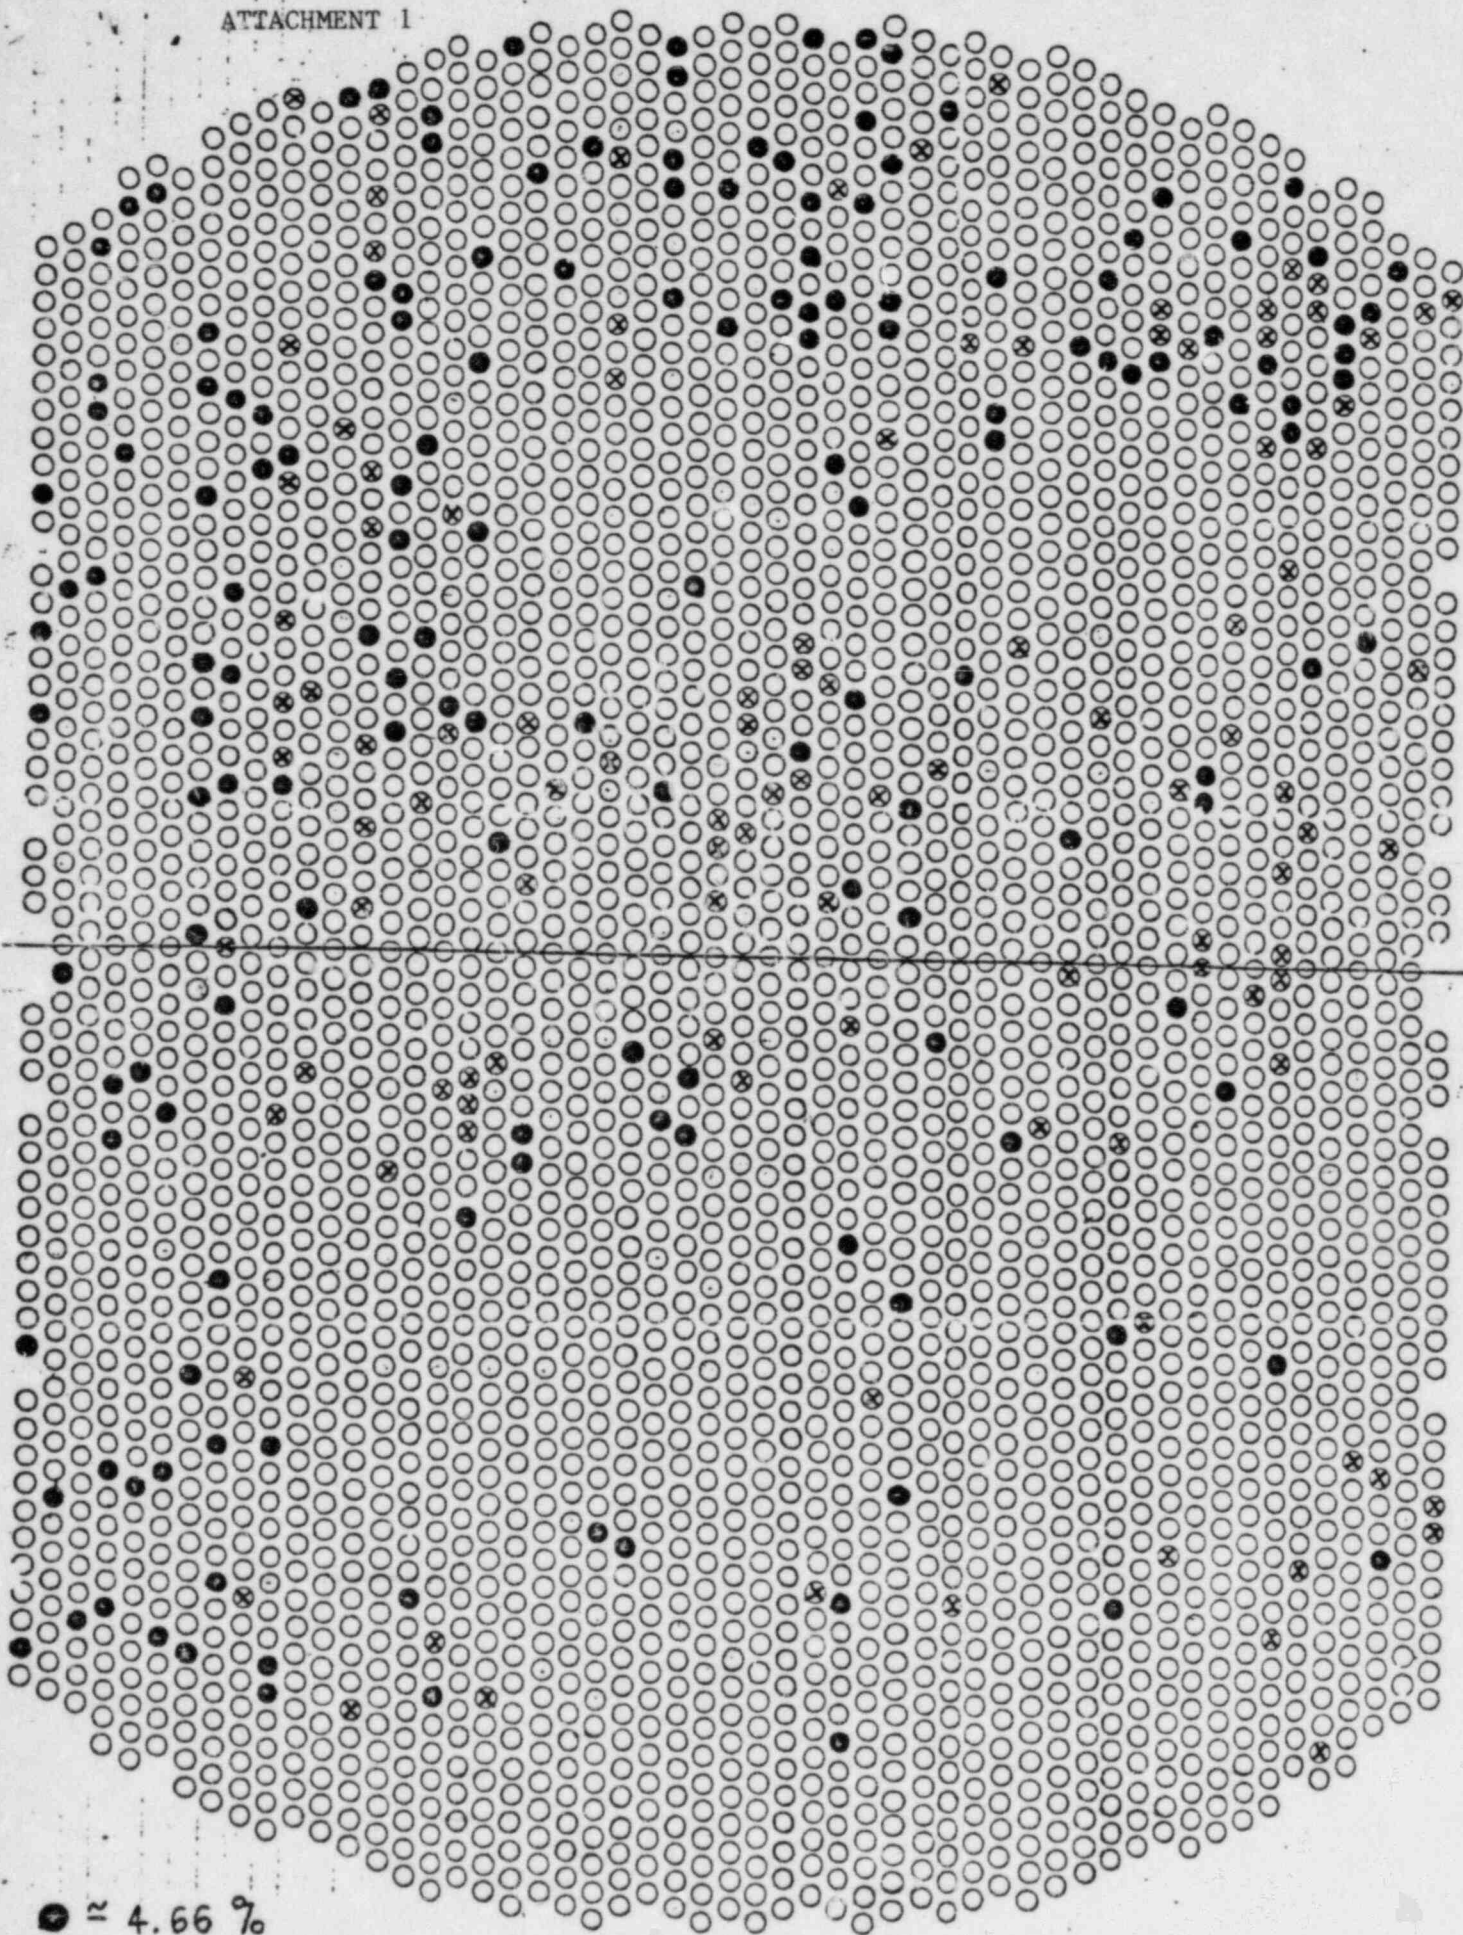
The cause of the leaks has not yet been determined. However, the inner tube walls appear to be corroding and pitting. Further investigation will be required to determine if this deficiency has generic implications. There have been no similar deficiencies in the past for other Bellefonte heat exchangers supplied by B&W under the nuclear steam supply system contract.

TVA has forwarded the NCR to B&W for corrective action. TVA and B&W are working to determine the cause of the leaks. The unit 1 CCW coolers will be examined to determine the extent of the tube leakage there. The unit 2 CCW cooler has tube leaks as shown on the attached sketch (attachment 1). Tubes marked in black have definite leaks somewhere in the length of the tube. Tubes marked with an "X" showed evidence of leakage around the rolled joint between the tube and tube sheet and also could have a leak in the length of the tube. As part of the overall effort, two leaking tubes from each cooler will be pulled and metallurgical tests will be performed on them. Then, an eddy current test will be performed on 15 to 20 percent of the tubes to determine the extent and pattern of leaks. Based on the result of the eddy current test, a tube with representative damage will be pulled for further metallurgical examination.

● $\approx 4.66\%$

⊗ $\approx 3.22\%$
