Facility: Unit No. 1

Event Date: January 23, 1983

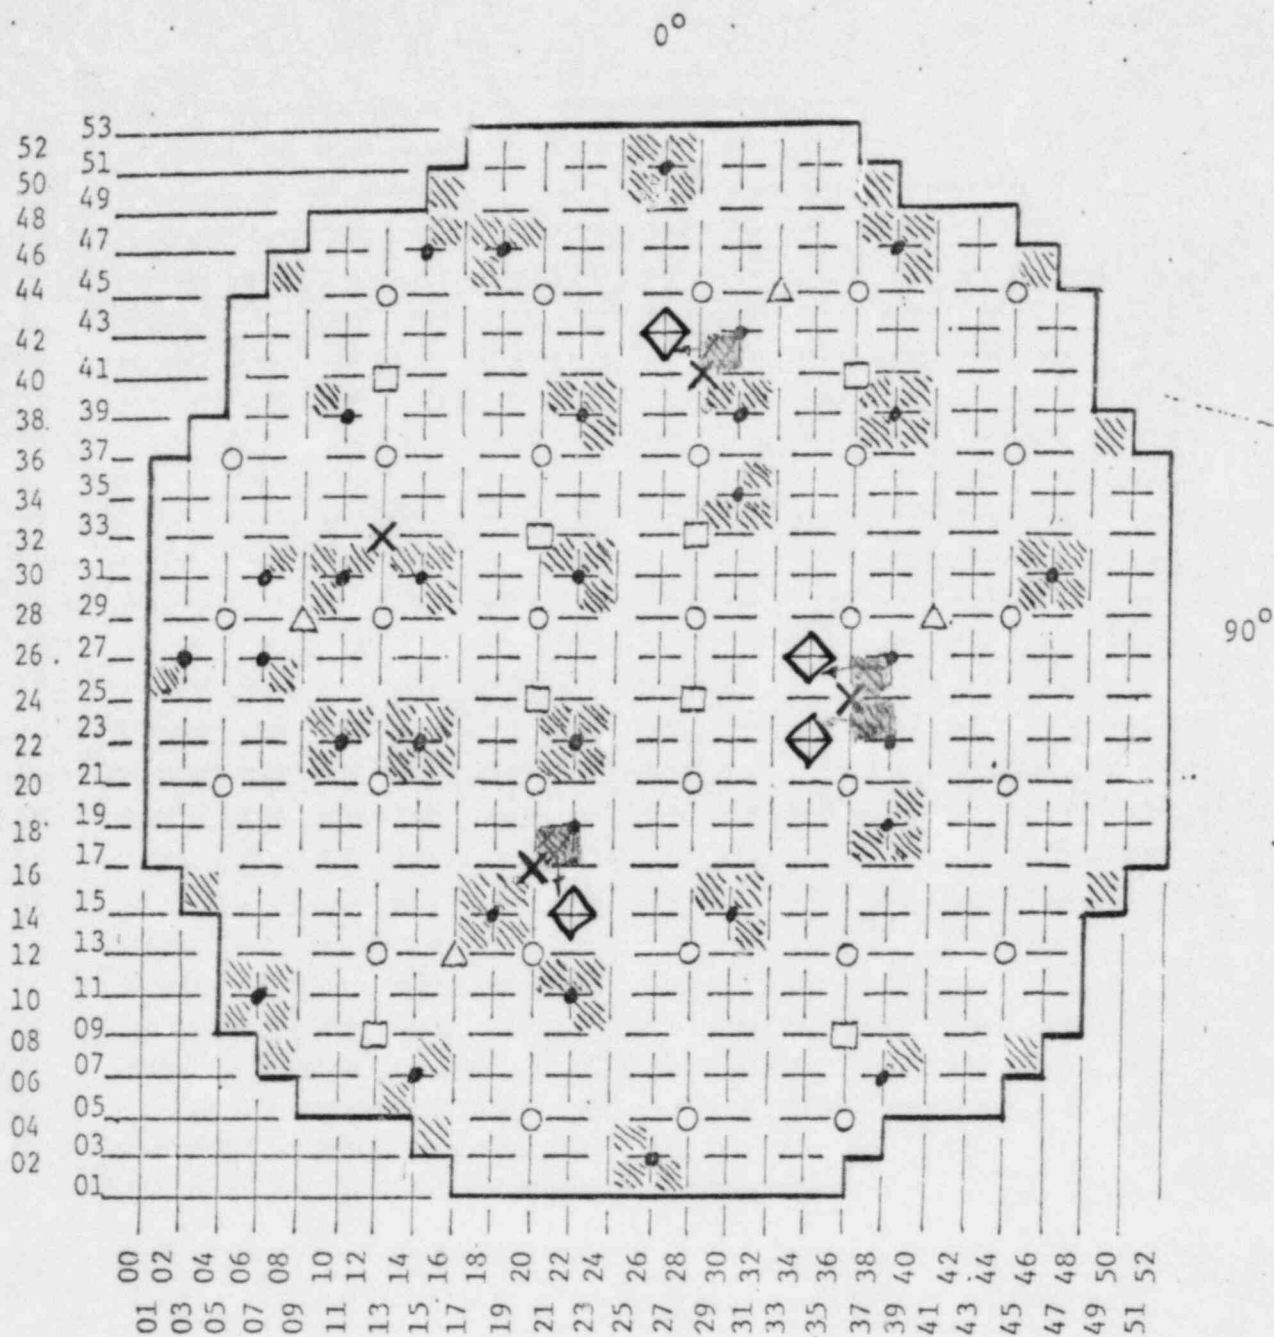
Figure 1 Core Arrangement (Top View) on 1-23-83

The control rod drive units for rods 22-19, 30-43, 38-23, and 38-27 were scheduled to be rebuilt following the completion of all other drive rebuilds when the fuel bundle in each cell would be moved to cells with fully inserted rods. Due to a problem encountered with uncoupling several drive units to be rebuilt, it was decided to work the four drives with fuel bundles. A fuel shuffle sequence had been prepared for relocating those four fuel bundles based on the remaining rod being inserted. At approximately 0300 on January 23, 1983, the fuel bundles were relocated in the core around withdrawn control rods 22-15, 26-43, 34-23, and 34-27. While performing surveillance requirements to assure that all withdrawn control rods had no fuel in the cell (4.9.10.2.1e) at 1245 on January 23, 1983, the fuel shuffle error was identified.

NOTE: Arrows denote locations where fuel assemblies were moved to cells with control rods withdrawn.

The inserted control rods around which the four fuel bundles were placed were inserted within one hour. The delay in inserting these rods occurred because they were under clearance when the problem was identified. A verification was also performed on core fuel location and that all control rods with fuel in their cells were inserted.
