ANNUAL REPORT

VIRGINIA POLYTECHNIC INSTITUTE
and STATE UNIVERSITY
RESEARCH REACTOR

January 1, 1982 to December 31, 1982

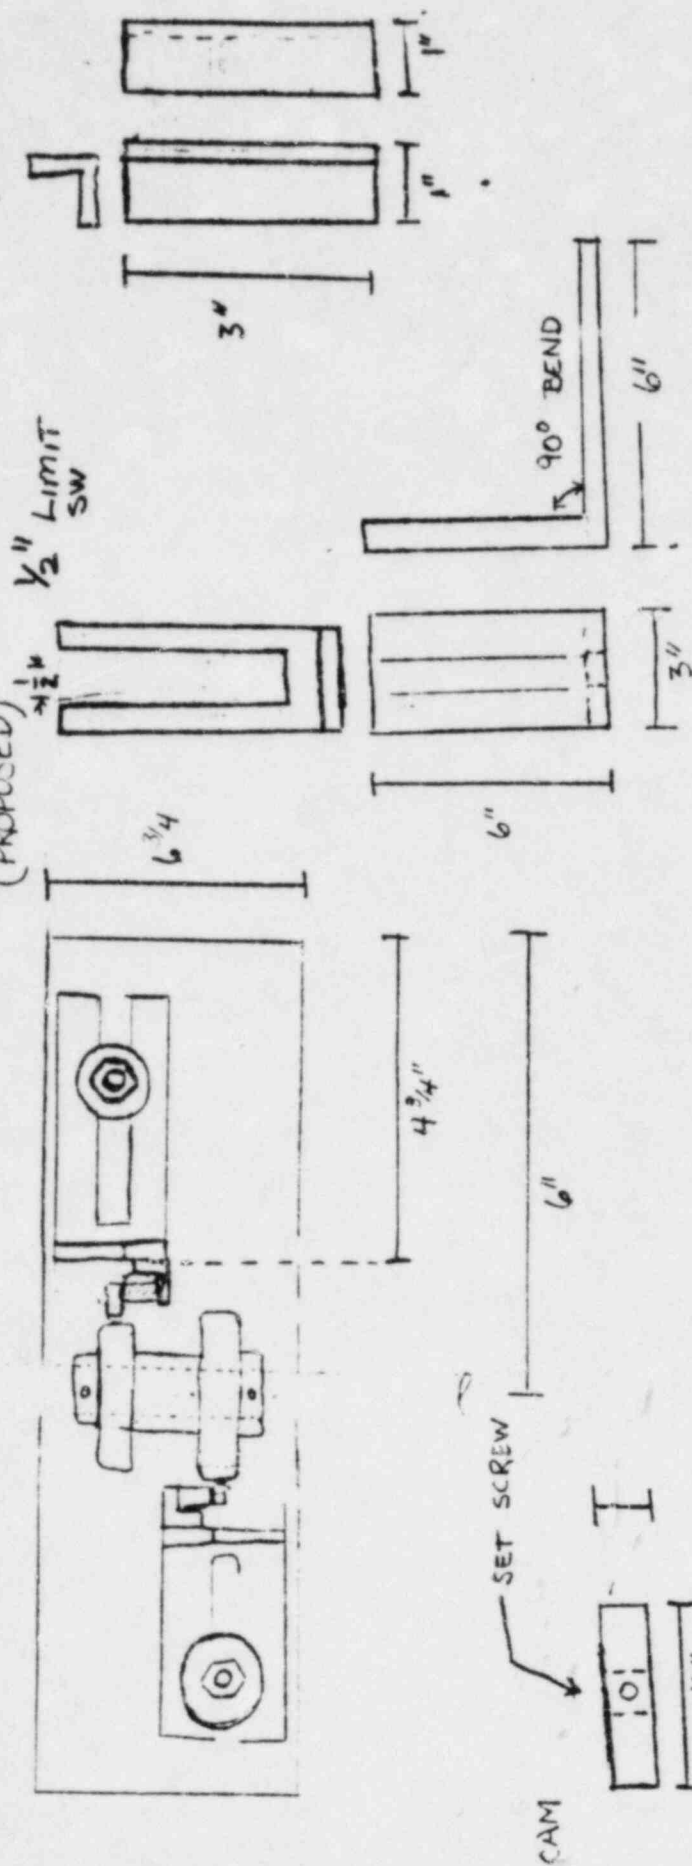
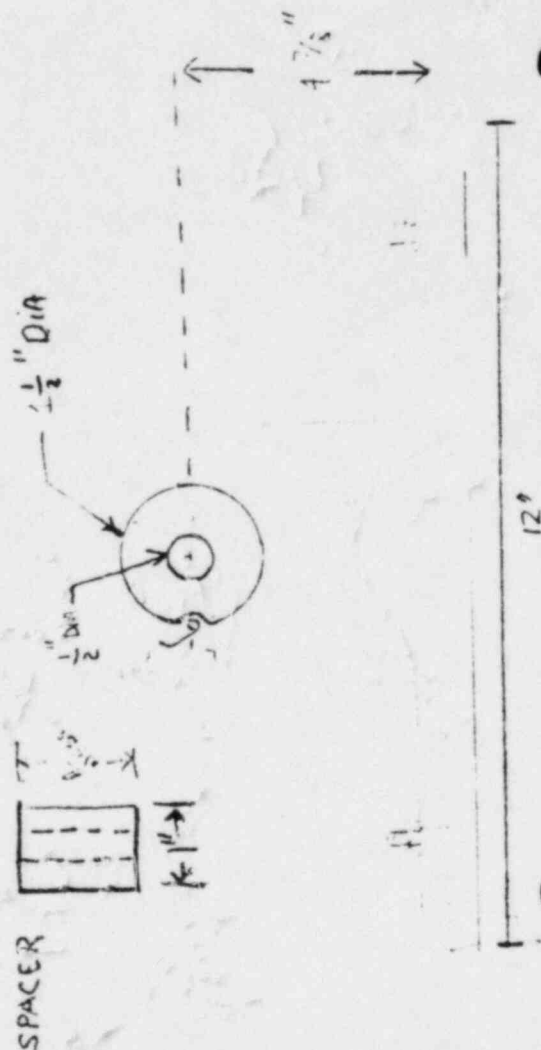
-LIMIT SWITCHES -
SAFETY ROD ONE
CHANGE
(PROPOSED)

Difficulty was experienced in Safety Rod One's operation (see III.A. and VII) and a change was necessitated. The limit switch and rod position indicators were relocated to allow greater flexibility in adjustment and decrease the possibility of interference with rod operation. Since installation, the new system has functioned extremely well and also resulted in a significant reduction in rod insertion time (see I.D). A greater amount of operating time is desired to ensure reliability and sustained performance. If, when re-evaluated, the current characteristics are maintained this new system shall be used for safety rod two and the shim-safety rod.

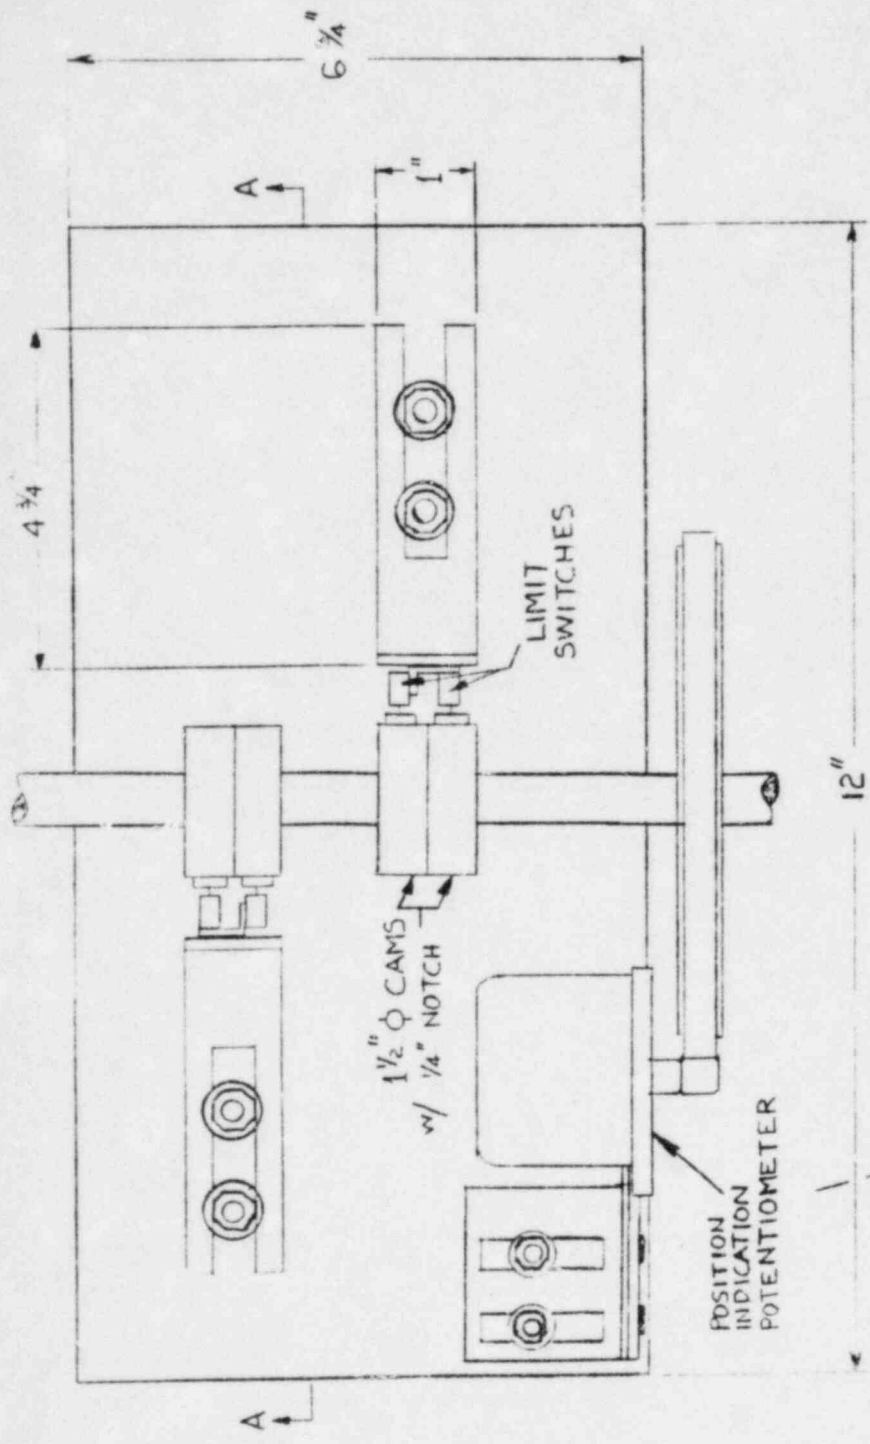
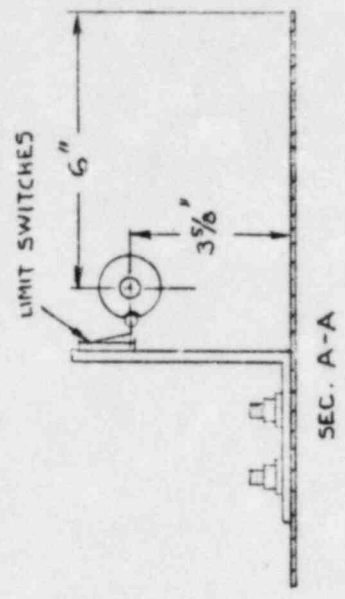
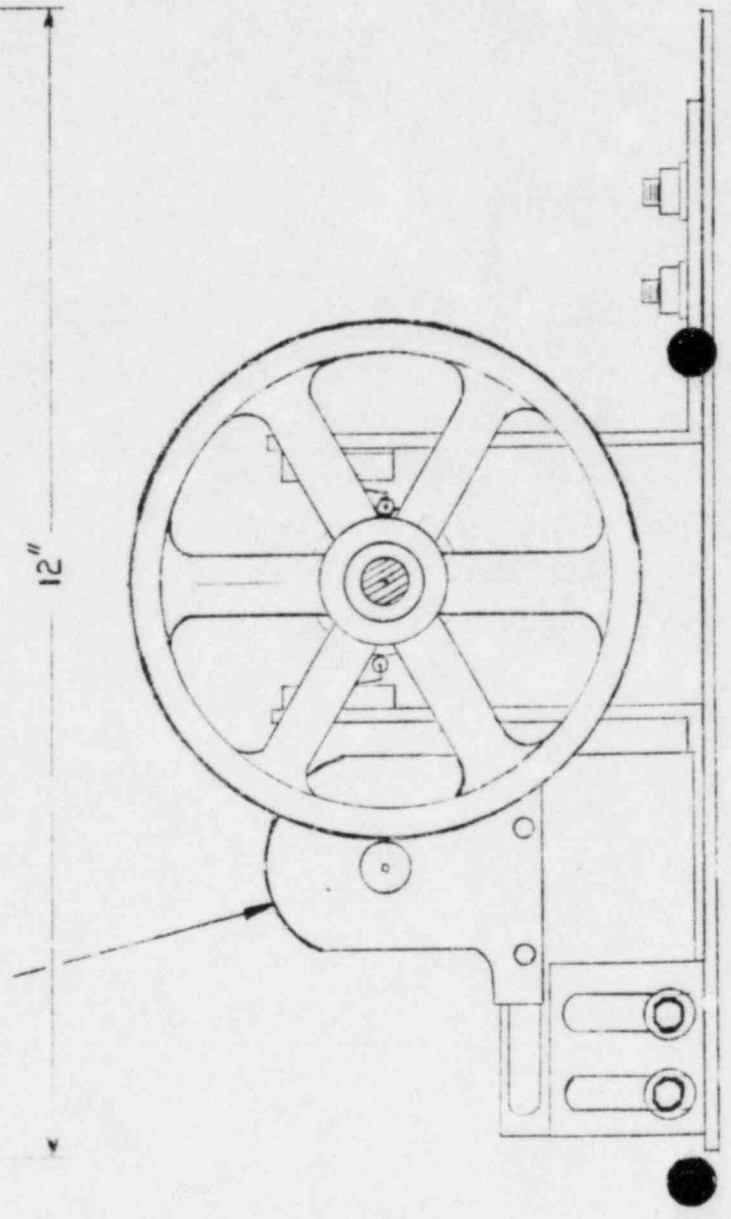
SAFETY ROD ONE
L.S. & RPI CHANGE
11/82

On the morning of June 24, 1982, a normal reactor start-up was being performed for a training program being conducted for South Carolina Electric and Gas reactor operators. Following withdrawal of safety rod one, the top limit switch failed to pick up. A technician was sent to check the limit switch and it was found to be out of adjustment. Apparently over a period of time, the top mounting plate for the limit switches had shifted slightly.

During the subsequent normal shutdown safety rod one failed to insert. The immediate actions for a stuck rod were carried out and the rod was manually inserted. Investigation revealed that the rod was maintained in its withdrawn position by the limit switch. The rotating element of the limit switch caused the point of the cam to catch between it and the plate the rotating element itself is mounted to. The plate the rotating element is attached to buckled from the weight of the rod until it came to a rest.

The limit switch was replaced and the rod cycled 10 times to recheck the replacement. Operation was satisfactory.
