January 17, 1983

## DIVERS REPORT

Service Water Intake Tunnel Inspection  
V.C. Summer Nuclear Plant, Jenkinsville, S.C.

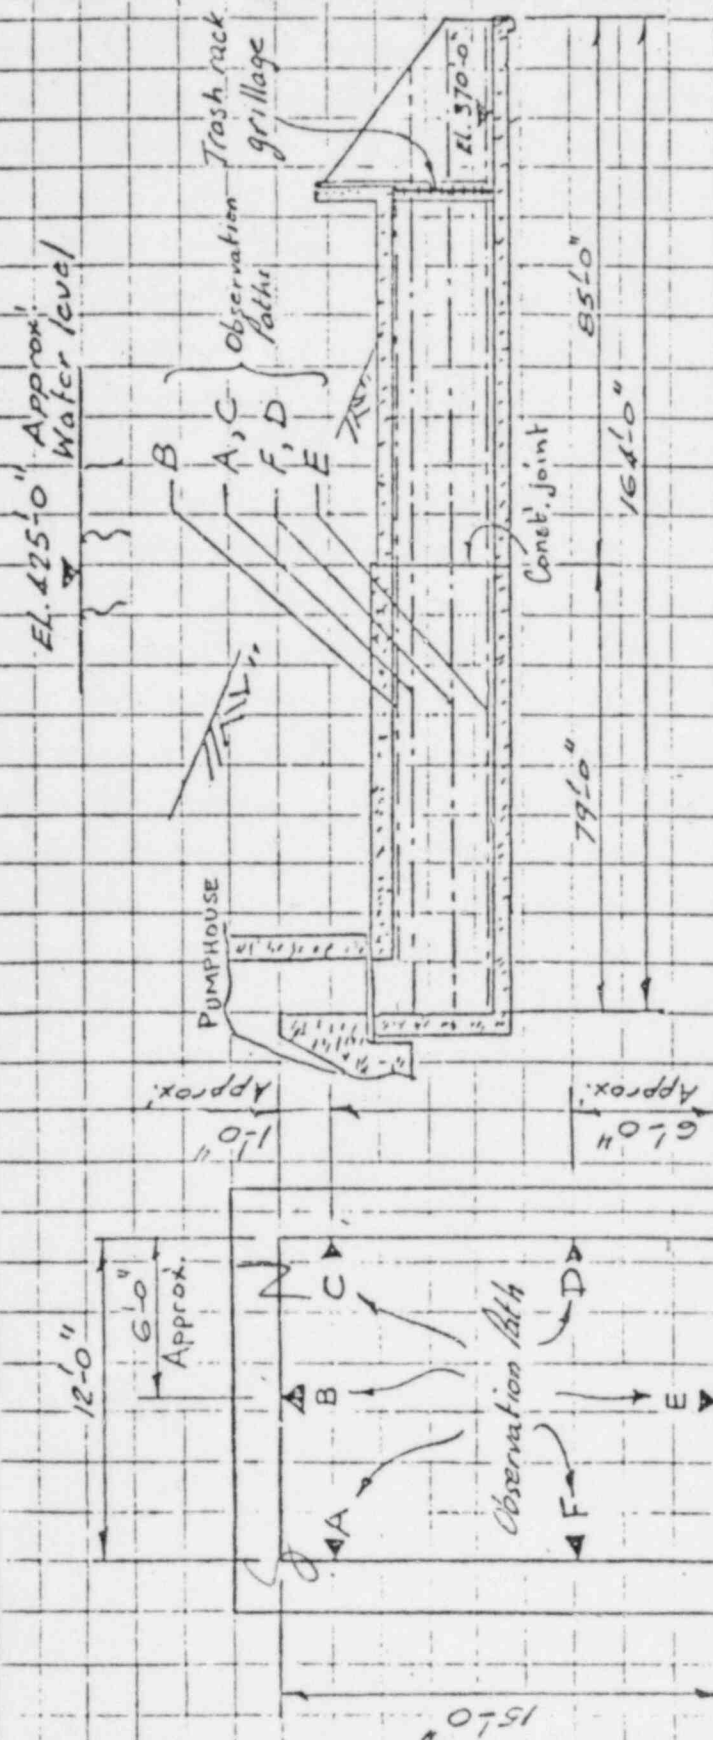
OBSERVATION PATH LOCATIONS SKETCH 1

Observation paths were established per sketch (1) with A, F representing the South Wall and C, D the North Wall. B is the roof and E the floor.
