**Department of Energy**

Subject: *2019 Annual Site Inspection and Monitoring Report for Uranium Mill Tailings  
Radiation Control Act Title I Disposal Sites*

Enclosed are seven copies of the *2019 Annual Inspection and Monitoring Report for Uranium Mill Tailings Radiation Control Act Title I Disposal Sites*. The report covers the annual inspections of the 19 Title I disposal sites managed by the U.S. Department of Energy Office of Legacy Management.

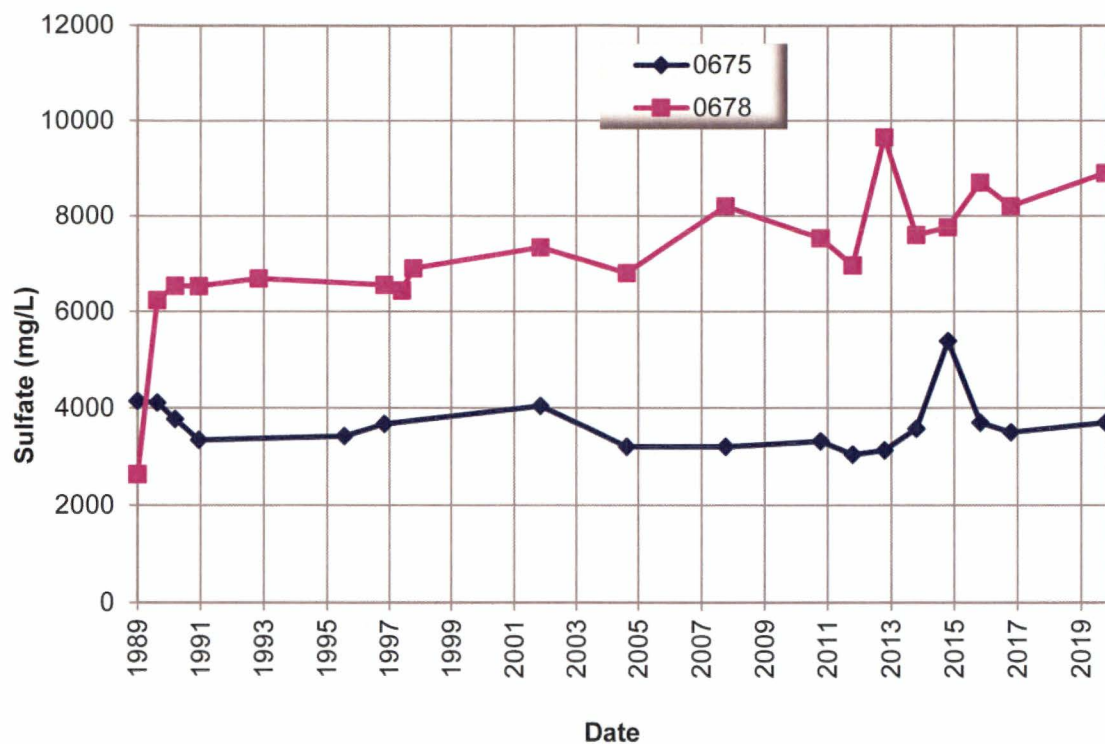
Figure 1-6. Sulfate in Groundwater at the Ambrosia Lake, New Mexico, Disposal Site

Sulfate levels have increased steadily in well 0678 from 6240 mg/L in 1989 to 8900 mg/L in 2019. Sulfate in well 0675 has been relatively consistent around the 4000 mg/L concentration value since 1989.

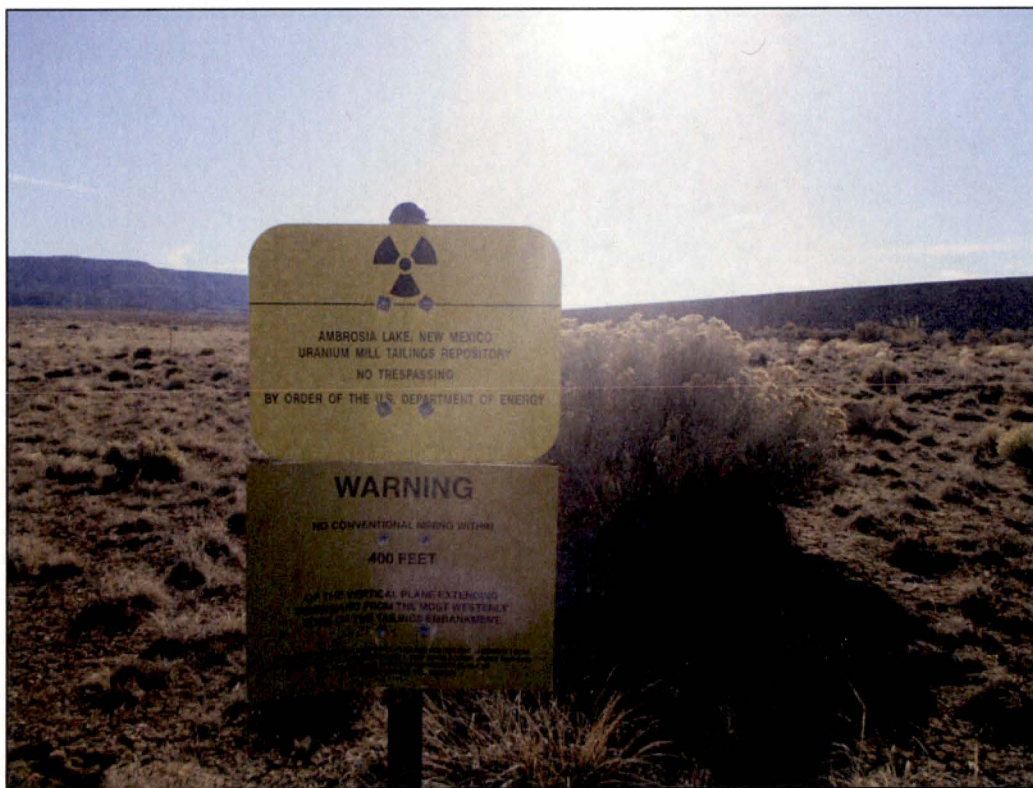
There are 70 perimeter signs, attached to steel posts set in concrete, positioned along the unfenced property boundary. Posts for perimeter signs P1 through P15 include additional warning signs about mining restrictions; several were bent by cattle but remained legible. The text on perimeter signs P1 through P15 was cracked but remained legible (PL-2). Following the annual inspection, LM replaced perimeter signs P1 through P15 and the mining restriction signs. No other maintenance needs were identified.

PL-2. Perimeter Sign P10 and Mining Restriction Sign (Replaced Following Inspection)

- Replacing the cracked entrance sign
- Replaced perimeter signs P1 through P15 and associated mining restriction signs

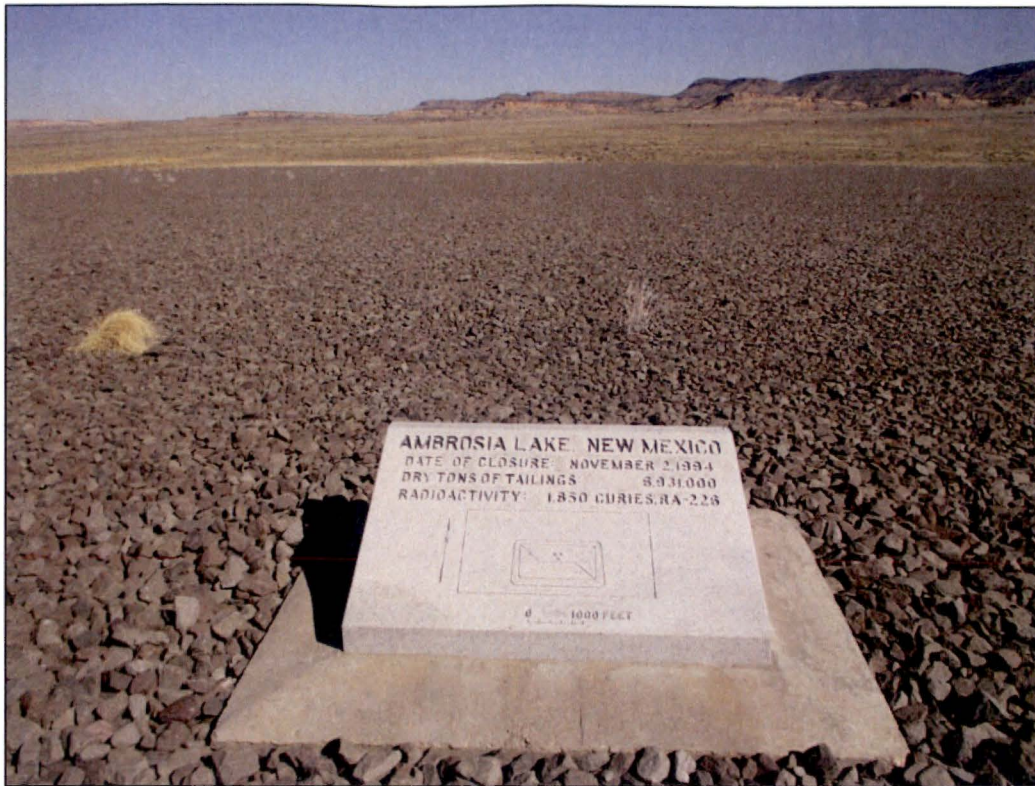
The site has two granite site markers. Site marker SMK-1 is just inside the site entrance, and site marker SMK-2 is on the top slope of the disposal cell (PL-3). No maintenance needs were identified.

*PL-3. Site Marker SMK-2*

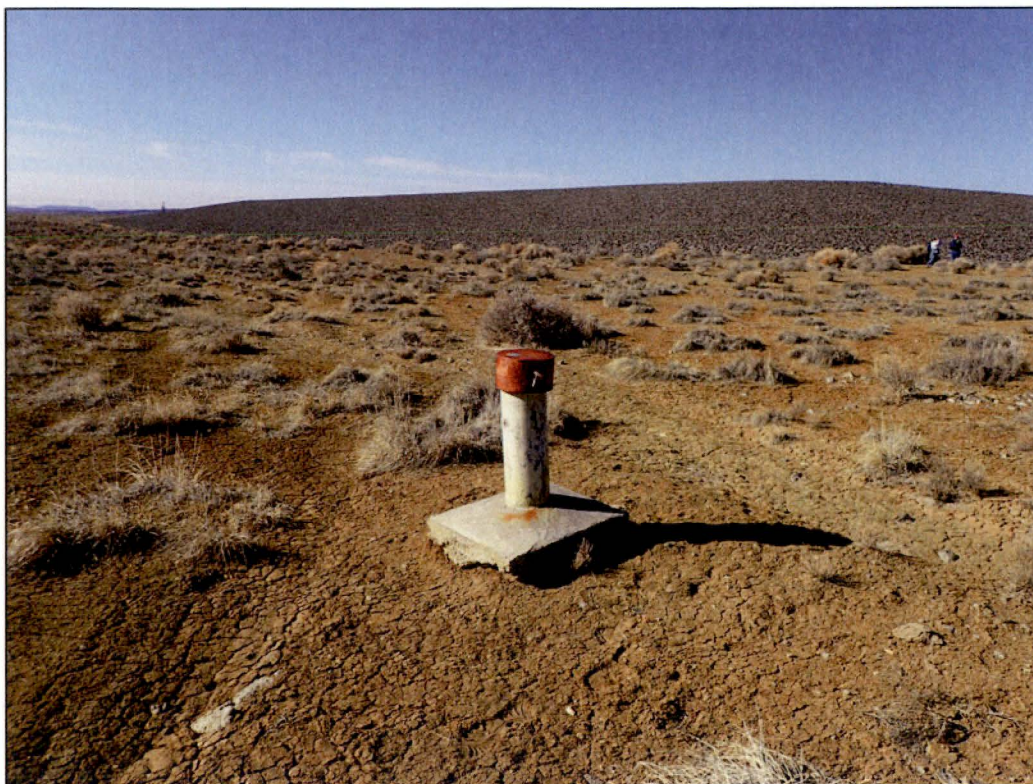
The site has three monitoring wells. A gully formation adjacent to well 0678 appears to be stable, and the well is not affected by the erosion (PL-5). All wellhead protectors observed during the inspection were undamaged, locked, and properly labeled. No maintenance needs were identified.

*PL-5. Monitoring Well 0678 with Disposal Cell in Background*

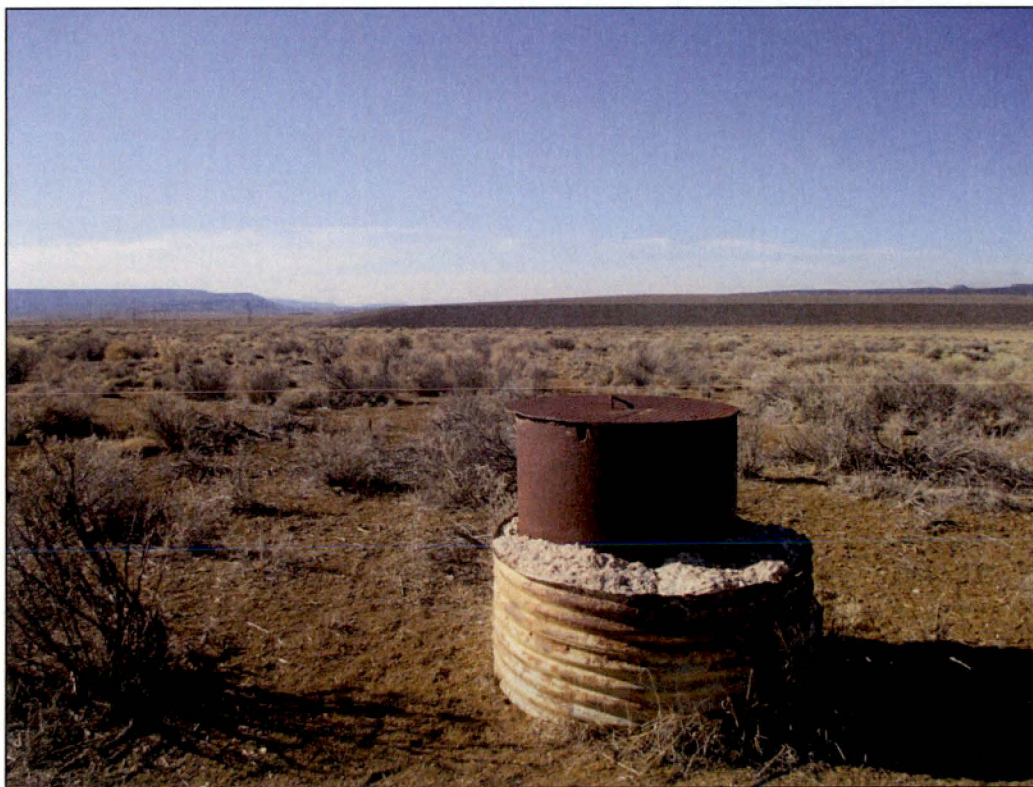
A mine vent shaft associated with an abandoned underground mine is within the site boundary in the northern portion of the site. The vent has a spot-welded cover and a casing that rises approximately 3 feet above the ground. The vent was secure at the time of the inspection (PL-6). Inspectors will continue to monitor the condition of the vent to ensure that the closure remains secure. No maintenance needs were identified.

*PL-6. Mine Vent Shaft*

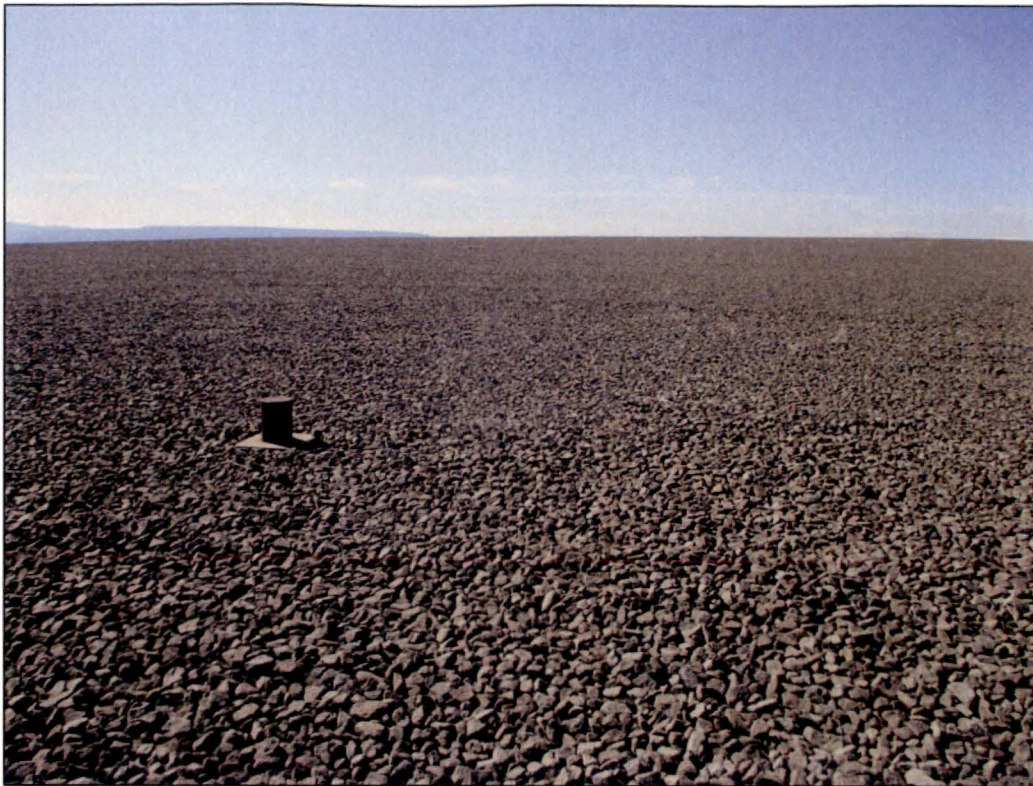
The disposal cell, completed in 1994, occupies 91 acres and is armored with basalt riprap to control erosion and deter animal and human intrusion. The top slope showed no evidence of cracking, slumping, or erosion, and there was no indication of riprap degradation. A shallow depression around settlement plate SP-4, near the northeast corner of the disposal cell cover, was first noted during the 1997 inspection and continued to grow in depth and area in subsequent years. The depression was repaired in August 2005. Visual observations during the 2017 annual inspection indicated that very minor settlement may have occurred since the depression was repaired. The area was inspected during the 2019 annual inspection, and although the area was observed to be slightly depressed, settlement was shallow enough that the depth or the extent could not be definitively assessed (PL-7). Inspectors will continue to monitor this area.

*PL-7. Minor Settlement near Settlement Plate SP-4*

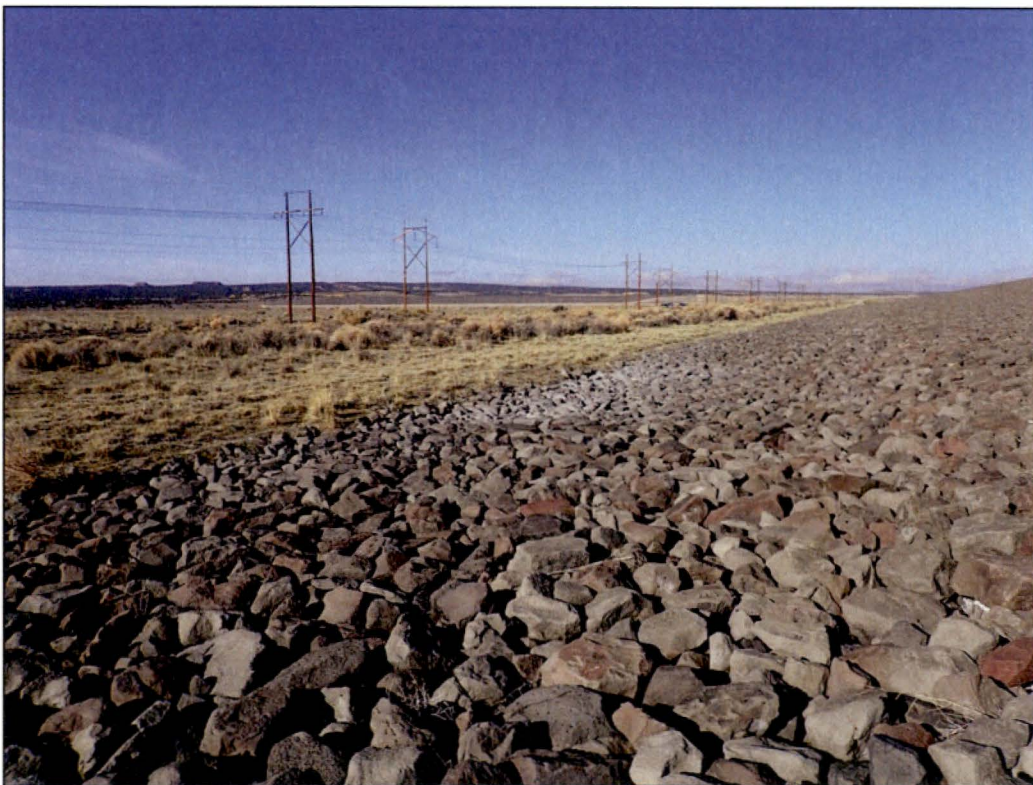
The basalt riprap-covered side slopes and apron showed no evidence of erosion, settling, slumping, or cracking. Standing water is occasionally observed in a portion of the south apron, but the area was dry during the inspection (PL-8). This location is the topographic low spot along the base of the disposal cell, and rainfall runoff collects in this area. No significant changes in the potential desiccation crack and small rills at the base of the disposal cell were observed (PL-9). Inspectors will continue to monitor this area. No maintenance needs were identified.

*PL-8. South Side Slope of Disposal Cell and Area That Ponds (Dry)*

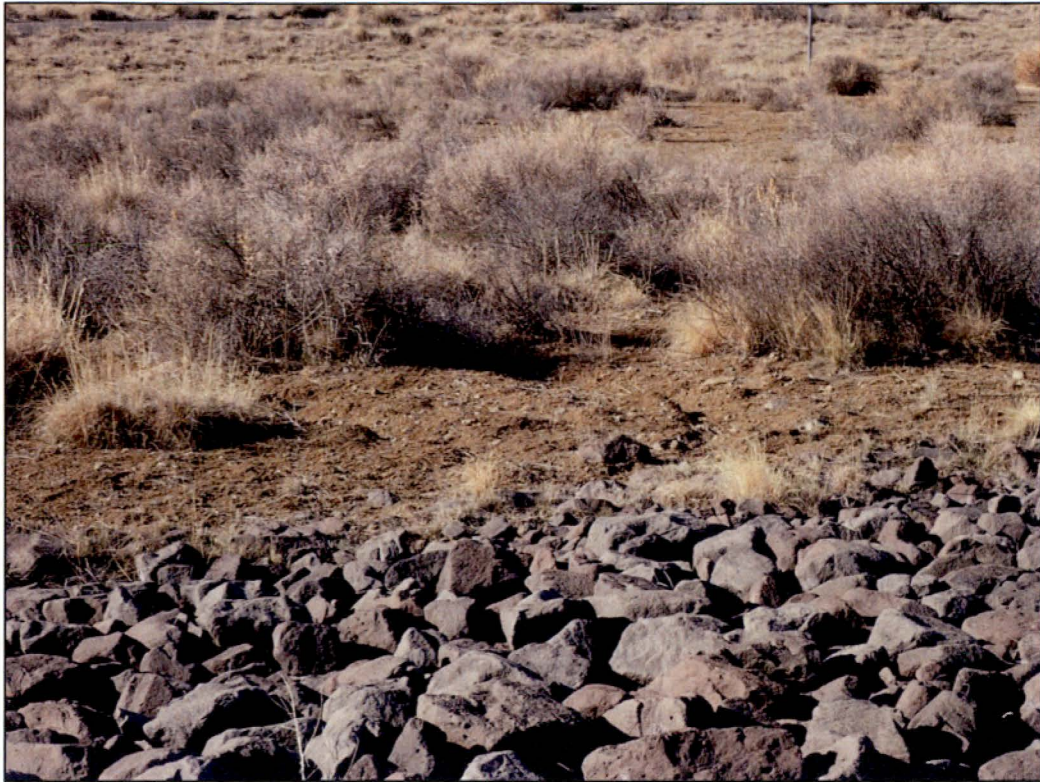
*PL-9. Rills at Southern Base of Disposal Cell*

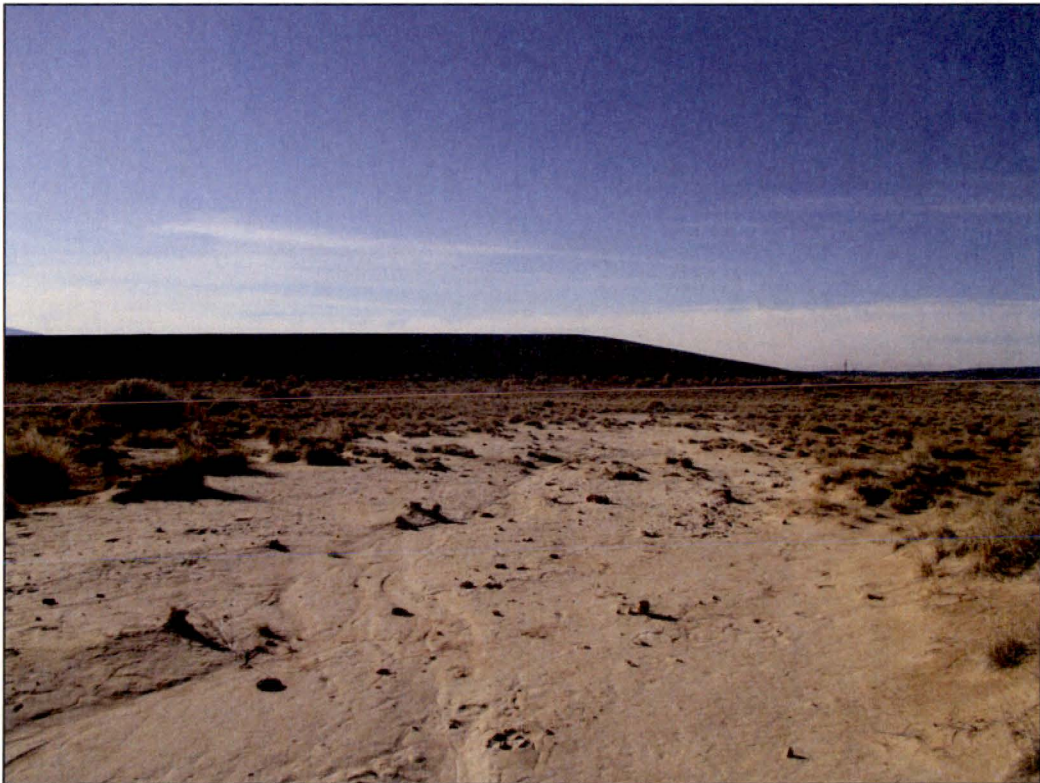
Onsite rills and gullies north and east of the disposal cell have been visually monitored for several years. While no new rills and gullies were observed during the 2019 annual inspection, existing rills and gullies continued to develop (PL-11). These erosional features do not threaten the disposal cell's performance or integrity, because headward erosion is progressing away from the disposal cell, and there is no significant sedimentation near the disposal cell. Inspectors will continue to monitor these features to confirm that they do not impact site features. No maintenance needs were identified.

*PL-10. Bare Spot North of Disposal Cell with Minor Rills*

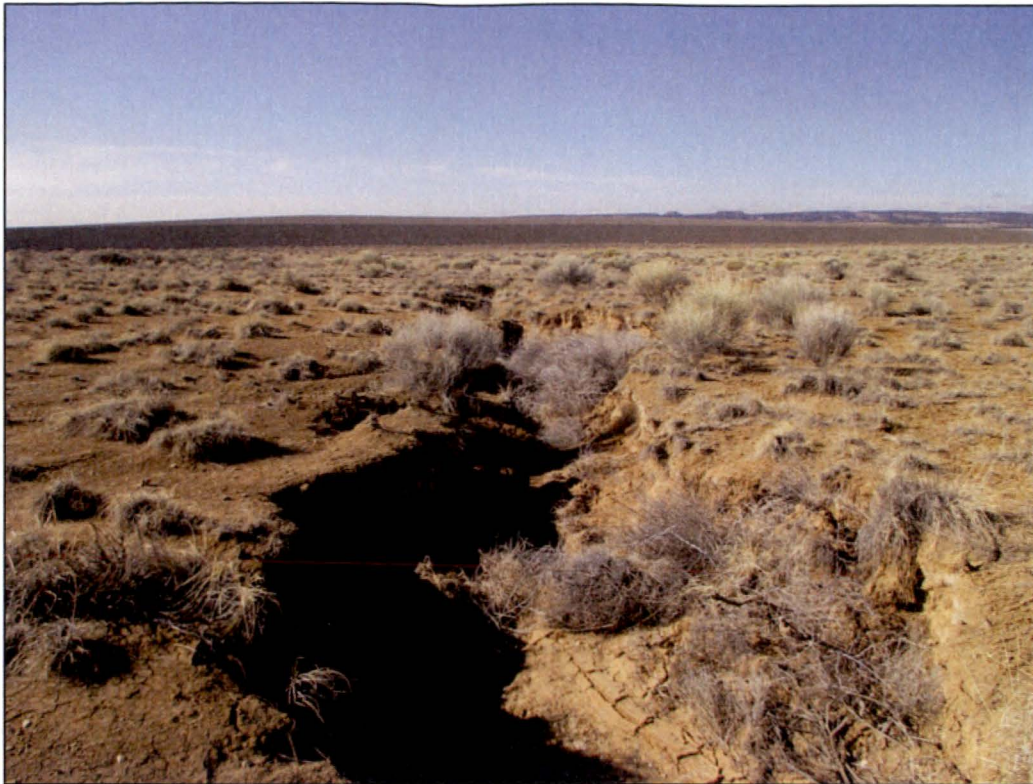
*PL-11. Erosion North of Disposal Cell*

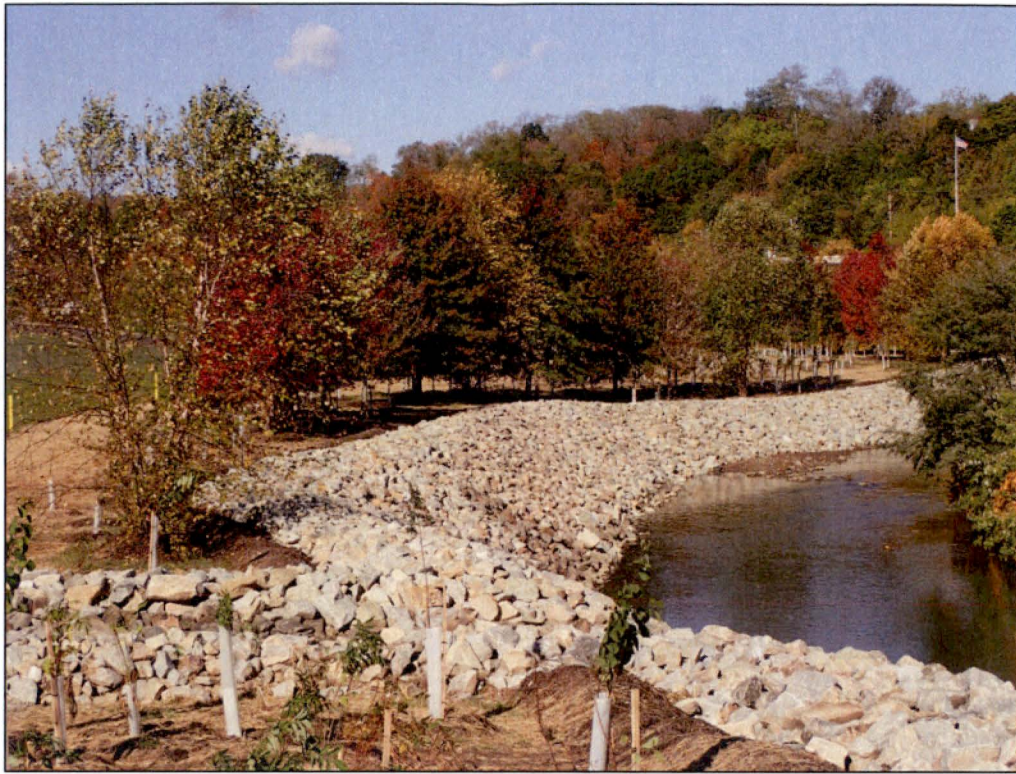
- **Canonsburg, Pennsylvania, Disposal Site:** Engineered repairs to the riprap-armored embankment of Chartiers Creek north of the disposal cell were completed. A riparian forest buffer was planted above and along the embankment to further stabilize the area against future stream flooding events and to reduce erosion upgradient of the riprap embankment. Disturbed areas were seeded with a pollinator-friendly native grass and wildflower mix.

*PL-5. Newly Repaired Riprap Embankment*

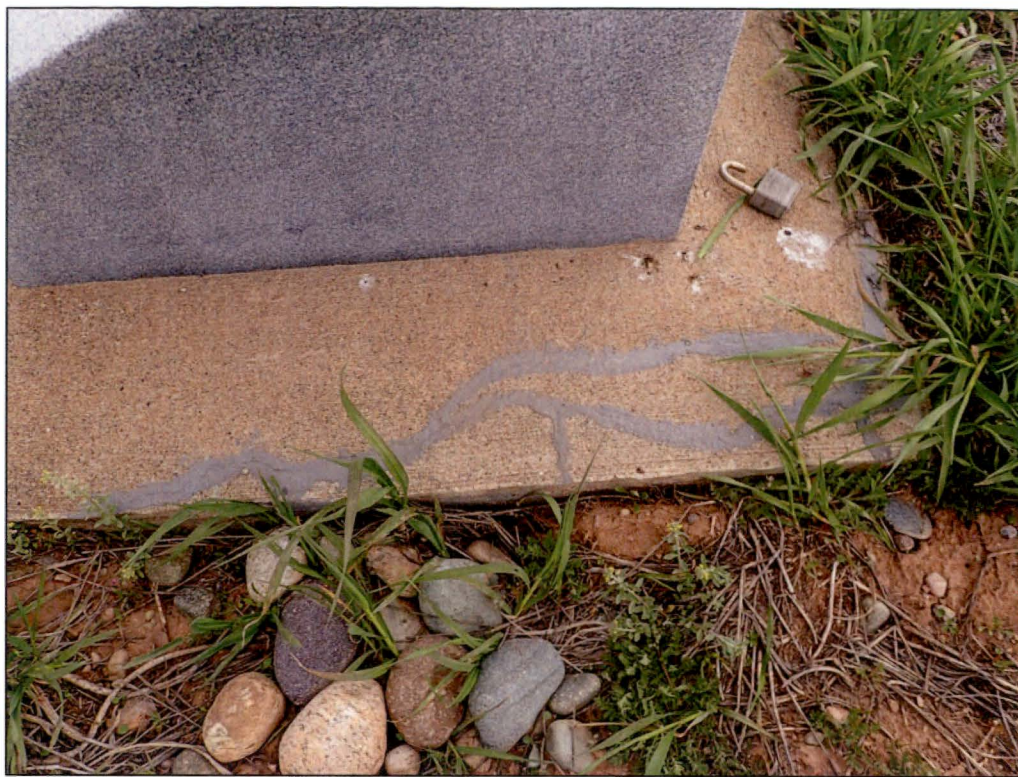
*PL-3. 2018 Repairs to Base of Site Marker SMK-2*

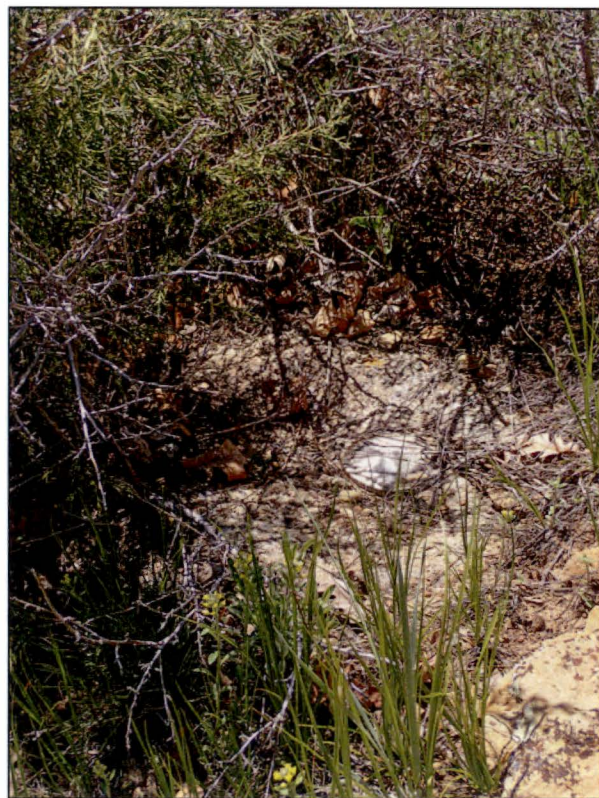
*PL-4. Vegetation Blocking Boundary Monument BM-5*

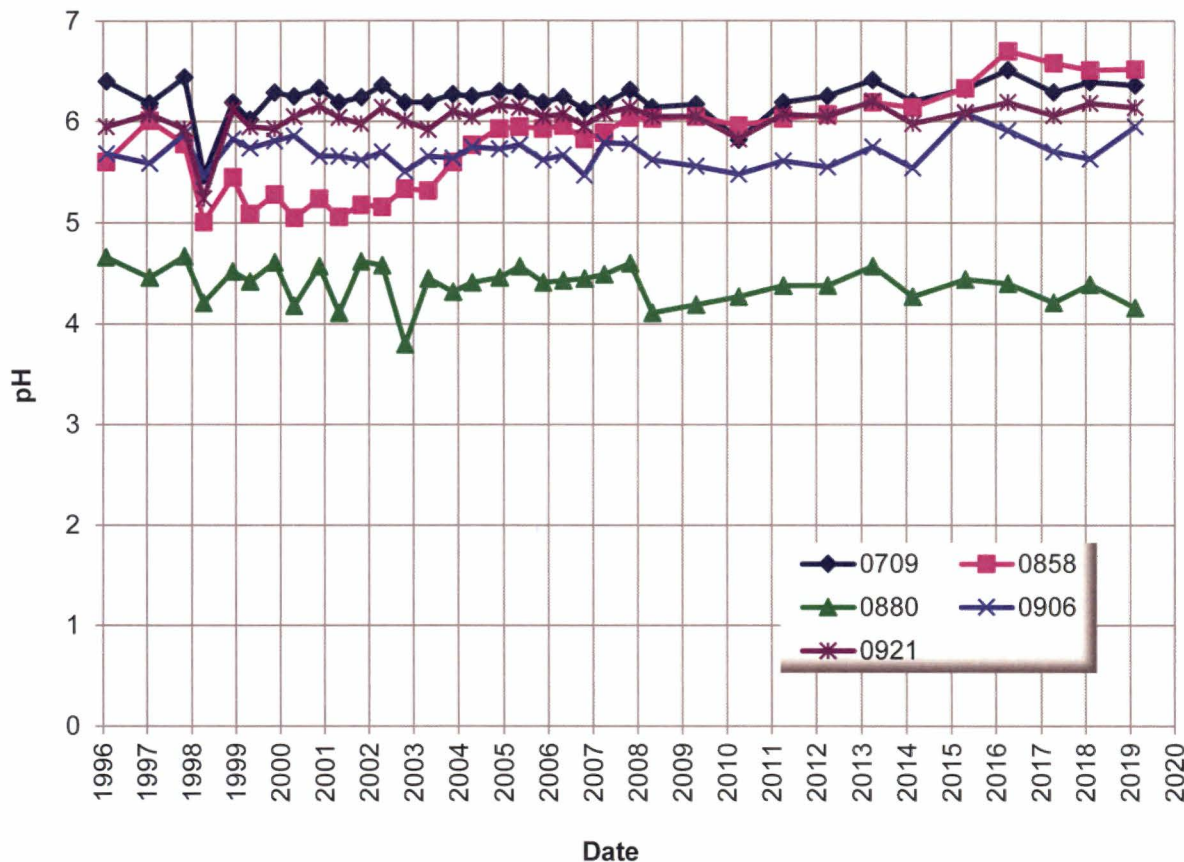
Figure 5-5. pH at Disposal Cell Performance Monitoring Wells at the Falls City, Texas, Disposal Site

**pH:** At the disposal cell performance monitoring wells, pH levels have historically been greater than the pH in tailings pore fluids (pH level of 2.93), with no significant upward or downward trends. Mann-Kendall testing indicates no trend in pH values at monitoring wells 0709 and 0906, an increasing trend at monitoring wells 0858 and 0921, and a decreasing trend at monitoring well 0880. In 2019, the pH levels in monitoring wells 0709, 0880, and 0921 decreased slightly, while the pH levels for monitoring well 0858 and 0906 increased slightly. The 2019 pH levels were within the range of historical values for all disposal cell performance monitoring wells (Figure 5-5).

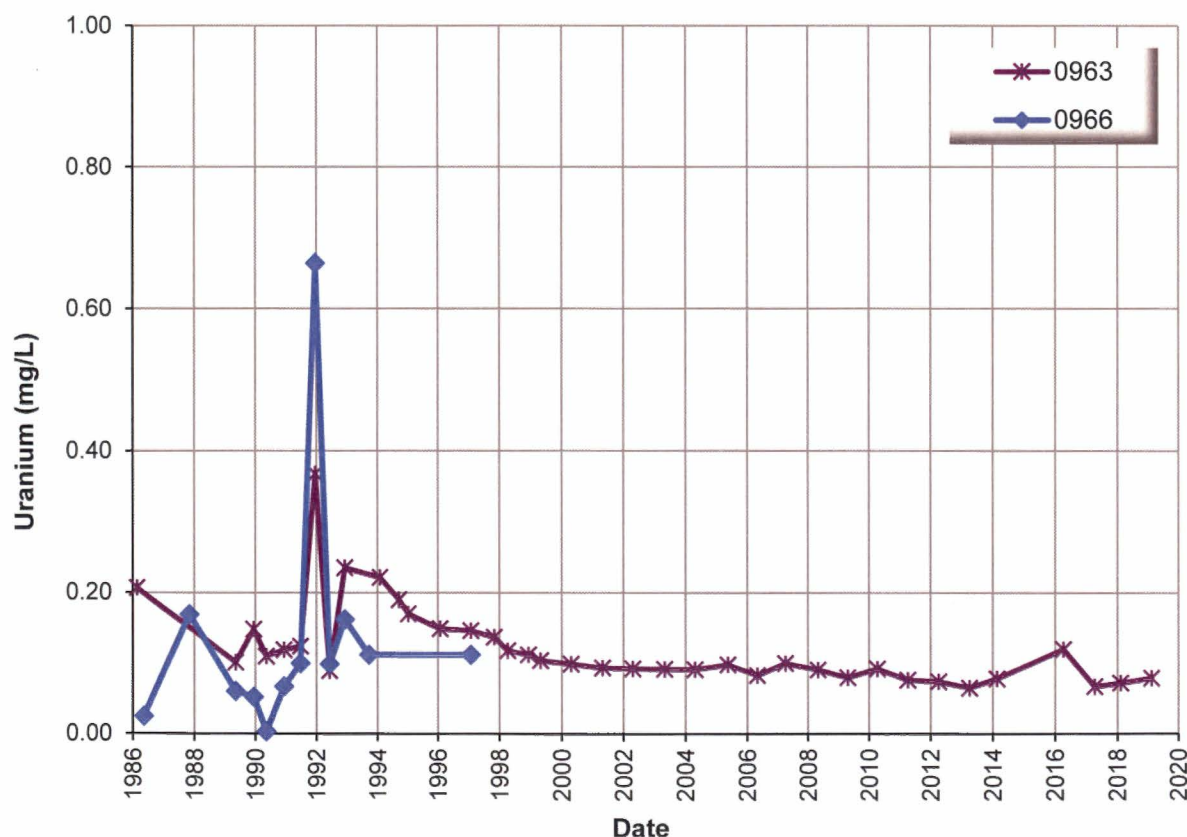
Figure 5-9. Uranium Concentrations in Monitoring Wells 0963 (in the Deweesville Aquifer) and 0966 (in the Dilworth Aquifer)

Figure 5-9 shows uranium concentration spikes in both wells (0963 and 0966) in 1992, with slowly declining uranium concentrations in 0963 over time (data for monitoring well 0966 are limited). This is likely due to an initial release of uranium and low pH tailings fluids during tailings deposition and subsequent acid leaching, with tailings removal by 1994 (DOE forthcoming). Monitoring well 0891 is the next Dilworth well directly downgradient of the low pH zone. Additionally, the elevated uranium at monitoring well 0891 is accompanied by elevated alkalinity and chloride, which also supports the conclusion that the elevated uranium is the result of passage of a slug of groundwater containing processing-related constituents.

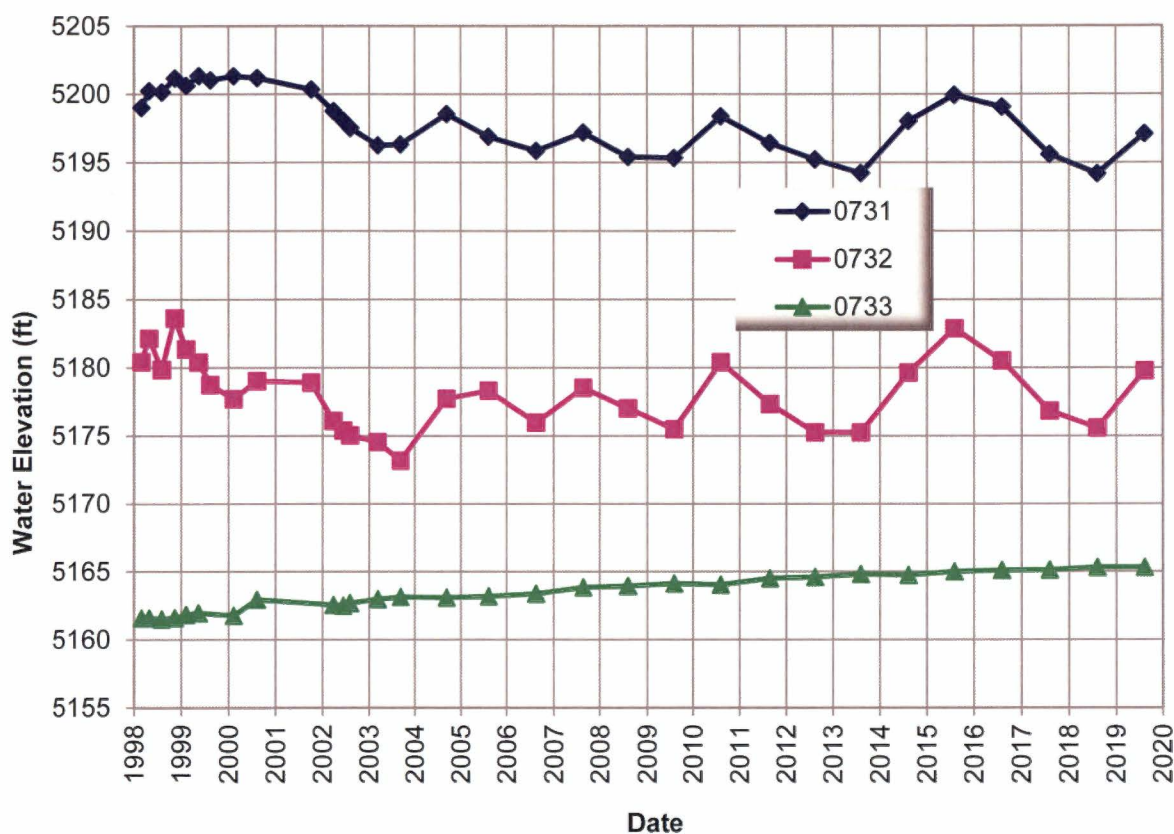
Figure 6-3. Water Level Measurements at the Grand Junction, Colorado, Disposal Site

Static water level measurements are obtained from each monitoring well before water quality samples are collected (Figure 6-3). Water levels in disposal cell monitoring well 0733 increased approximately 4 ft since 1998 and has remained lower than the adjacent water levels in the two paleochannel monitoring wells. Groundwater levels in wells 0731 and 0732 remained relatively constant with the same apparent trend in variability, suggesting the two paleochannel systems are influenced by the same upgradient recharge mechanisms.

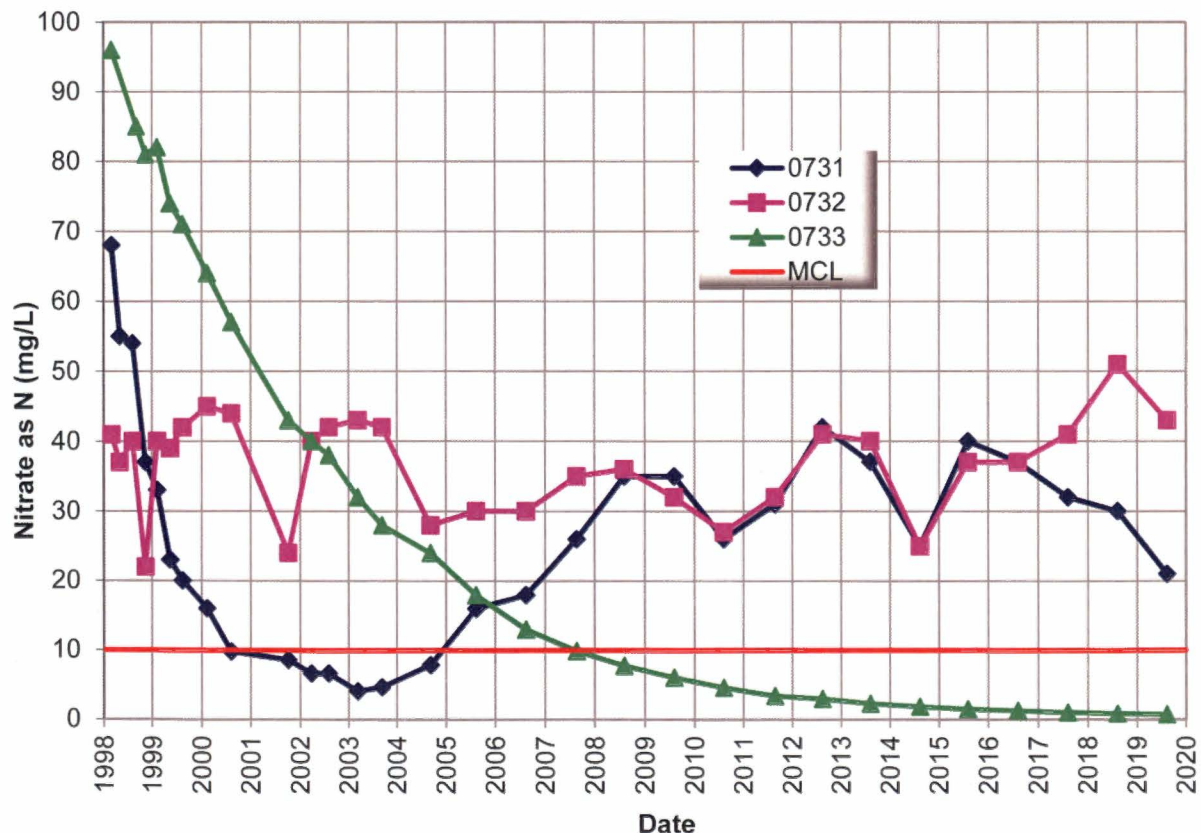
Figure 6-4. Nitrate (as N) in Groundwater at the Grand Junction, Colorado, Disposal Site

Since 1999, nitrate (as N) concentrations in disposal cell monitoring well 0733 continued to decline, reaching a low of 0.74 mg/L in 2019 (Figure 6-4). Nitrate concentrations continued to exceed the MCL of 10 mg/L in the paleochannel monitoring wells 0731 and 0732. Mann-Kendall trend tests for nitrate concentrations in monitoring well 0732 showed a statistically significant increasing trend from 2003 to 2019 and a historic high value in 2018.

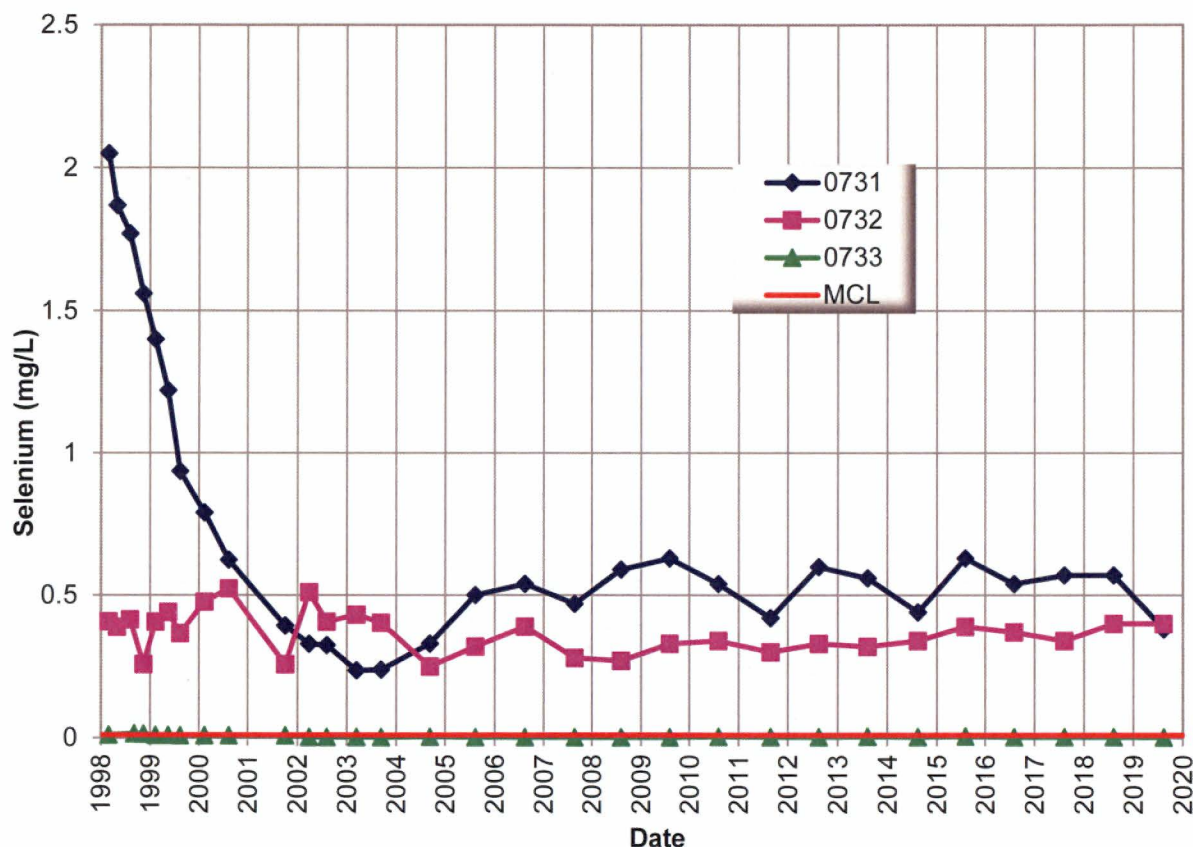
Figure 6-5. Selenium in Groundwater at the Grand Junction, Colorado, Disposal Site

Selenium concentrations continued to exceed the MCL of 0.01 mg/L in the paleochannel monitoring wells 0731 and 0732, with no apparent trend in either well since 2001 (Figure 6-5). Selenium occurs naturally in the Mancos Shale deposits that underlie the disposal cell at concentrations slightly greater than the MCL of 0.01 mg/L. Paleochannel monitoring wells 0731 and 0732 are screened at the contact of the Mancos Shale unconsolidated soil and the alluvium. Background groundwater quality in these wells is brackish, with elevated TDS levels ranging from 870 to 7010 mg/L; this supports the theory that the shale is the source of the elevated selenium concentrations in both paleochannel monitoring wells. Disposal cell monitoring well 0733 is not screened in the weathered Mancos Shale, and selenium concentrations remain below the MCL.

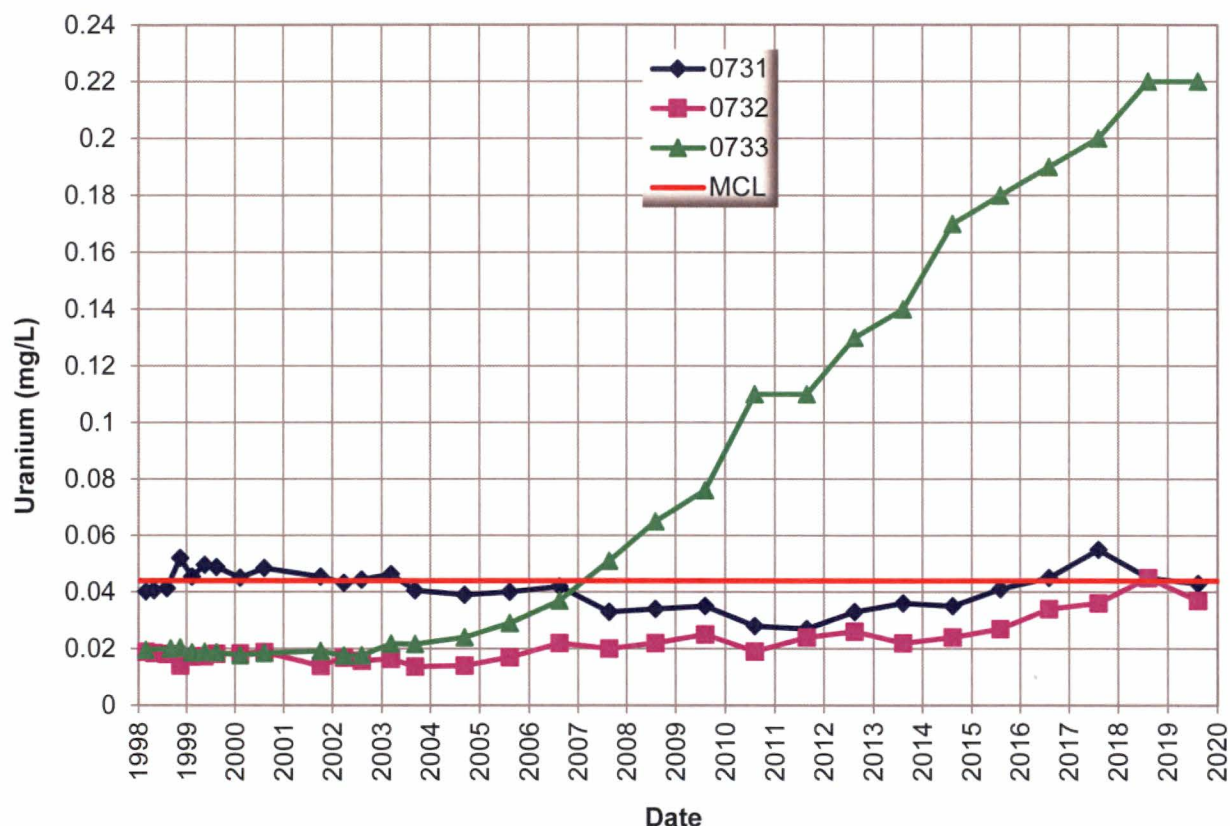
Figure 6-6. Uranium in Groundwater at the Grand Junction, Colorado, Disposal Site

Uranium concentrations in groundwater slightly exceeded the MCL of 0.044 mg/L in both paleochannel monitoring wells in 2018 and remained near the MCL in 2019. Mann-Kendall trend tests for uranium concentrations show a statistically increasing trend for all three wells from 2010 to 2019. Wells 0732 and 0733 also had statistically increasing trends since 2003, according to Mann-Kendall (Figure 6-6). Uranium concentrations in disposal cell monitoring well 0733 have increased from 0.02 mg/L in 2002 to 0.22 mg/L in 2019. Increasing uranium beneath the disposal cell is coinciding with the addition of residual radioactive material to the open cell. Relatively high concentrations of uranium and other constituents are expected for a well screened in the disposal cell tailings. Constituents of concern and water levels in well 0733 are not subject to compliance goals and are monitored solely for information-gathering purposes.

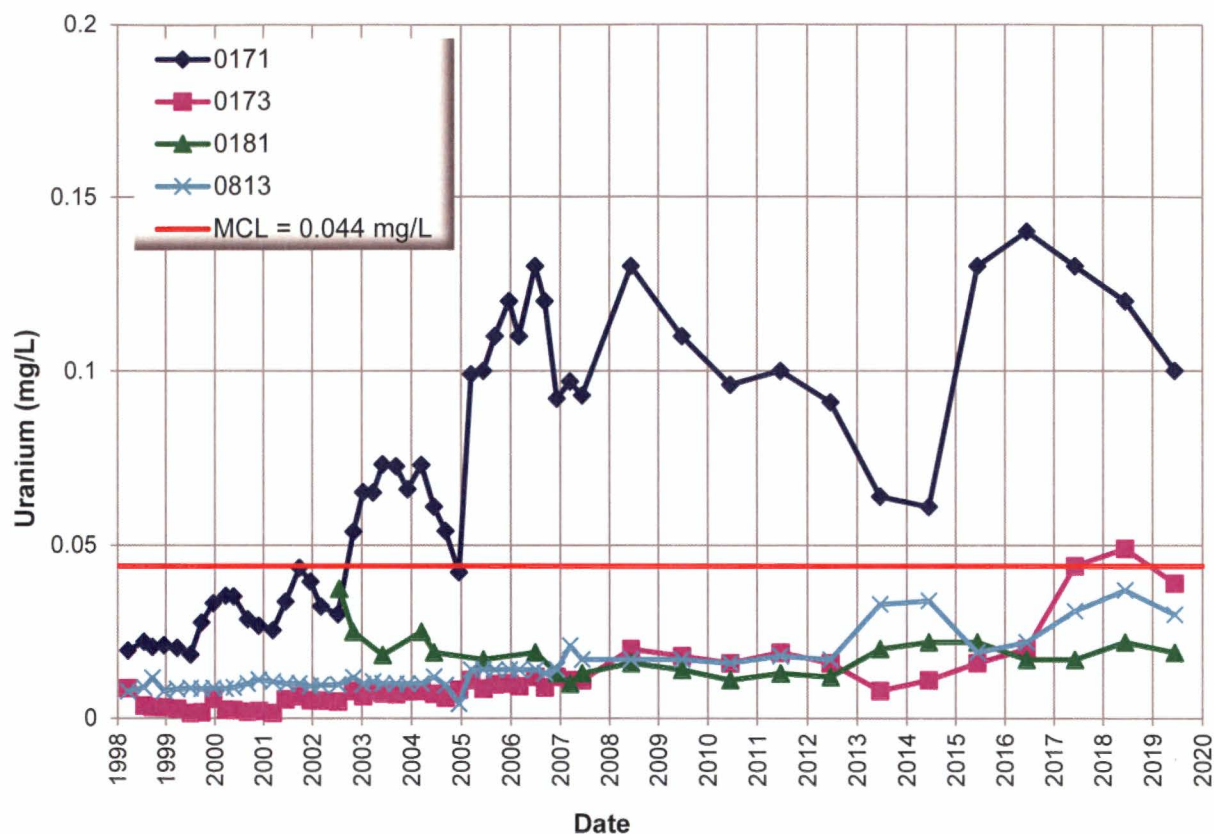
Figure 7-6. Uranium at Point of Compliance Wells at the Green River, Utah, Disposal Site

Uranium concentrations in POC well 0171 routinely exceed the UMTRCA and LTSP concentration limits, while the other POCs remain mostly below the MCL. Well 0173 exceeded 0.044mg/L once in 2018 (Figure 7-6). Uranium concentrations at POC well 0171 have varied considerably, ranging from a low of 0.0184 mg/L in 1999 to a high of 0.14 mg/L in 2016. The 2019 uranium concentrations were within the range of historical values for all POC wells.

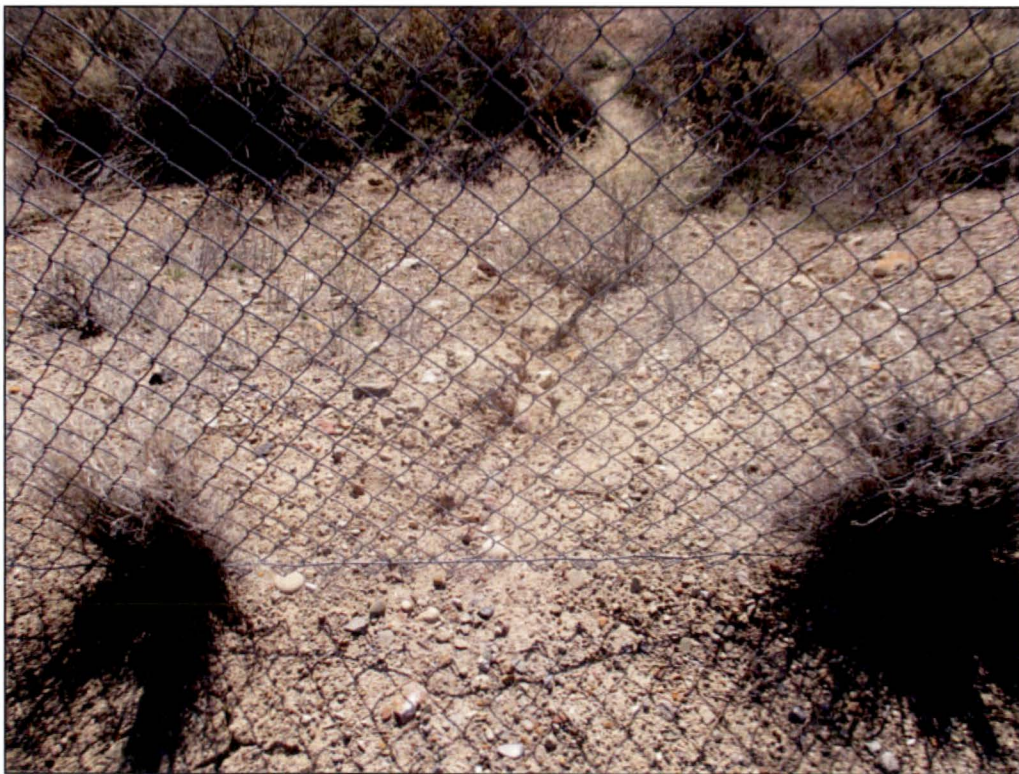
*PL-2. Minor Erosion Under Southeast Security Fence Line (Repaired)*

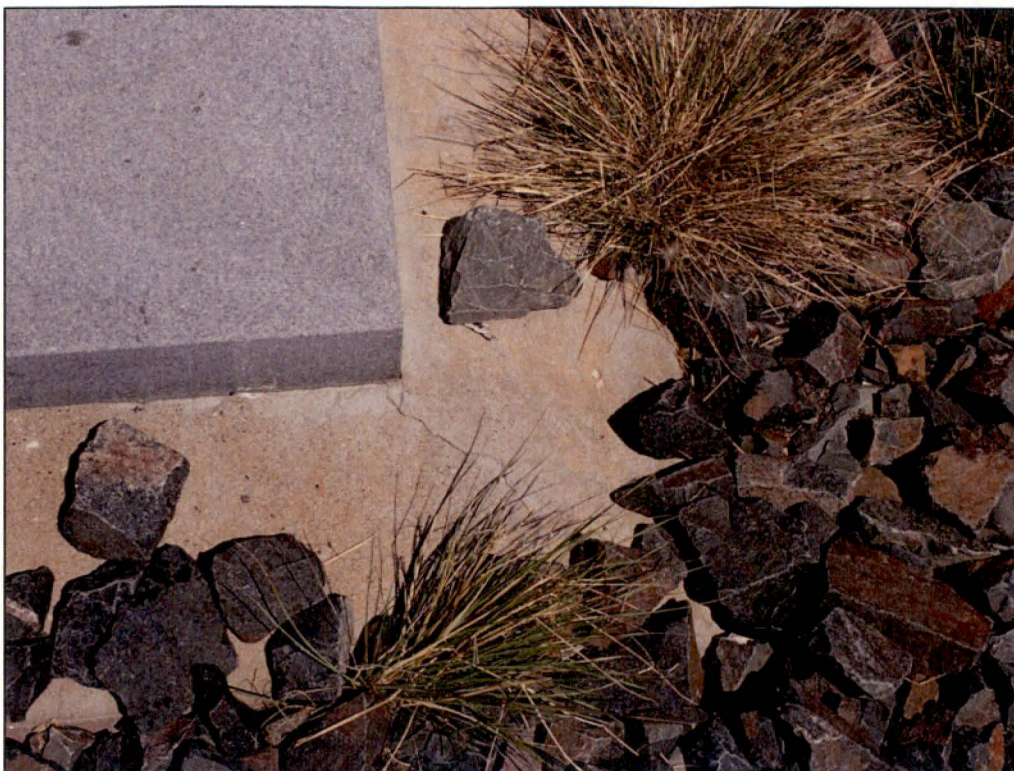
*PL-3. Small Crack in Base of Site Marker SMK-2*

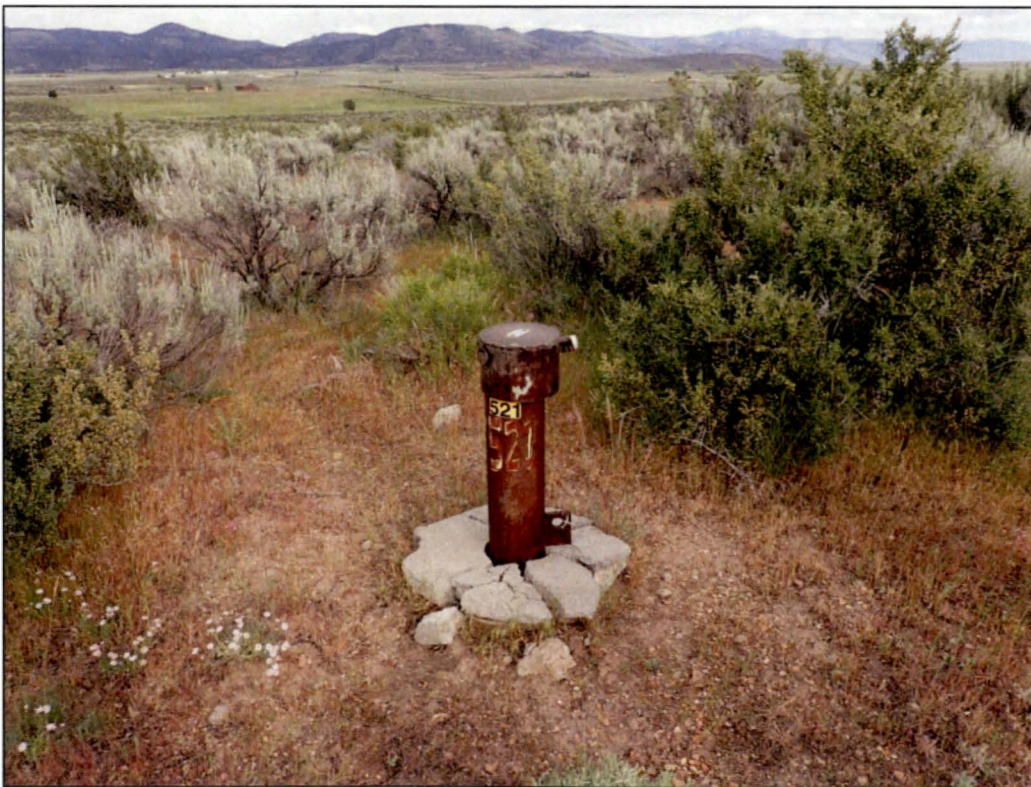
*PL-8. Monitoring Well 0521 with Cracked Concrete Base*
