**Department of Energy**

Subject: *2019 Annual Site Inspection and Monitoring Report for Uranium Mill Tailings  
Radiation Control Act Title I Disposal Sites*

Enclosed are seven copies of the *2019 Annual Inspection and Monitoring Report for Uranium Mill Tailings Radiation Control Act Title I Disposal Sites*. The report covers the annual inspections of the 19 Title I disposal sites managed by the U.S. Department of Energy Office of Legacy Management.

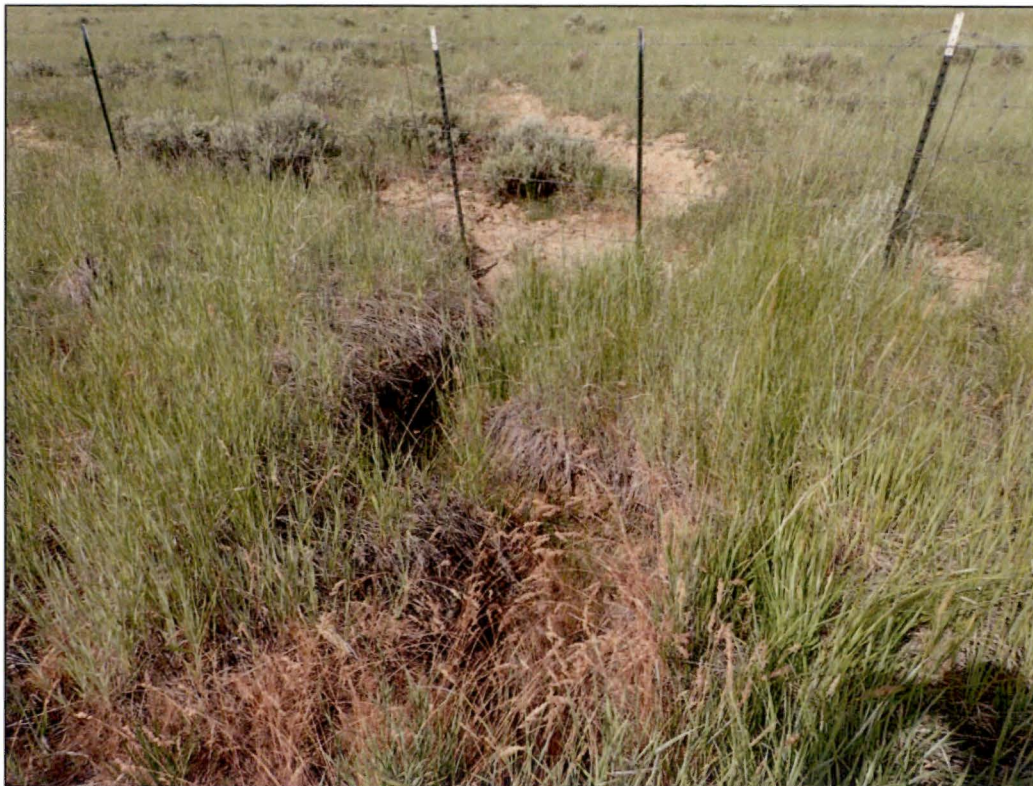
*PL-13. Gully Downgradient of Toe Drain 3*

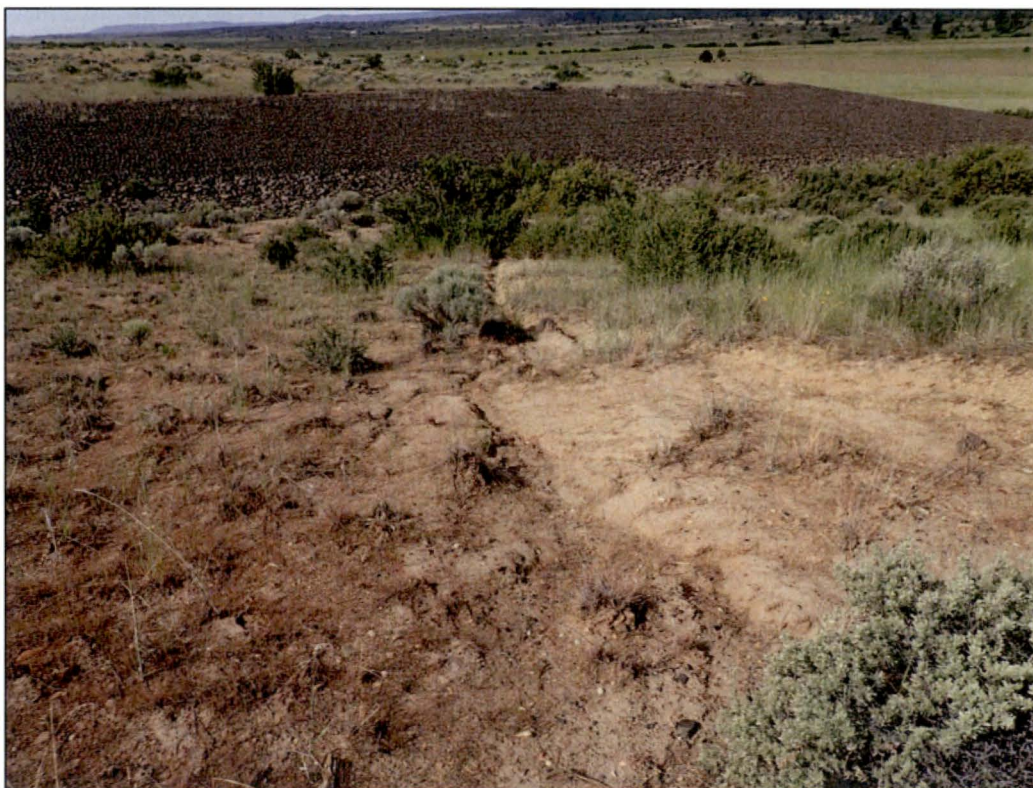
*PL-14. Erosion Rills North of Disposal Cell*
