## 10.0 Lowman, Idaho, Disposal Site

The Lowman, Idaho, Uranium Mill Tailings Radiation Control Act (UMTRCA) Title I Disposal Site (site) was inspected on June 13, 2019. No changes were observed on the disposal cell or in the associated drainage features. Inspectors identified a minor maintenance need but found no cause for a follow-up inspection. Groundwater monitoring is not required and was discontinued in 2004.

Figure 10-1. 2019 Annual Inspection Drawing for the Lowman, Idaho, Disposal Site

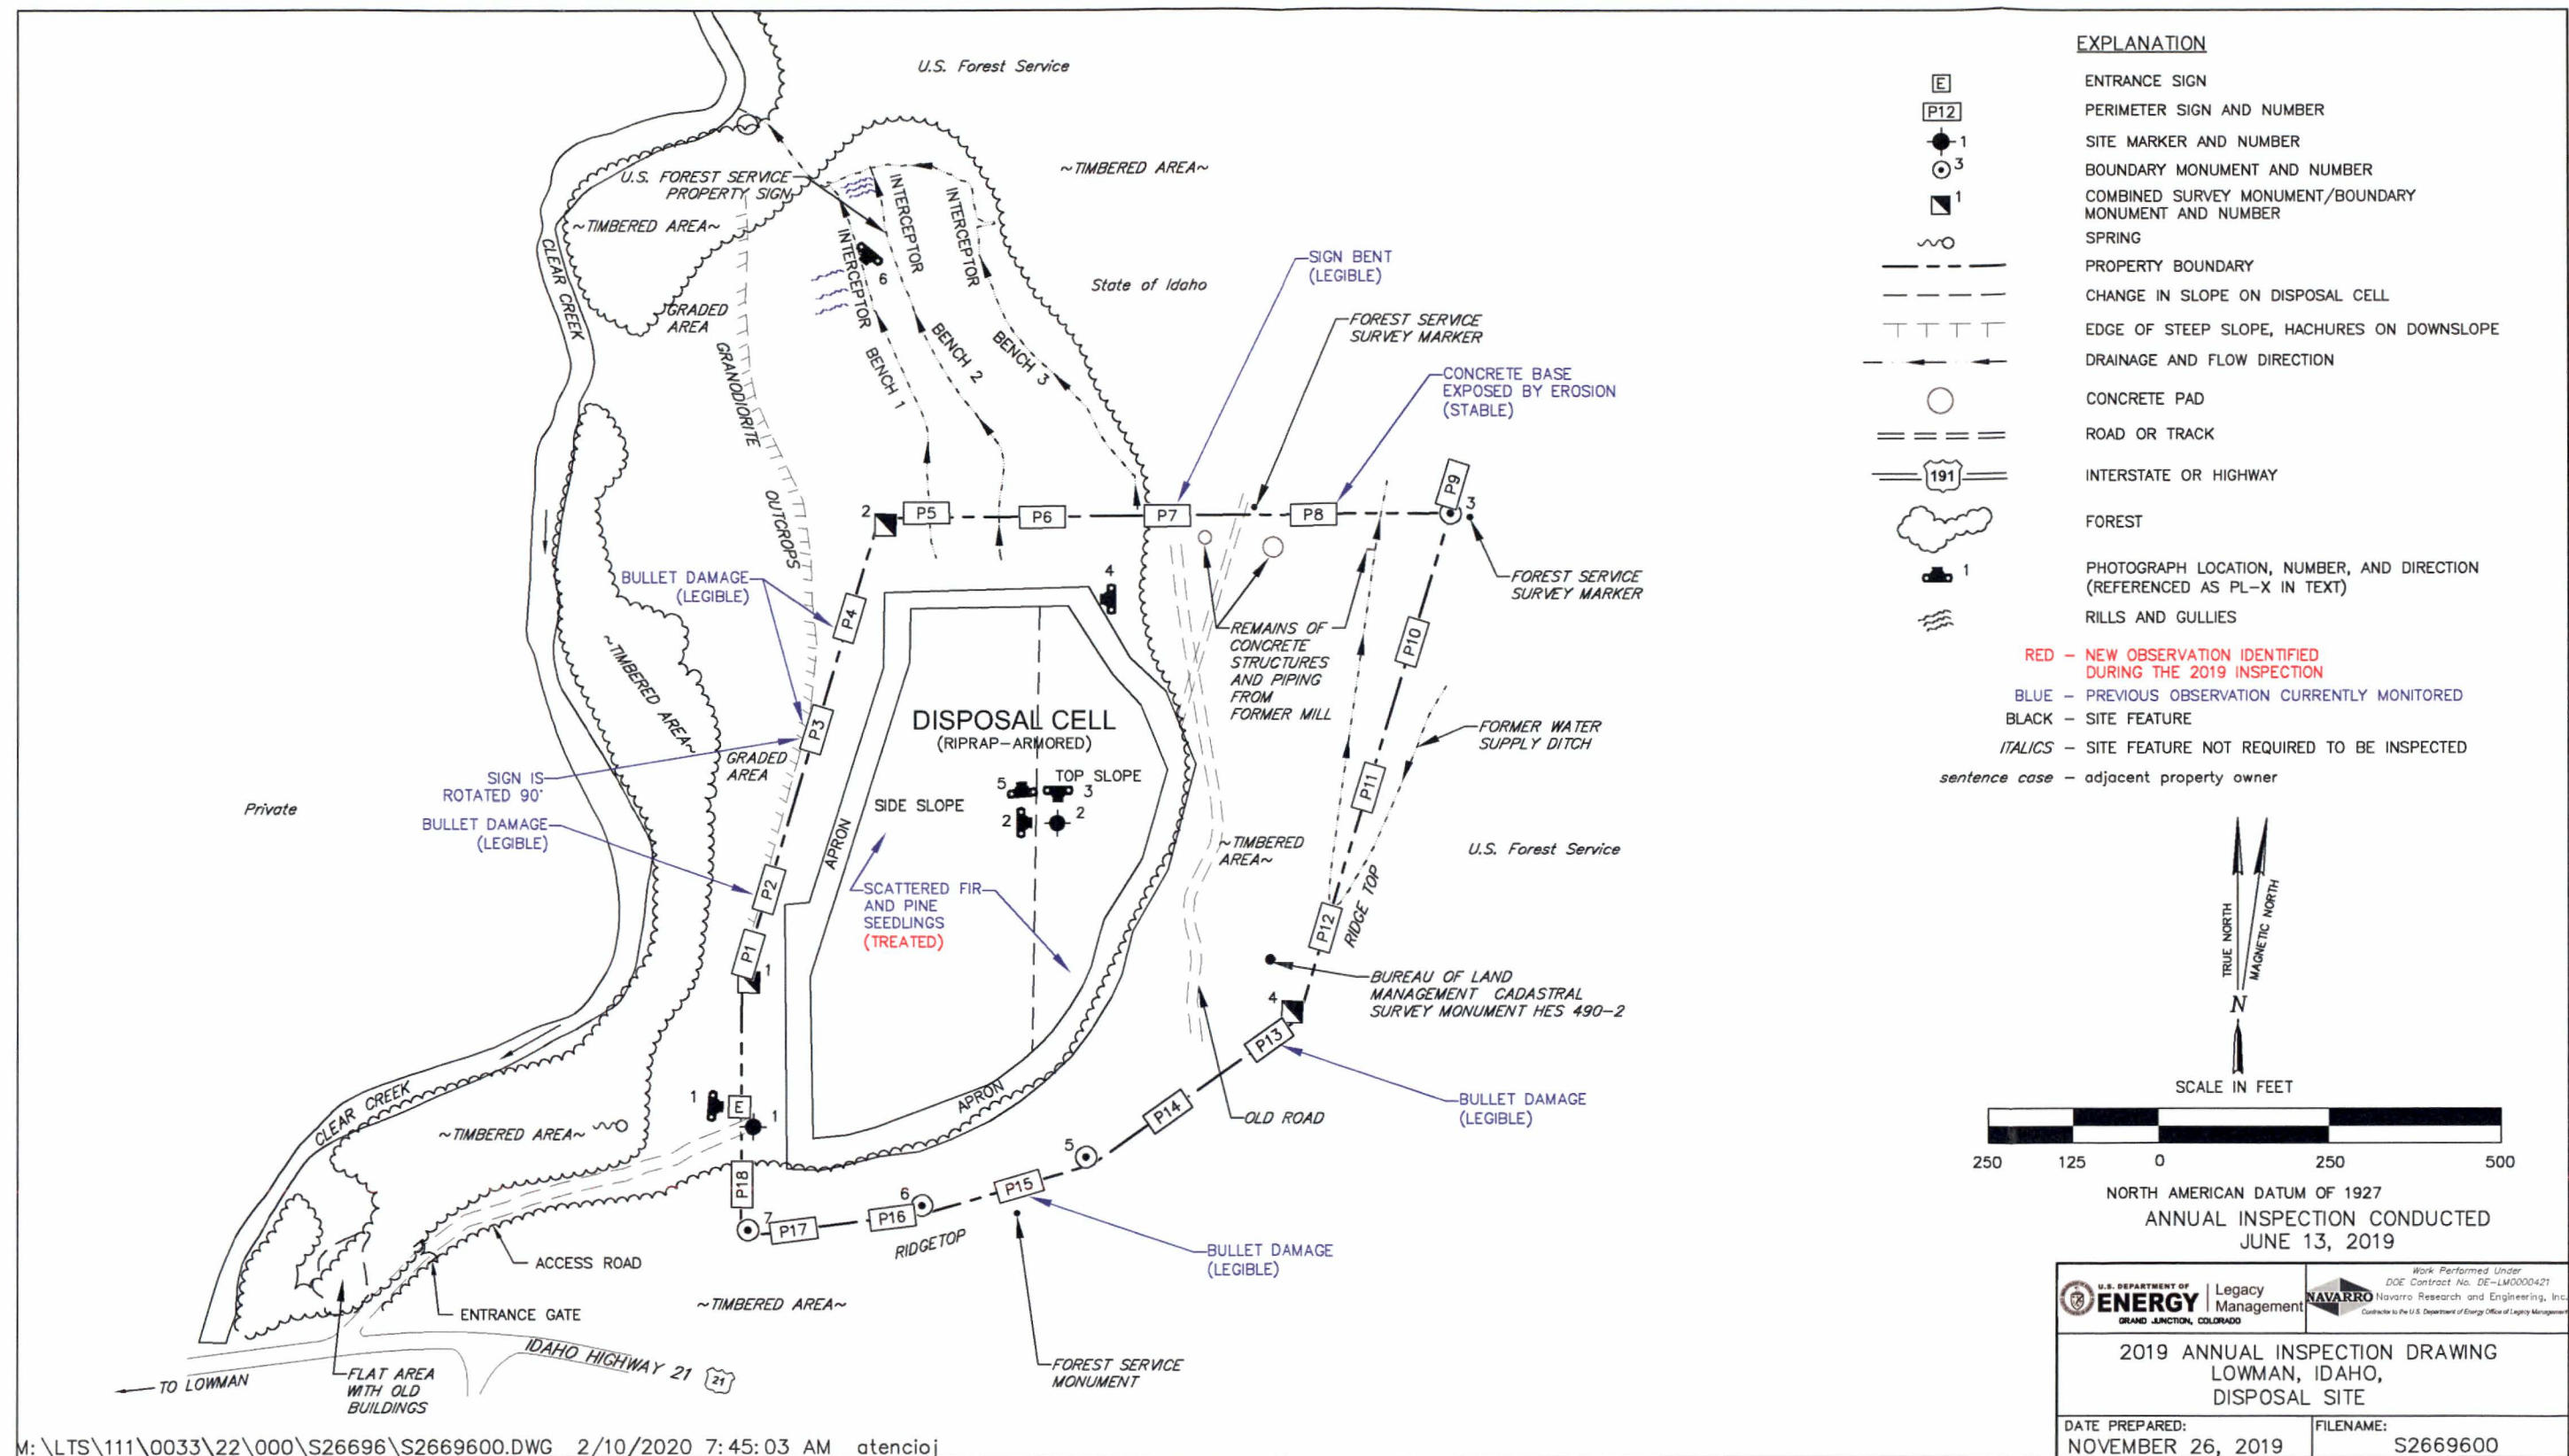
Figure 10-1 shows the locations of site features in black, including site surveillance features and inspection areas. Site features that are present but not required to be inspected are shown in italic font, and new observations identified during the 2019 annual inspection are shown in red. Observations from previous inspections that are currently monitored are shown in blue text. There were no new observations in 2019. Inspection results and recommended maintenance activities associated with site surveillance features are described in the following subsections. Photographs to support specific observations are identified in the text and in Figure 10-1 by photograph location (PL) numbers. The photographs and photograph log are presented in Section 10.10.

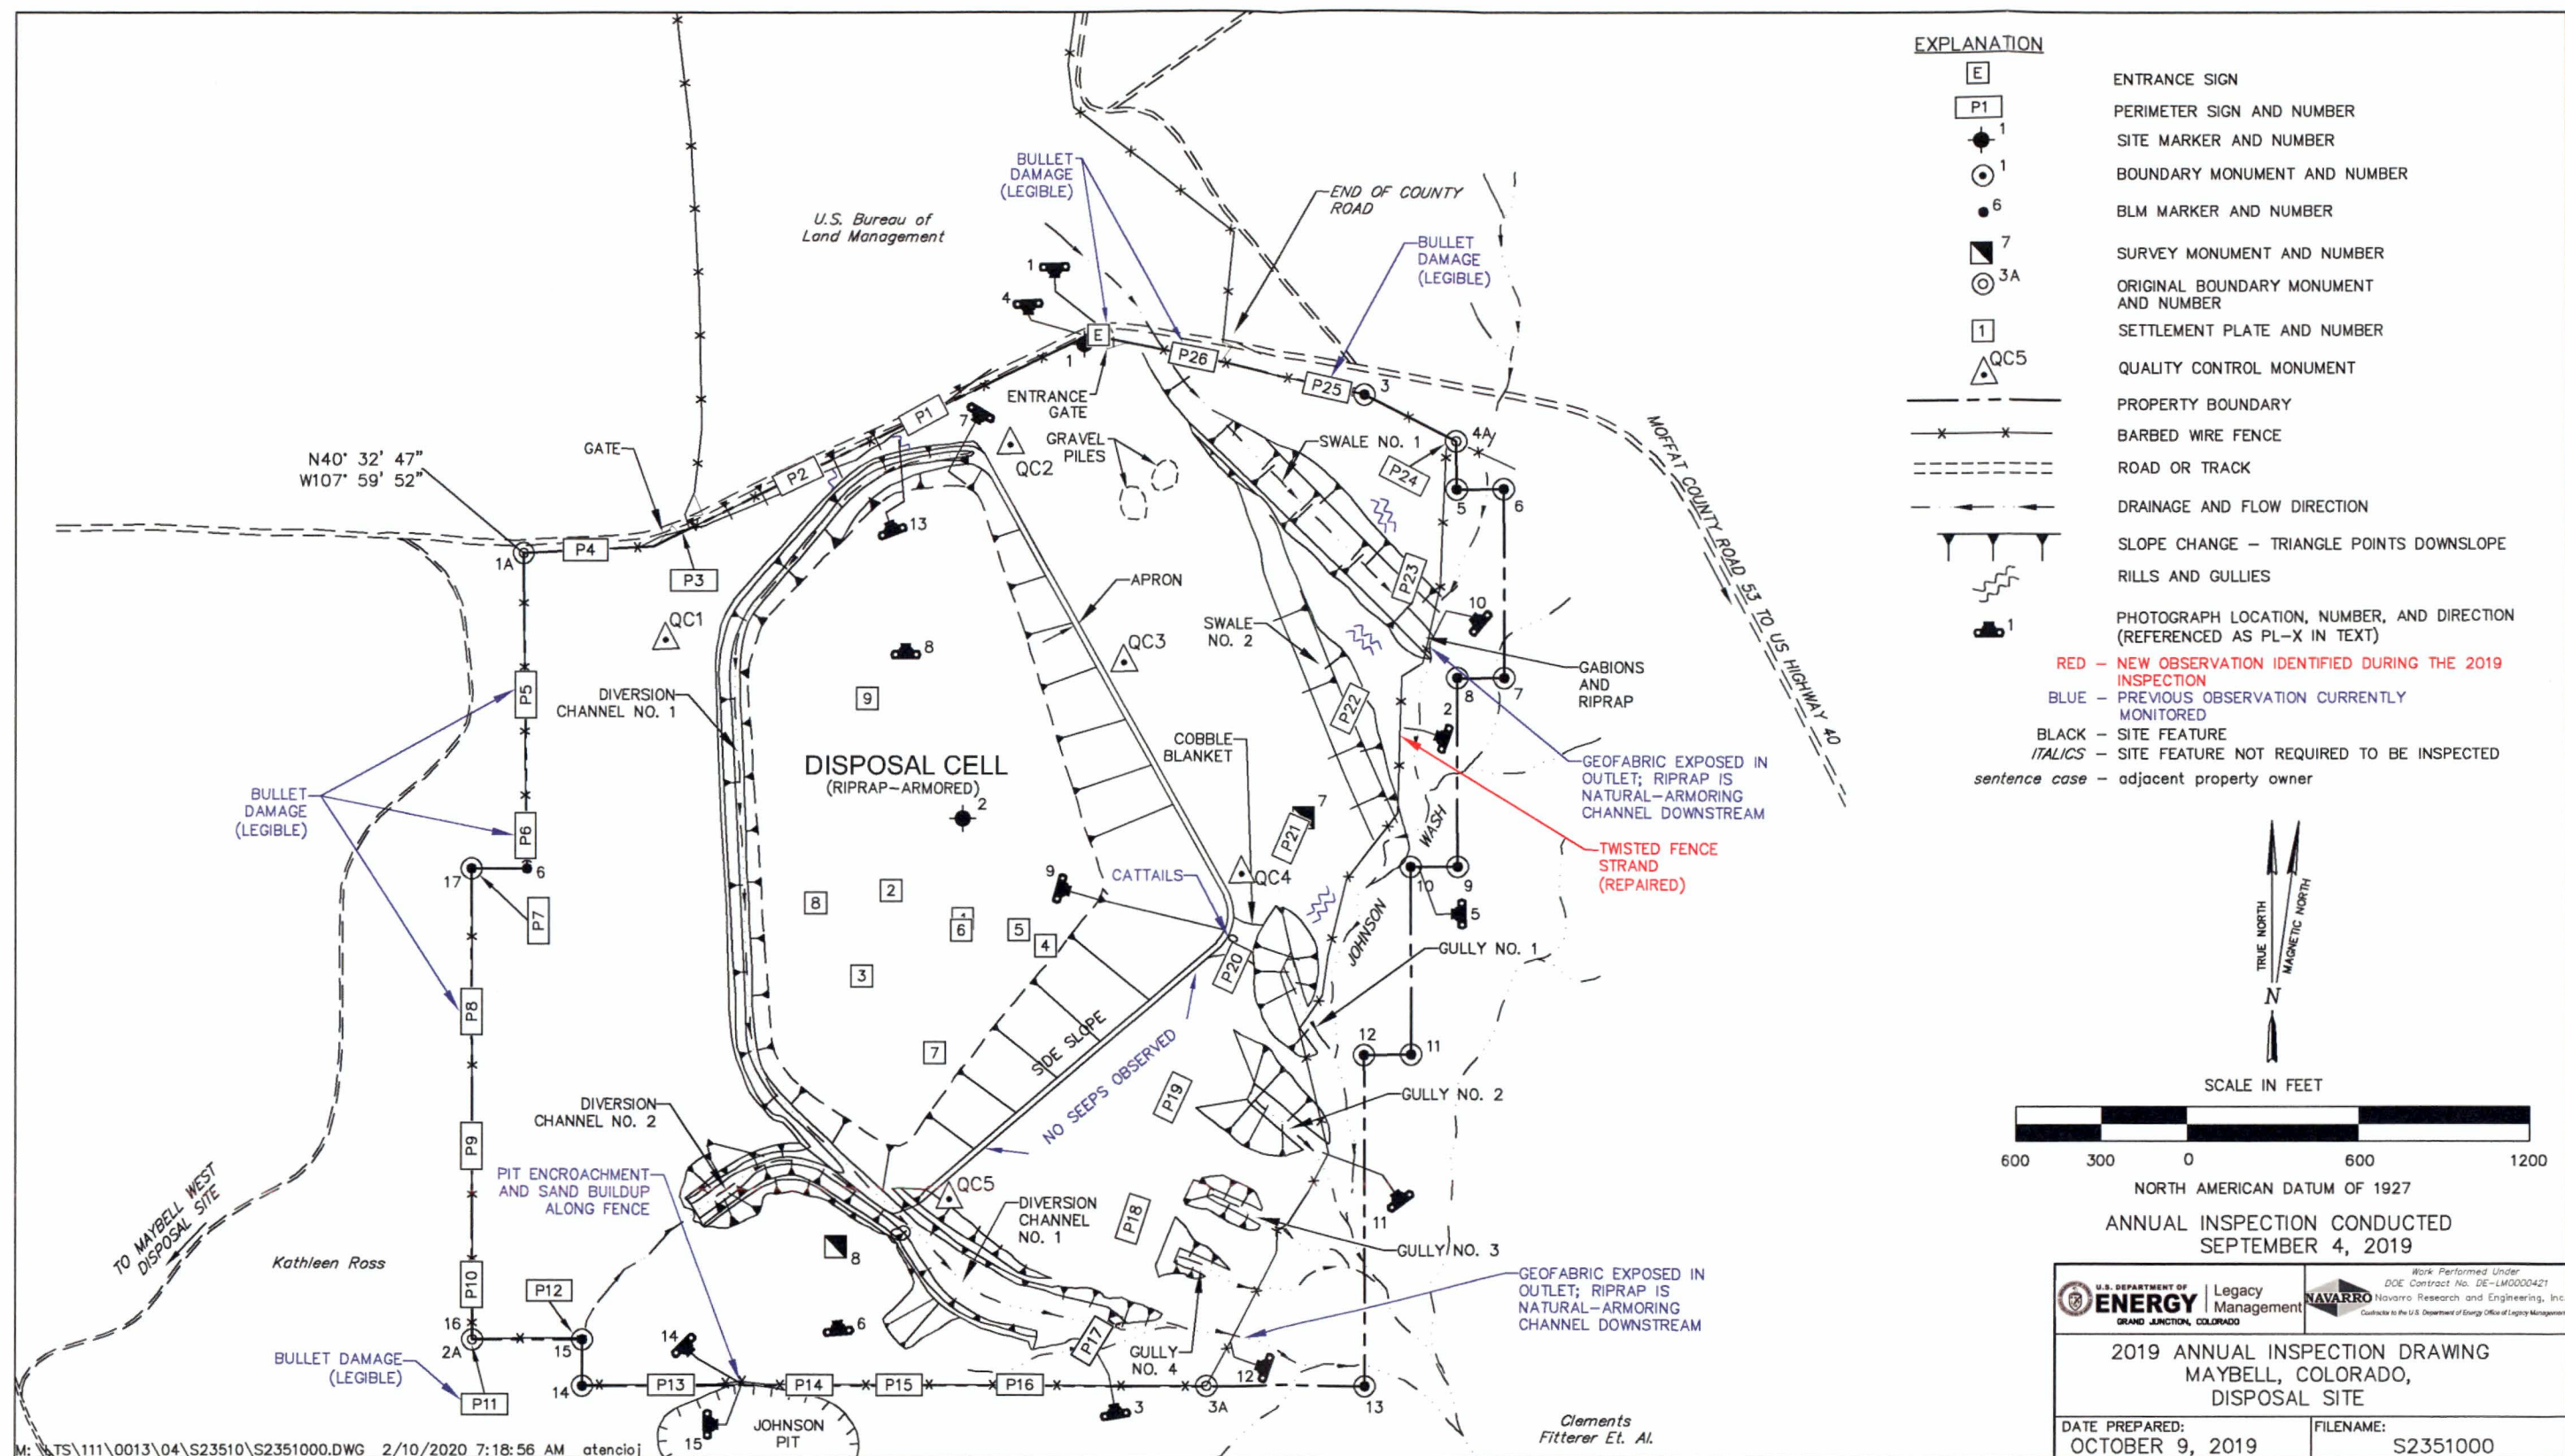
Figure 11-1. 2019 Annual Inspection Drawing for the Maybell, Colorado, Disposal Site

Figure 11-1 shows the locations of site features in black, including site surveillance features and inspection areas. Site features that are present but not required to be inspected are shown in italic font. Observations from previous inspections that are currently monitored are shown in blue text, and new observations identified during the 2019 annual inspection are shown in red. Inspection results and recommended maintenance activities associated with site surveillance features are included in the following subsections. Photographs to support specific observations are identified in the text and in Figure 11-1 by photograph location (PL) numbers. The photographs and photograph log are presented in Section 11.10.

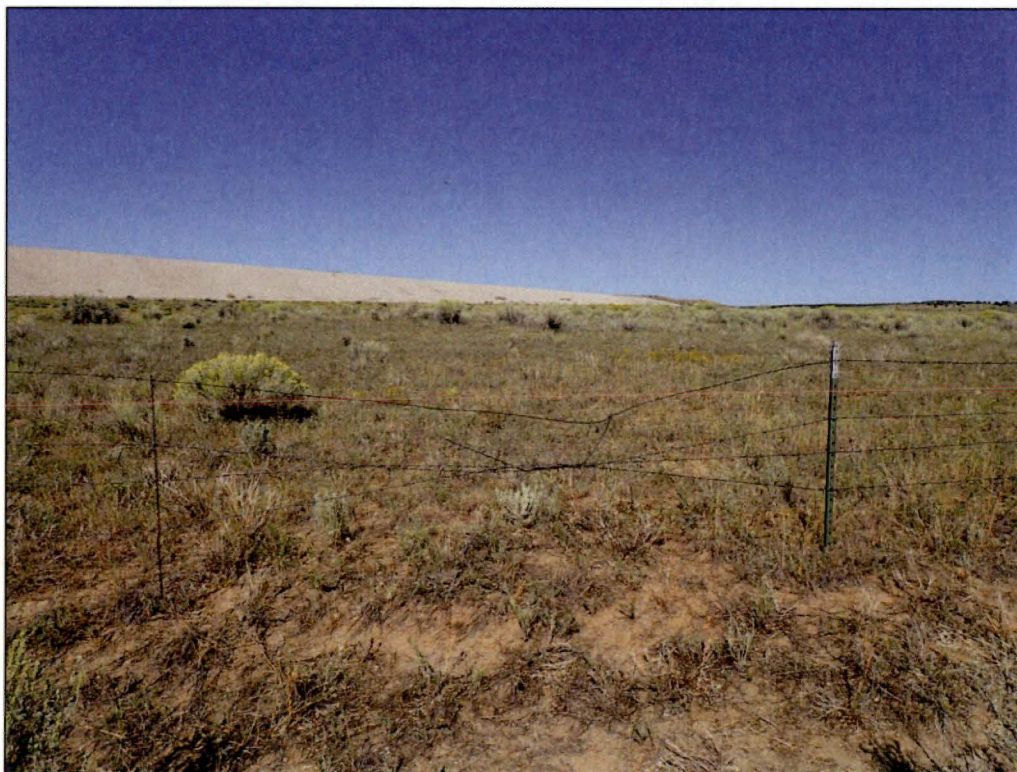
To facilitate land management by LM, a four-strand barbed-wire perimeter fence encloses the disposal cell, drainage structures, and much of the site. The site is in wintering grounds frequented by big-game animals (primarily pronghorn, deer, and elk) and is also surrounded by open range used to graze cattle. As a result, minor damage to the perimeter fence periodically occurs. Perimeter fence strands were twisted in one location (PL-2) and were repaired following the inspection.

*PL-2. Twisted Perimeter Fence Strands (Repaired)*

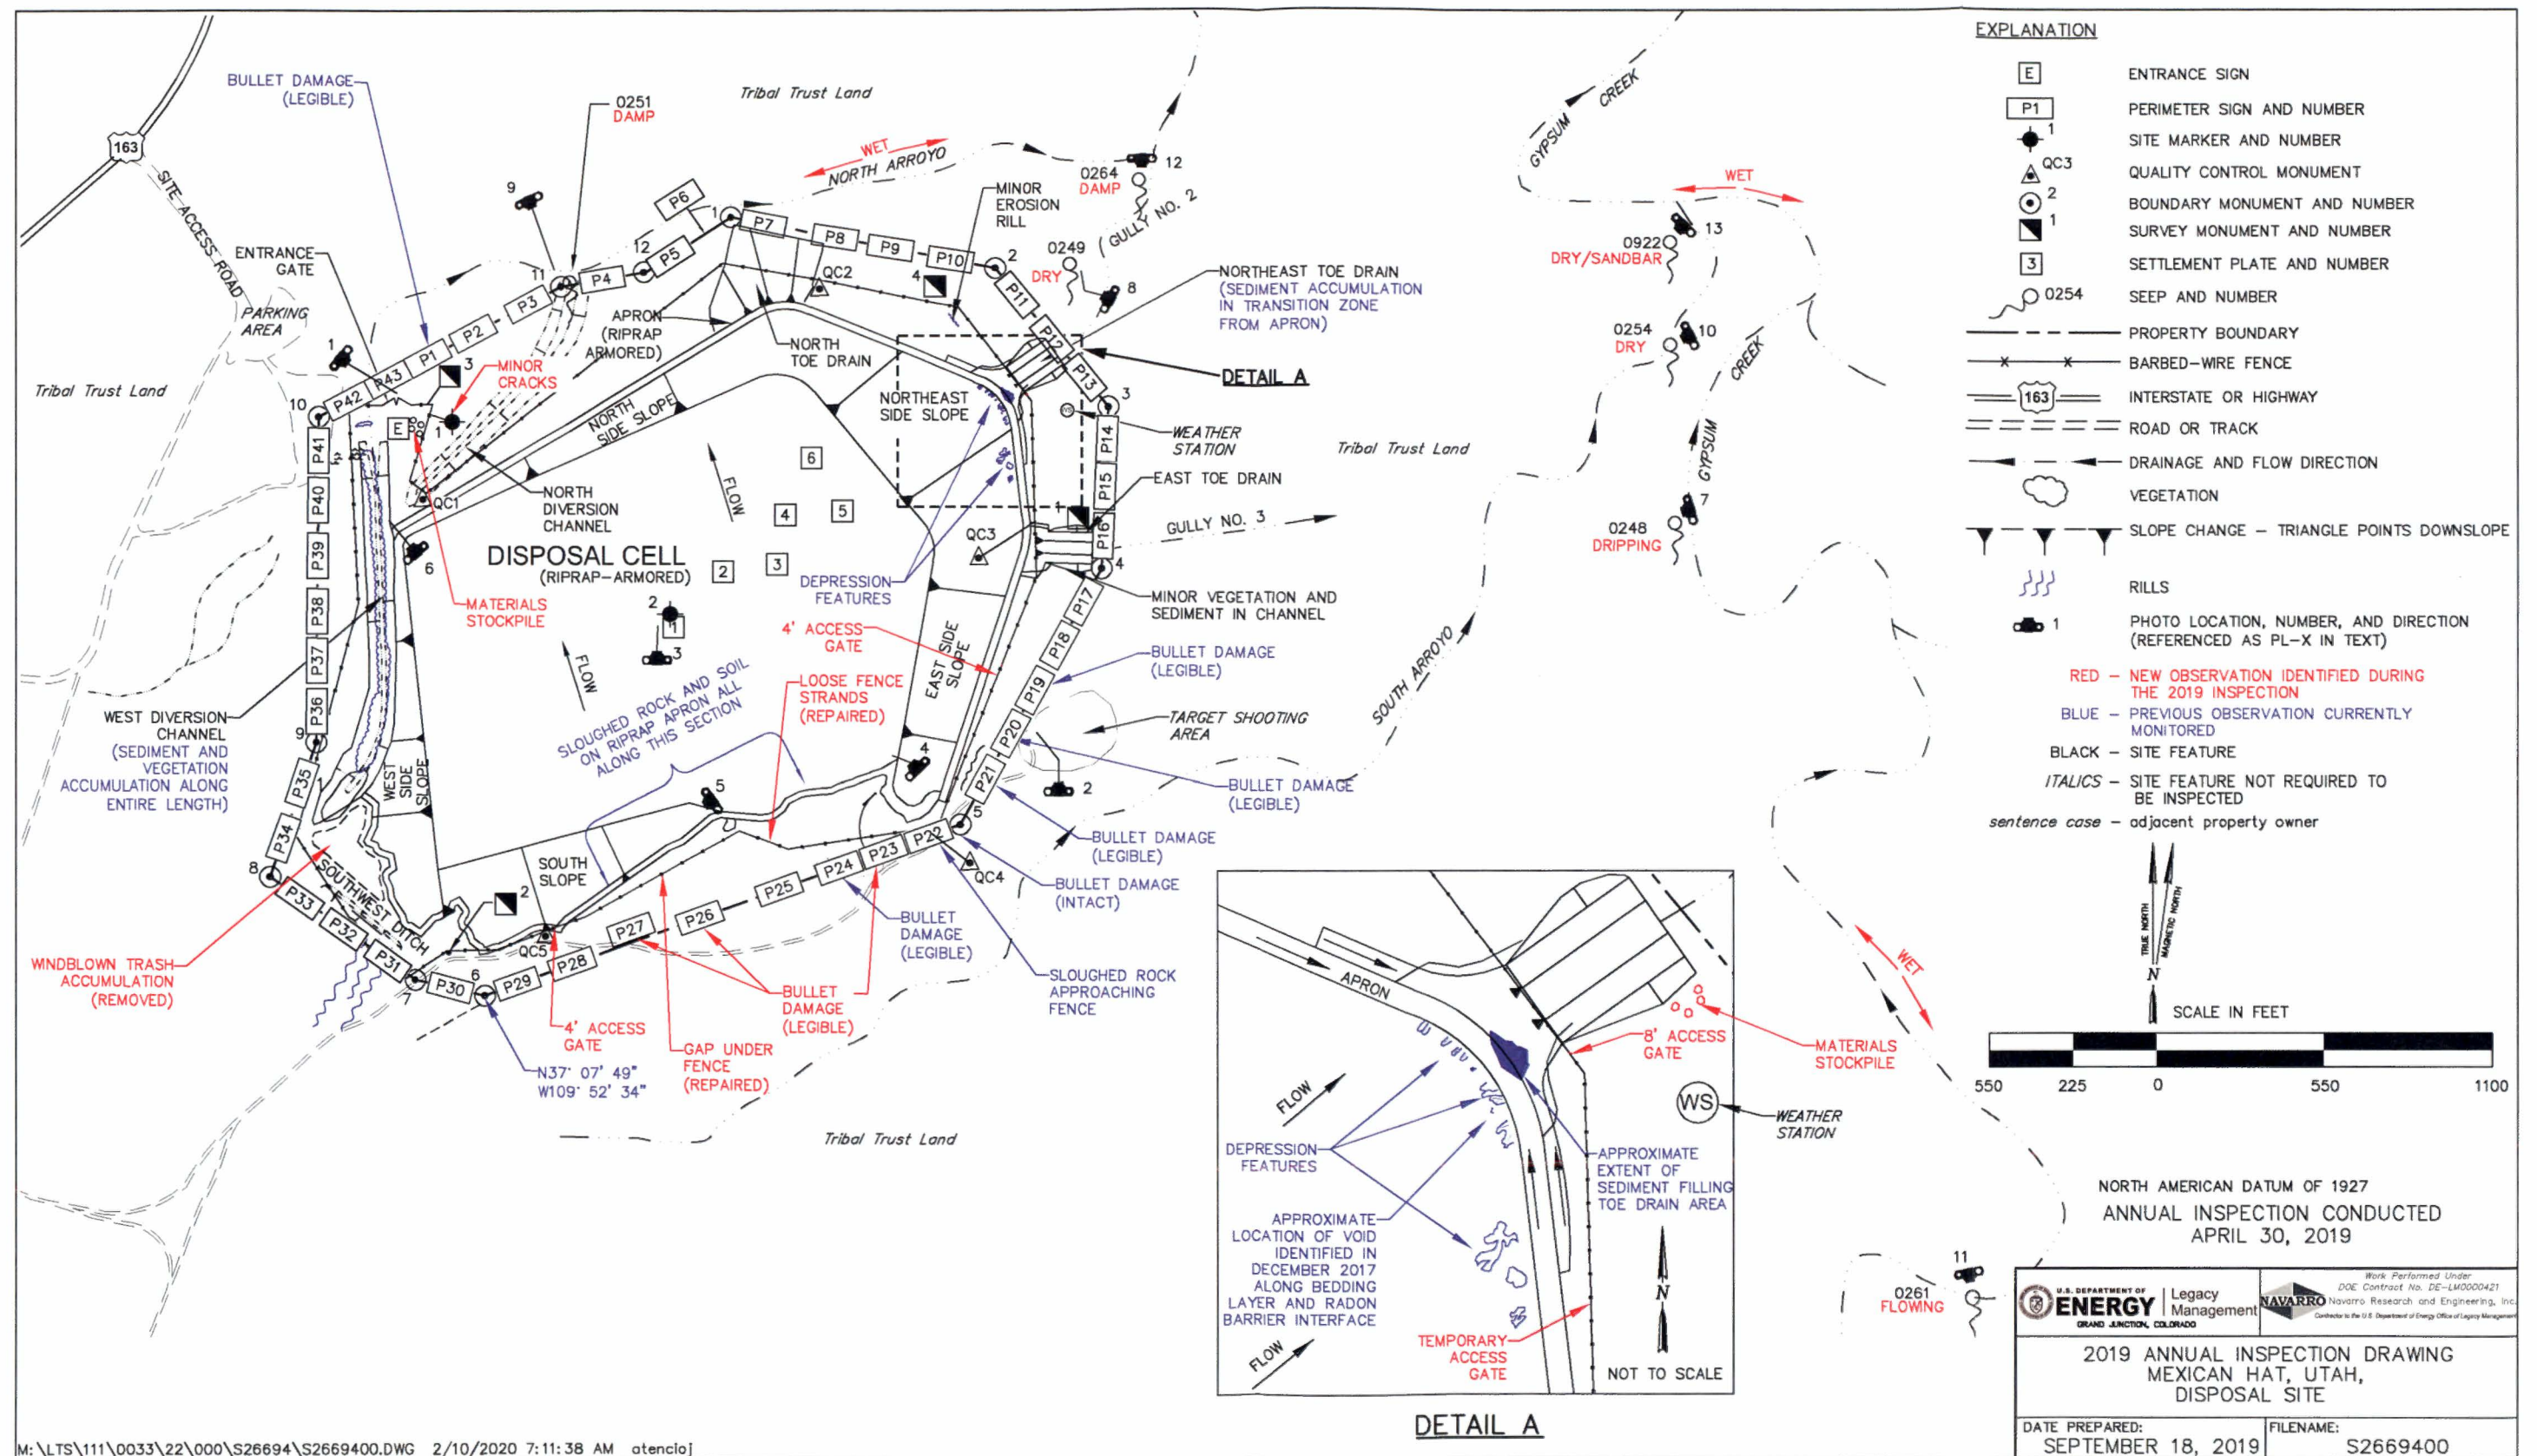
Figure 12-1. 2019 Annual Inspection Drawing for the Mexican Hat, Utah, Disposal Site

Figure 12-1 shows the locations of site features in black, including site surveillance features and inspection areas. Site features that are present but not required to be inspected are shown in italics. Observations from previous inspections that are currently monitored are shown in blue text, and new observations identified during the 2019 annual inspection are shown in red. Inspection results and recommended maintenance activities associated with site surveillance features are included in the following subsections. Photographs to support specific observations are identified in the text and in Figure 12-1 by photograph location (PL) numbers. The photographs and photograph log are presented in Section 12.10.

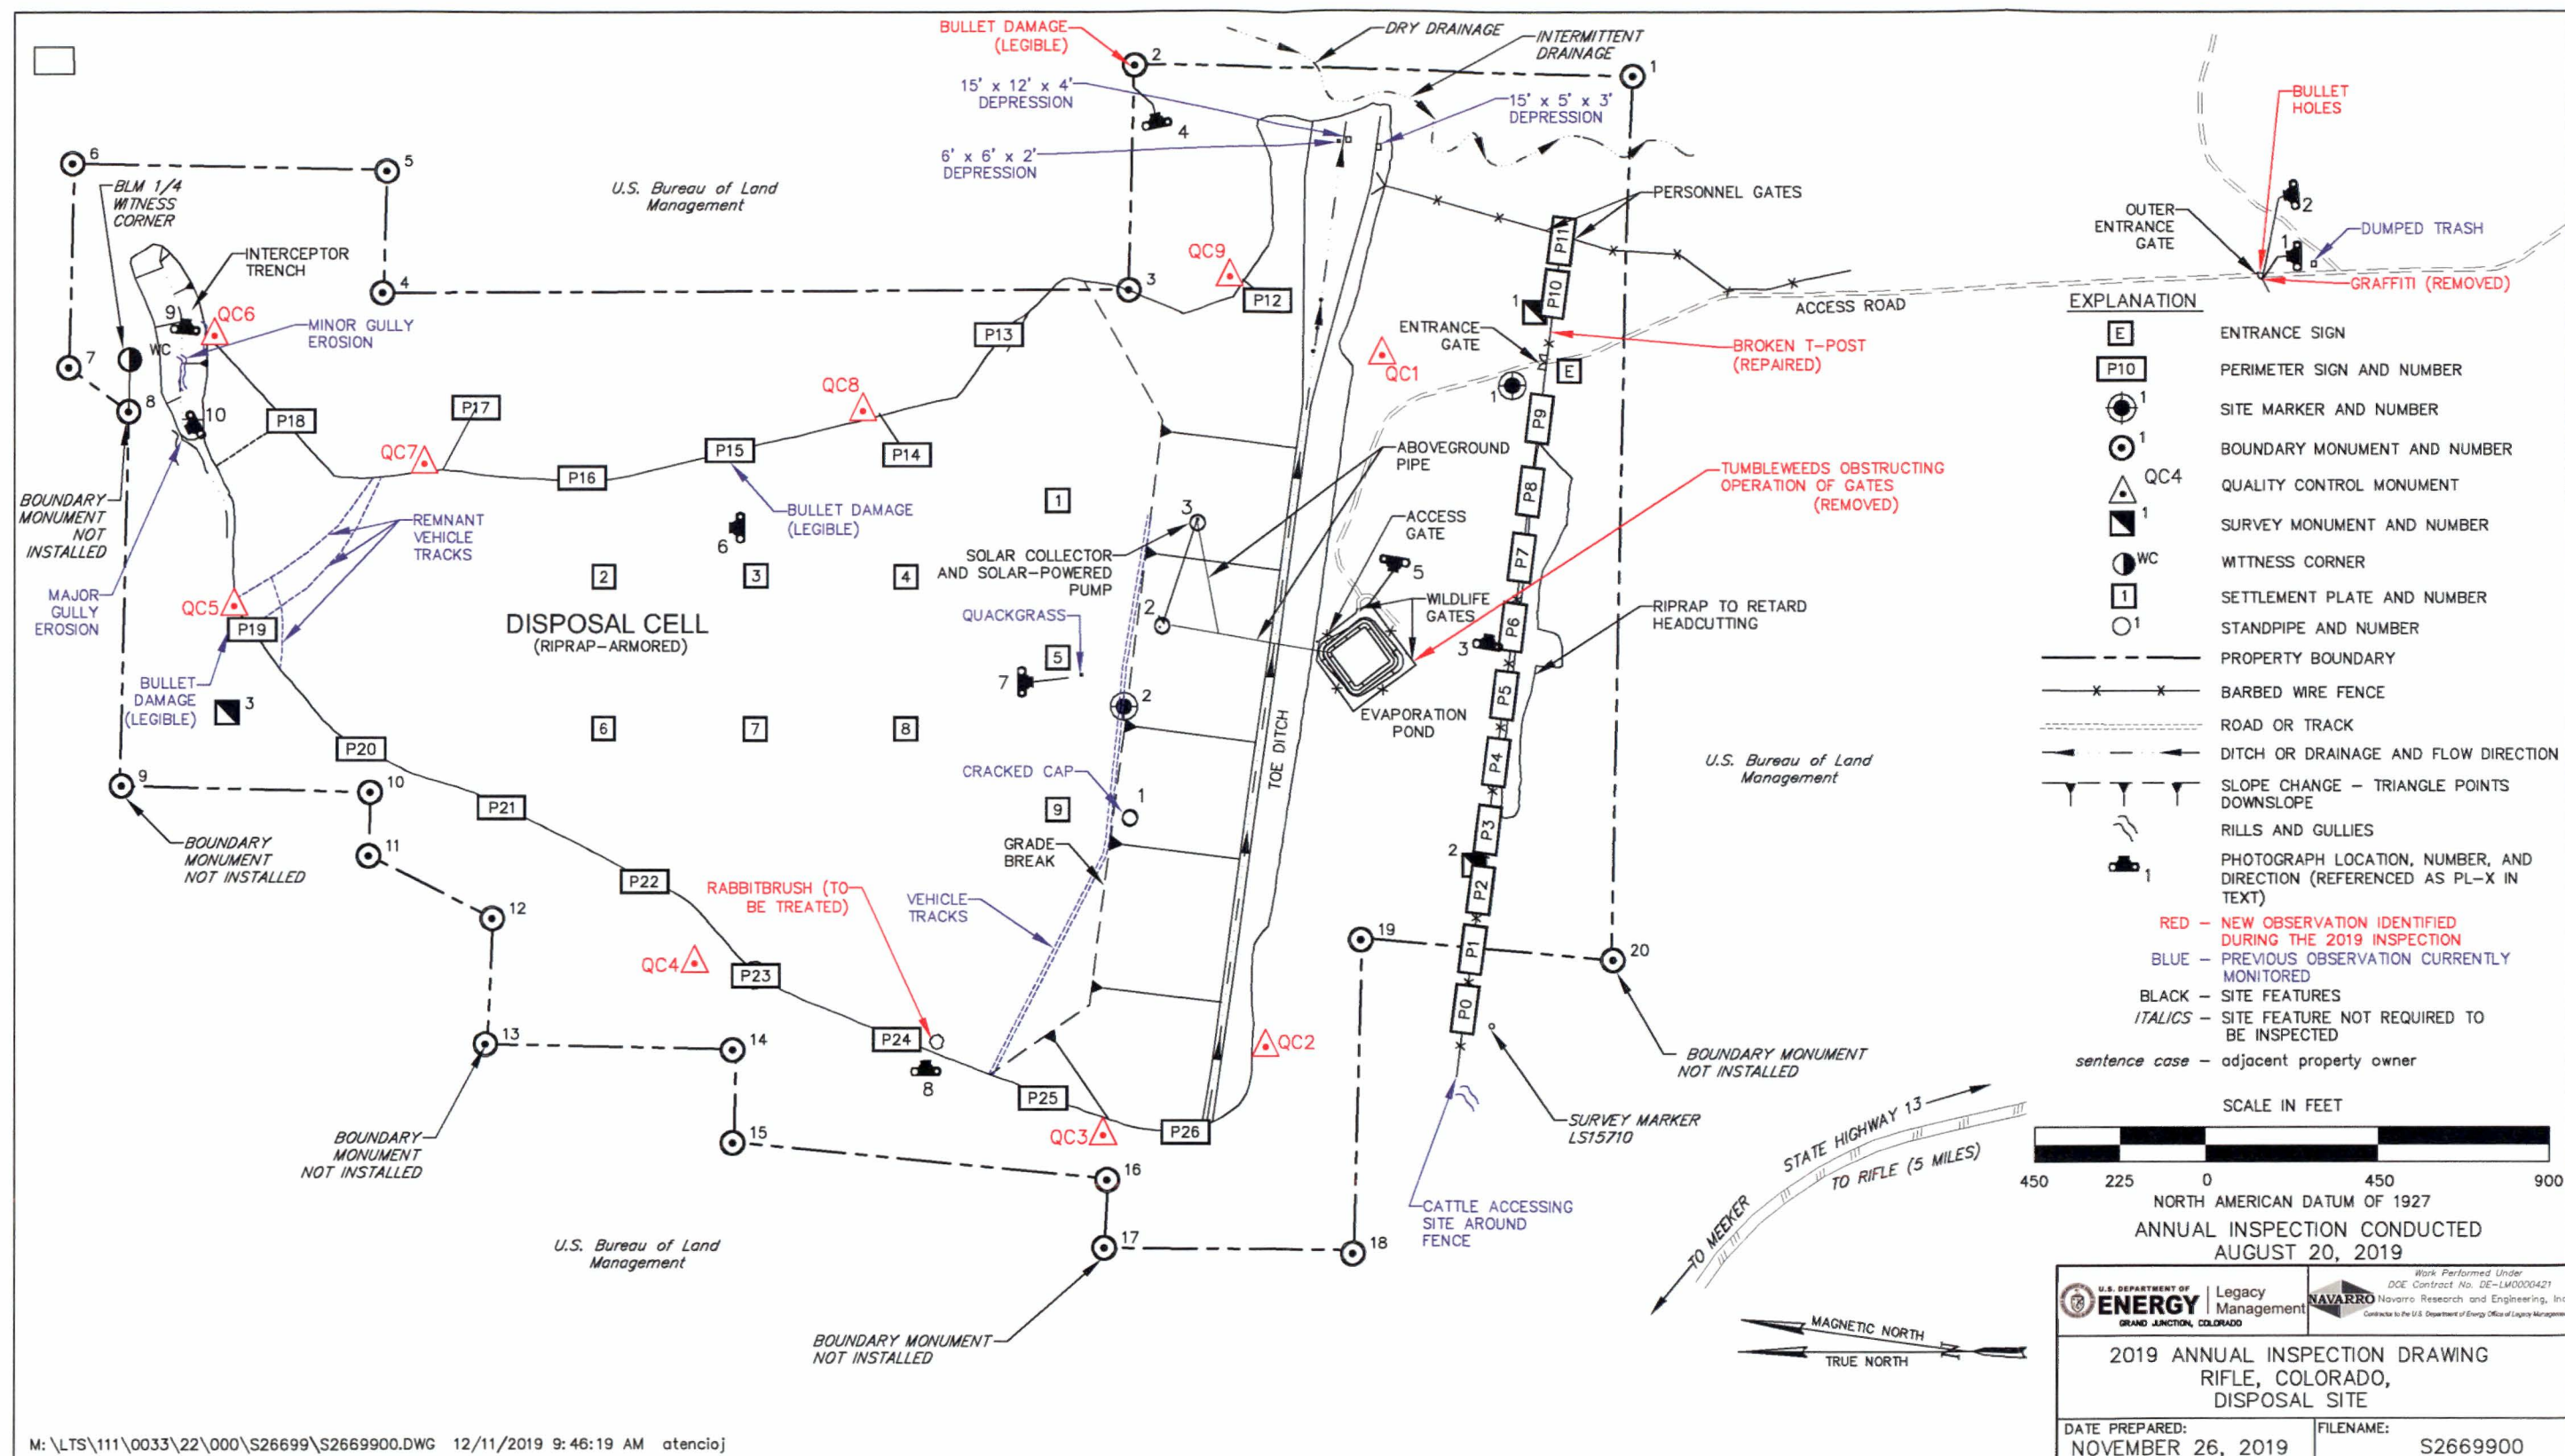
Figure 14-1. 2019 Annual Inspection Drawing for the Rifle, Colorado, Disposal Site

A four-strand barbed-wire stock fence at the south end of the site extends to the edge of steep-sided arroyos that bound the site on the east and west. In previous years, livestock associated with an adjacent BLM grazing allotment would go around the fence to graze onsite vegetation. Results from the 2019 inspection showed vegetation regrowth in the livestock trails that were identified in the 2018 inspection (PL-3). One T-post near survey monument SM-1 was broken at the base of the ground surface; however, it is unclear if this was caused by livestock. The T-post was repaired following the 2019 inspection. Two barbed-wire personnel gates are at the southeast corner of the site. The northern gate, which provides access to DOE property, was locked with a chain and padlock. The southern gate is left open to allow livestock on the adjacent BLM allotment to pass through the fence.

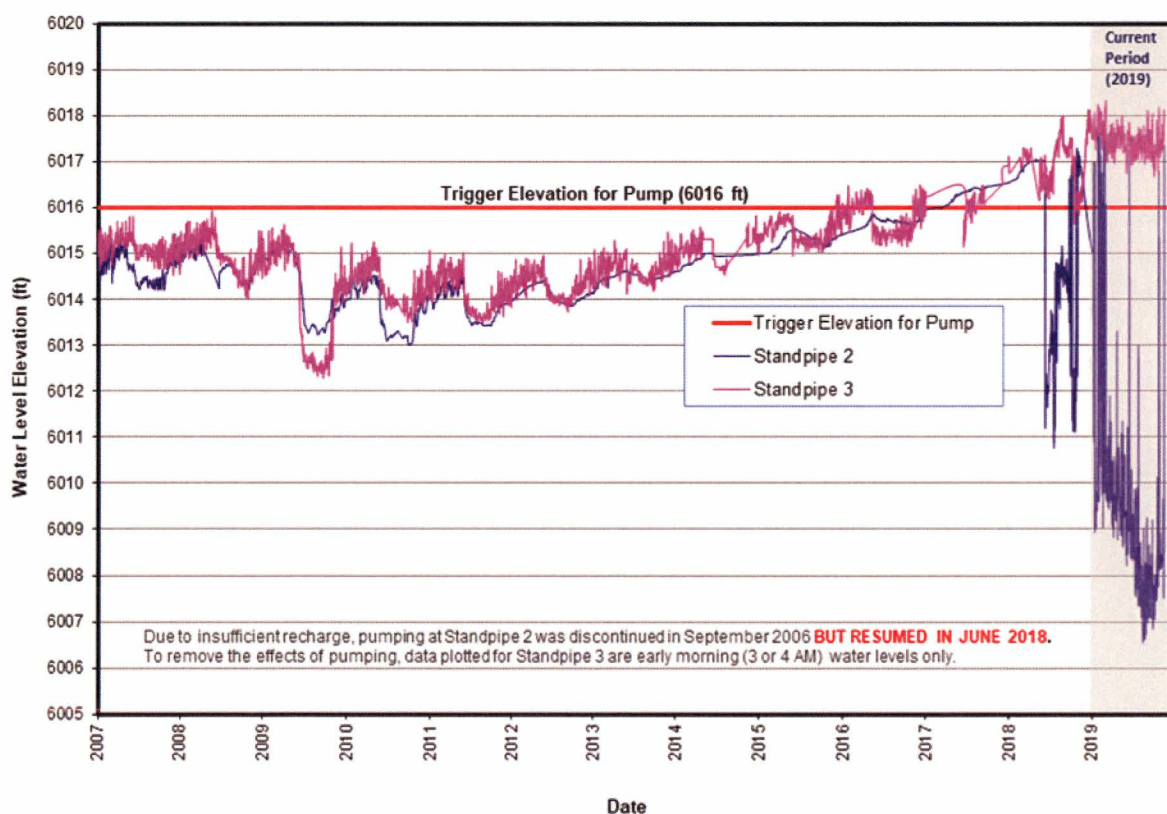
Figure 14-2. Disposal Cell Pore-Water Levels in Standpipes 2 and 3 at the Rifle, Colorado, Disposal Site

Data fluctuations in standpipe 2 observed in 2018 and 2019 are due to the restart of pumping and various equipment and instrumentation maintenance repairs. Downhole video in both standpipes revealed significant fouling in the screened interval. Redevelopment of the standpipe 2 to remove mineral scale and biogrowth is planned for 2020. LM will investigate the cause of the rising trend and will develop mitigation actions as appropriate.

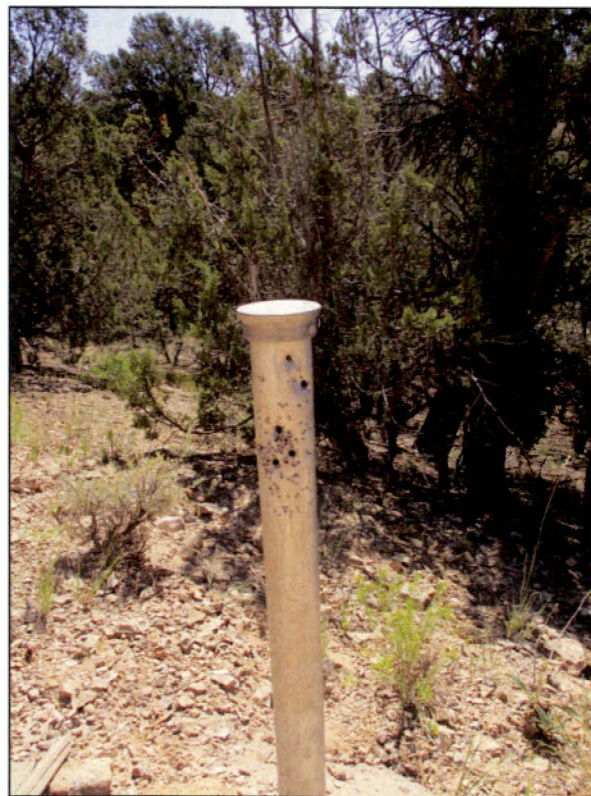
*PL-4. Bullet Damage (Legible) in Boundary Monument BM-2*

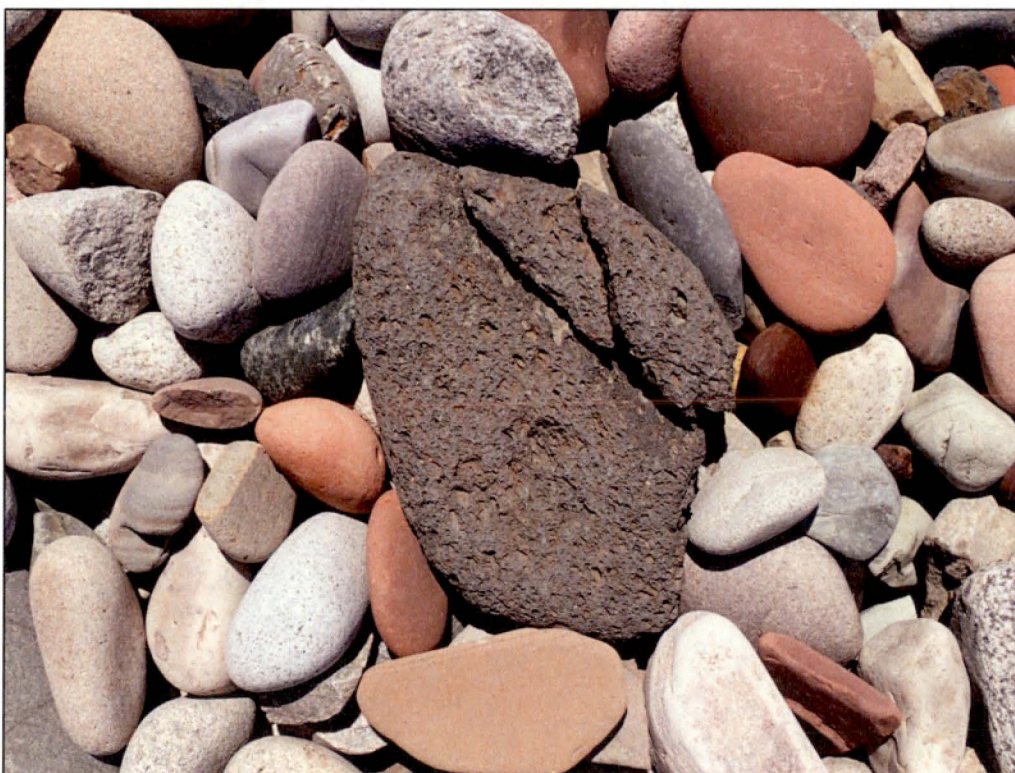
*PL-6. Fractured Rock on Disposal Cell Top*

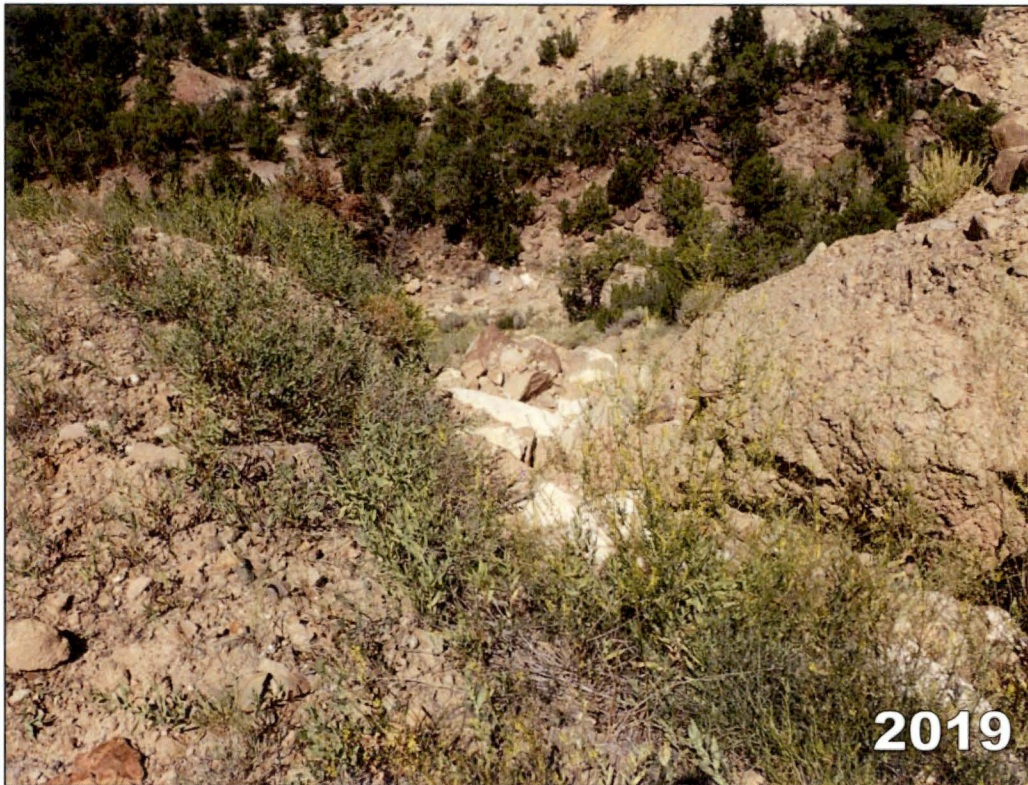
*PL-10. (a) Erosion in Interceptor Trench Outfall Channel—2019*

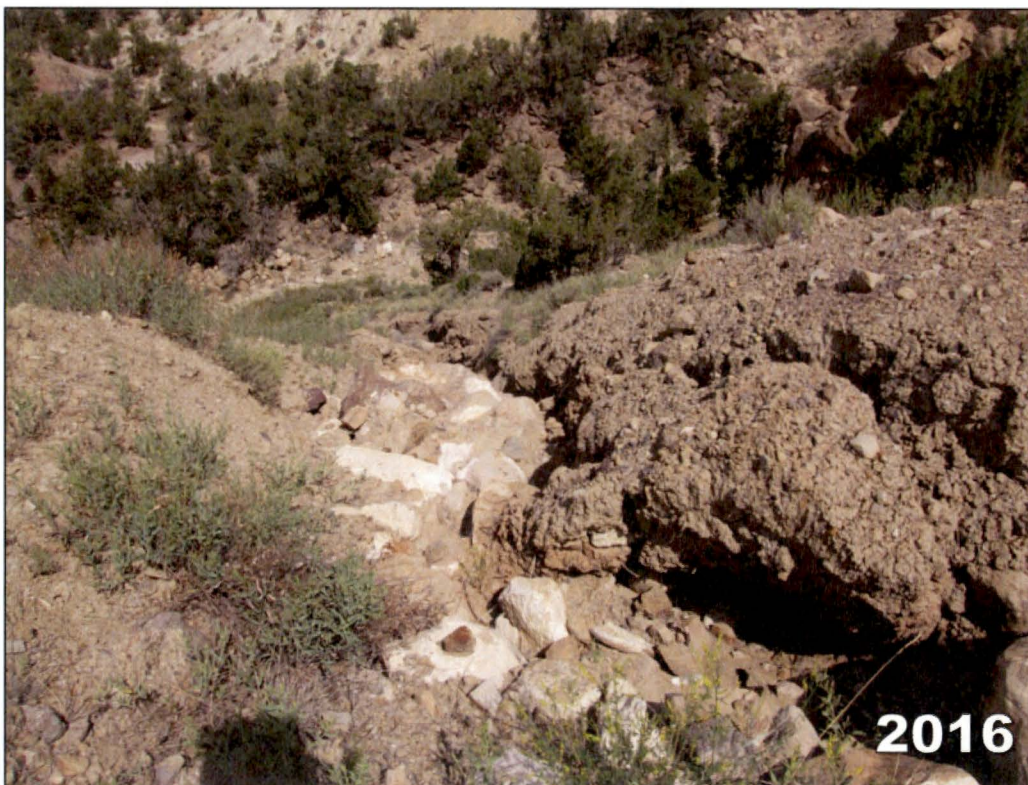
*PL-10. (b) Erosion in Interceptor Trench Outfall Channel—2016 Photo for Comparison*

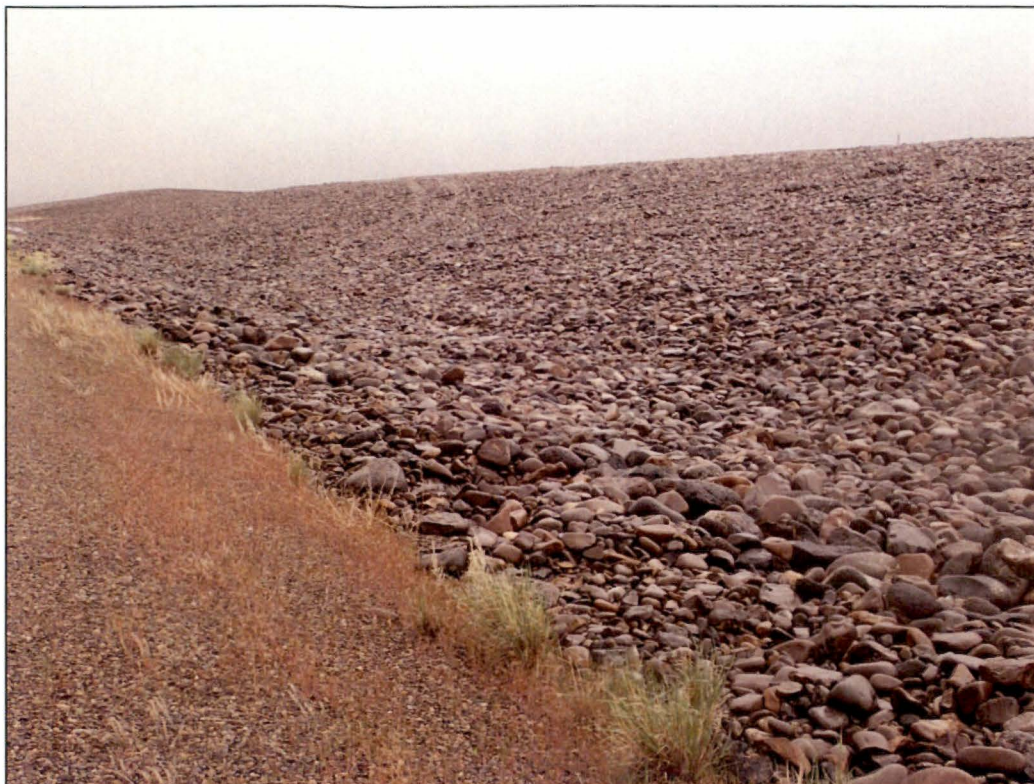
*PL-3. Tracks Observed on East Side Slope of Disposal Cell*

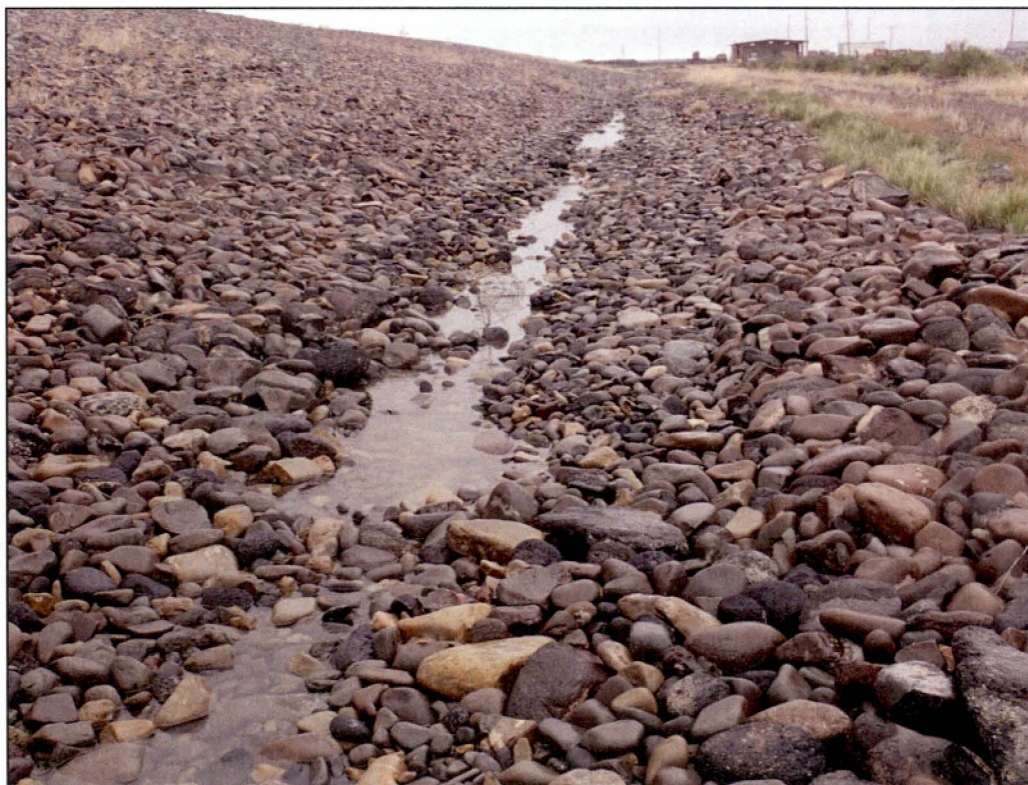
*PL-15. Standing Water in Disposal Cell Toe Drainage*
