## 10.0 Lowman, Idaho, Disposal Site

The Lowman, Idaho, Uranium Mill Tailings Radiation Control Act (UMTRCA) Title I Disposal Site (site) was inspected on June 13, 2019. No changes were observed on the disposal cell or in the associated drainage features. Inspectors identified a minor maintenance need but found no cause for a follow-up inspection. Groundwater monitoring is not required and was discontinued in 2004.

Figure 10-1. 2019 Annual Inspection Drawing for the Lowman, Idaho, Disposal Site

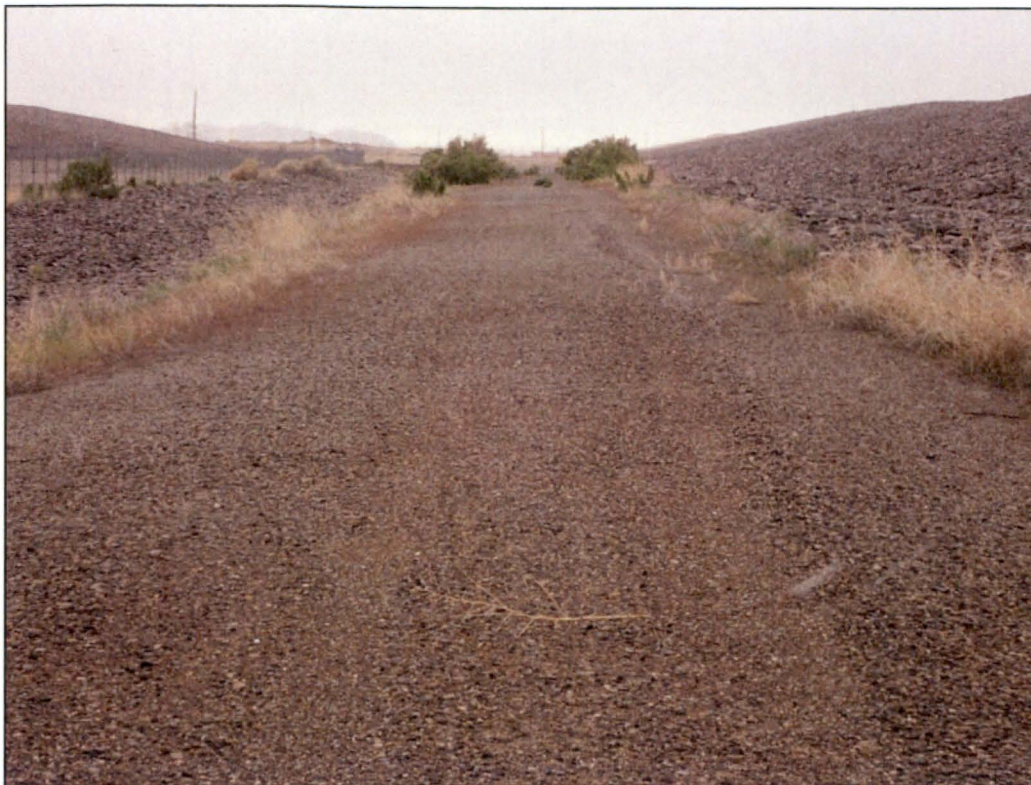
*PL-16. Saltbush Growing on Disposal Cell Access Road*

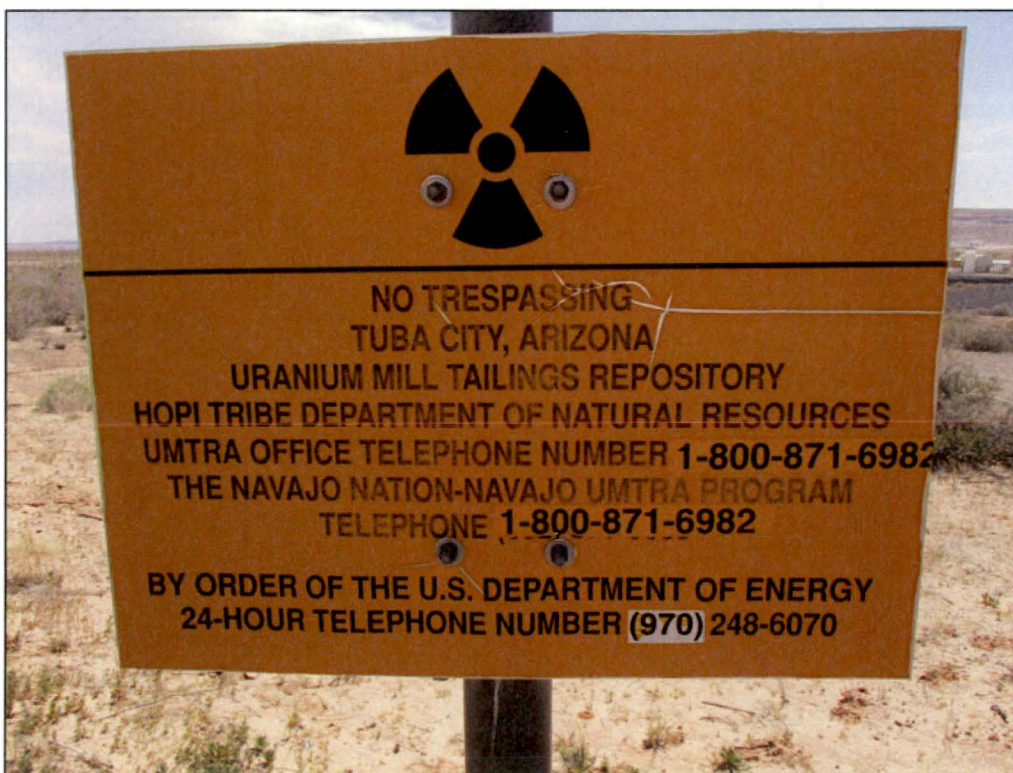
PL-2. Entrance Sign on Post at Entrance Gate (Replaced Following Inspection)

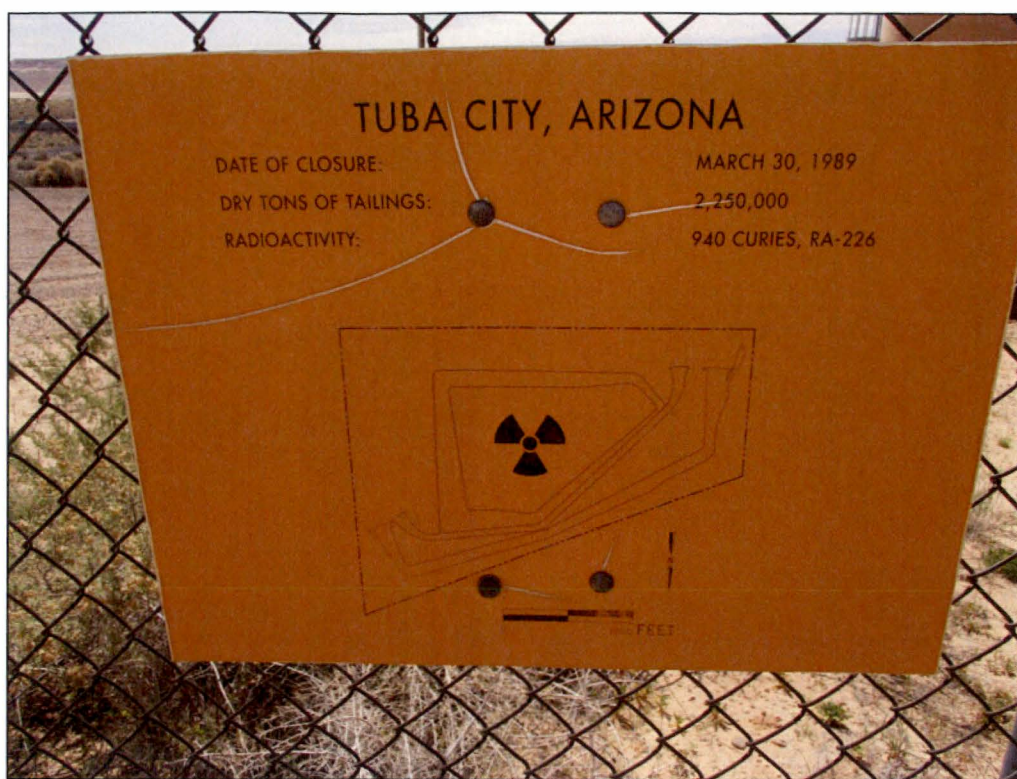
*PL-3. Pictorial Entrance Sign on Entrance Gate (Replaced Following Inspection)*

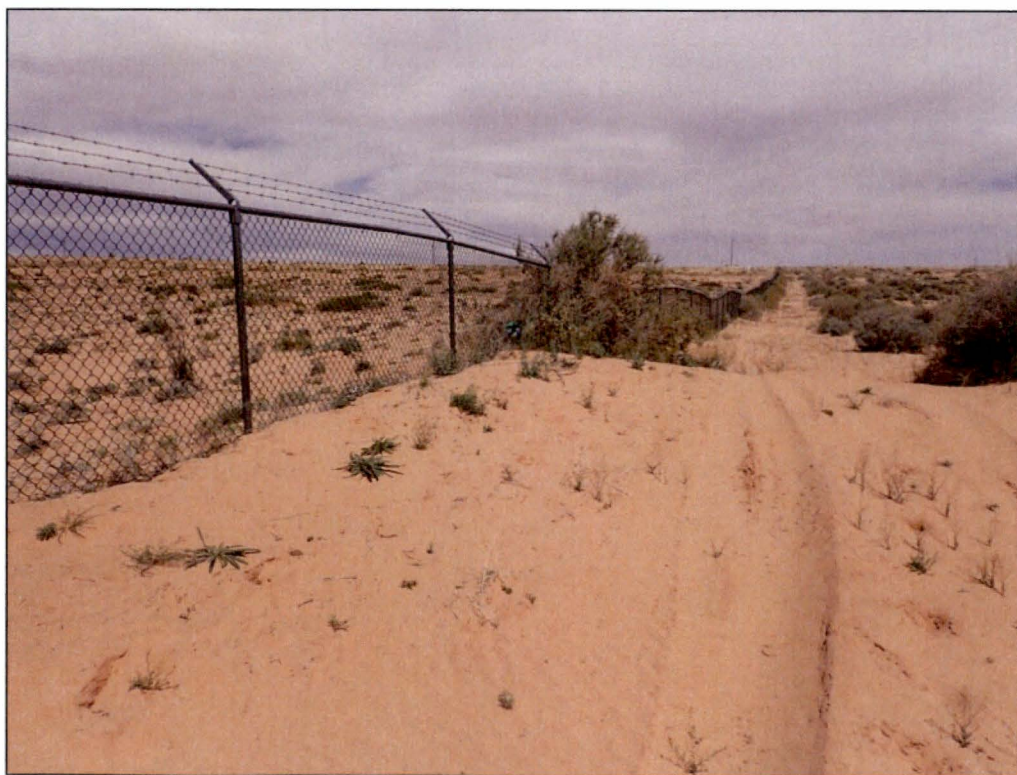
*PL-4. Sand Accumulation Along Western Perimeter Fence and Road (Removed Following Inspection)*

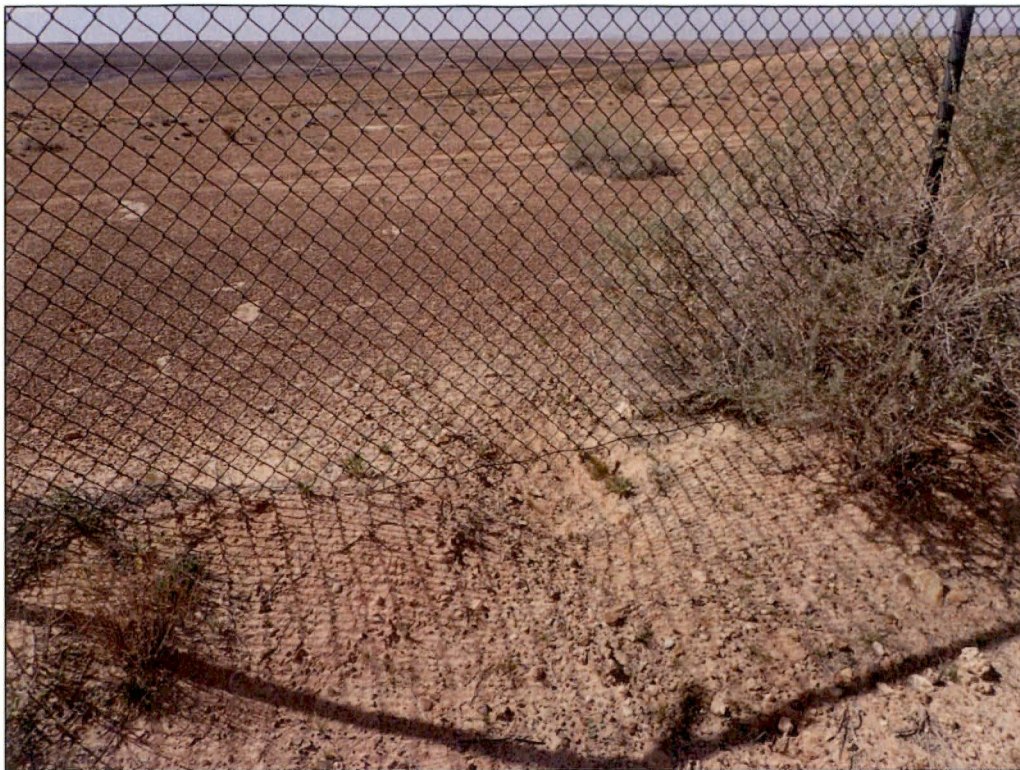
*PL-5. Animal Burrow Under Perimeter Fence (Repaired Following Inspection)*

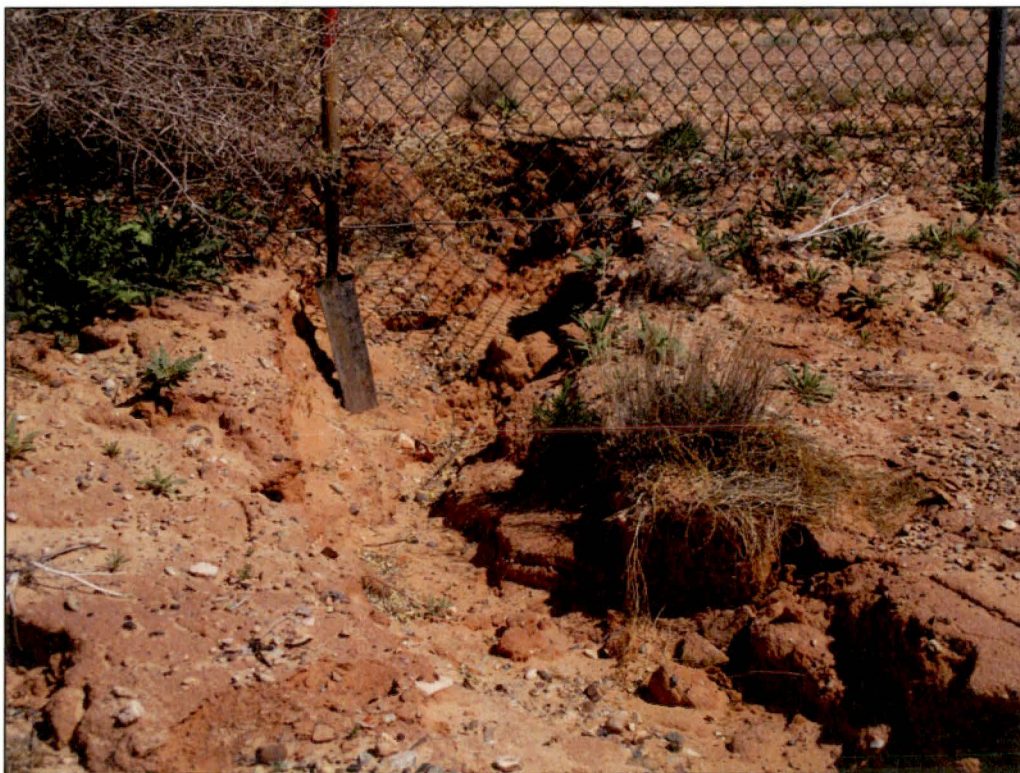
*PL-6. Soil Erosion Under Perimeter Fence Between Perimeter Signs P27 and P28 (Repaired Following Inspection)*

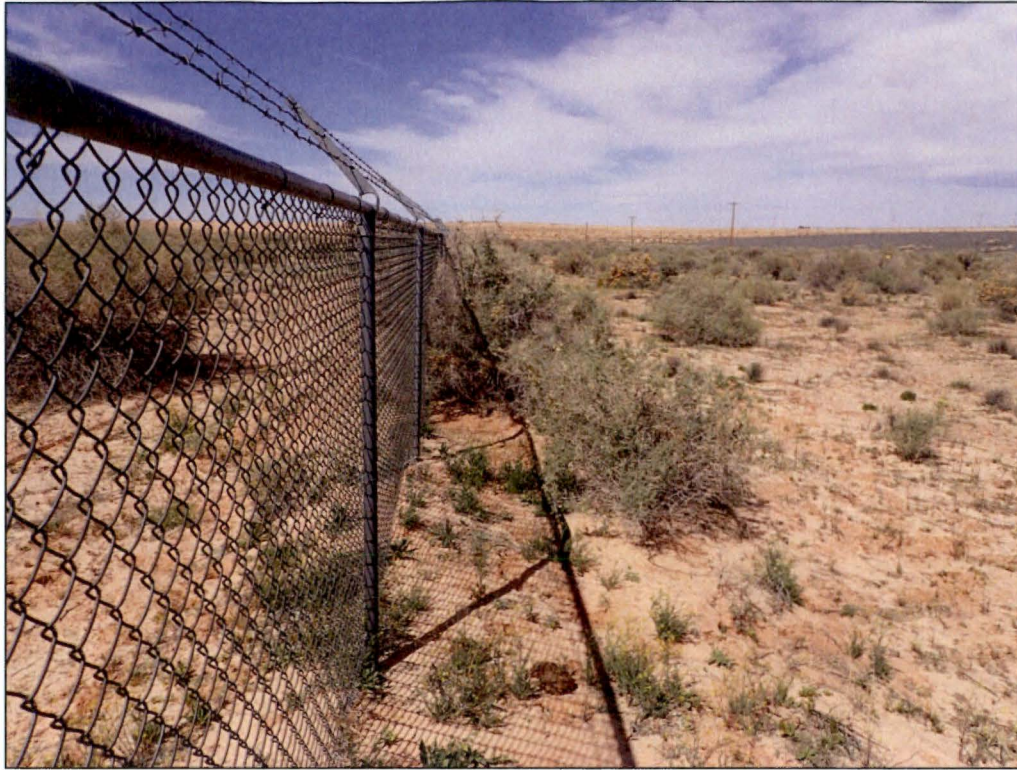
*PL-7. Dense Shrub Growth on Perimeter Fence (Removed Following Inspection)*

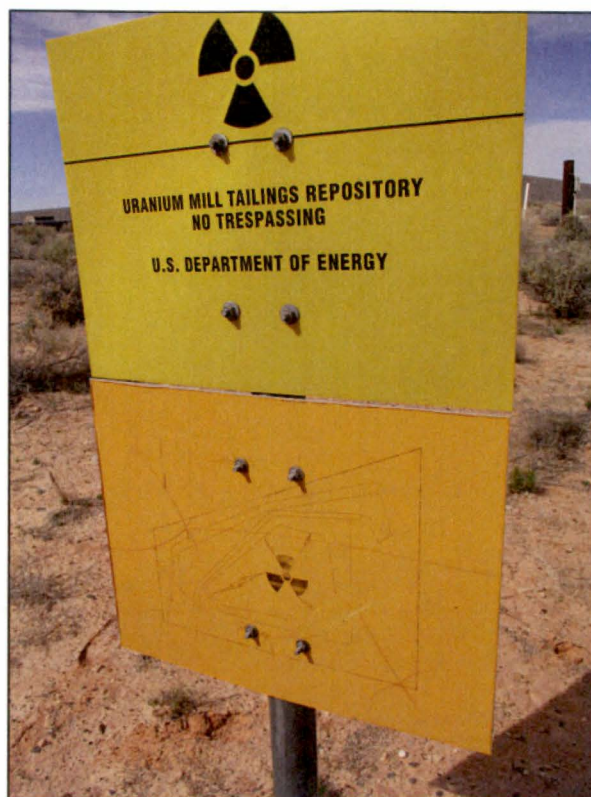
*PL-9. Perimeter Sign P24; Pictorial Sign Faded (Replaced Following Inspection)*

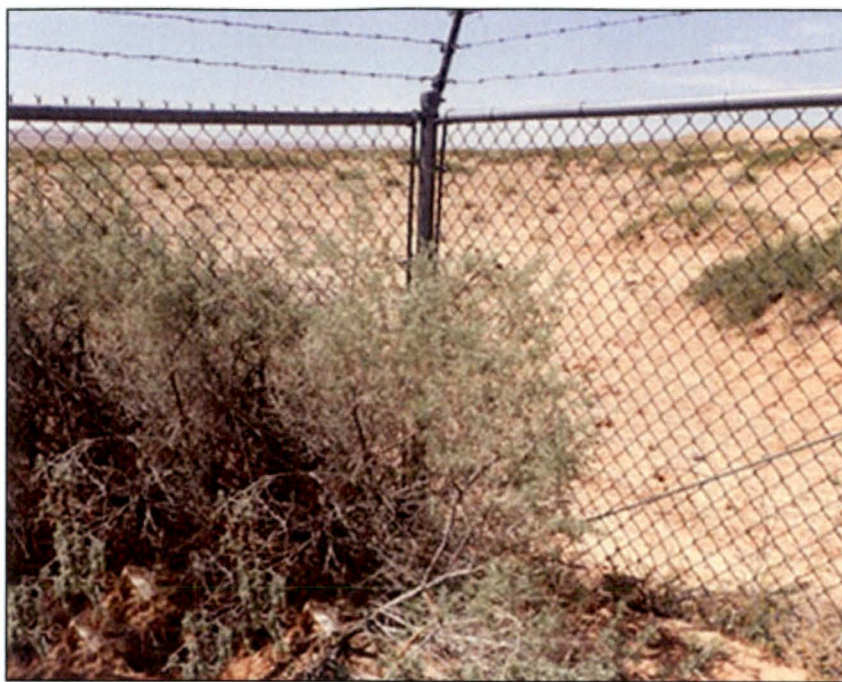
*PL-11. Survey and Boundary Monument SM/BM-1 Buried in Sand  
(Found Following Inspection and Permanent T-Post Installed)*

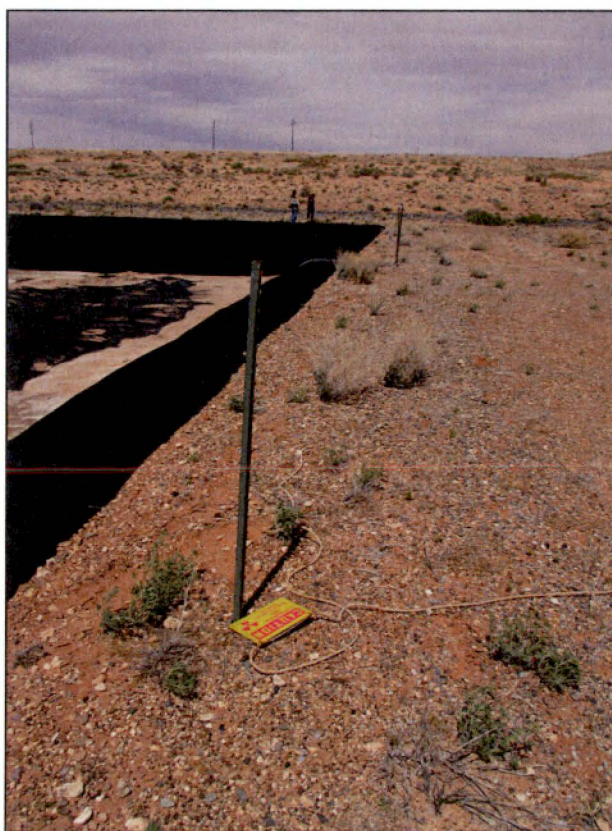
*PL-18. Downed Safety Rope and Caution Sign  
(Replaced with Steel Rope and New Caution Sign Following Inspection)*

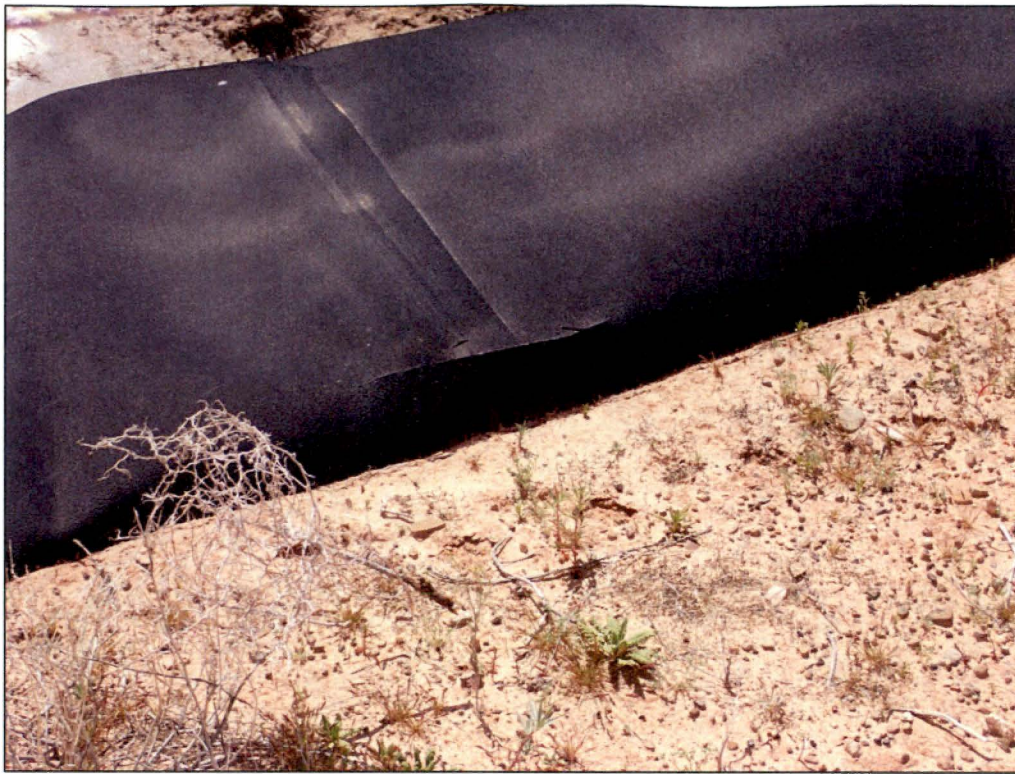
*PL-19. Crack in Evaporation Pond Liner (Repaired)*

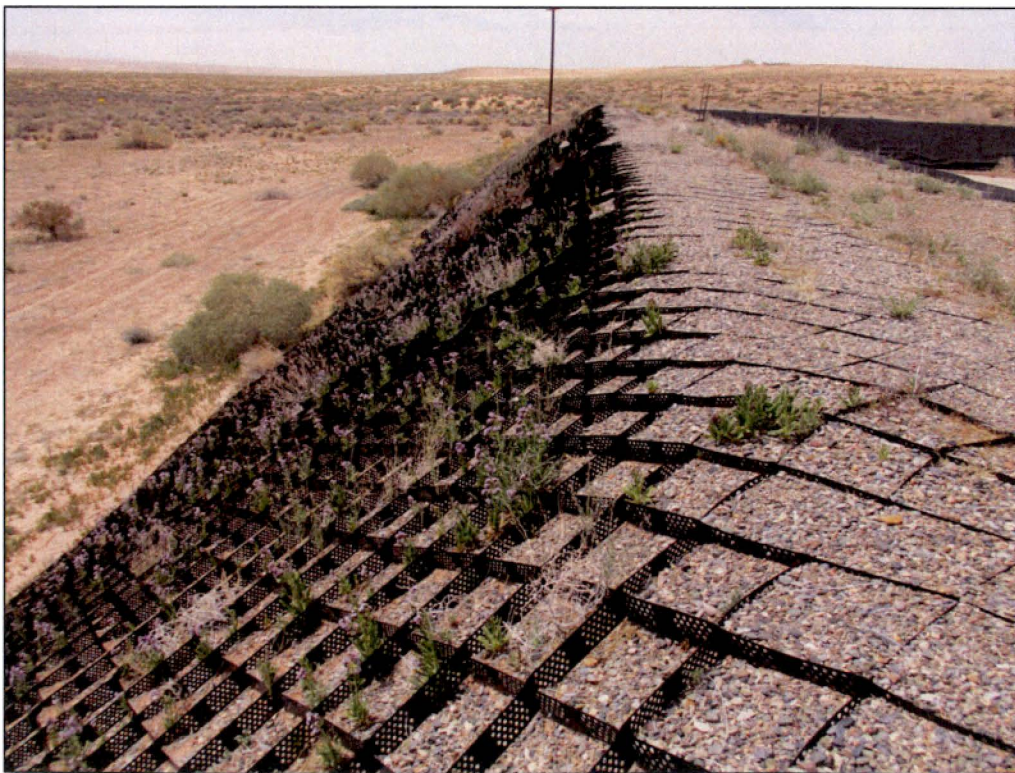
*PL-20. Exposed Geofabric*
