DOCKET NO. 50-266
FINAL REPORT OF STEAM GENERATOR TUBE INSPECTION
POINT BEACH NUCLEAR PLANT UNIT 1

MICROSCOPIC AND OTHER EXAMINATIONS OF
NUCLEAR STEAM GENERATOR TUBING REMOVED
FROM POINT BEACH NO. 1 IN MARCH 1980

RE-EVALUATION OF EDDY CURRENT TAPES FOR TUBES R19C37, R30C41, R26C53, R30C44, R28C38, R32C42, R22C46, AND R30C57

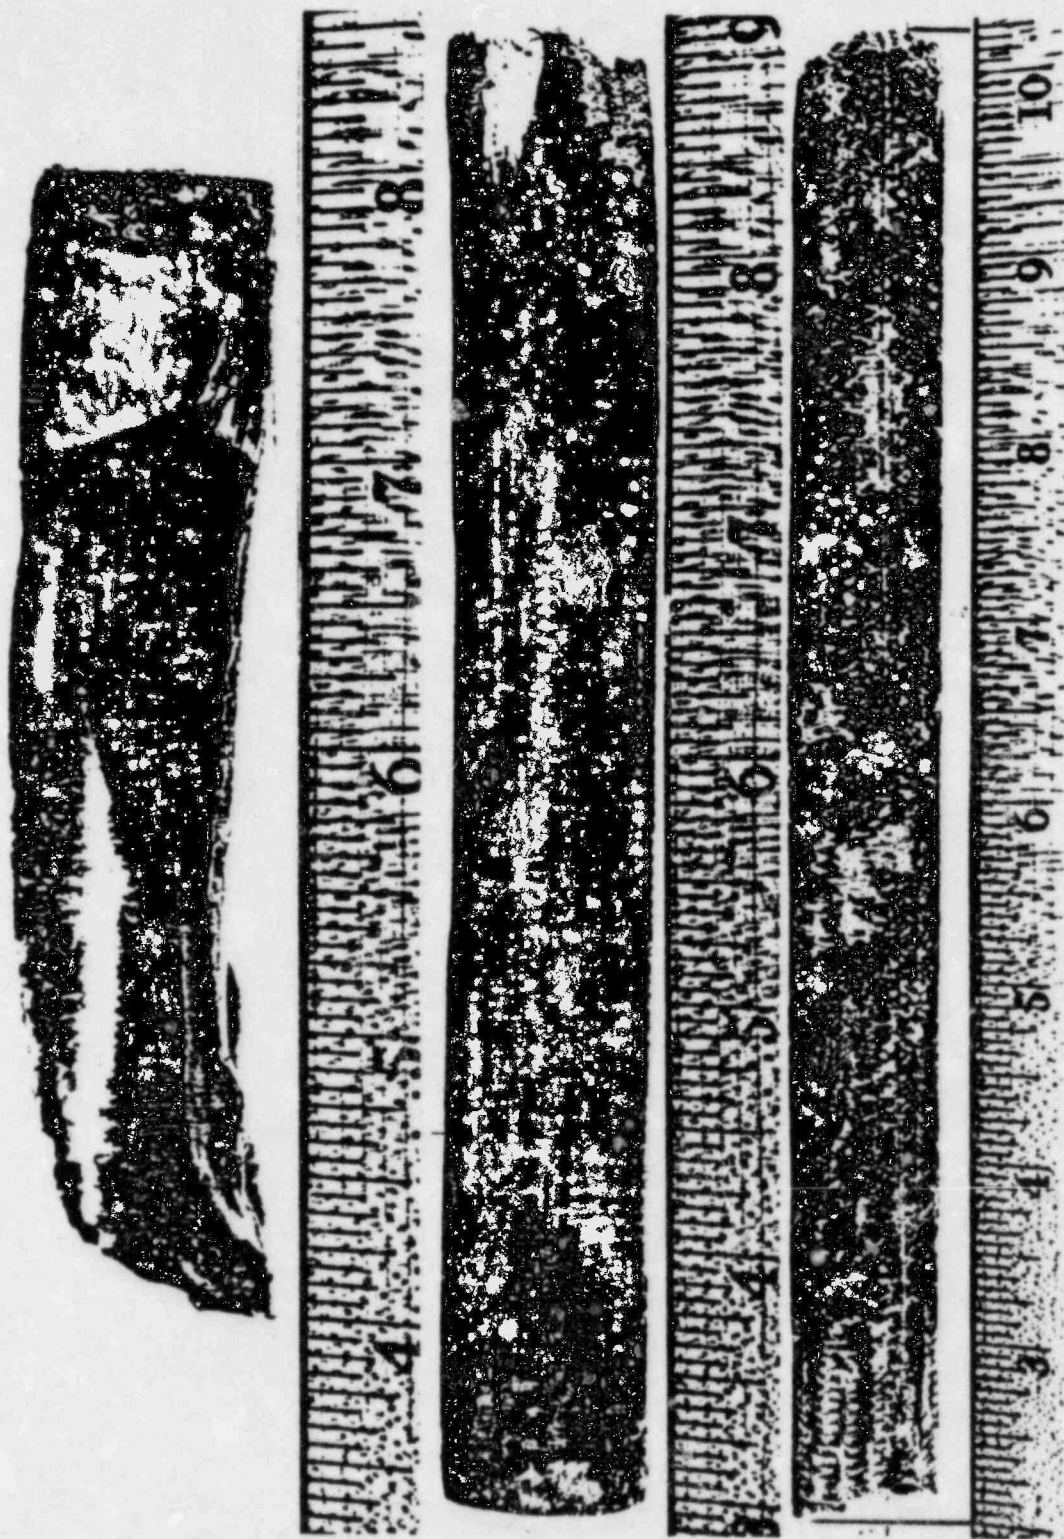
FIGURE 1. Tube B(26-53), Hot leg Inlet Sections, As-Received. Left-to-right = increasing elevation from piece nearest primary face of tube sheet (far left). Ruler insets, used in bench-top photographing, are of slightly different magnifications than accompanying tube sections and provide only relative guides to the individual magnification. Primary flow direction is upward.

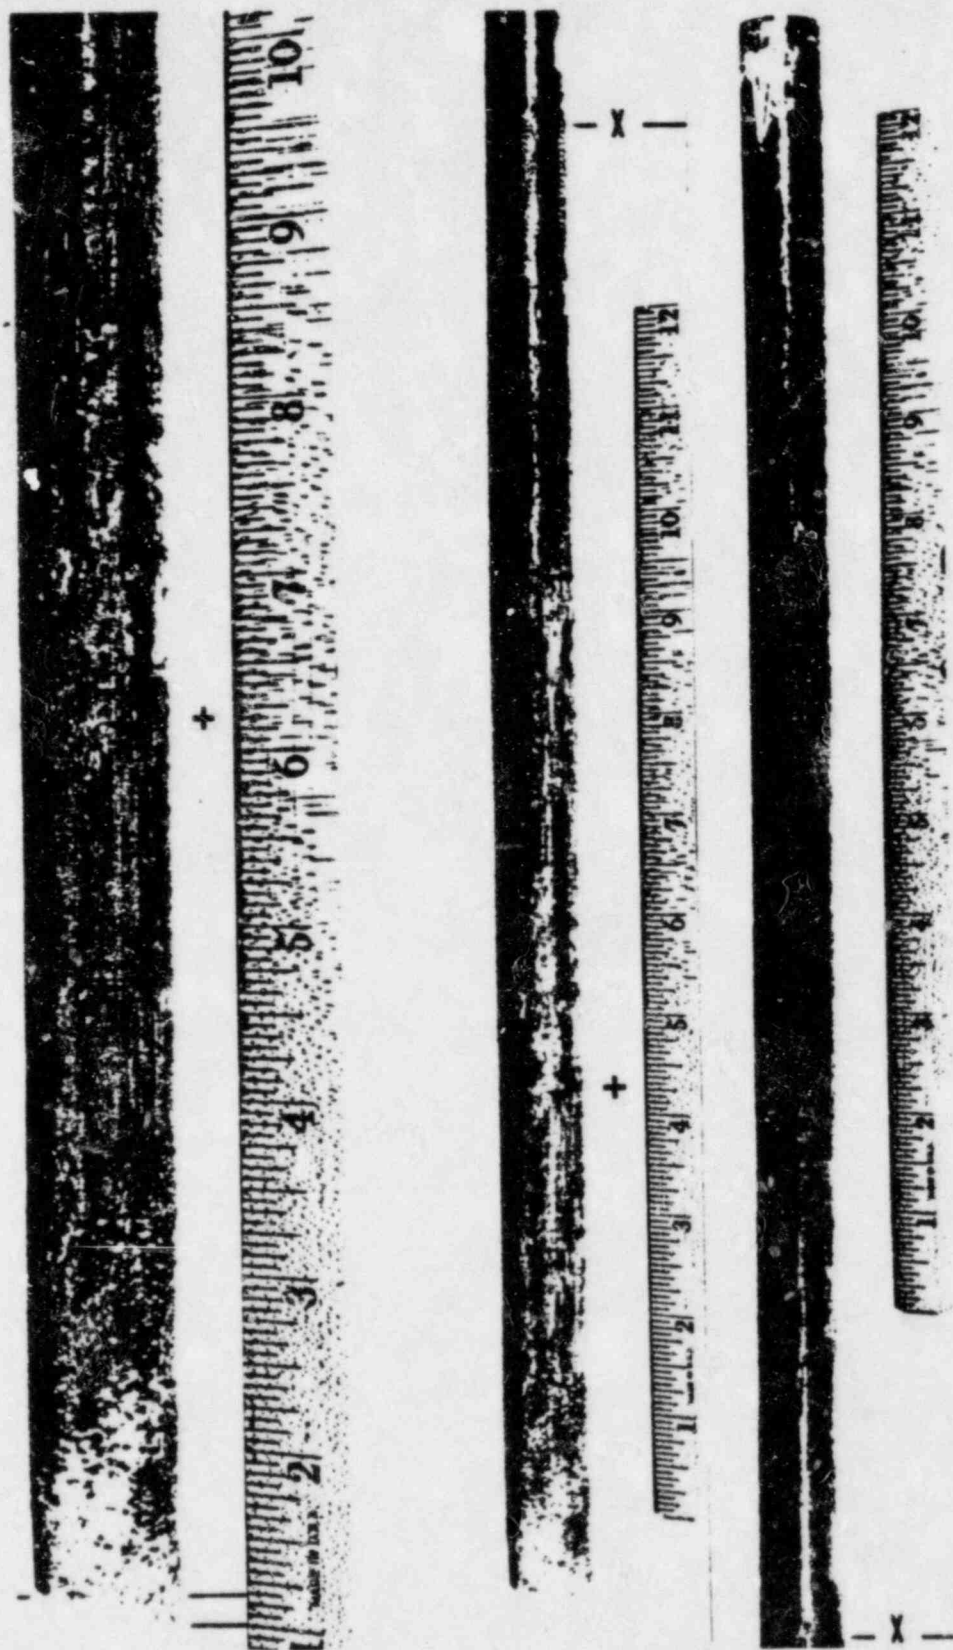
FIGURE 2. Tube B(26-53), Additional As-Received Section adjoining and above the topmost section of Figure 1. The + denotes the tube sheet ring, (shown at 2 magnifications). X-X are match lines of the montage of the pair at right. Primary flow is upward. (A higher section of this tube was also received and photographed but is not shown.)

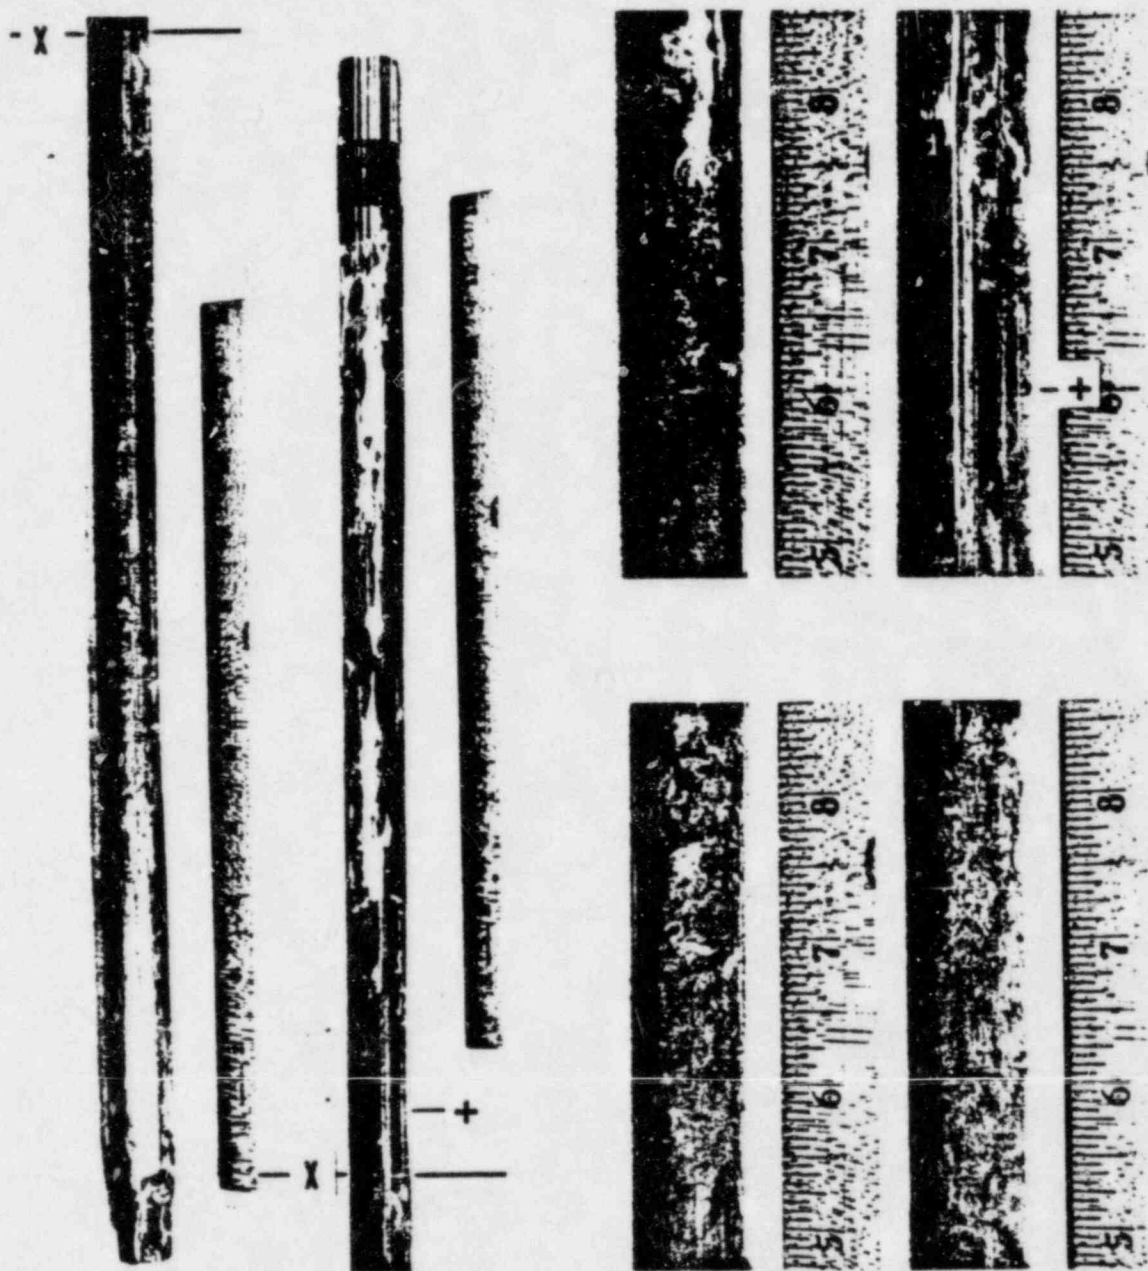
FIGURE 3. Tube B(30-41), As-received Inlet-End Section. X-X denotes match lines in the pair at left, and the + mark locates the tube sheet ring, shown in 2 magnifications and 4 rotations at the right. Primary flow is upward and the 4 pictures are arranged with 0° = top left, 90° = top right, 180° = lower left, and 270° = lower right. Ruler insets provide only relative magnifications. (A second section above this section was also photographed and is not shown.)

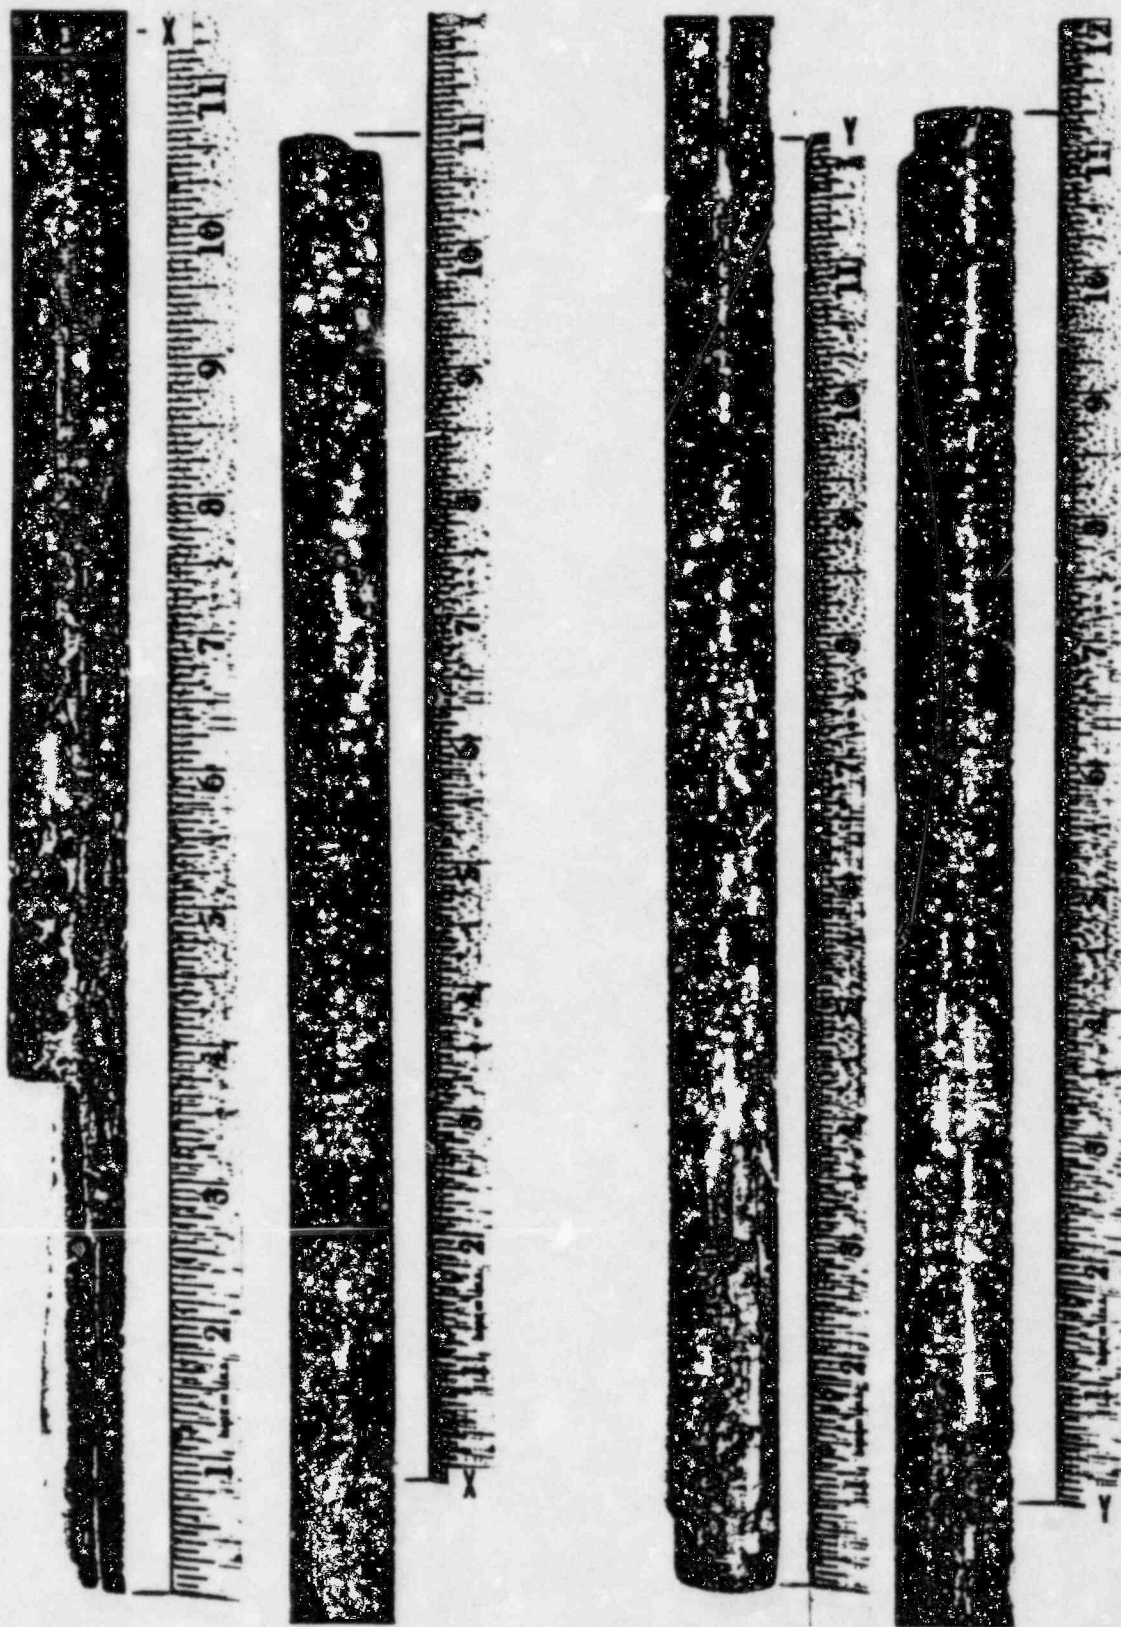
FIGURE 4. Tube B(19-37), As-received Inlet-End Sections. Section nearer the primary face of tube sheet is left, with X-X denoting match lines. Adjoining higher section is at right, with match lines at Y-Y. Primary flow is upward.

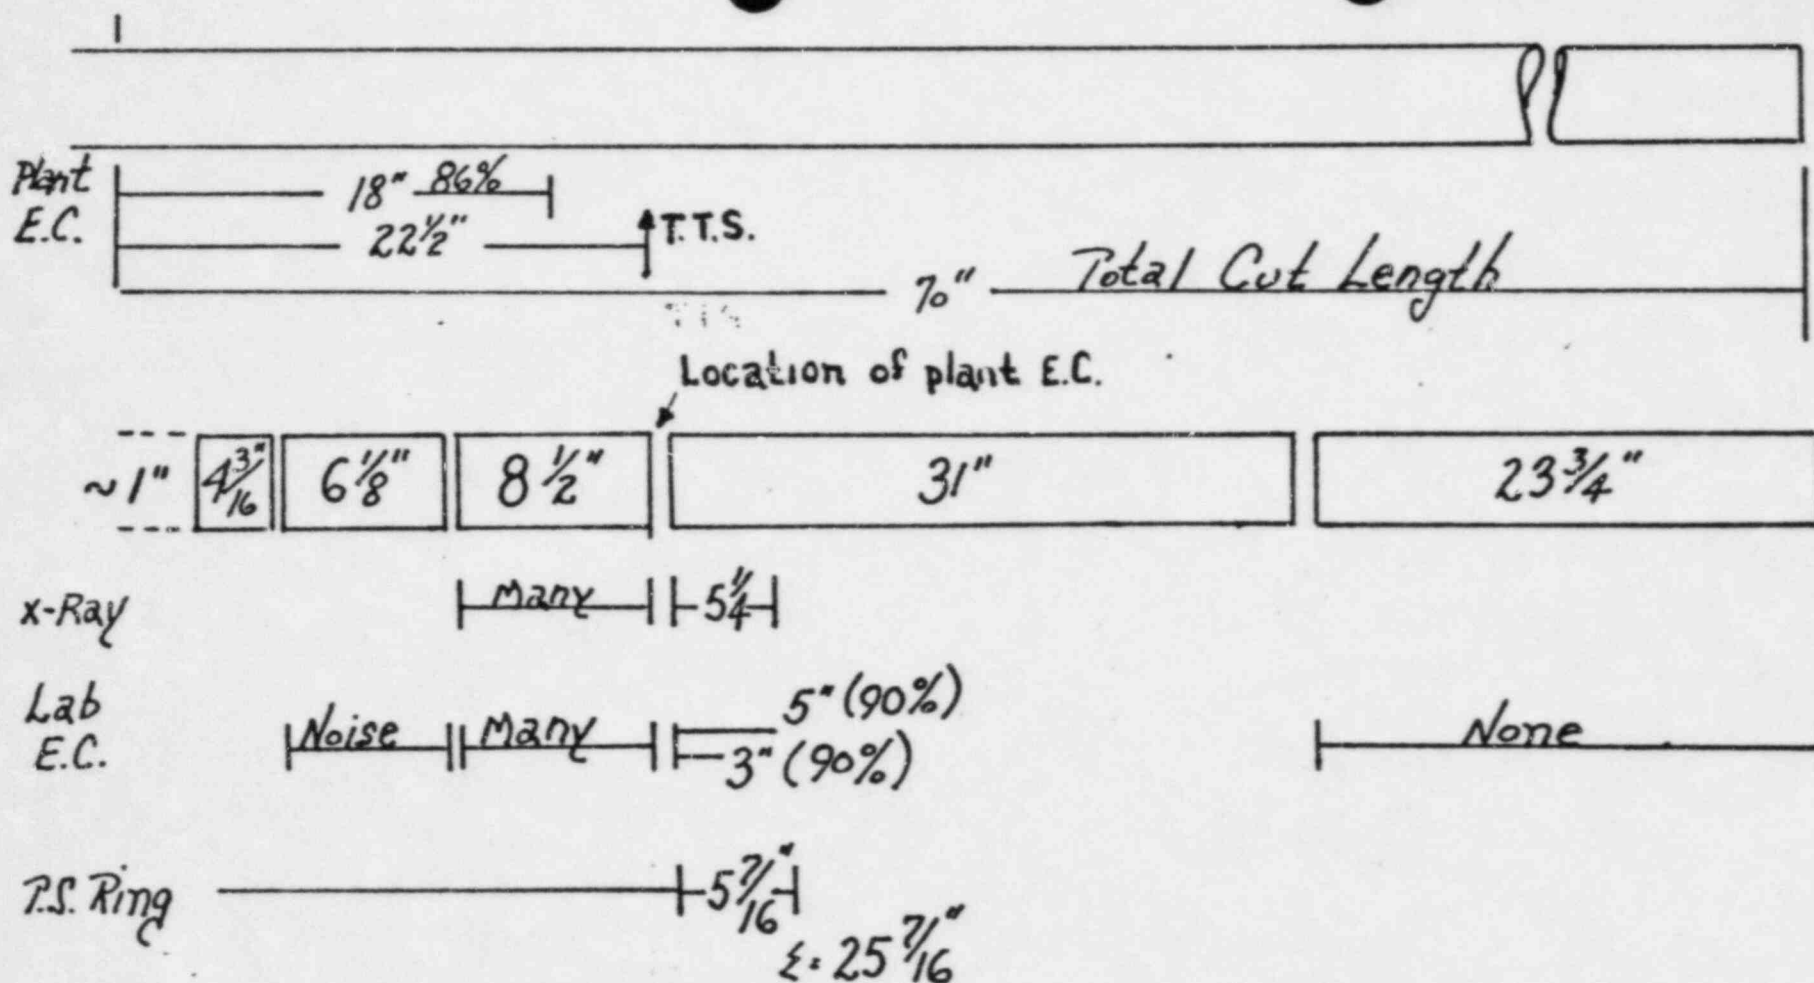
FIGURE 4A. Comparison of plant E.C. signal locations and E.C. findings in the laboratory.

Tube 26-53
 Total Lab Length : 74 9/16"
 Less : 70
 Total Stretch : 4 9/16"
 Stretch Above T.S. : 3.7%
 Stretch Inside Crevice : 25%

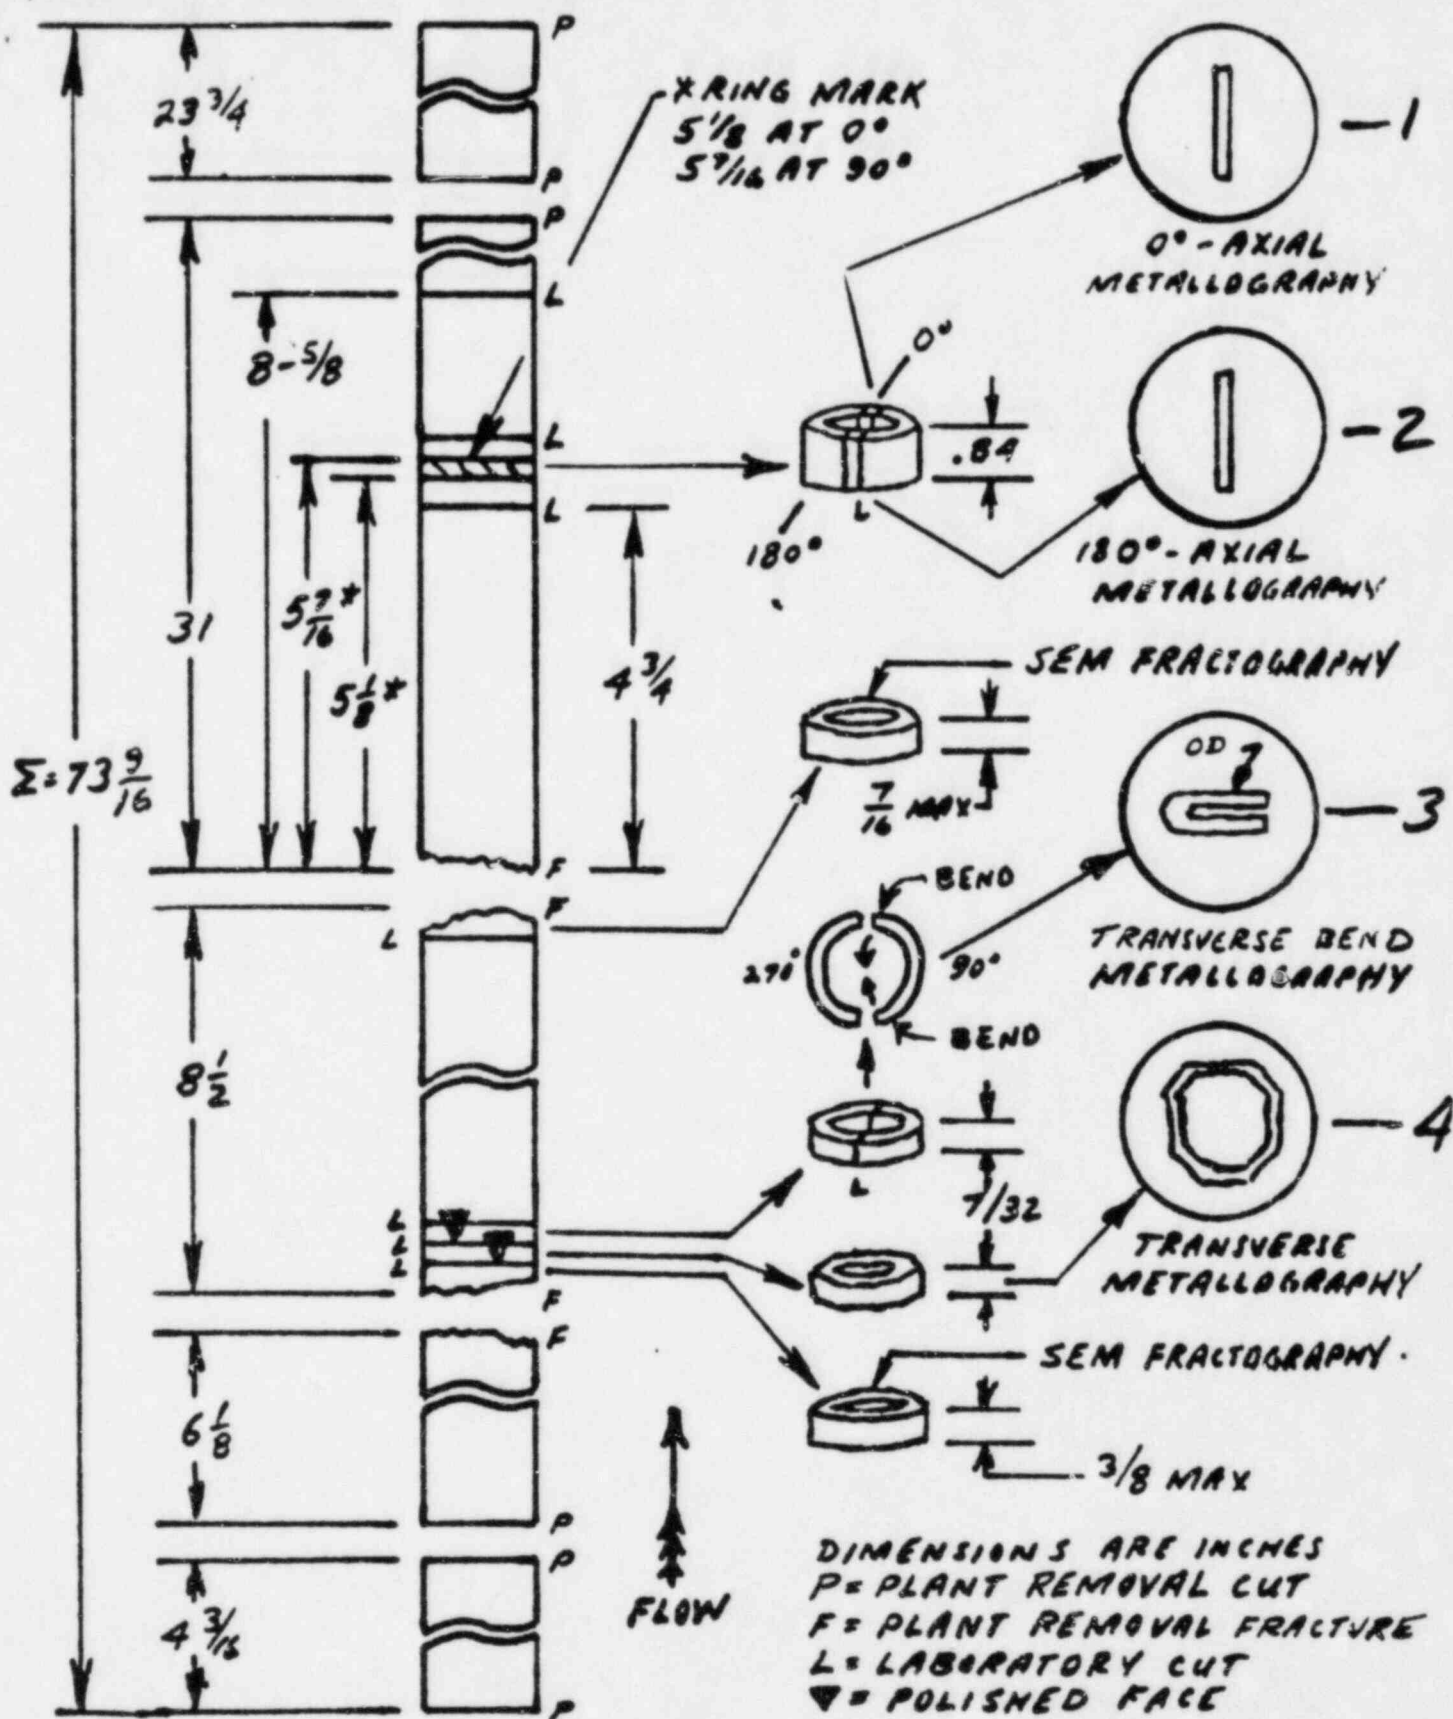
The as-received tube lengths, the locations of sections for microscopic examinations, and a conspectus of the metallography and fractography appear schematically in Figure 6. Two axial cross sections, numbered 1 and 2 in Figure 6, were made through a circumferential, OD "ring" mark which appeared at an elevation on the tube which corresponded with the top of the tube sheet. This ring and adjacent tubing surfaces are shown at 4 rotations in Figure 7.

FIGURE 6. WEP B(26-53) - Laboratory Samples for Microscopic Examinations.

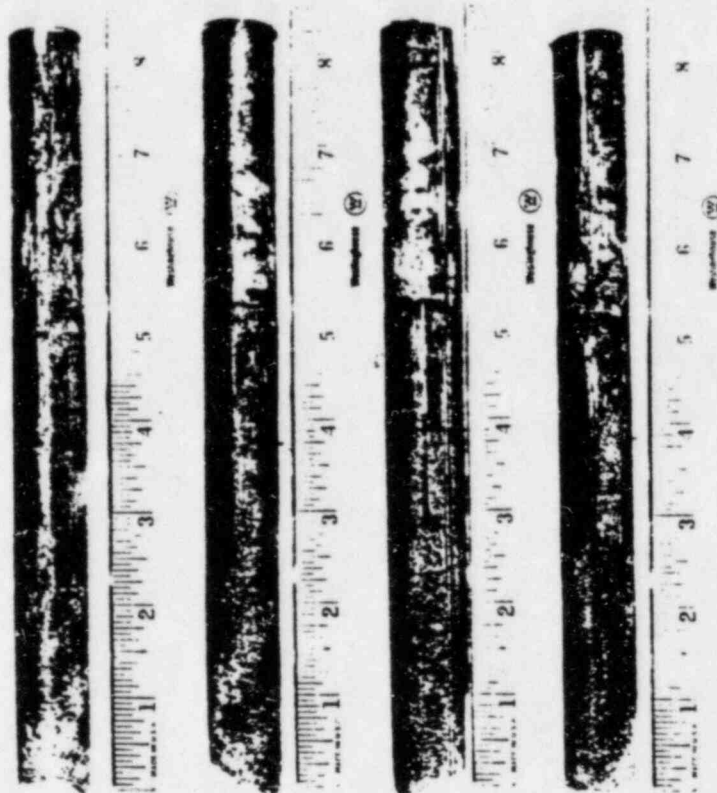
FIGURE 7. Tube B(26-53). Additional views of area containing ring at top of tube sheet, after preliminary sectioning prior to metallographic sampling. Left-to-right: 0°, 90°, 180°, 270°. Primary flow is upward.

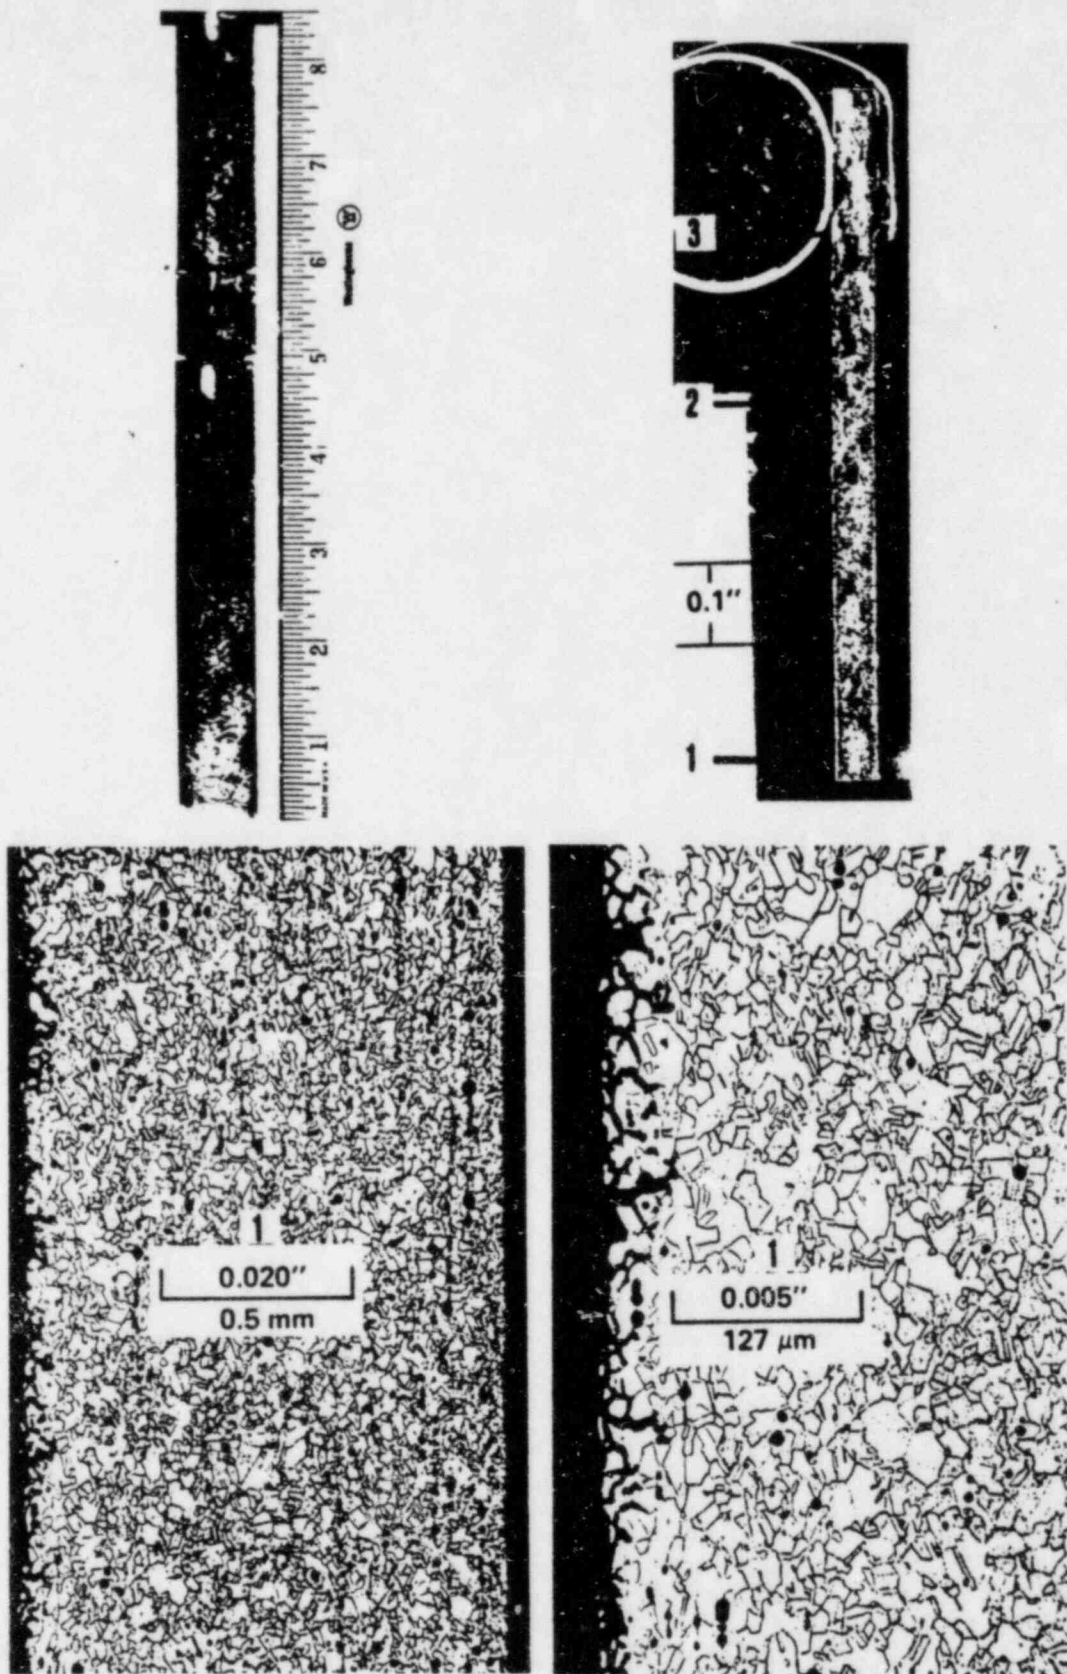
Sectioning of one of the axial sections at the tubesheet ring is depicted in Figure 8, together with a photomacrograph of the resultant section and photomicrographs of the OD edge at an elevation immediately below the ring. Similar photomicrographs at elevations of the ring and immediately above it appear in Figure 9. Very shallow grain boundary involvement (≤ 0.002 in. long) was detected below the ring over the entire 0.08 in. axial length shown in Figure 8. Isolated 0.002 in. max. indications were found in a short zone (0.02 in. long) above the ring, as shown in Area 3 of Figure 9. Figures 10 and 11 correspond to Figures 8 and 9 for the second axial cross section through the ring at 180° from the preceding section. Photomicrographs show the same shallow (~ 0.002 in.) grain boundary involvement (Figure 10), except that a deeper, opened network of intergranular corrosion $1/2$ to $5/8$ in. below the ring was also present (Figure 11).

FIGURE 8. B(26-53), Metallography through Ring at Top of Tubesheet.
 Upper left = sectioning. Upper right = photomacrograph of
 polished and etched longitudinal cross section with OD on
 left. Lower pair = photomicrographs of OD area 1 below ring.
 Etchant = bromine in methanol.
 (Primary flow is upward.)

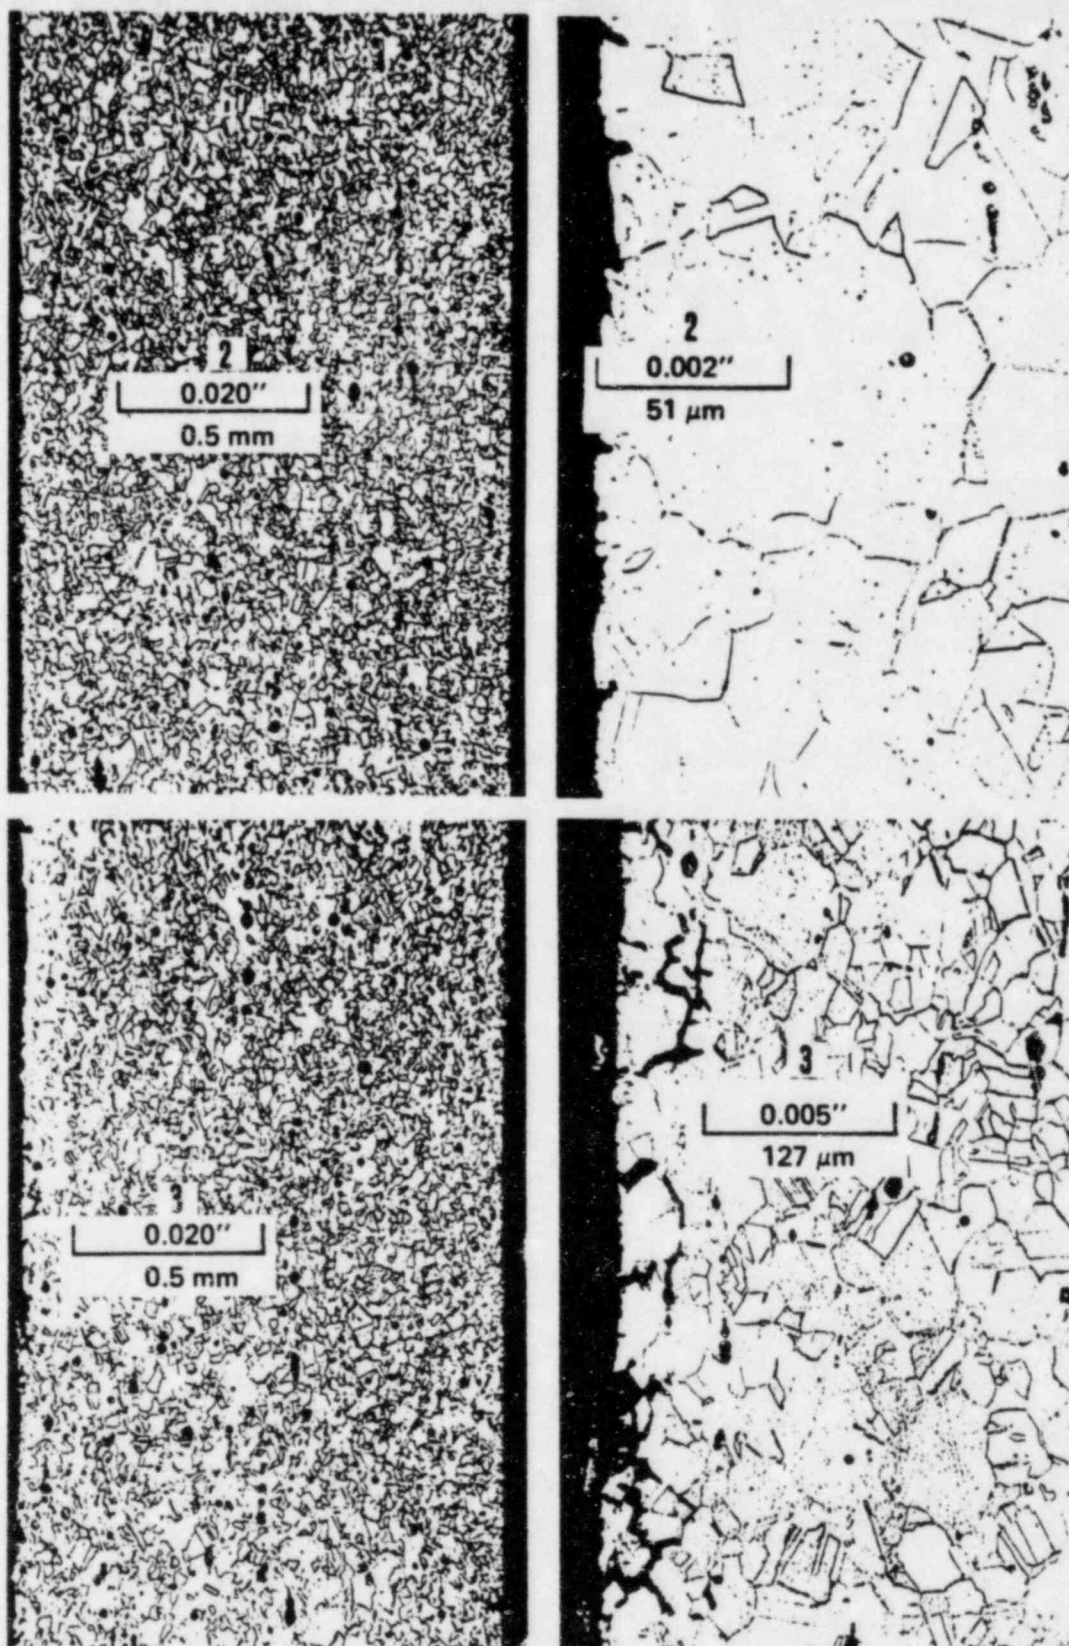
FIGURE 9. R(26-53), Etched Photomicrographs of Longitudinal Section through Tube Sheet Ring. Area 2 = near ring; Area 3 = above ring. Areas are located in Figure 7. OD is at left; primary flow is upward.

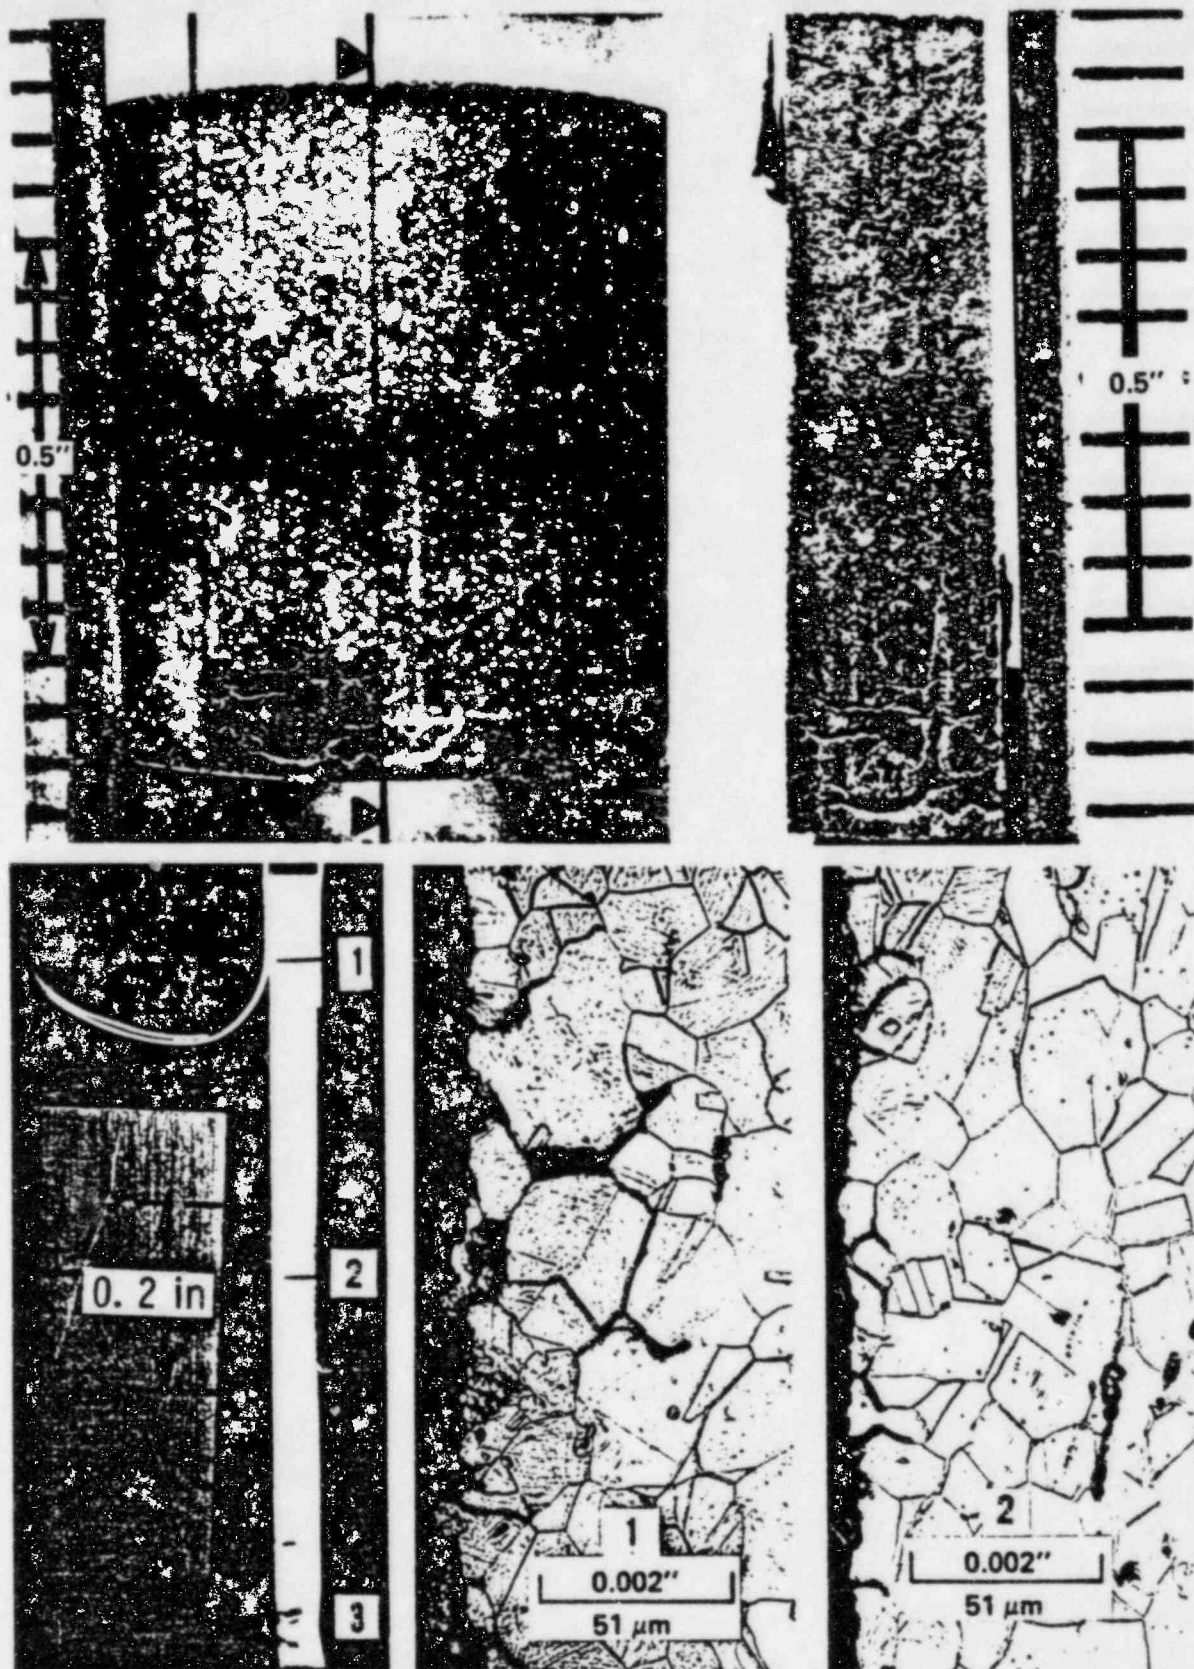
FIGURE 10. B(26-53), Longitudinal Cross Section No. 2 through Tube Sheet Ring. Opposite side of tube from section shown in Figures 8 and 9. Upper pair shows sectioning and resultant section. Lower left is a photomacrograph of as-polished cross section. OD areas 1 and 2 are shown in high-magnification etched photomicrographs at bottom. Primary flow is up.

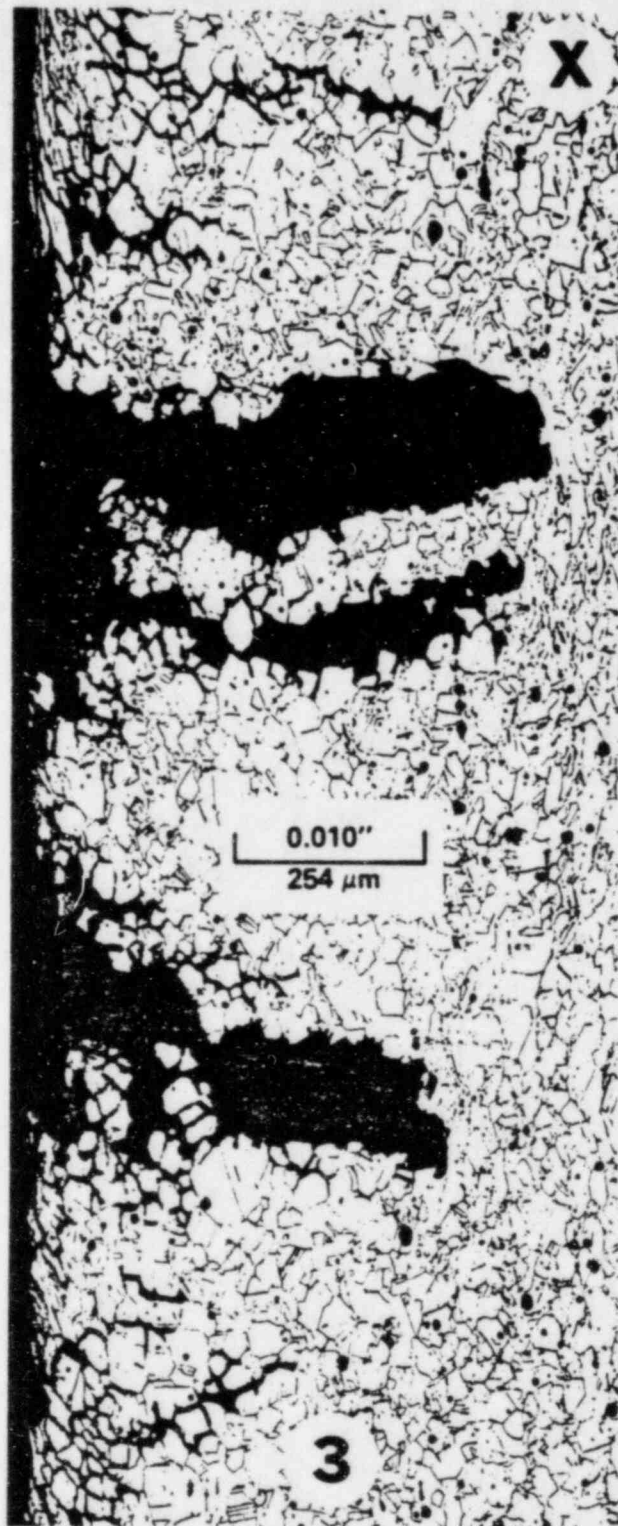
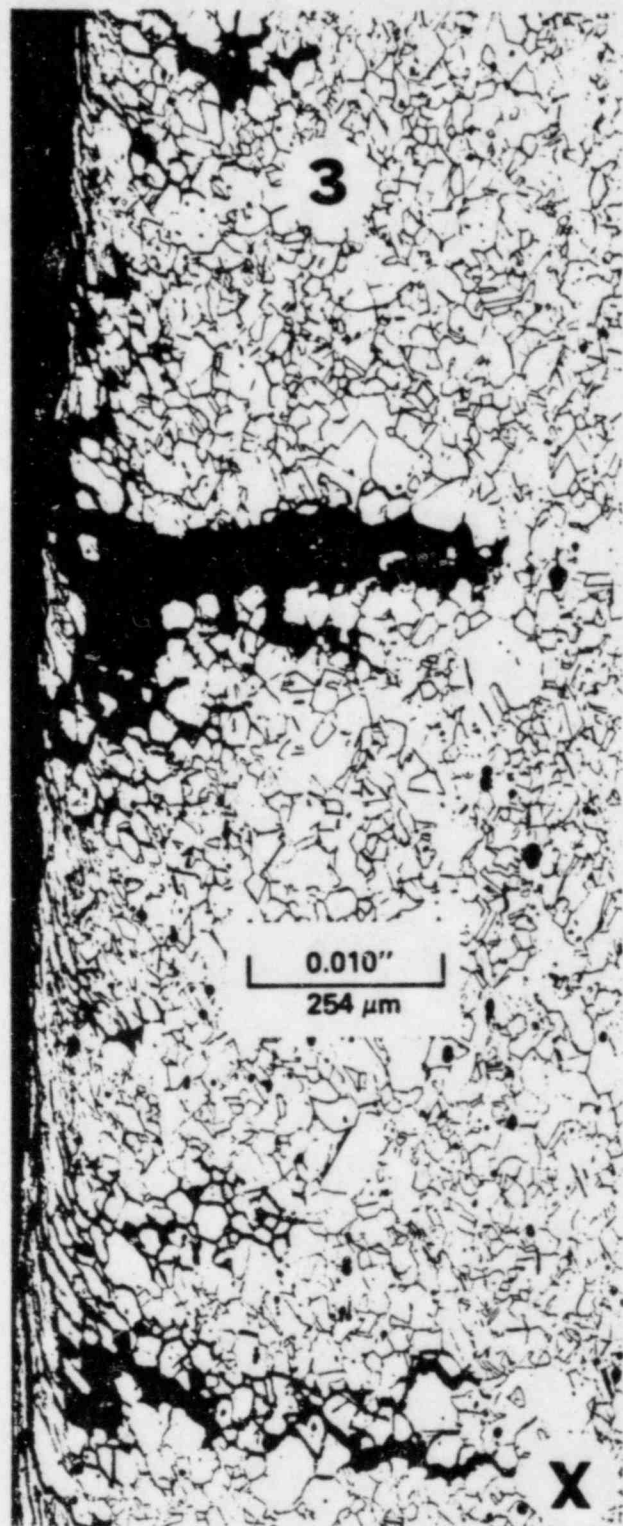
FIGURE 11. B(26-53), Longitudinal Cross Section No. 2, below Tube Sheet Ring, Area 3 of Figure 10. OD is left; primary flow is up.

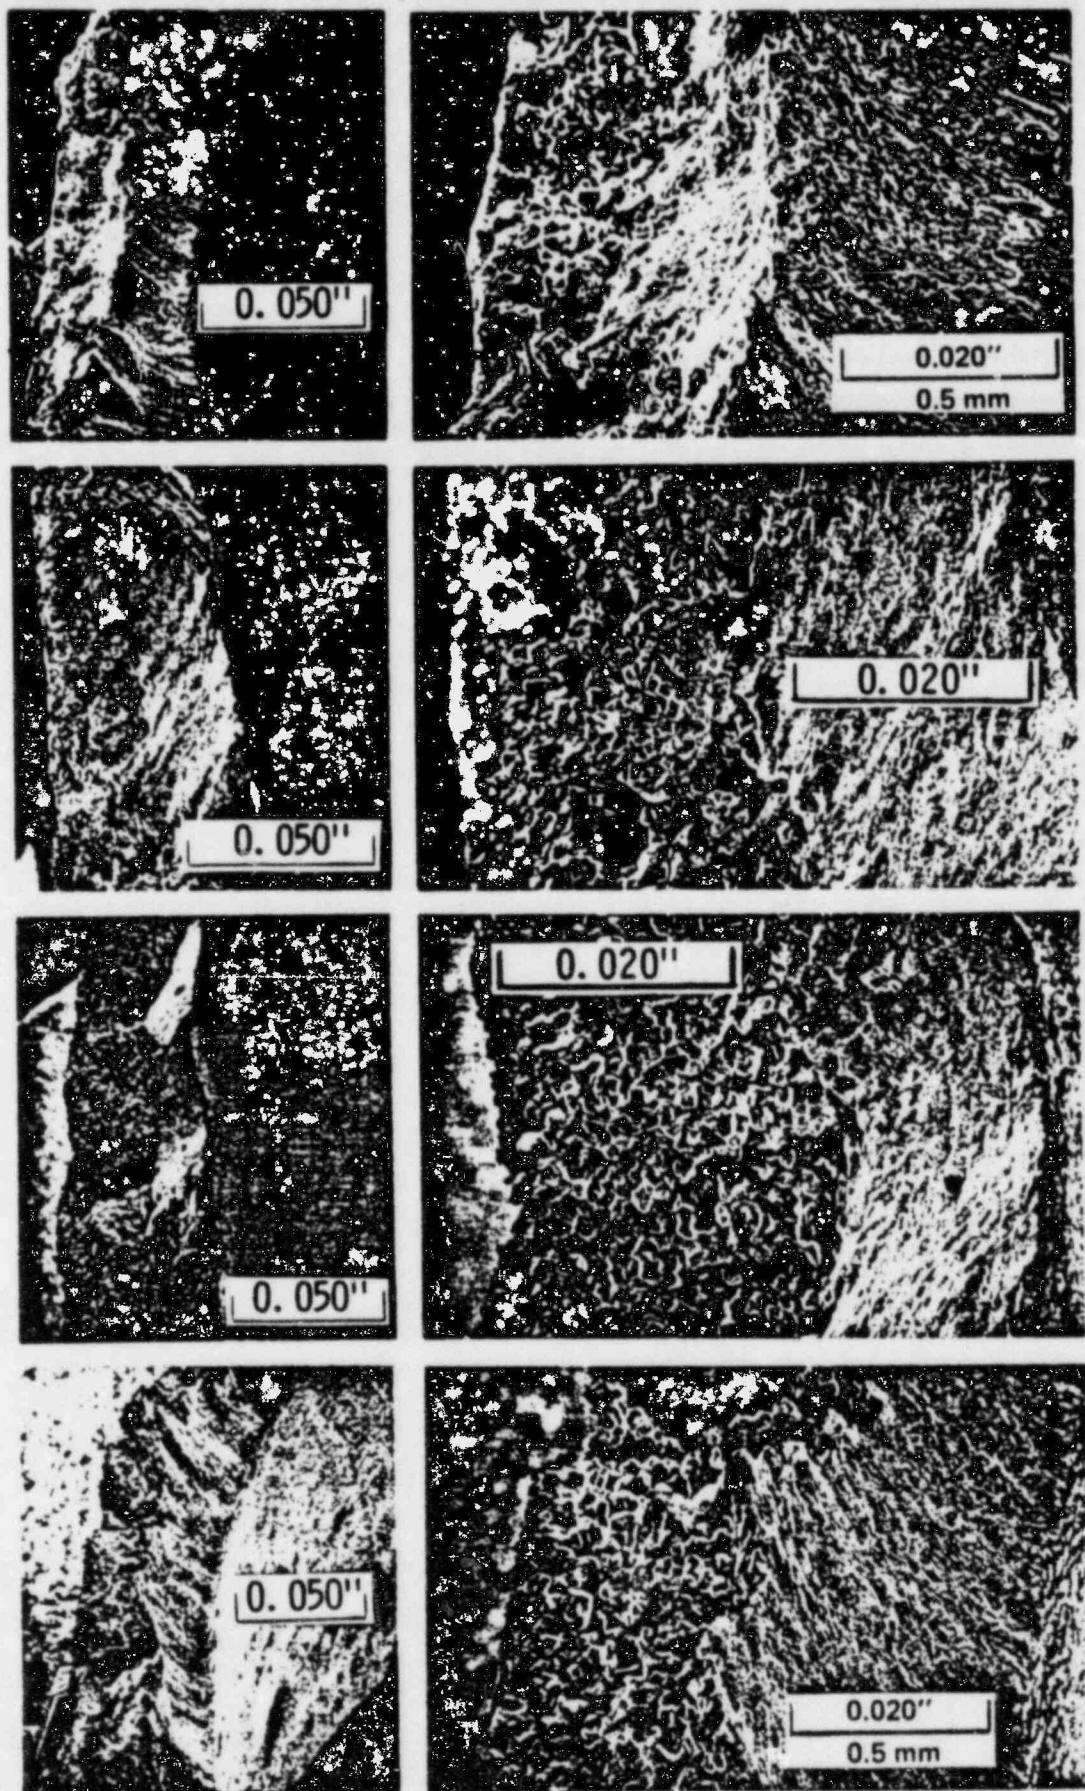
Study of the 24 fractographs (taken every 30 degrees) from the sum of both fractures reveals a shear lip at every point examined, indicating that the intergranular corrosion was not through wall and confirming that the fractures were the result of pulling the tube apart in the removal operations. The depth of intergranular corrosion as determined by the fractography, varied with circumferential location but was usually 50 to 80% through-wall at both elevations. The bent cross sections shown in Figure 16 contained about 0.010 in. of deformed metal near the inside surface after the intergranular corrosion was opened up. This value, ~20% of the tube wall thickness, was consistent with the fractography with respect to the depth of intergranular corrosion in this area of the tube.

FIGURE 13. B(26-53), Sample 3, Fracture Face within Tube Sheet. SEM's taken at 30° intervals beginning at 0° (top) to 90° (bottom). Magnifications vary from point to point within each SEM because of specimen tilt.
