DOCKET NO. 50-266
FINAL REPORT OF STEAM GENERATOR TUBE INSPECTION
POINT BEACH NUCLEAR PLANT UNIT 1

MICROSCOPIC AND OTHER EXAMINATIONS OF
NUCLEAR STEAM GENERATOR TUBING REMOVED
FROM POINT BEACH NO. 1 IN MARCH 1980

RE-EVALUATION OF EDDY CURRENT TAPES FOR TUBES R19C37, R30C41, R26C53, R30C44, R28C38, R32C42, R22C46, AND R30C57

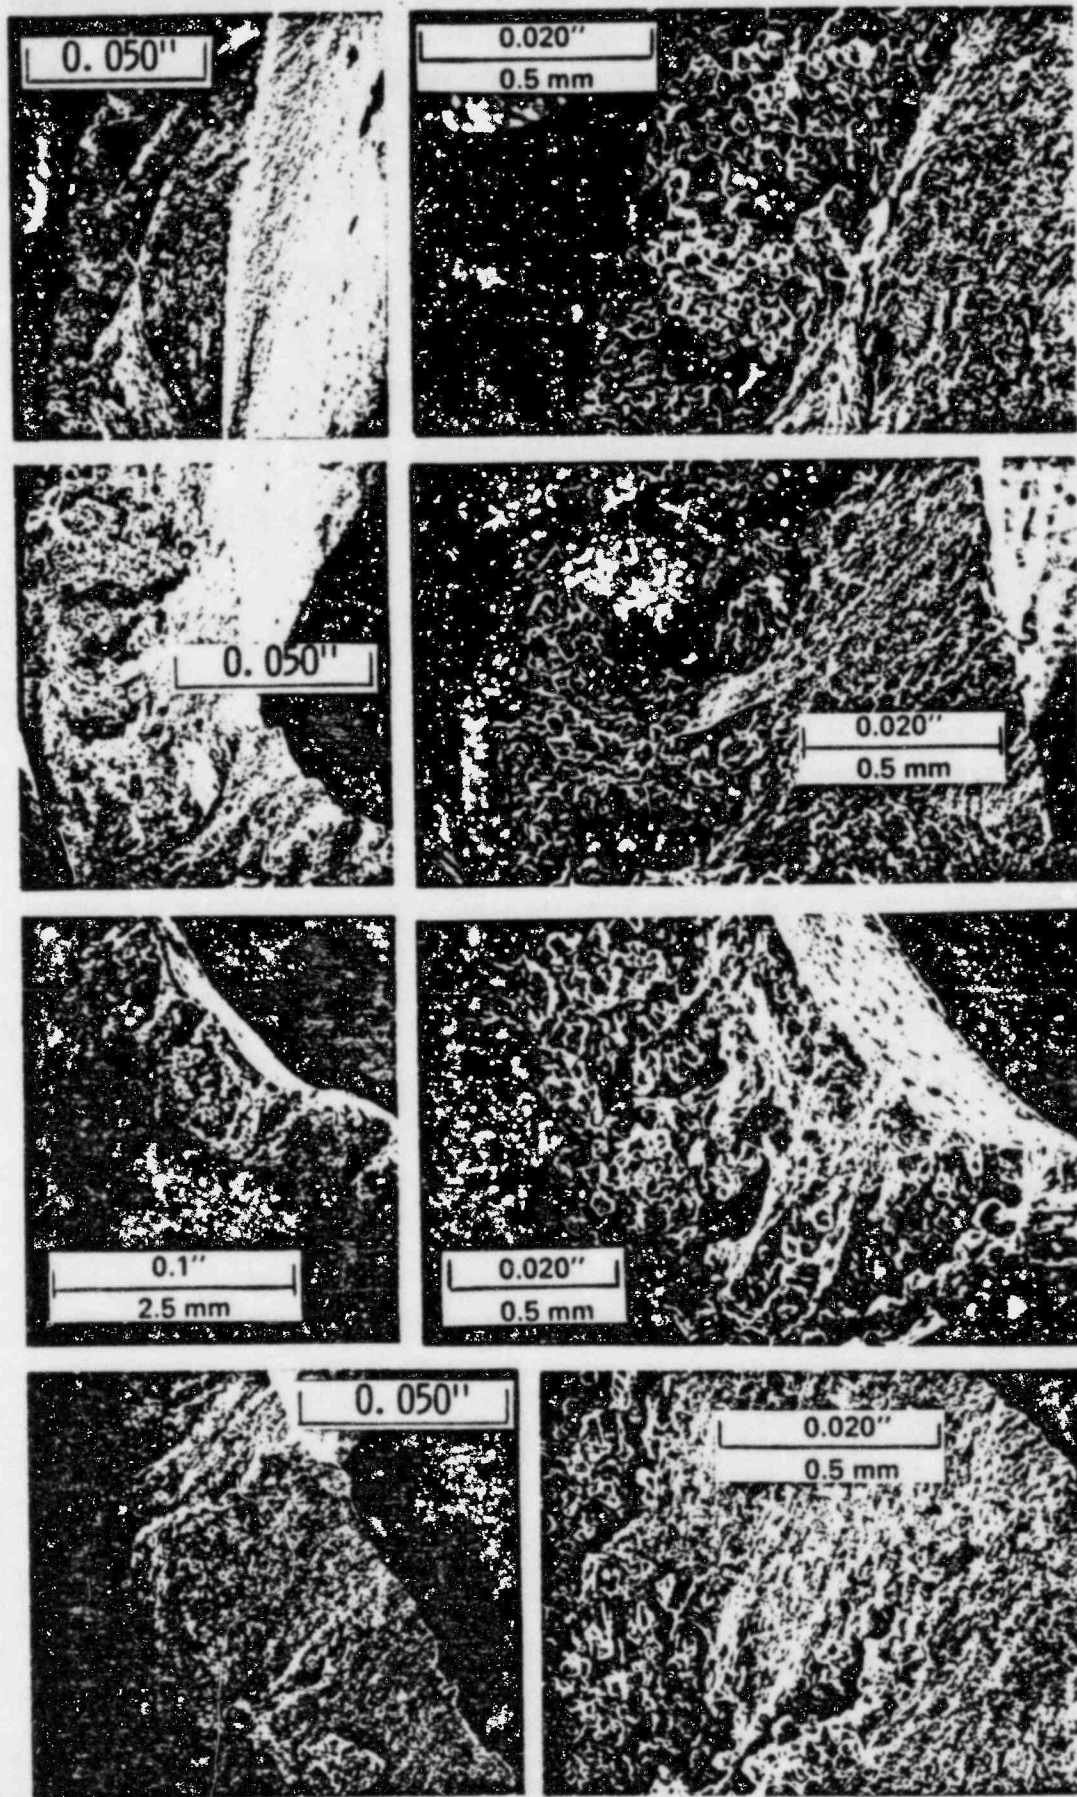
FIGURE 14. B(26-53), Sample 3. SEM fractographs of preceding series.
 Top = 120°, Bottom = 200°, sequentially arranged in 30° intervals.
 Magnifications vary because of sample tilt.

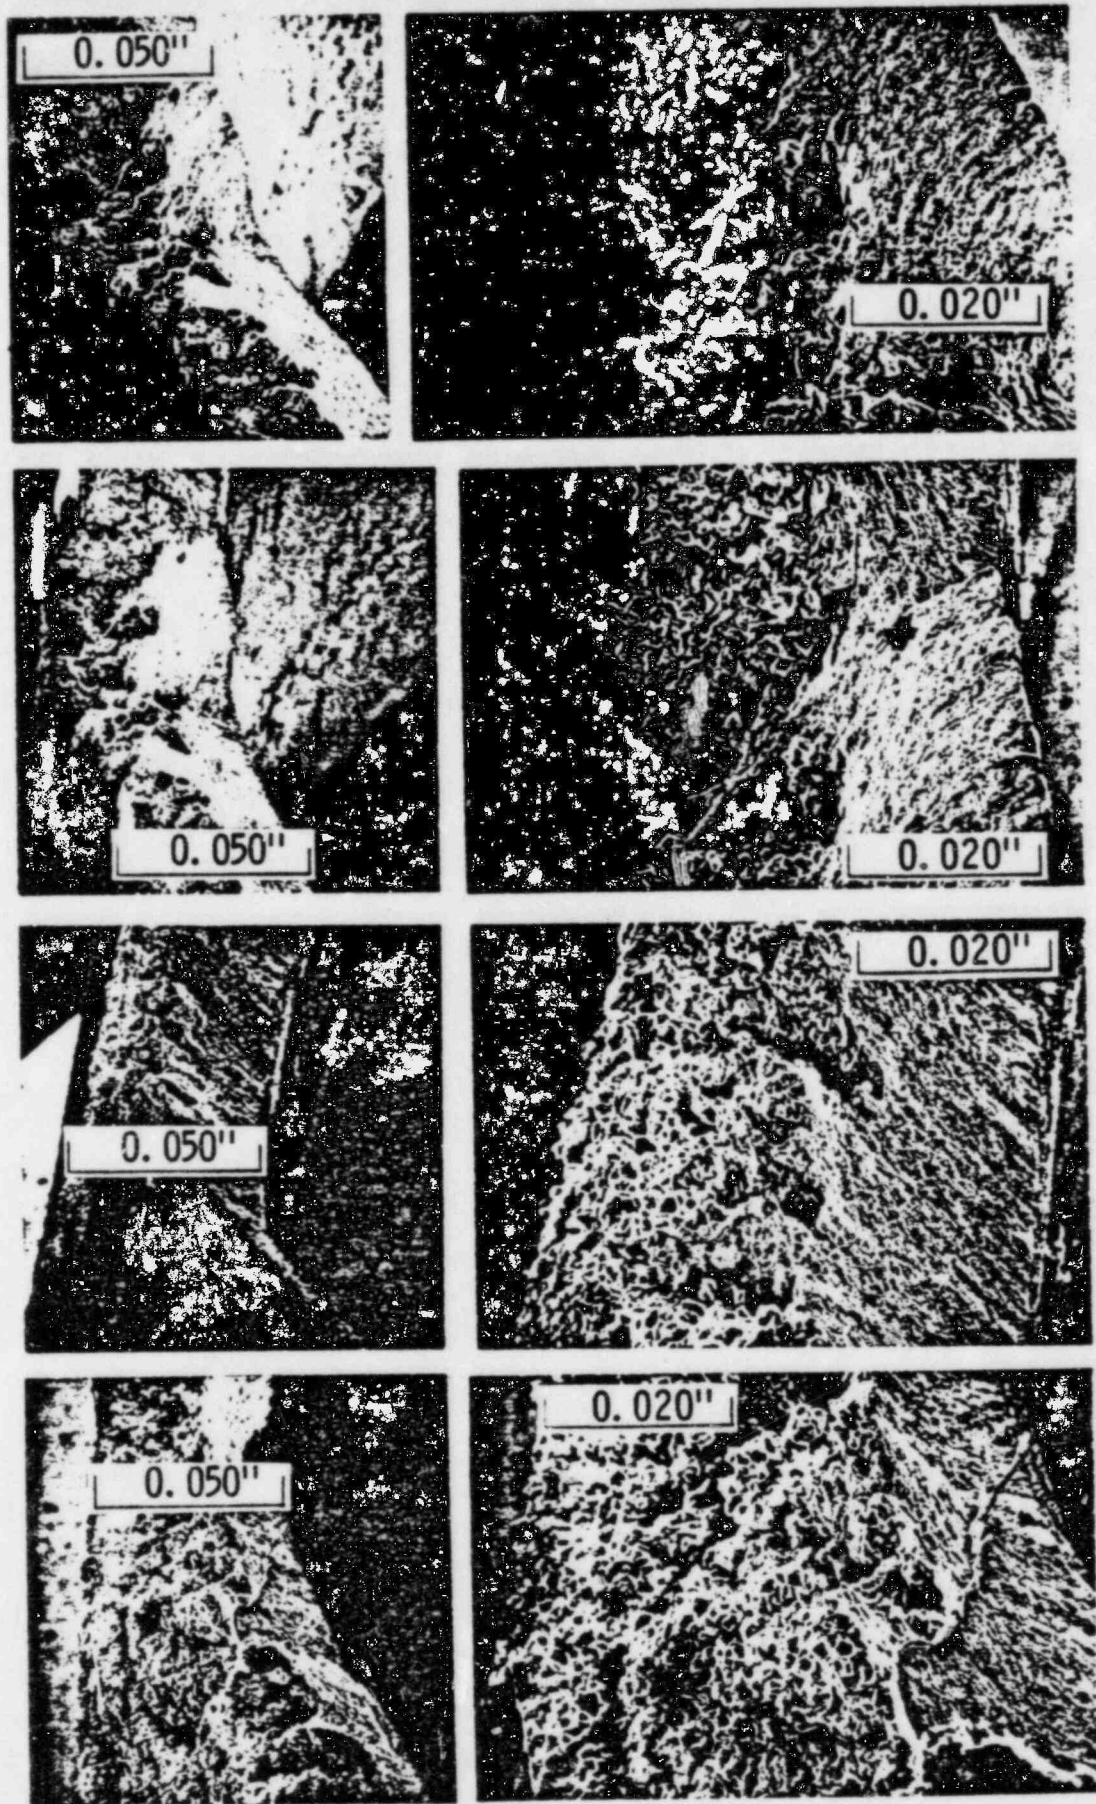
FIGURE 15. B(25-53), Sample 3. Conclusion of SEM fractography of Figures 13 and 14. Top = 240°, Bottom = 330°, with 30° intervals in order. Variable magnifications due to tilt of sample.

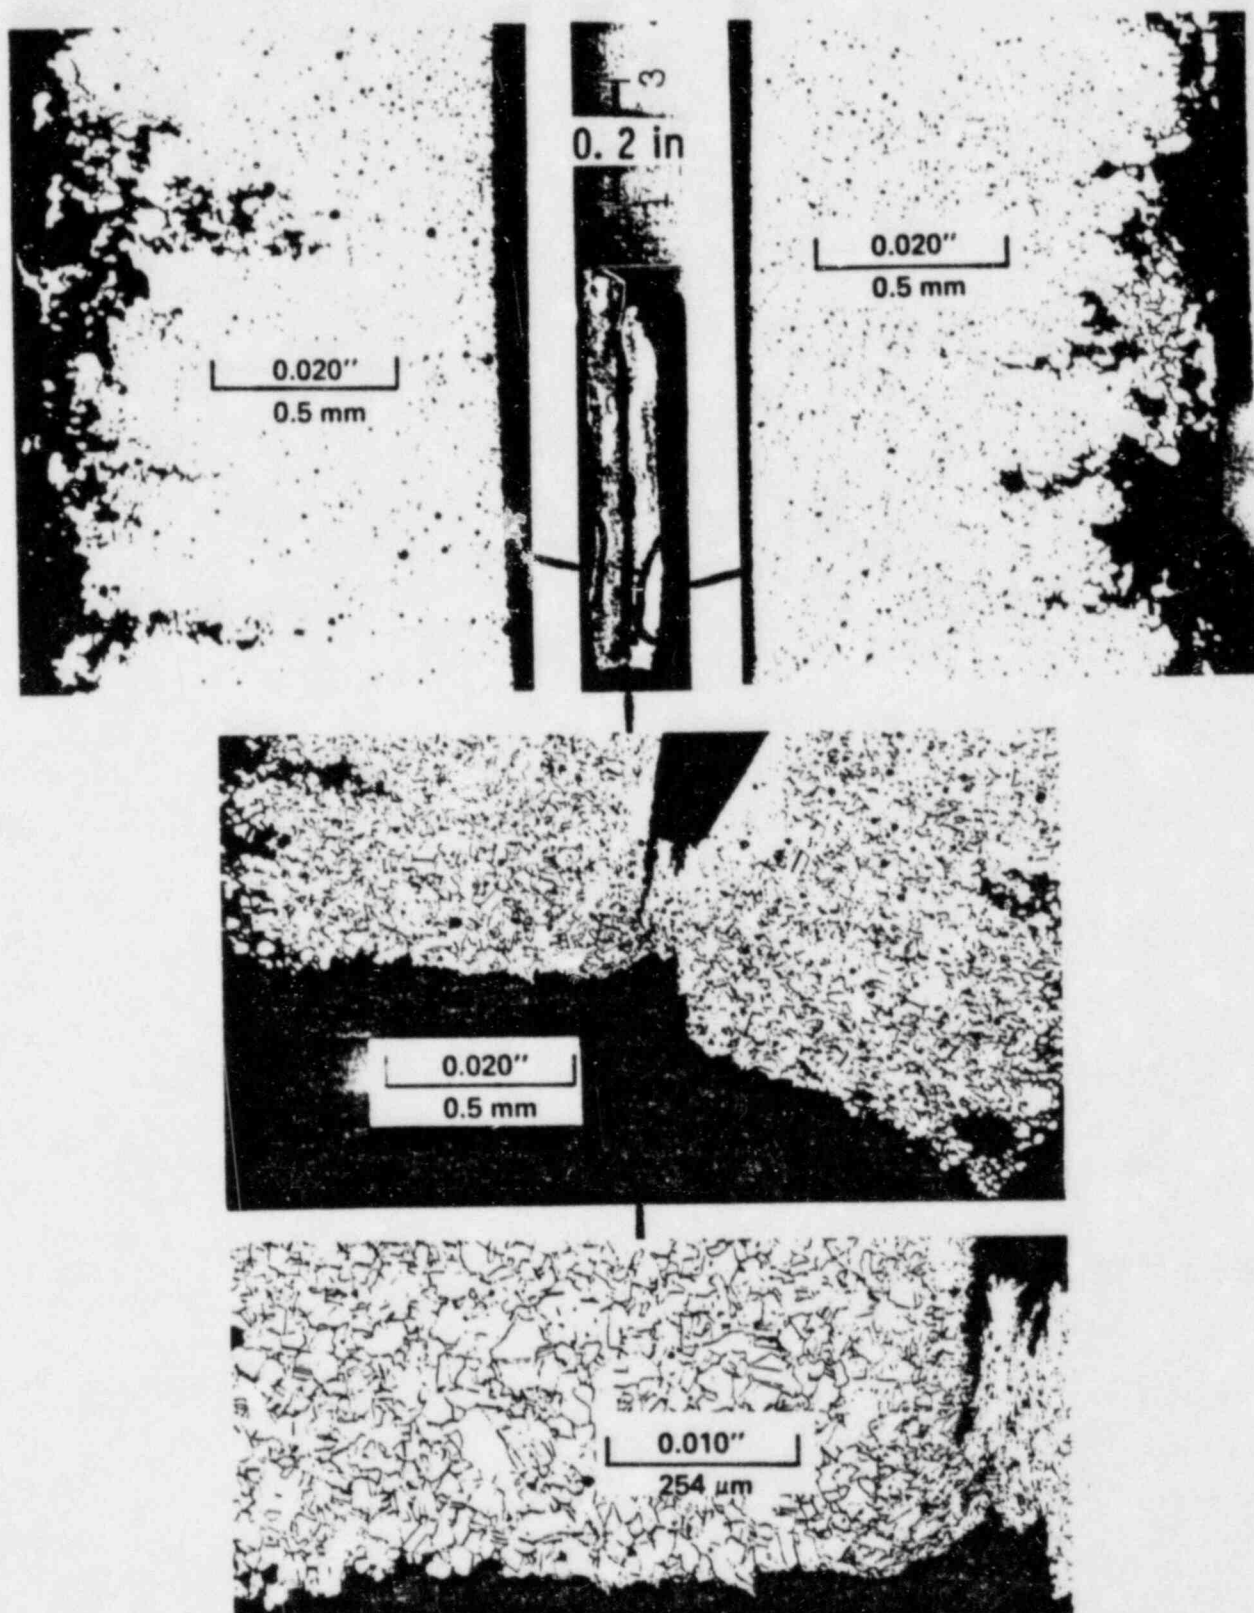
FIGURE 16. B(26-53), Transverse Half-Ring Cross Section within Tube Sheet (Sample 4 of Figure 5). Sample was first bent on itself to open up OD intergranular involvement. Inset at top shows OD at outer edges, ID surfaces touching in middle, and remaining ligament at bottom. Lower 2 photomicrographs show the intergranular involvement edge-on (horizontal orientation) and ligament area.

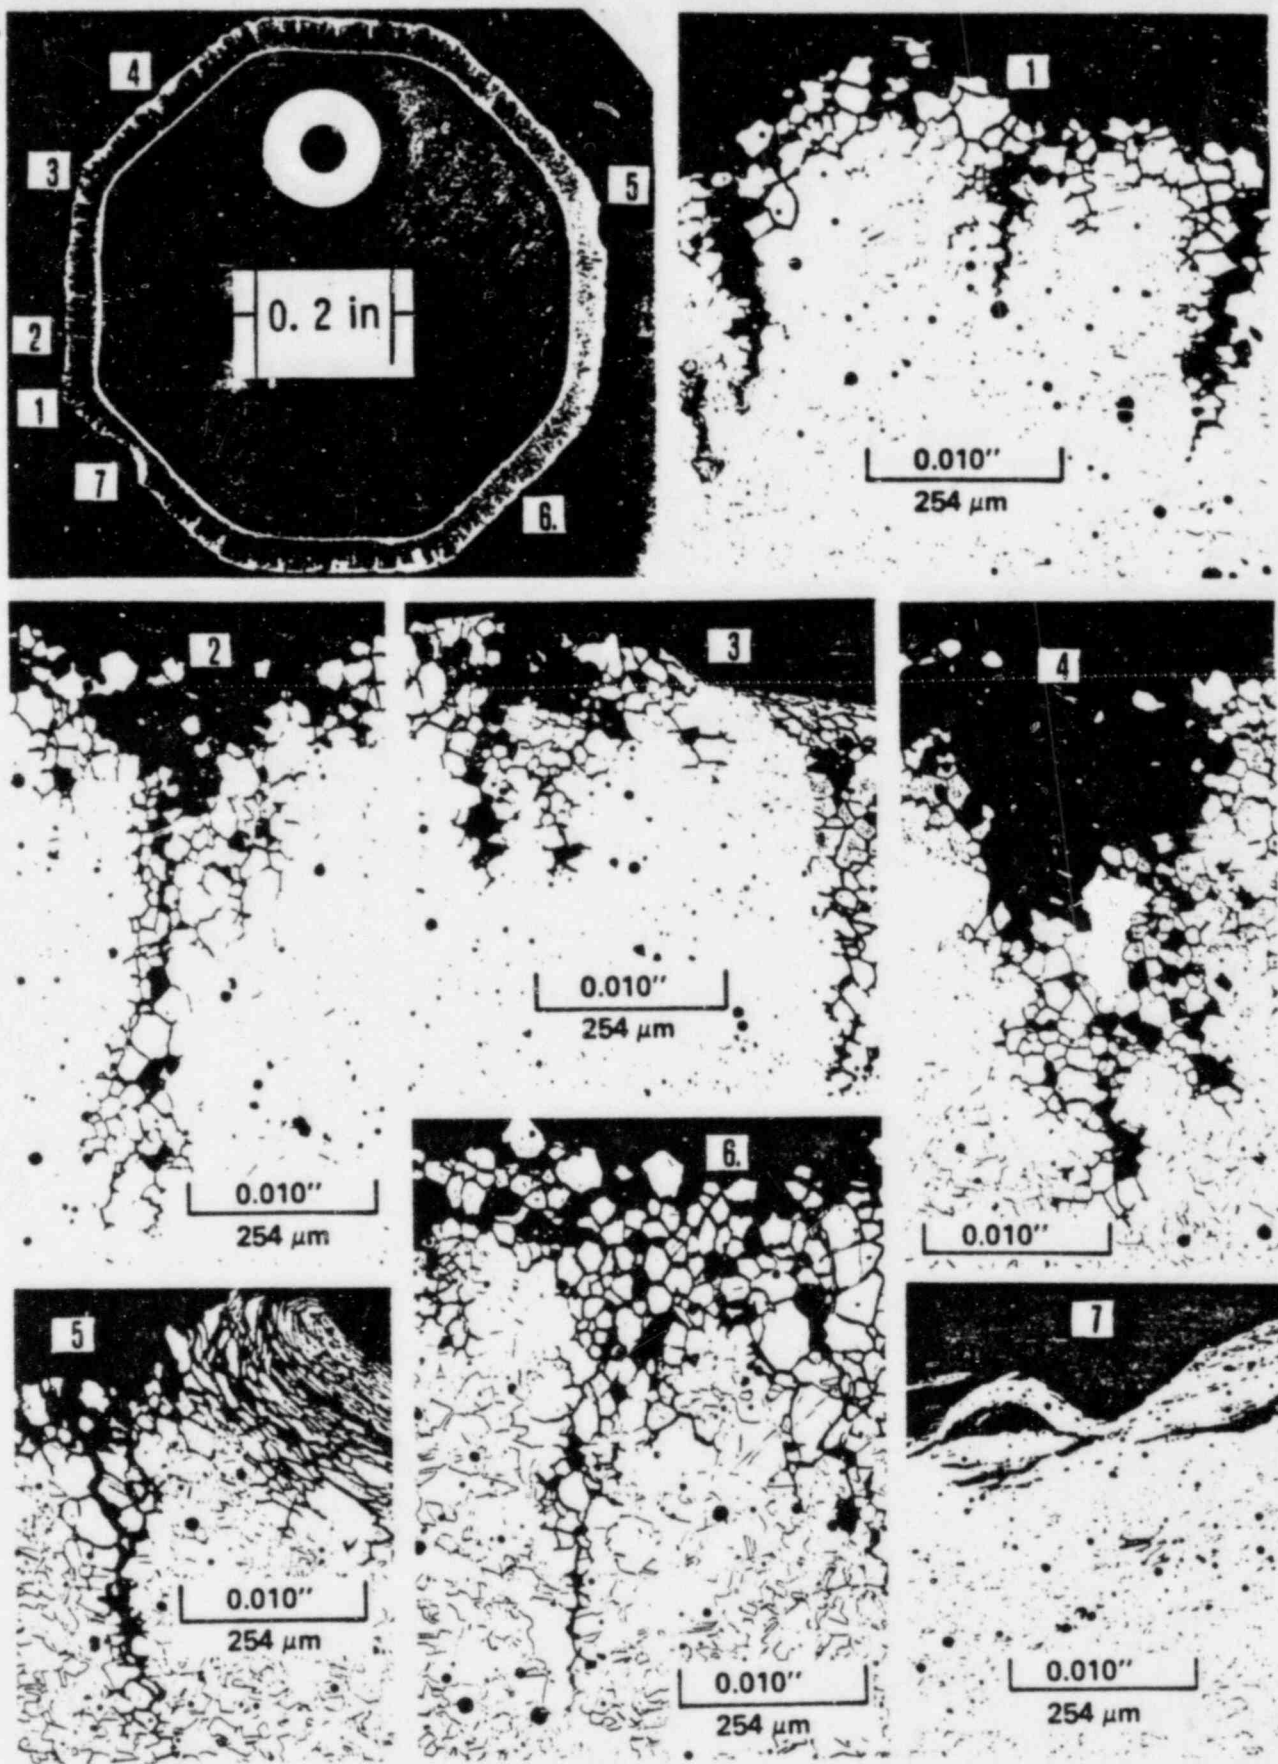
FIGURE 17. B(26-53), Transverse Full-Ring Cross Section within Tube Sheet at Point of Distortion due to Tube Pulling. Upper left = photomicrograph of etched octagonal-shaped (distorted) transverse sample (No. 5 of Figure 6). Photomicrographs are of OD areas.

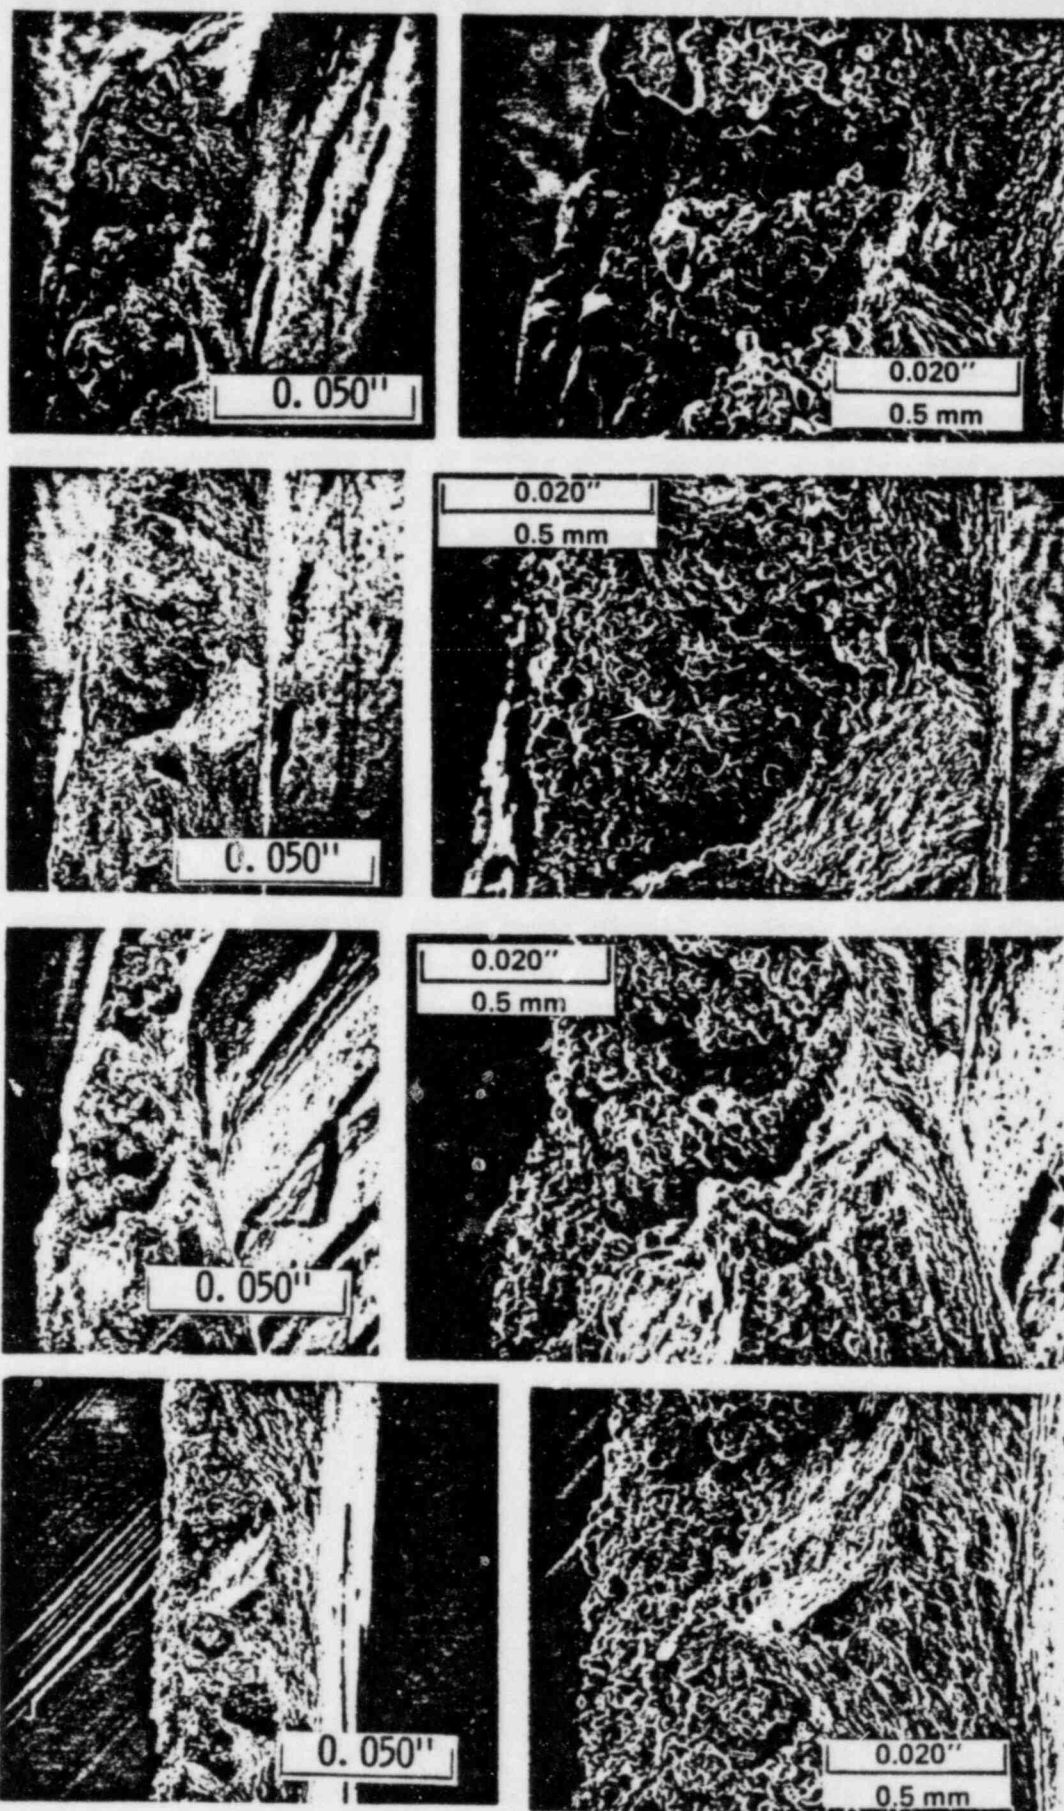
FIGURE 18. B(26-53), Sample 6 of Figure 7. Fracture surface nearer to primary face of tube sheet than similar sample of Figures 13 - 15. SEM's at 30° intervals from 0° (top) to 90° (bottom). Magnifications vary with location within each SEM due to specimen tilt.

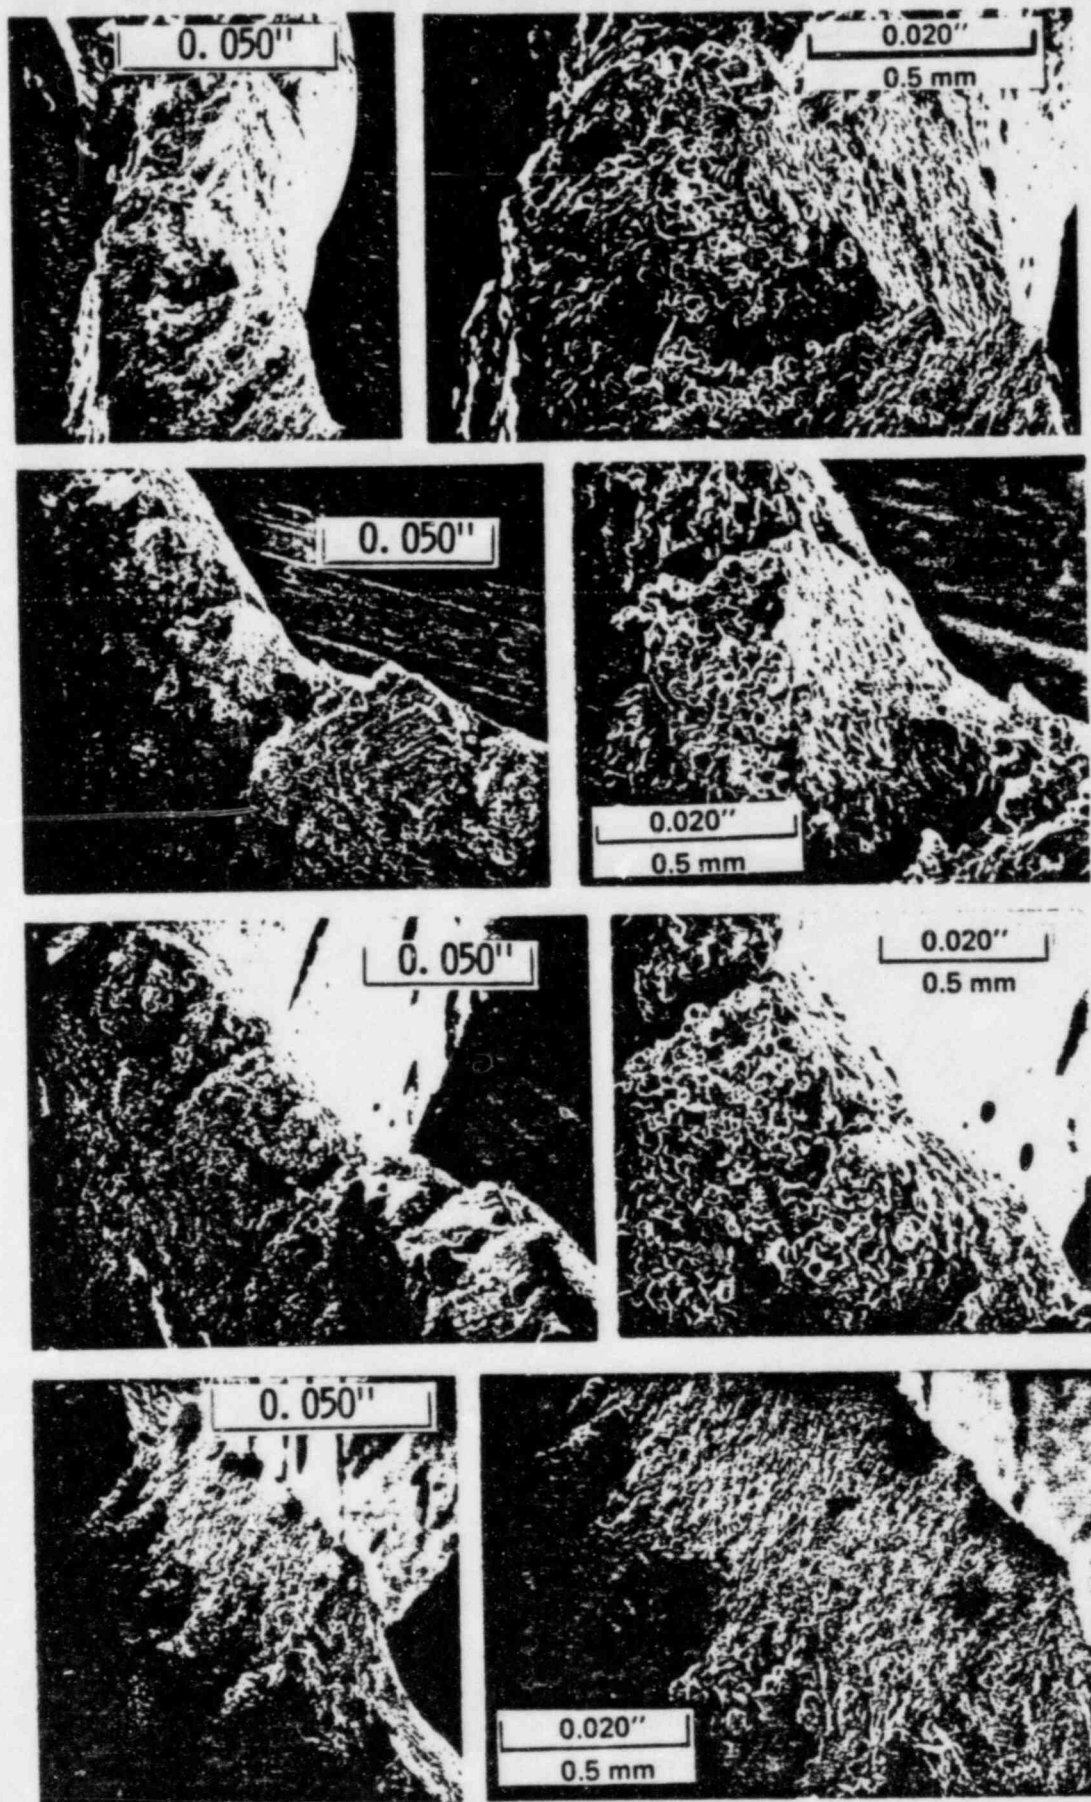
FIGURE 19. B(26-53), Sample 6. Additional SEM fractographs at 30° intervals from 120° (top) to 200° (bottom). Variable magnifications due to specimen tilt.

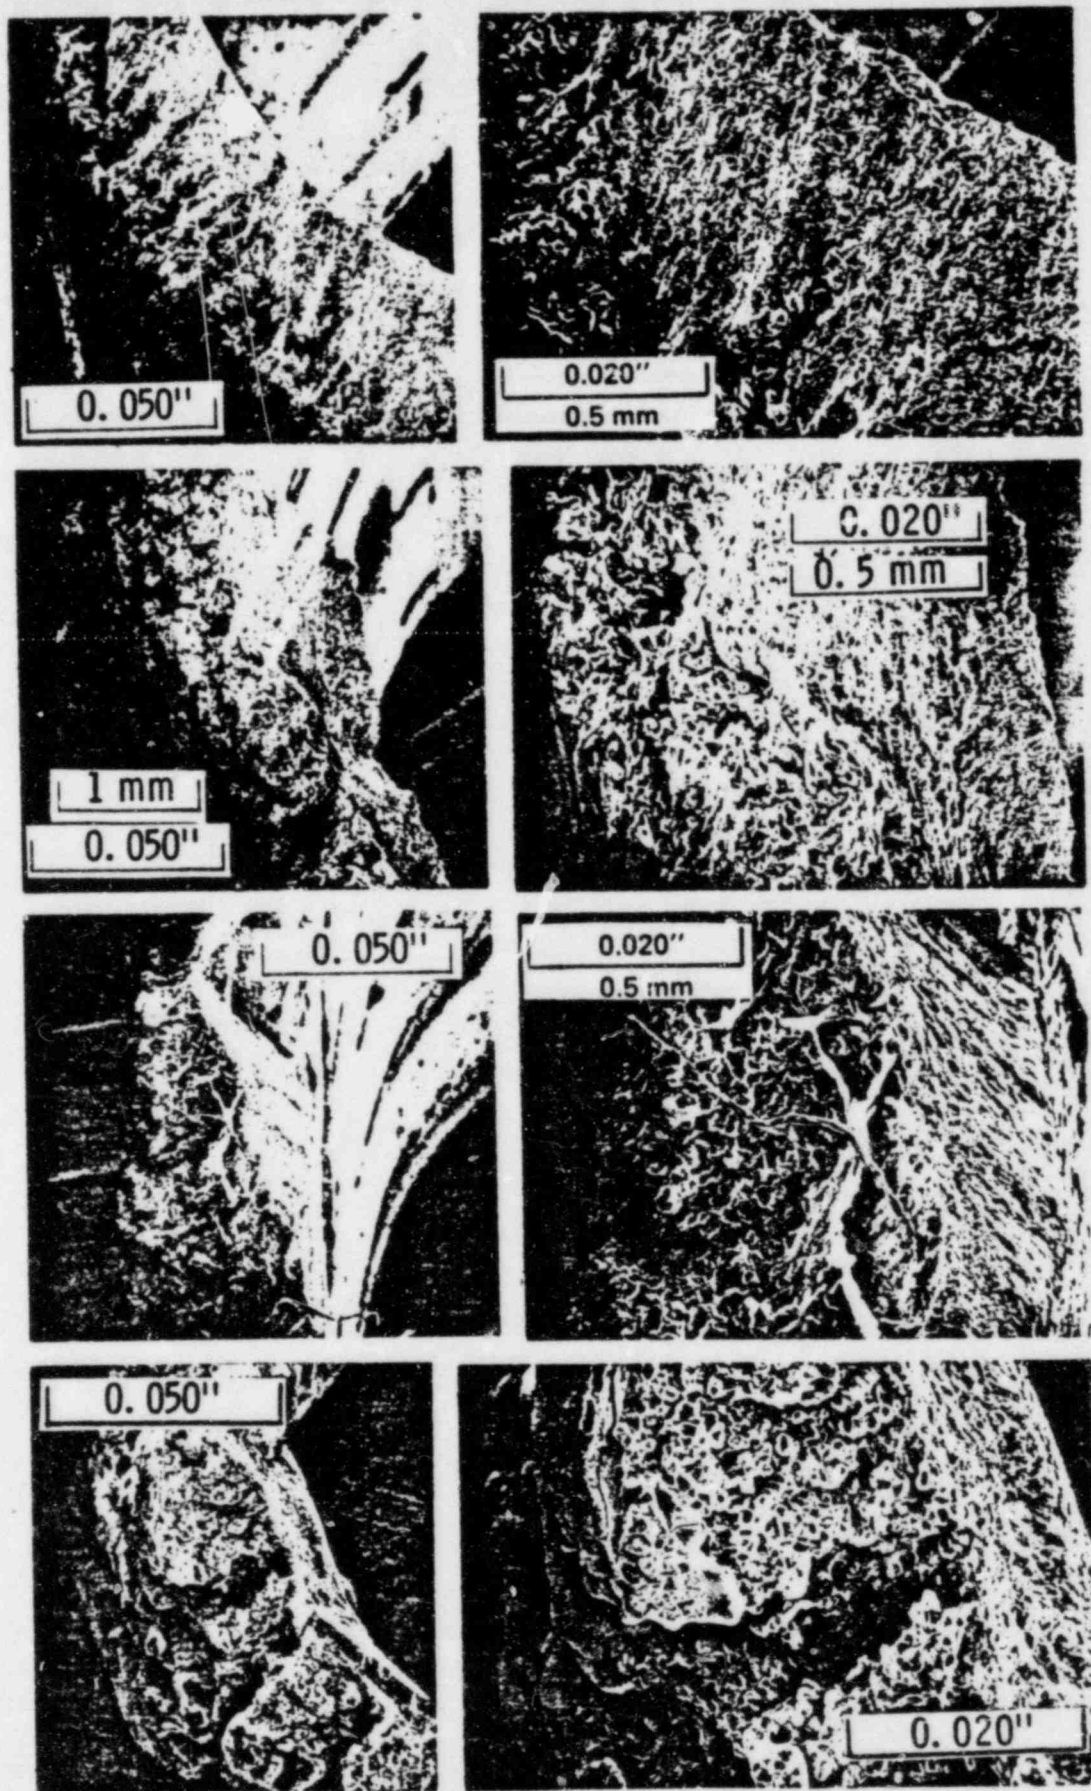
FIGURE 20. B(26-53), Sample 6. Concluding SEM fractographs at 30° intervals from 240° (top) to 330° (bottom). Magnifications vary within each photomicrograph due to specimen tilt on the stage of the SEM.

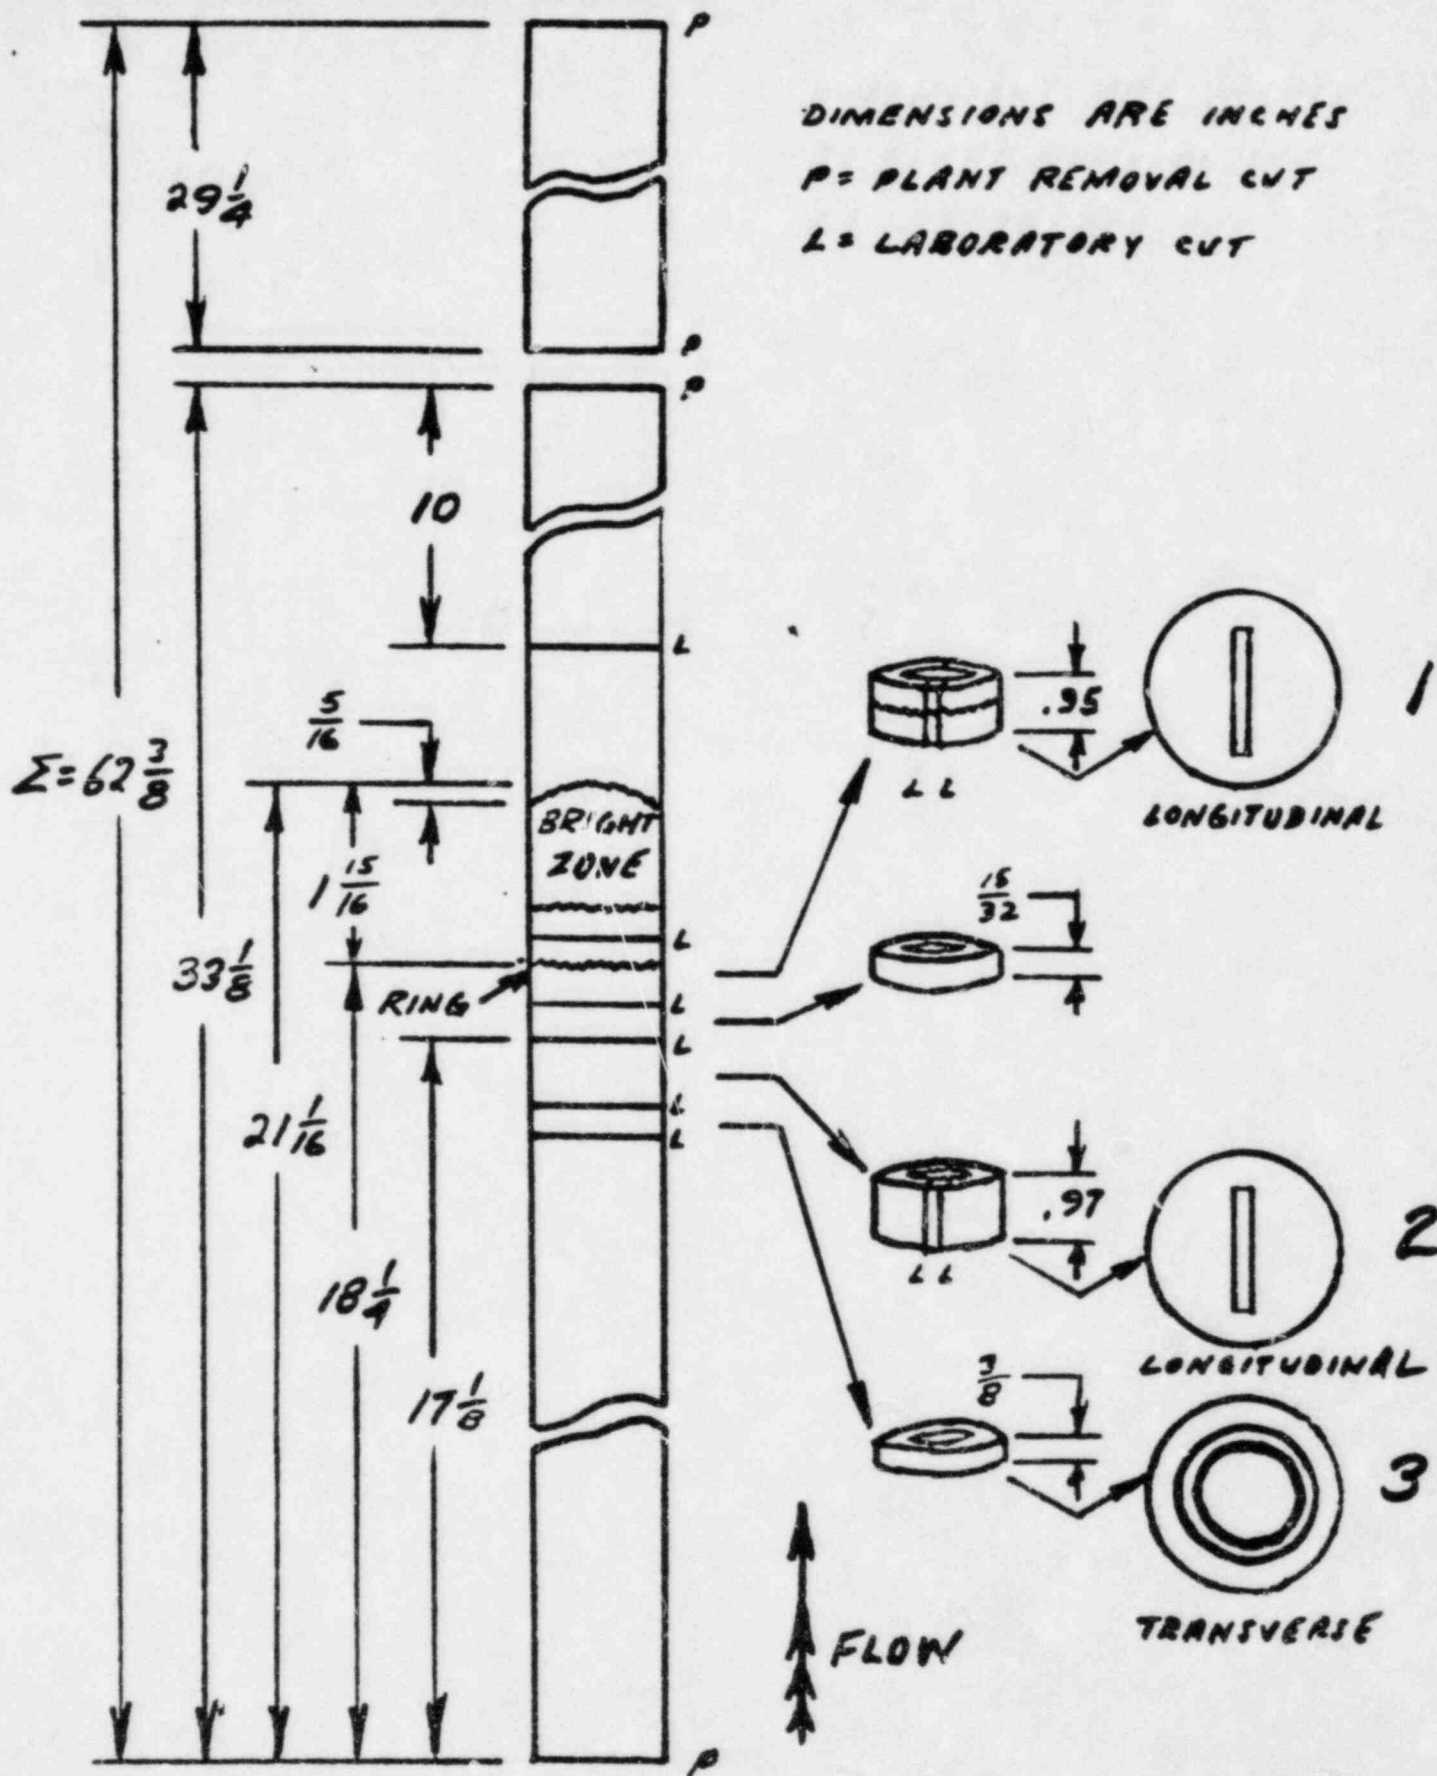
FIGURE 21. WEP B(30-41) - Laboratory Samples for Microscopic Examinations.

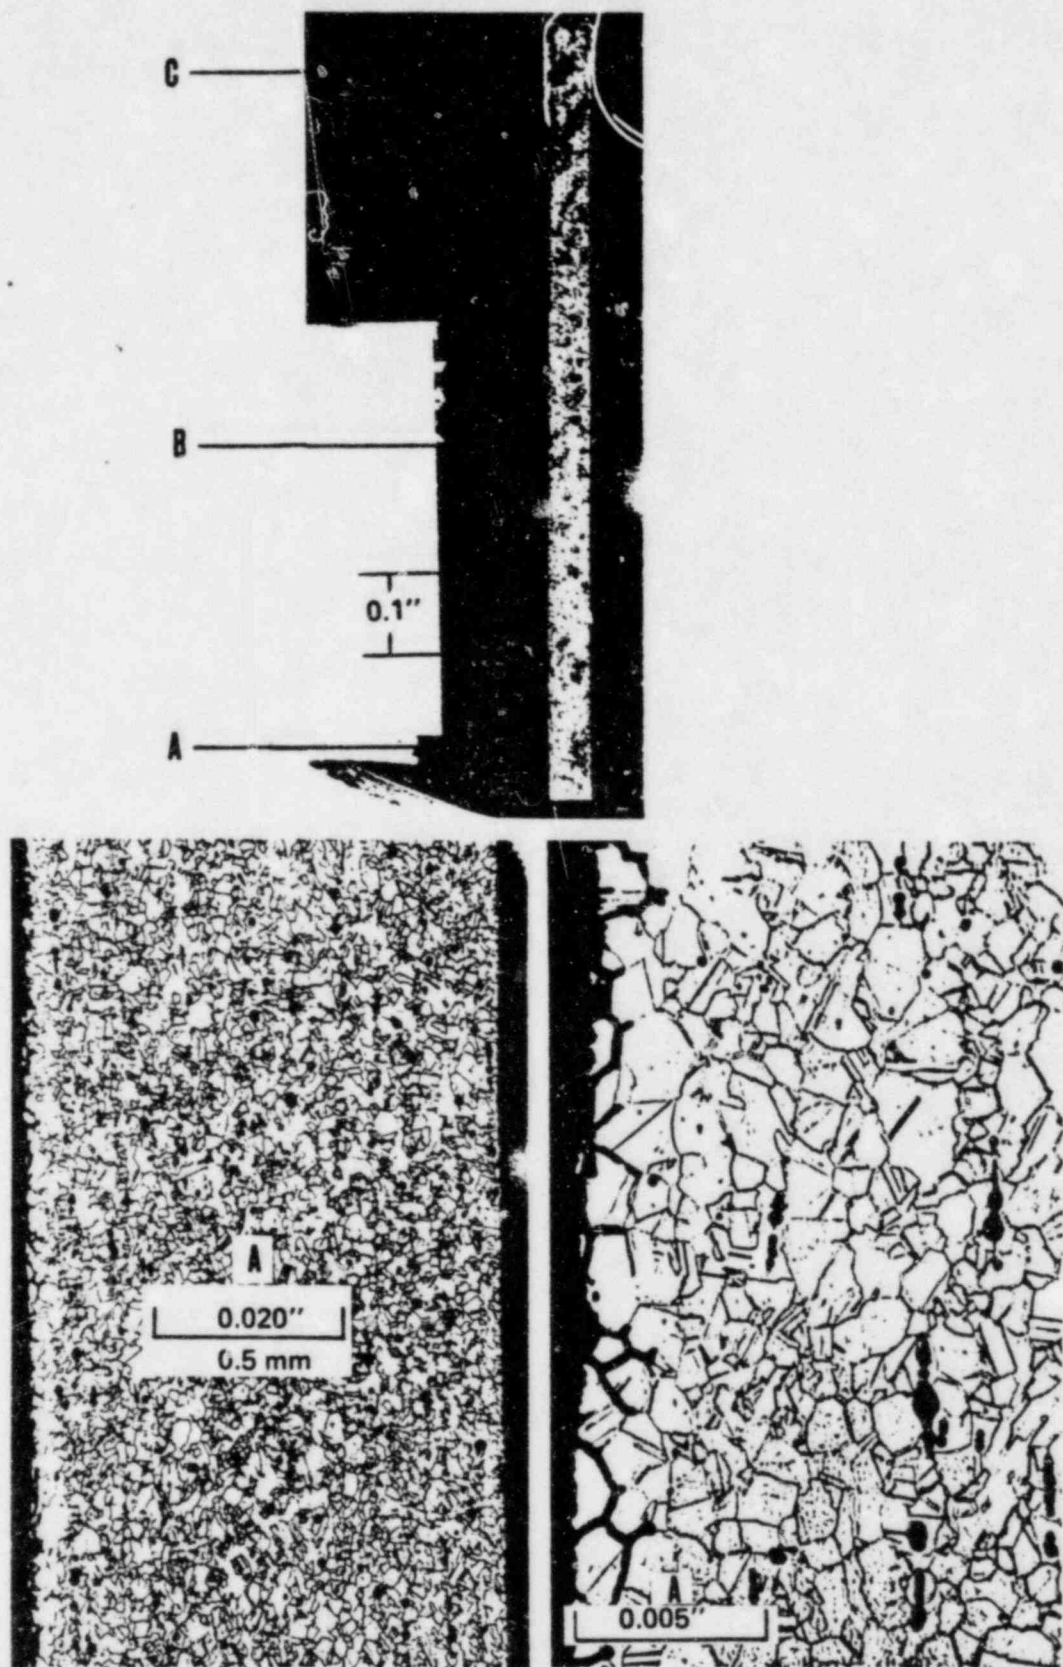
The results of the metallography through the tube sheet ring appear in Figures 23 and 24. Very shallow grain boundary involvement to a maximum of 2 grains (0.002 in.) was detected below the ring (Figure 23), and even more shallow involvement, less than 1 grain deep (≤ 0.001 in.), was observed at and above the ring (Figure 24). The axial cross section taken 1-1/4 to 2-1/4 in. below the ring and shown in Figures 25 and 26 contained intergranular corrosion to 65% of the wall thickness,

FIGURE 23. B(30-41), Longitudinal Section through Tube Sheet Ring. Upper picture: etched photomacrograph of mounted section with OD at left and primary flow upward. Lower pair of photomicrographs: Area A below the ring, OD on left. (Bromine - methanol etchant.) Sample 1 of Figure 21.

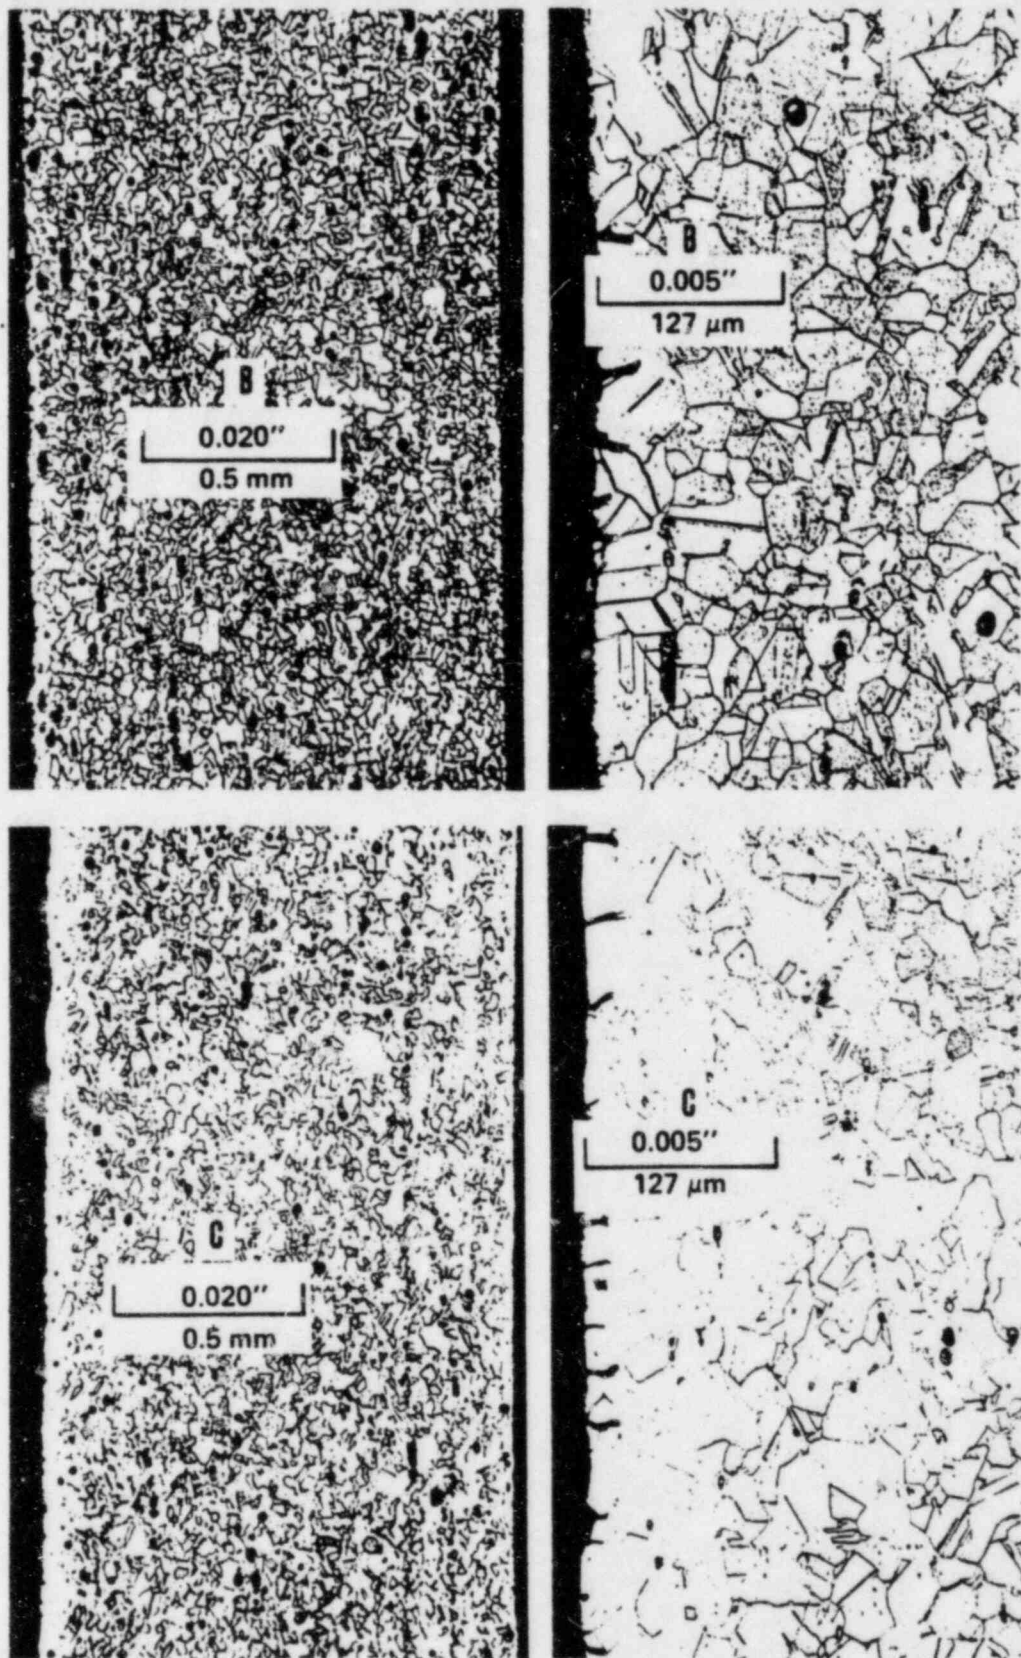
FIGURE 24. B(30-41), Longitudinal Cross Section through Tube Sheet Ring. Area B (near ring) and Area C (above ring) of Figure 23. The OD is at the left.

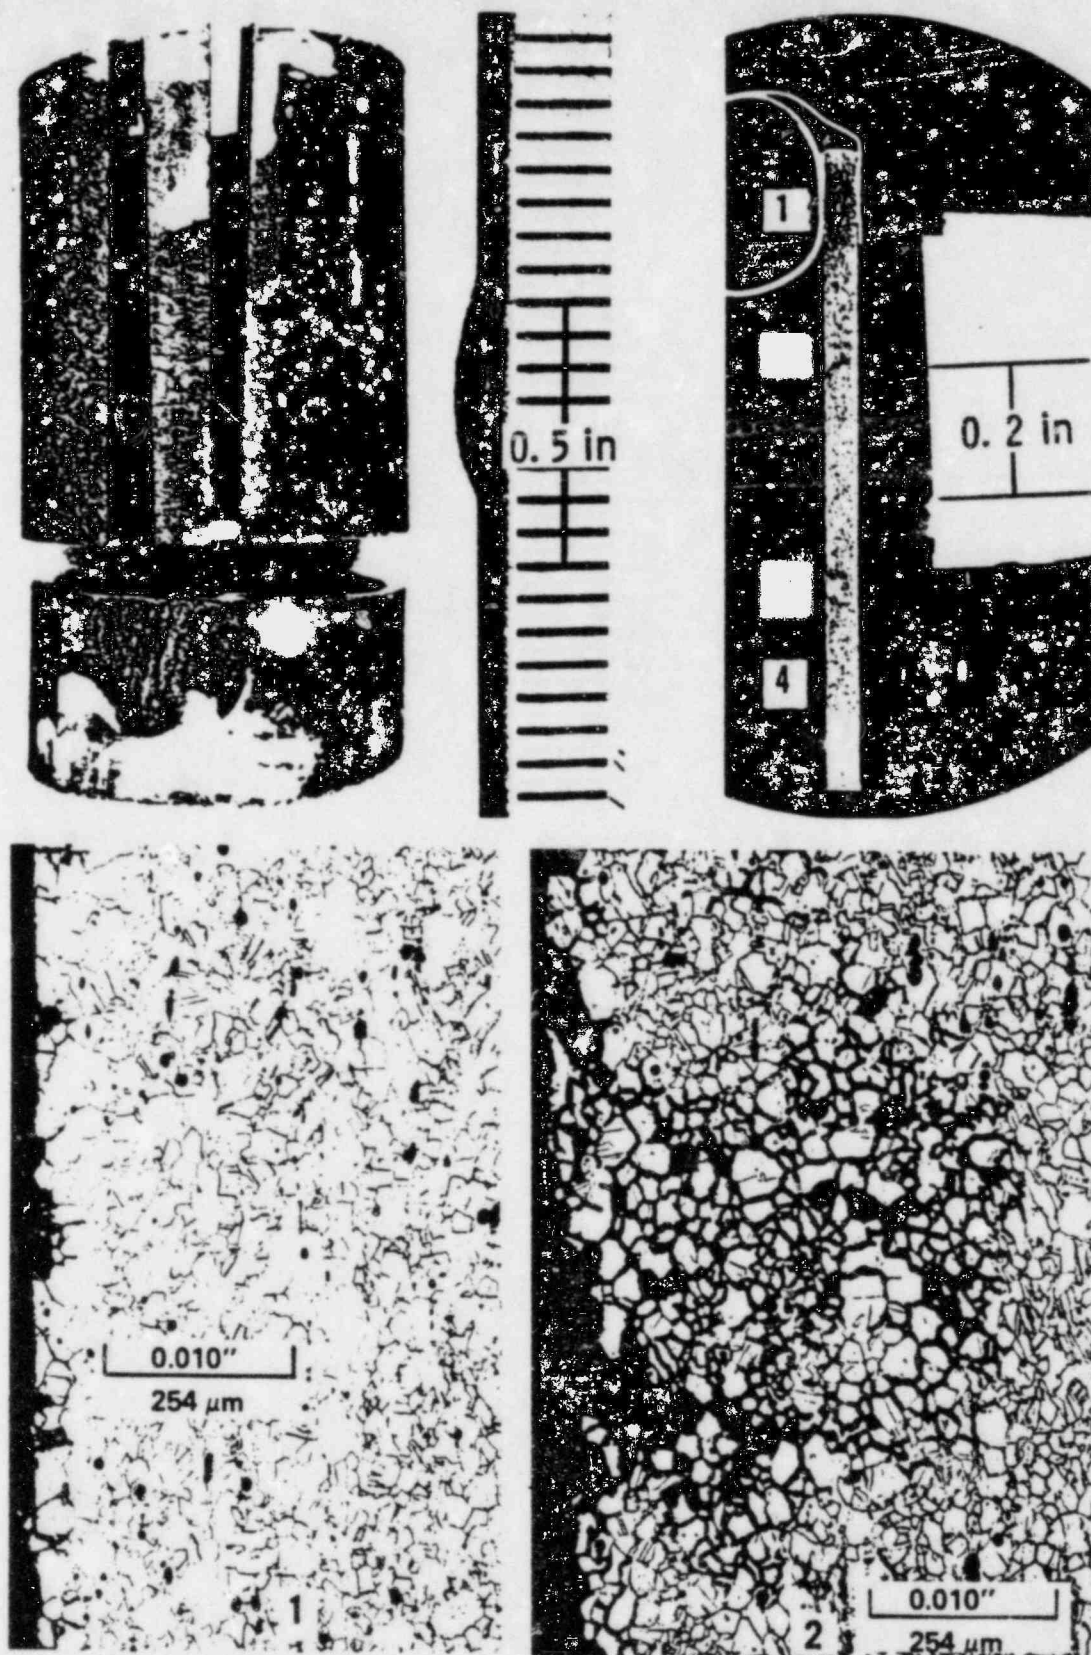
FIGURE 25. B(30-41). Microscopic samples from within the tube. Upper left shows longitudinal sample (No. 2 of Figure 21) and lower ring transverse section (No. 3 of Figure 21). Upper right = photomacrograph of mounted longitudinal section, OD at left. Lower 2 = Longitudinal Areas 1 and 2, with OD at left. Primary flow = upward.
