DOCKET NO. 50-266
FINAL REPORT OF STEAM GENERATOR TUBE INSPECTION
POINT BEACH NUCLEAR PLANT UNIT 1

MICROSCOPIC AND OTHER EXAMINATIONS OF
NUCLEAR STEAM GENERATOR TUBING REMOVED
FROM POINT BEACH NO. 1 IN MARCH 1980

RE-EVALUATION OF EDDY CURRENT TAPES FOR TUBES R19C37, R30C41, R26C53, R30C44, R28C38, R32C42, R22C46, AND R30C57

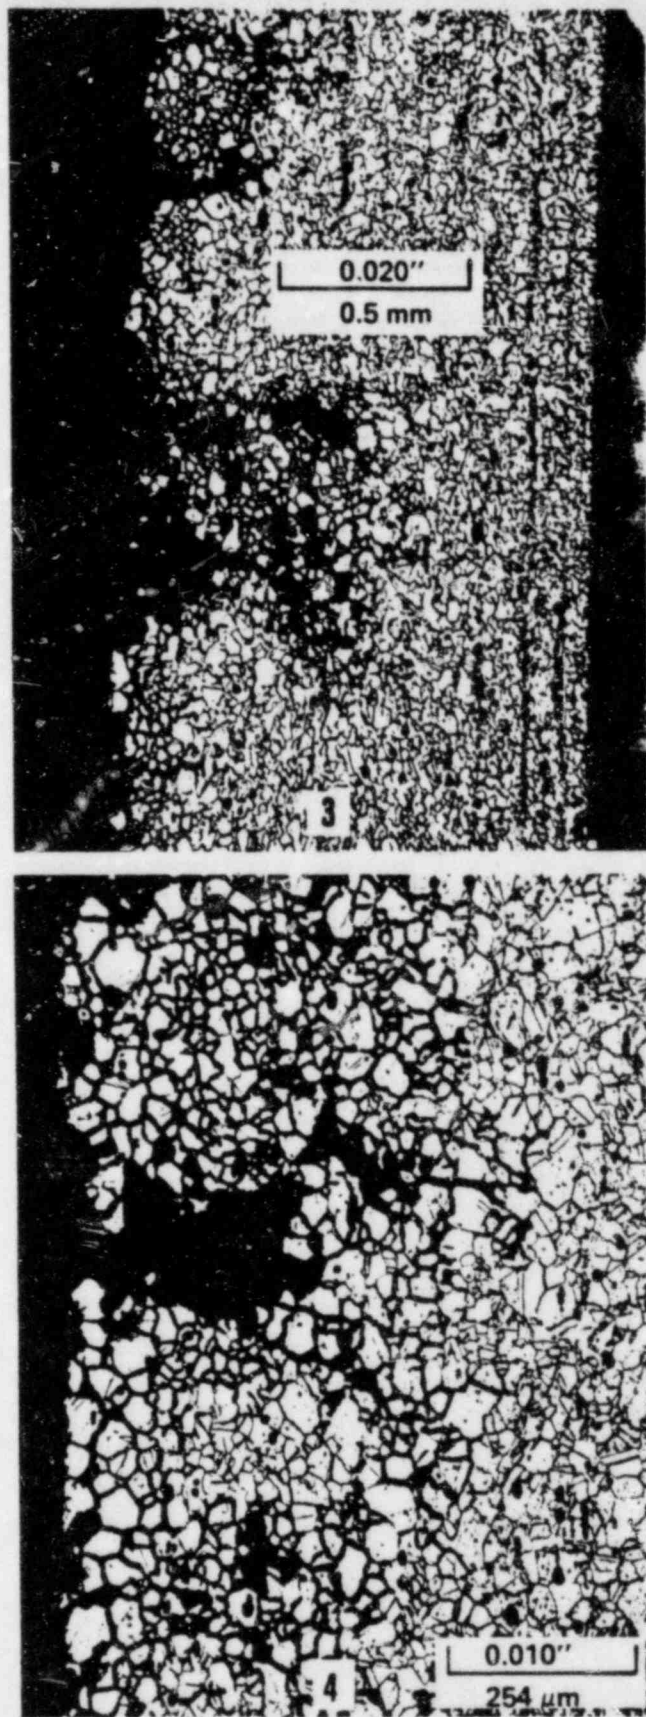
FIGURE 26. B(30-41), Longitudinal Cross Section within Tube Sheet (Sample 2 of Figure 21). Areas 3 and 4 of Figure 25. OD is at left.

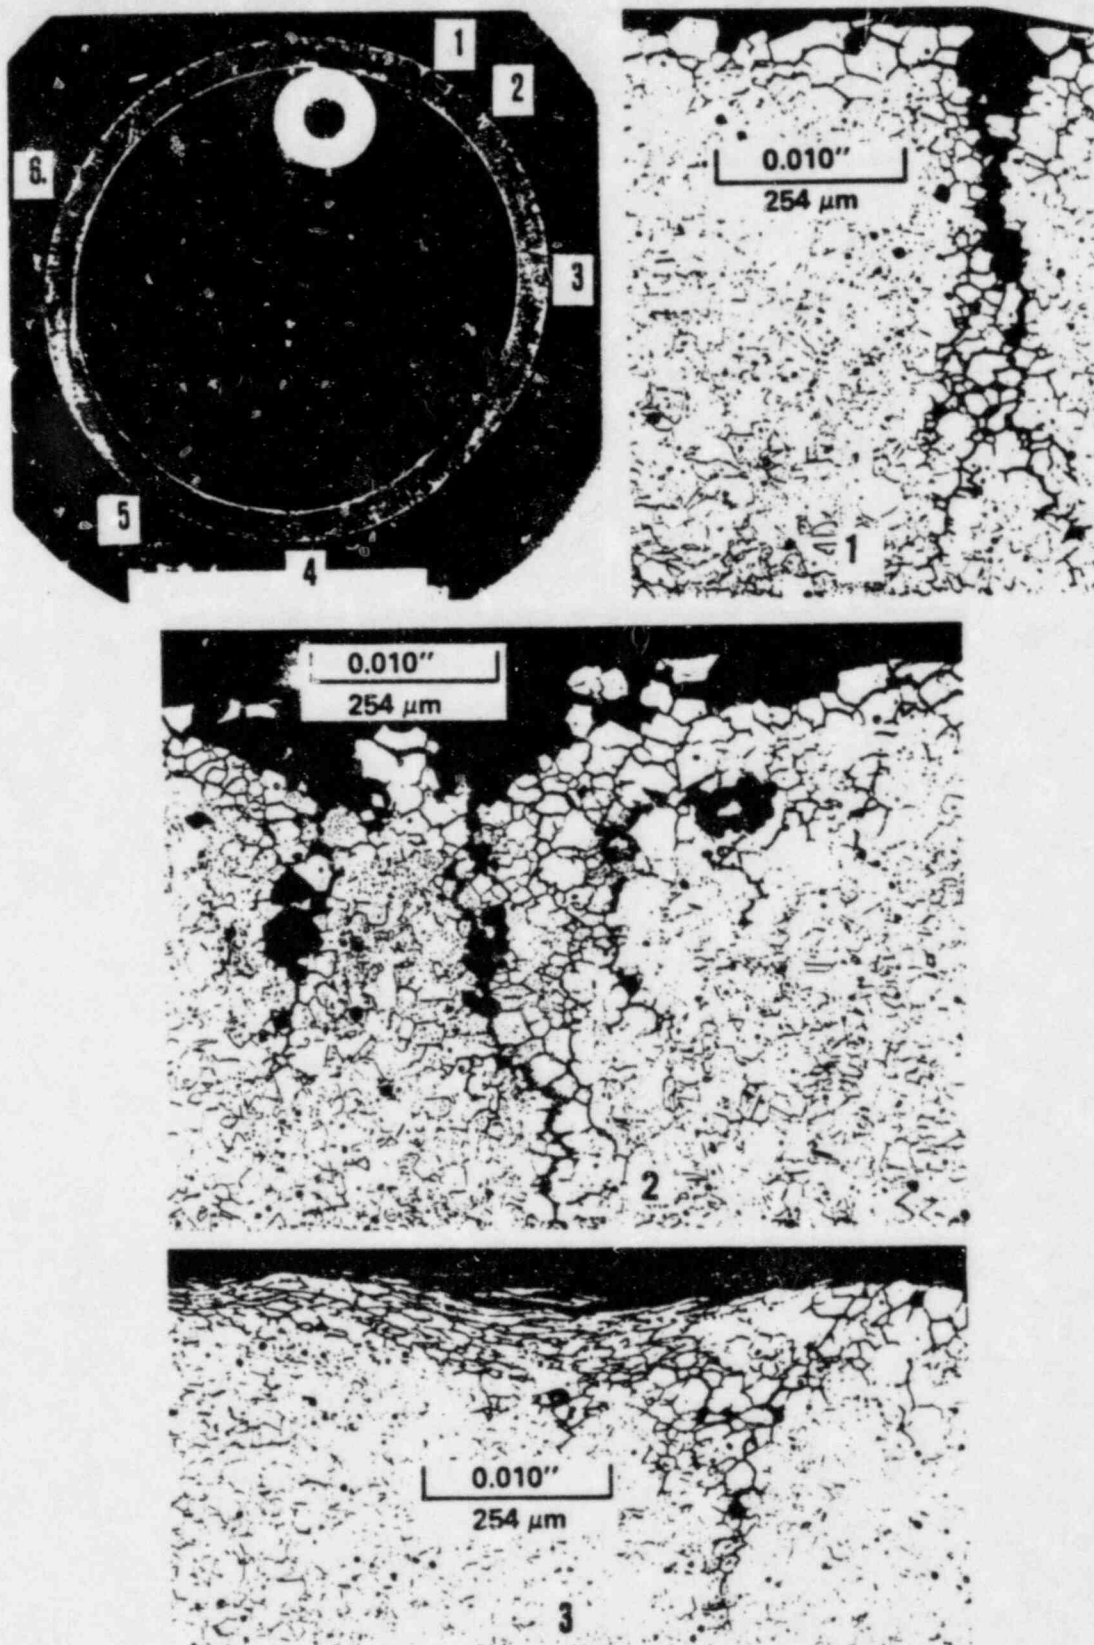
and the transverse cross section just below this axial section had intergranular corrosion to 55 - 60% of the wall (Figures 27 and 28).

FIGURE 27. B(30-41), Transverse Cross Section within Tube Sheet, Sample 3 of Figure 21. Photomicrographs are of OD edges at identified locations.

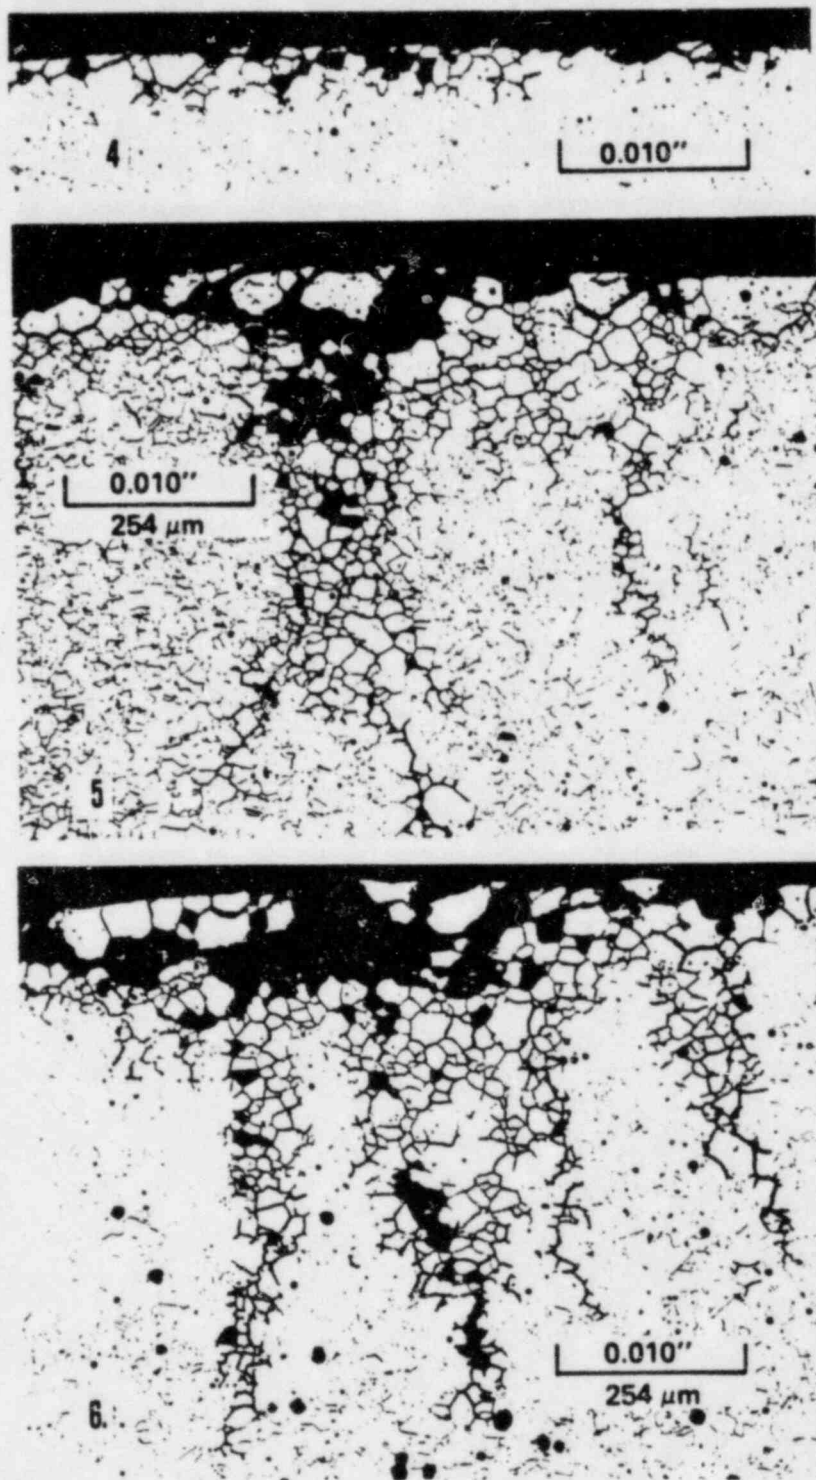
FIGURE 28 B(30-41), Transverse Cross Section with Tube Sheet. Continuation of OD photomicrographs at location shown in Figure 27.

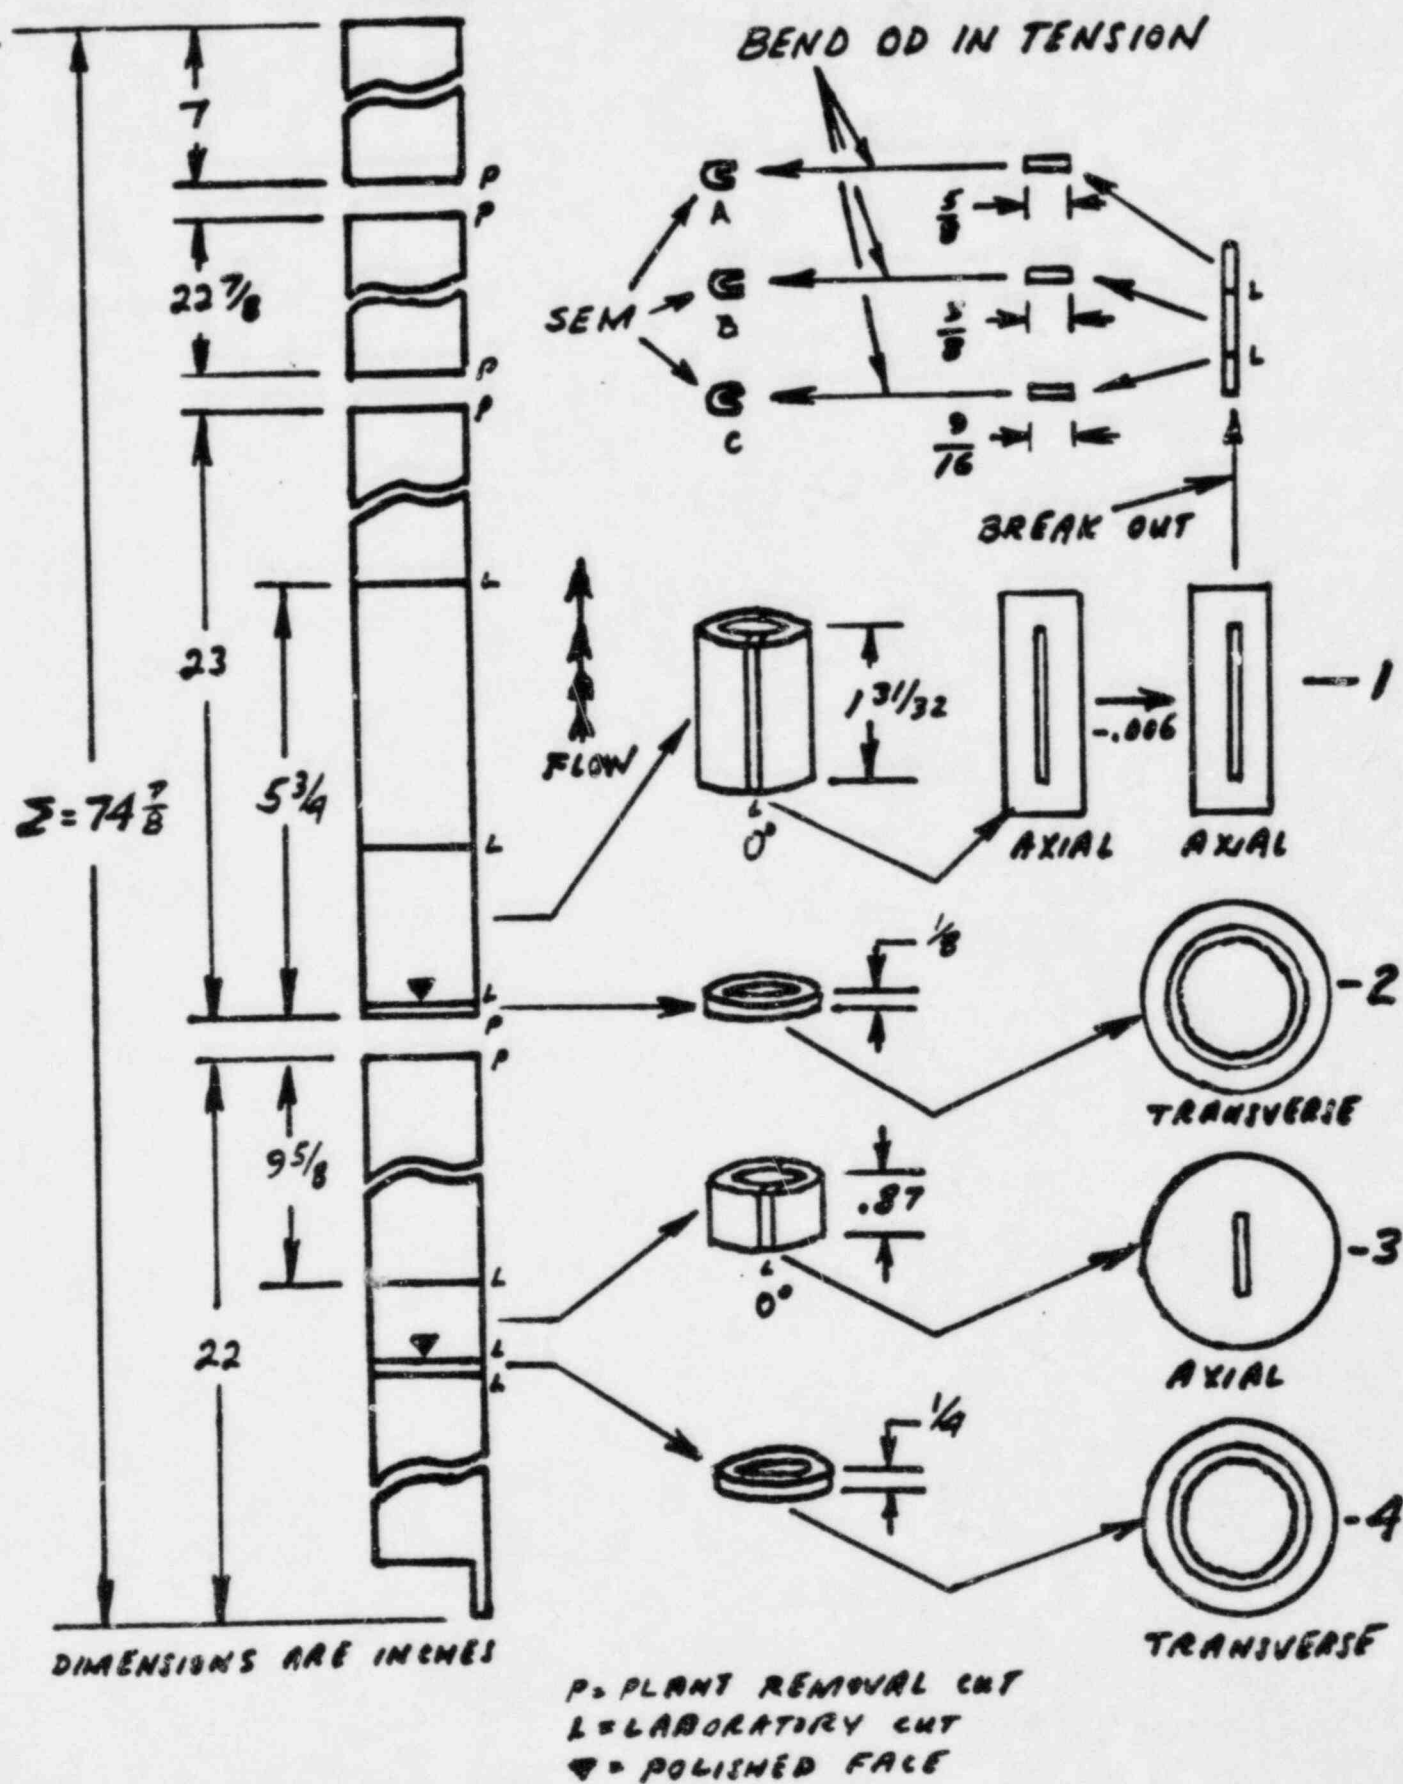
FIGURE 29. WEP B(19-37) - Laboratory Samples for Microscopic Examinations.

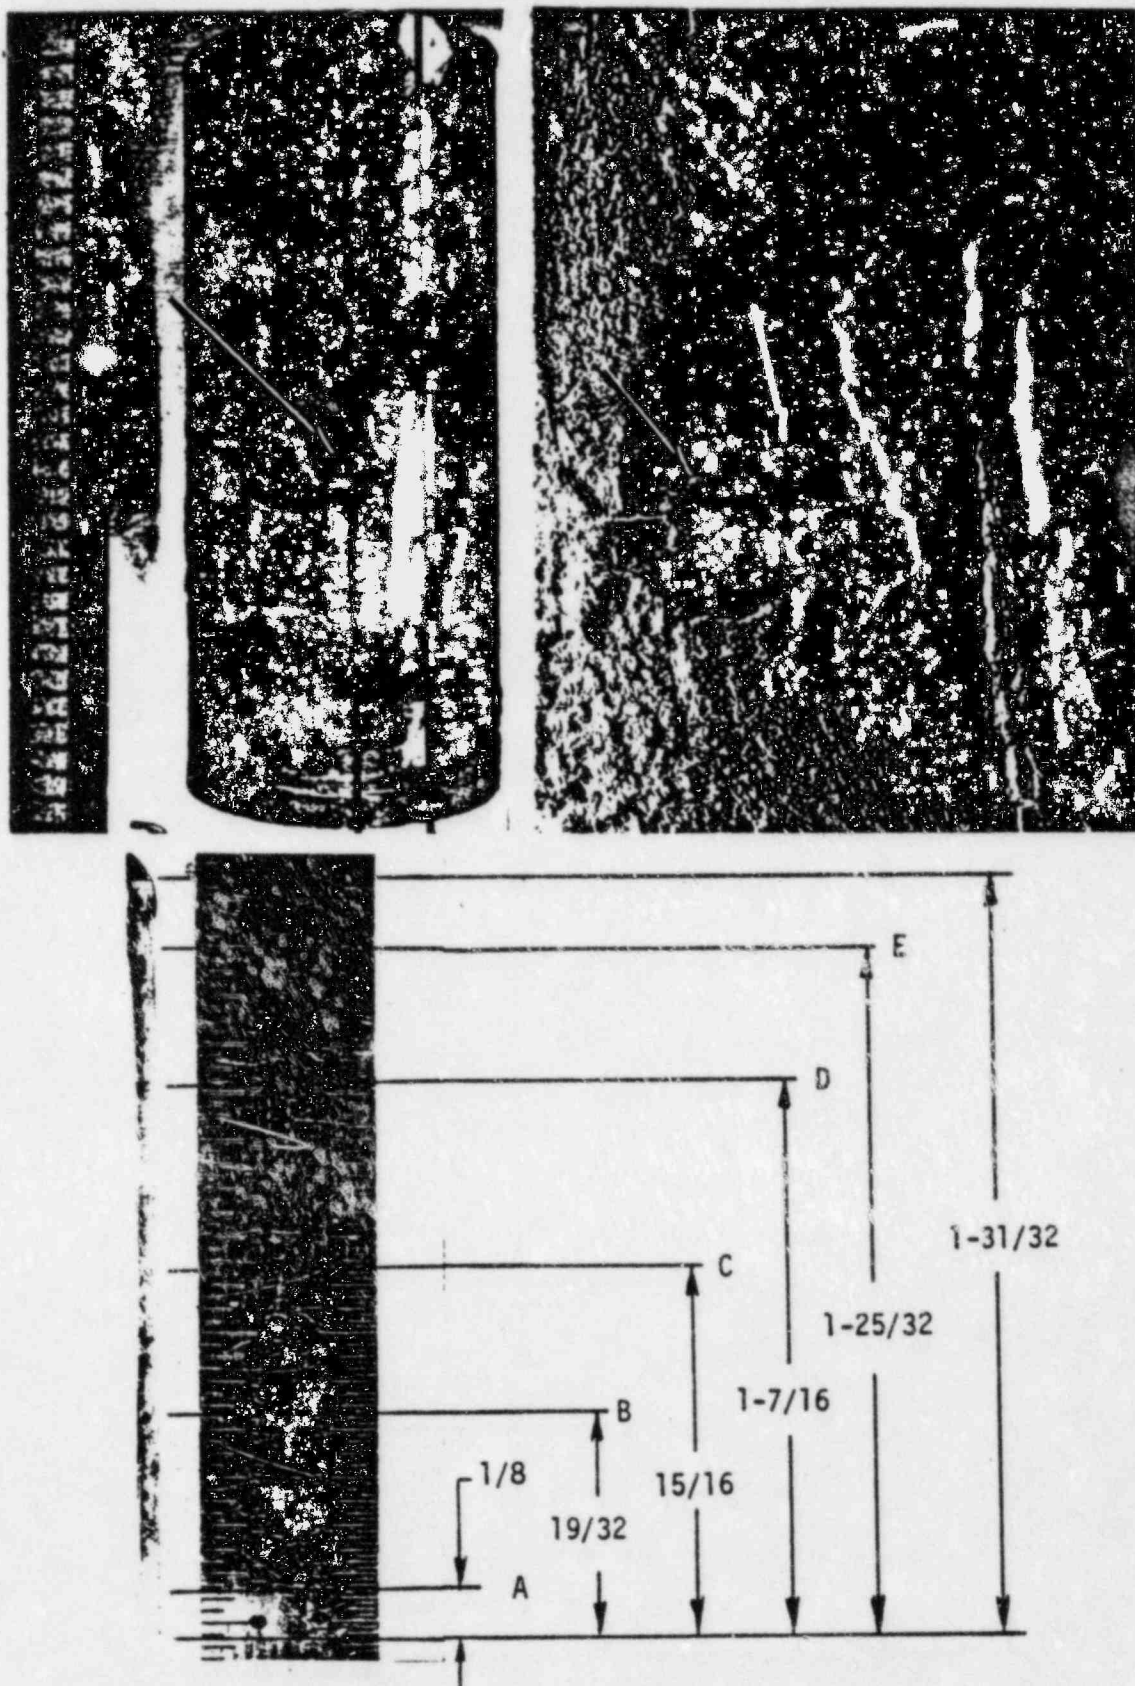
FIGURE 31. B(19-37). Top of Tube sheet Region. Sectioning for special 2-in.-long longitudinal micro. Upper pair shows cut lines and zone through which micro was made (arrows). The symbol ► denotes the polished face. Lower picture is a photomicrograph of the resultant cross section (OD on left) with locations (A-E) of high-magnification photomicrographs (Figures 32-35). Primary flow is upward. (Sample 1 of Figure 29.)

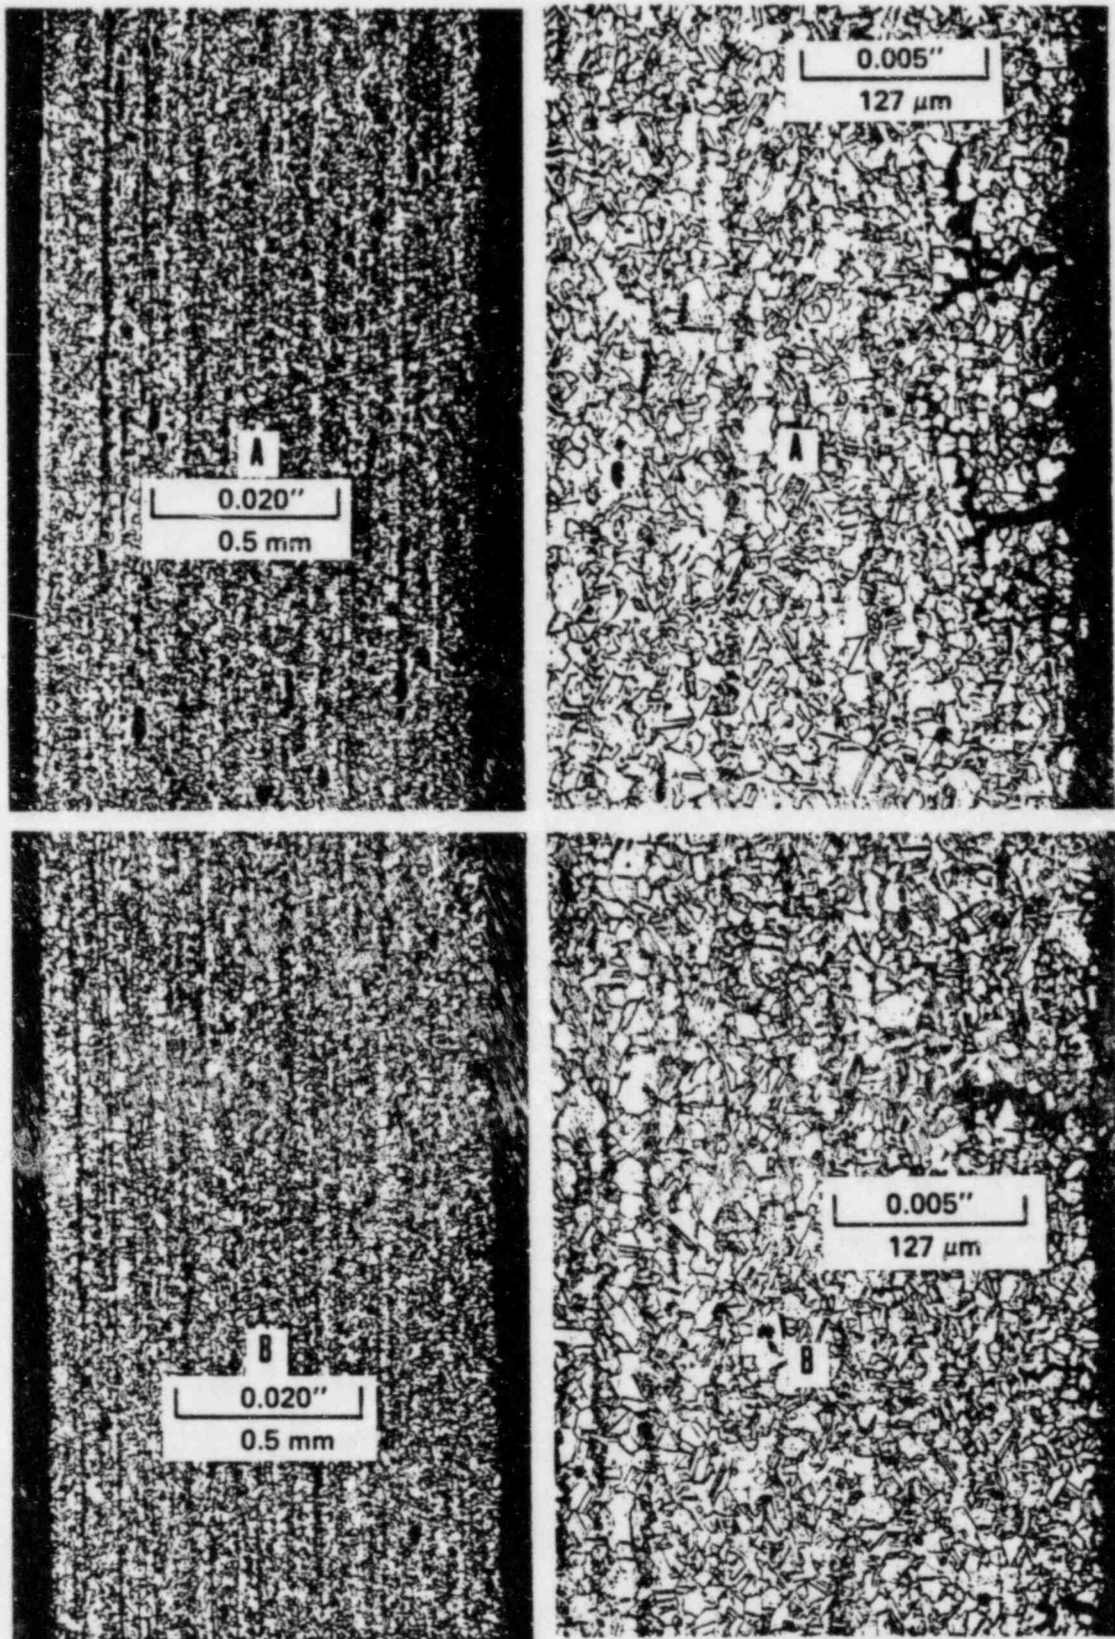
The results of the metallographic examination of the special 2-in.-long micro are collected in Figures 32 through 36. A maximum depth of 0.0185 in. of intergranular involvement was detected at the mid-elevation of this section (Figures 33 and 36). Above this point, two areas studied had only extremely shallow (≤ 0.0008 in.), isolated indications (Figure 34). The cut and bent sections from 3 elevations on this section are shown in Figures 37 and 38. The uppermost bend sample (Figure 37) contained the shallowest, opened intergranular involvement which, from the scanning electron micrographs, were superficial.

FIGURE 32. B(19-37), Top of Tube Sheet, 2-in.-long Axial Micro. Areas A and B of Figure 31, lower. OD edges are at right; primary flow is upward. Etched with bromine in methanol.

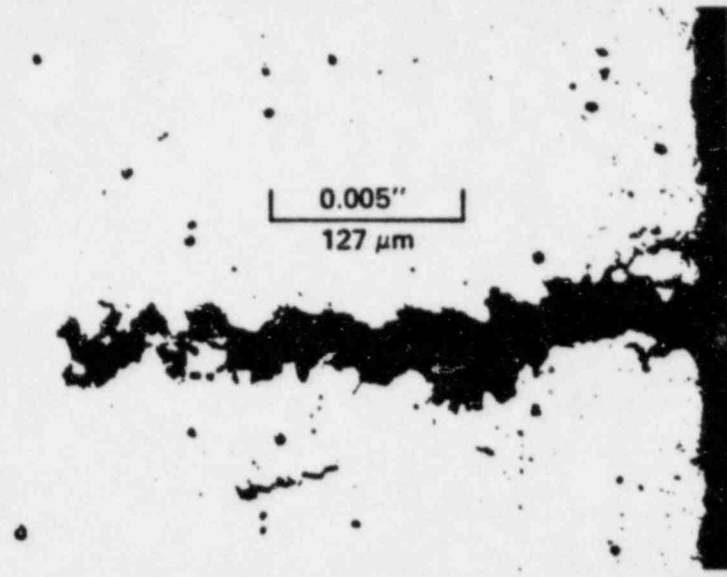
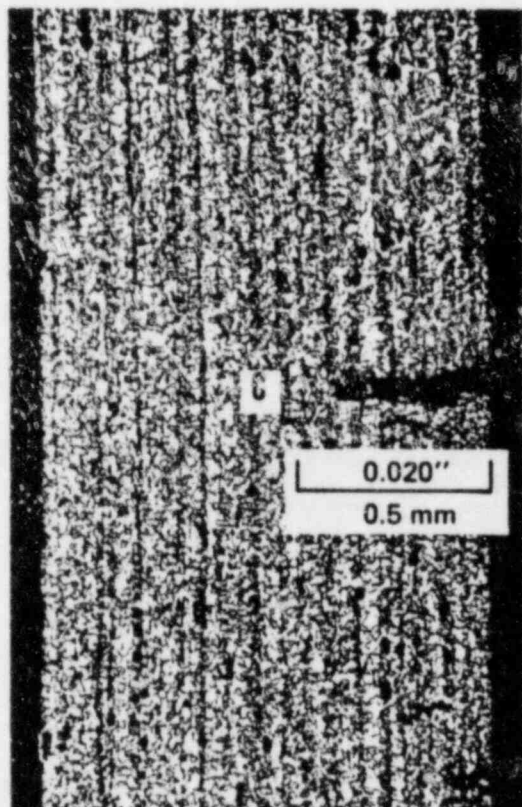
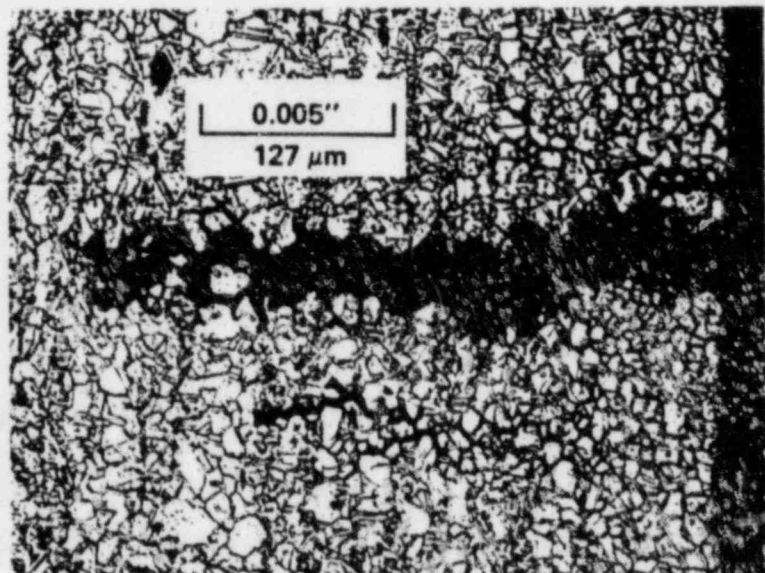
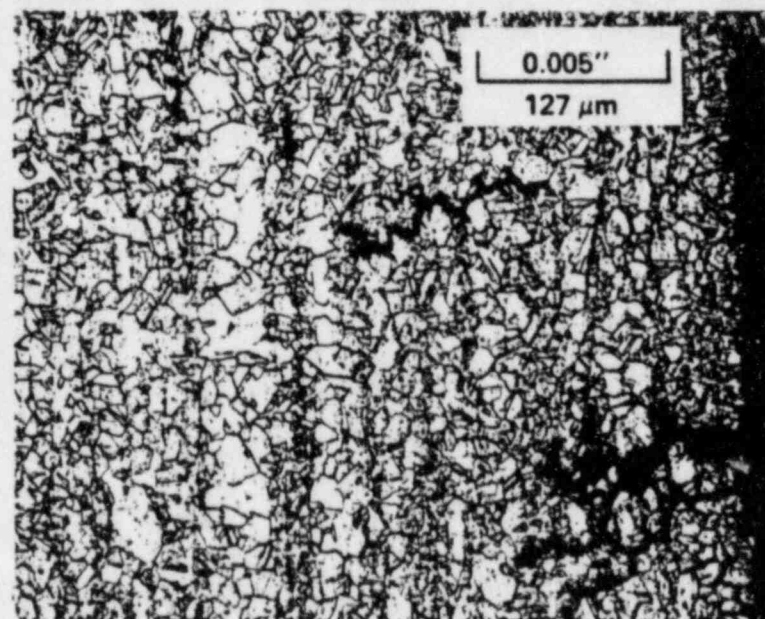
FIGURE 33. B(19-37), Axial Section at Top of Tube Sheet, Area C of Figure 21. OD is at left; primary flow is upward.

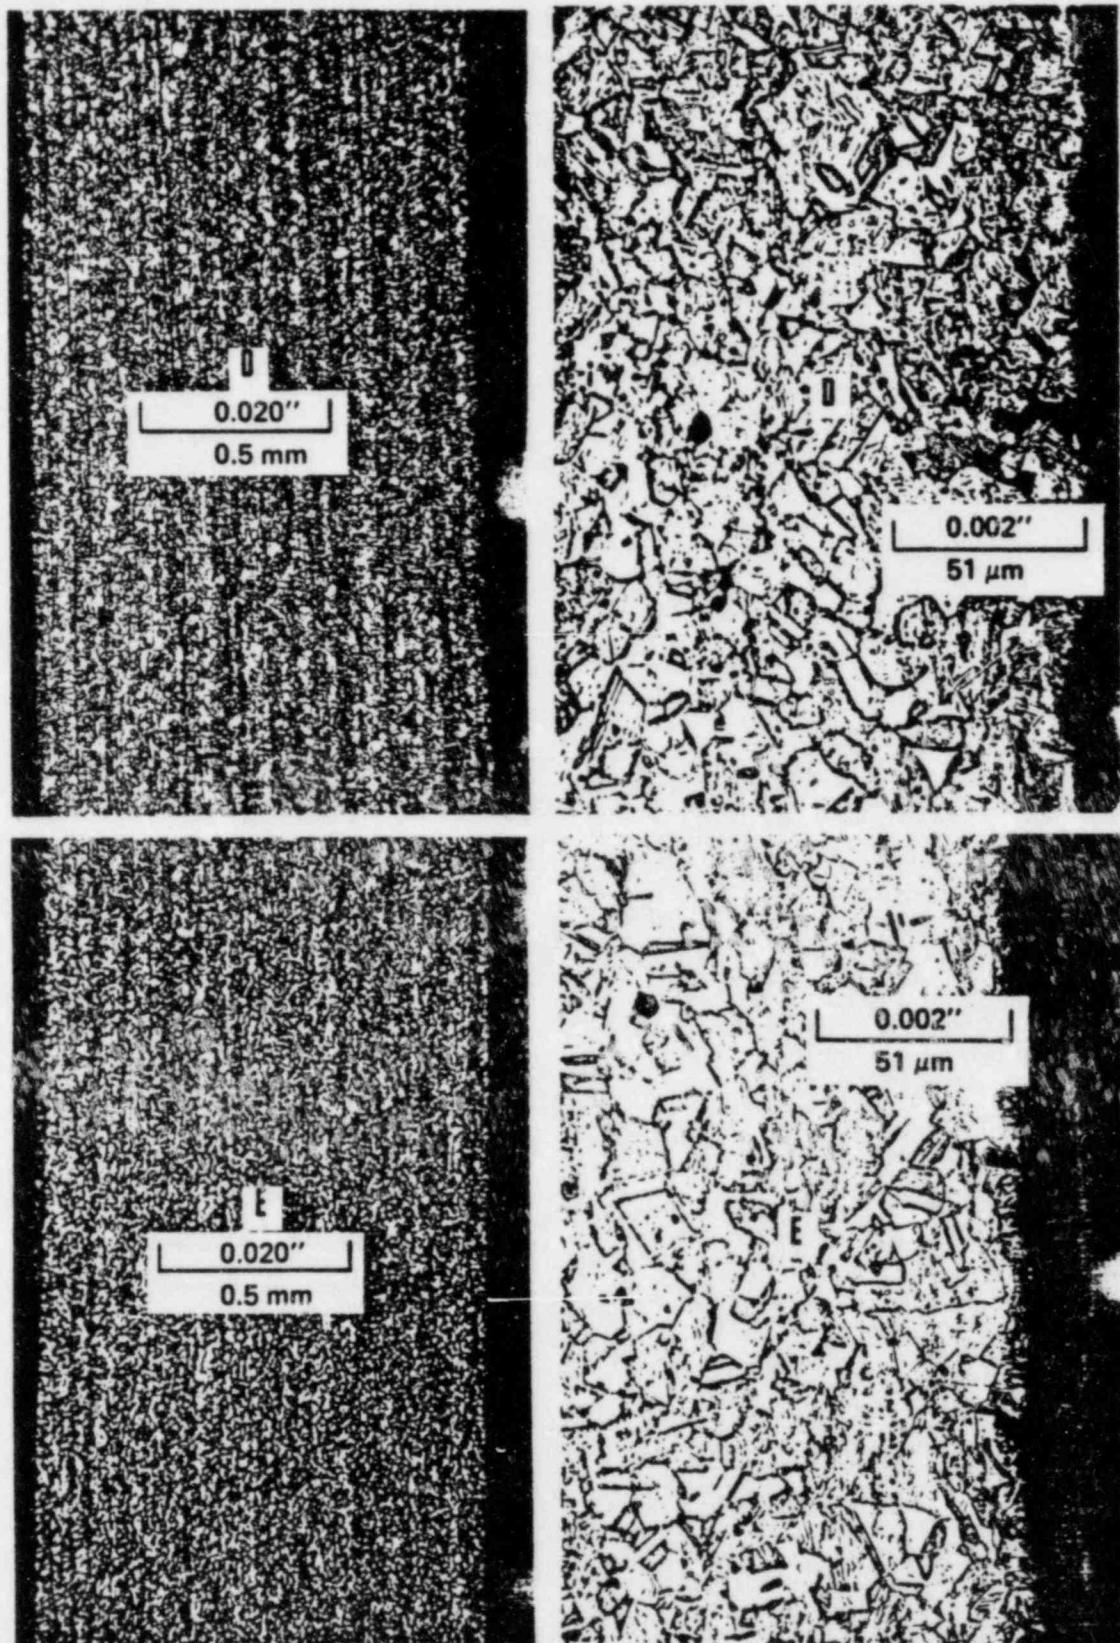
FIGURE 34. B(19-37), Axial Section at Top of Tube Sheet, Areas D and E of Figure 31. OD edges are to the right and primary flow is upward.

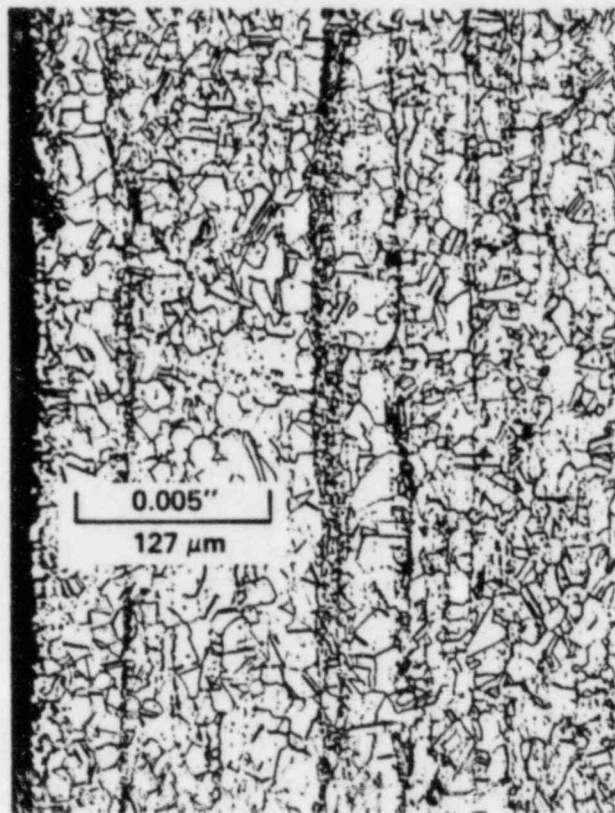
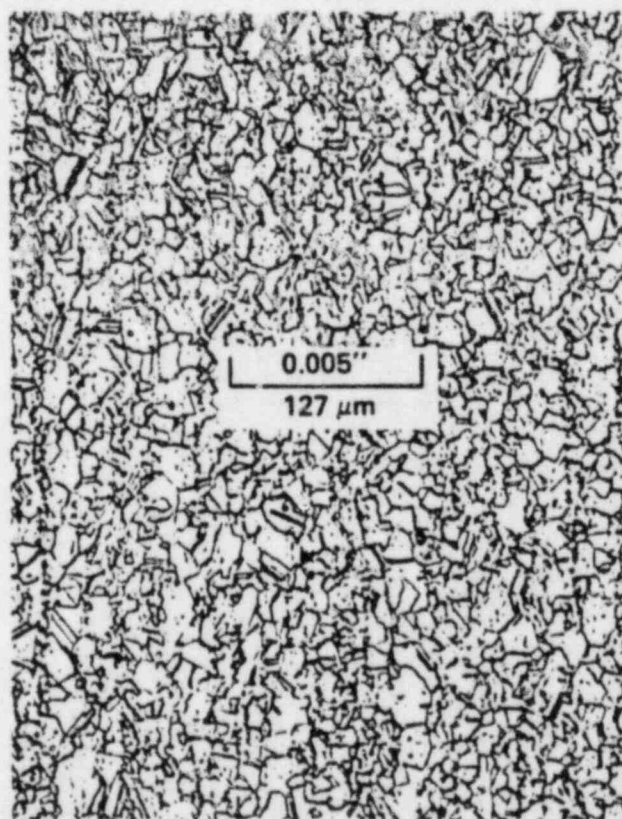
FIGURE 35. B(19-37), Axial Section at Top of Tube Sheet, Area A of Figure 31. Photomicrographs of ID edge (upper) and midwall region (lower).

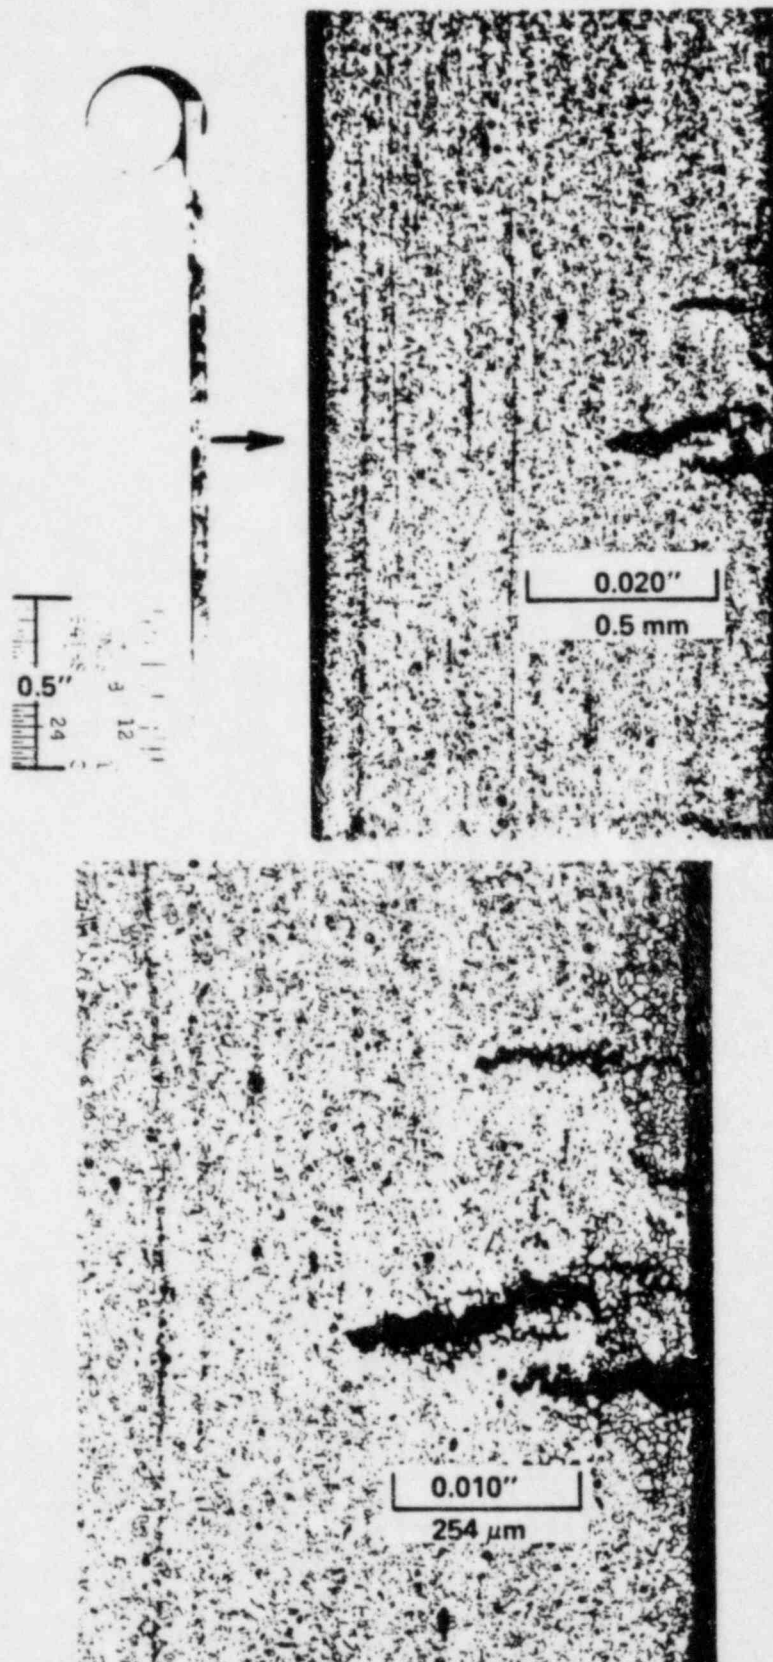
FIGURE 36. B(19-37). Axial Cross Section at Top of Tube Sheet (Sample 1 of Figure 29), Reground 0.006 in. deeper than plane of Figures 31 - 35. Upper left = photomicrograph of repolished sample. Photomicrographs are at Area C of Figures 31 and 33. The OD is at right and primary flow is upward.

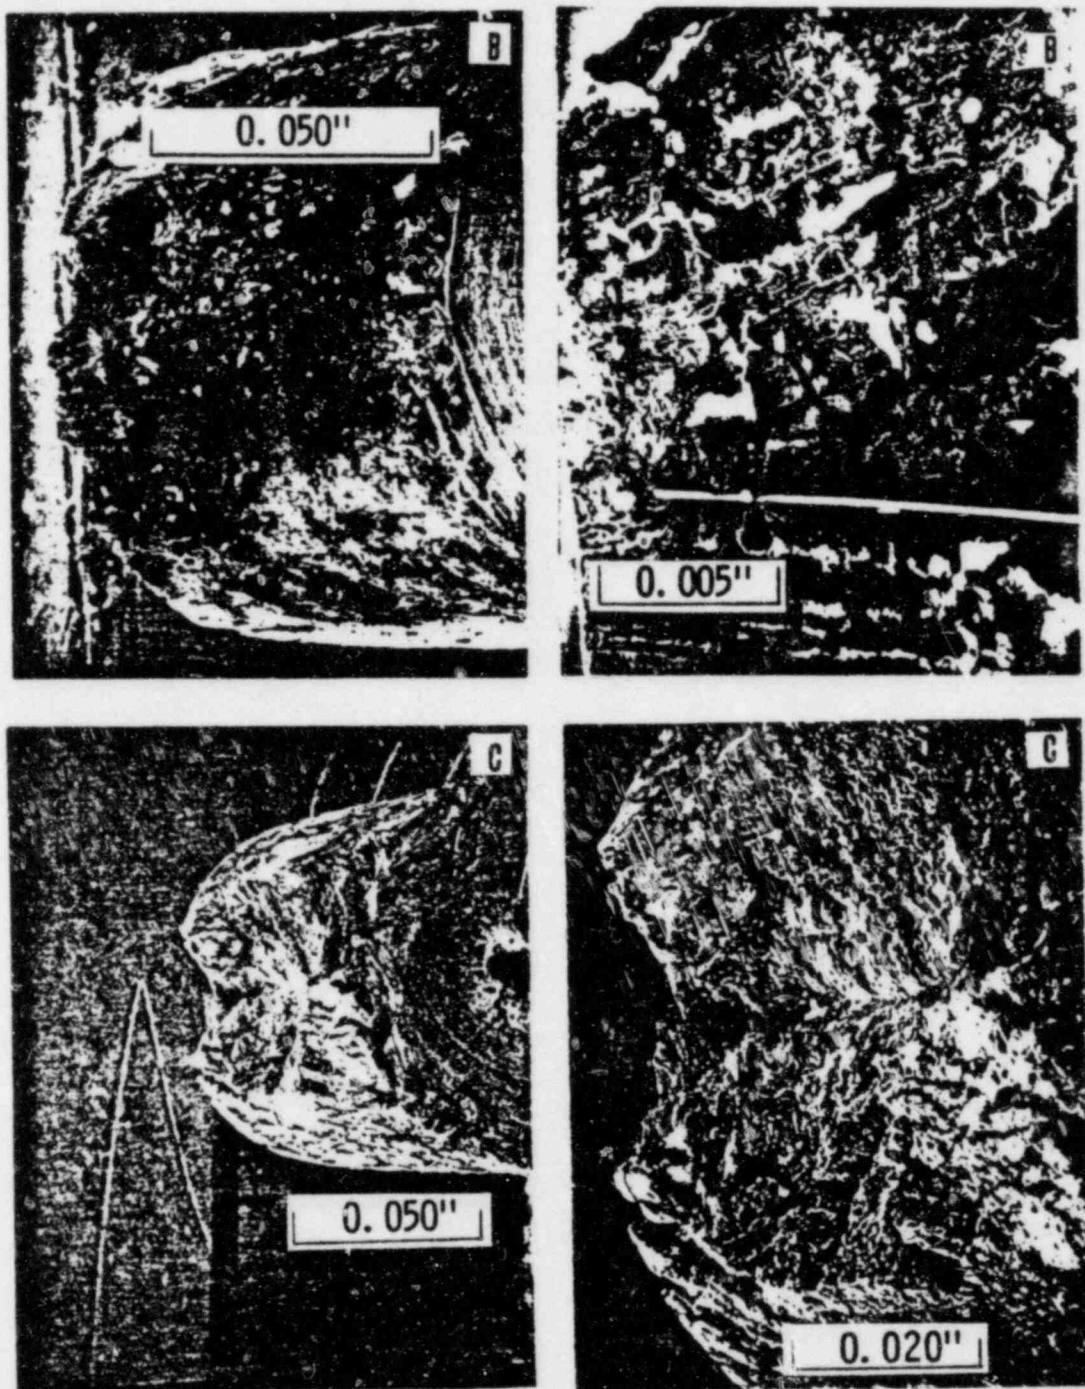
FIGURE 38. B(19-37), Axial Section at Top of Tube Sheet. Bent sections B and C of Figures 29 and 37, SEM's.

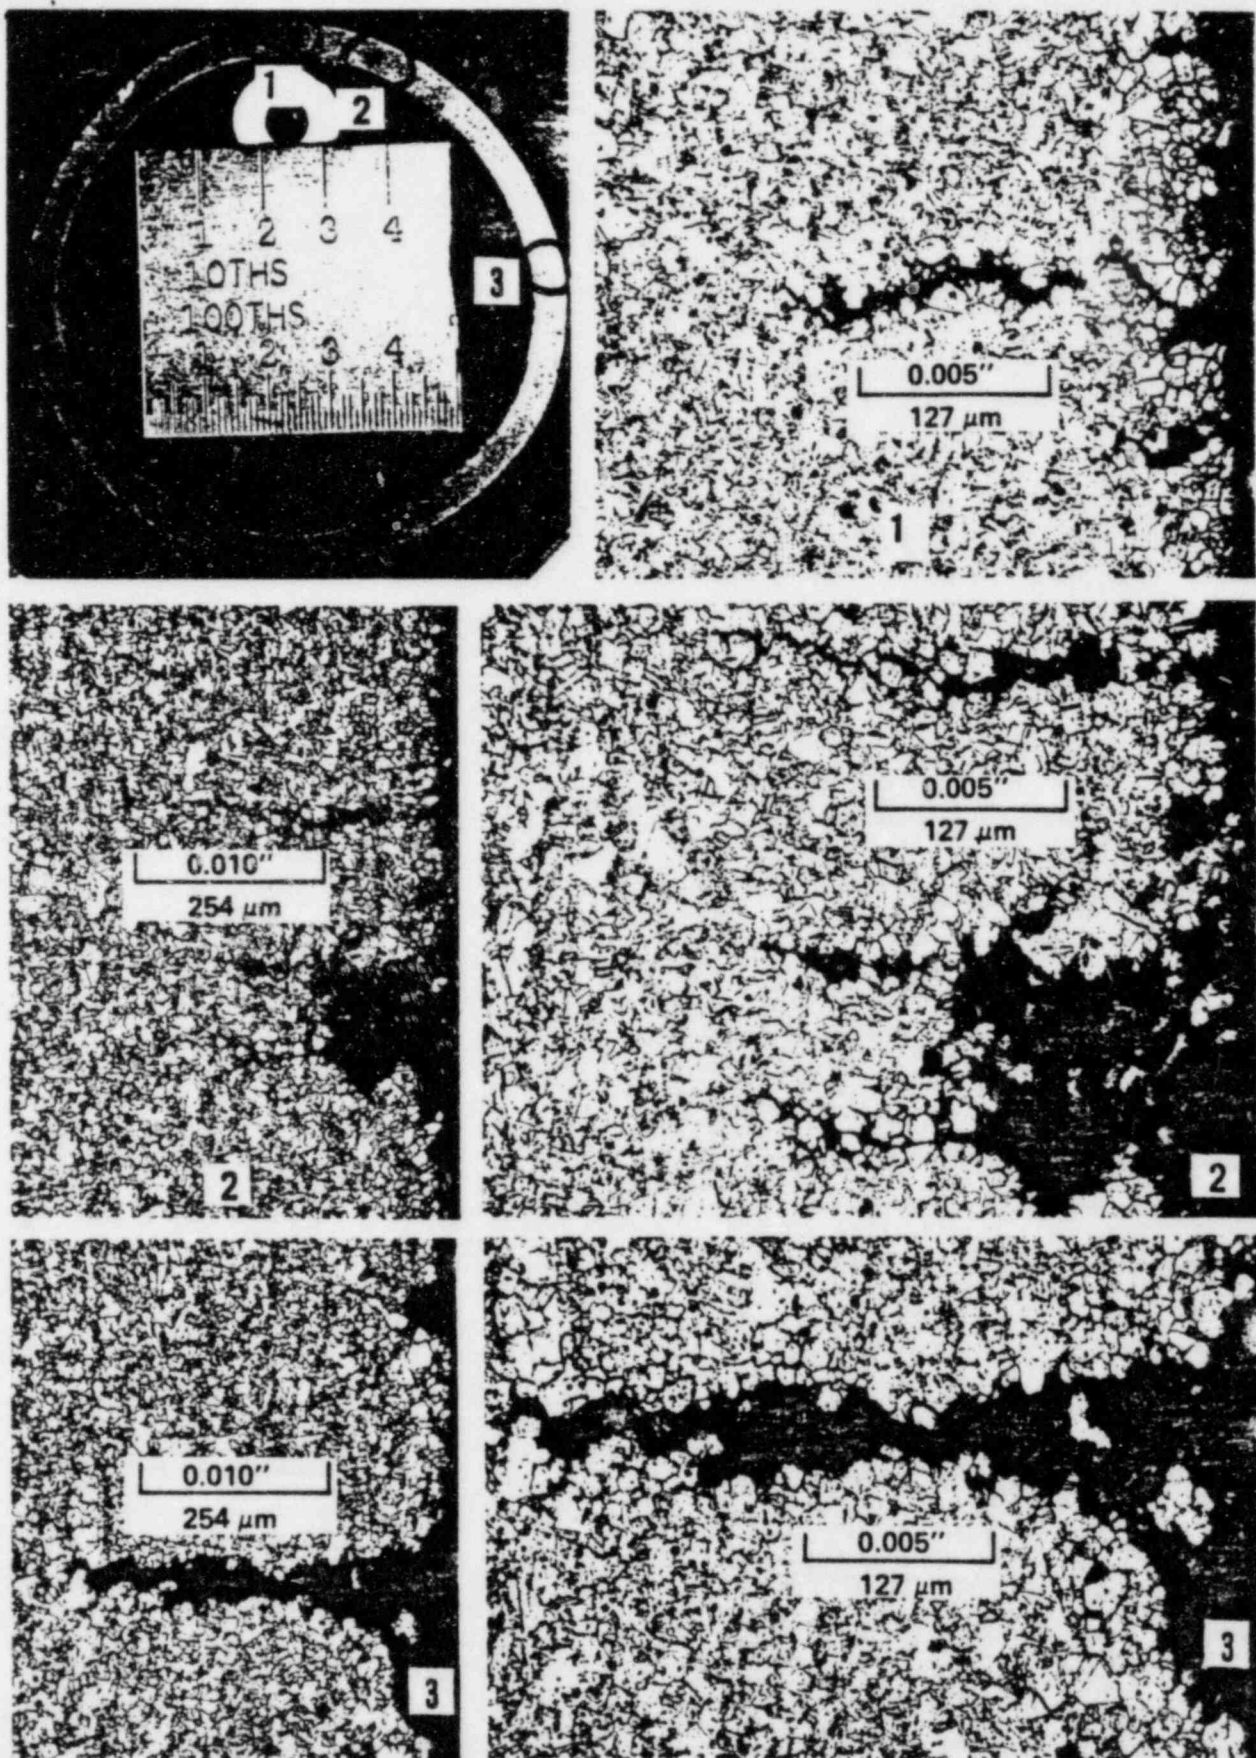
FIGURE 39. B(19-37), Transverse Cross Section below and adjacent to the 2-in.-long micro at top of tube sheet. This is sample 2 of Figure 29. Photomicrographs are of OD edges.

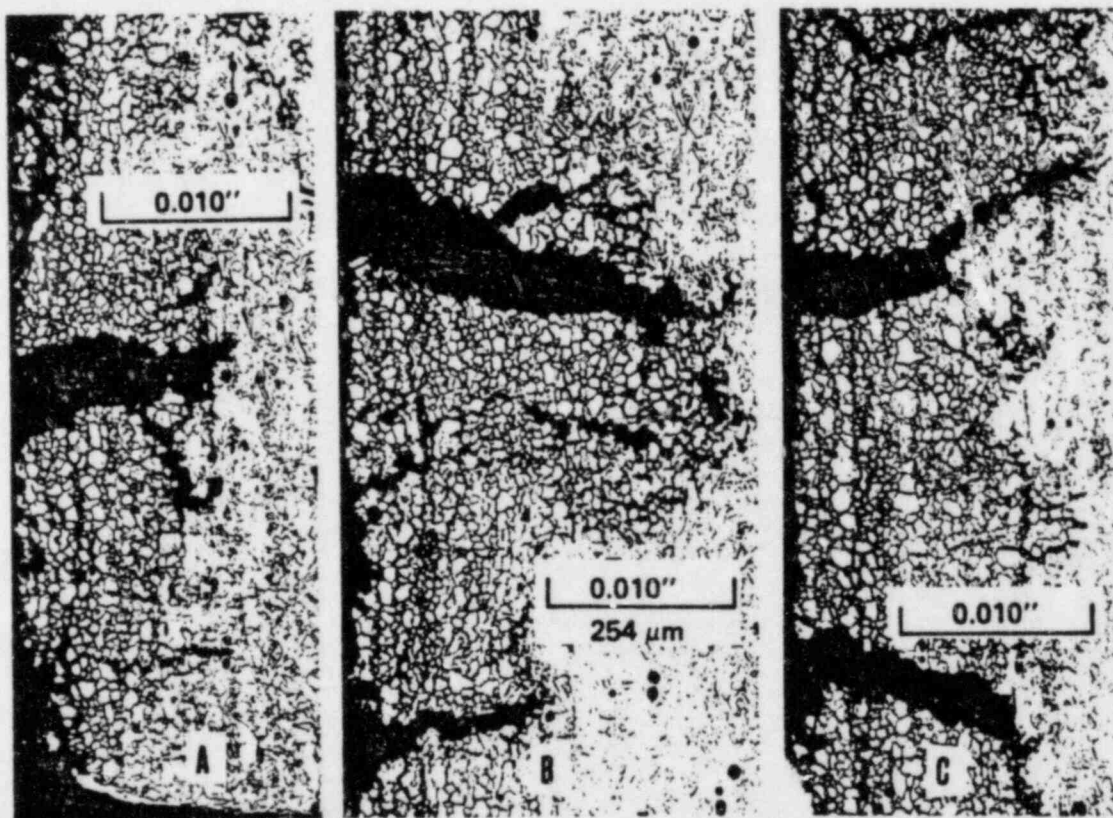
FIGURE 40. B(19-37), Longitudinal Cross Section from within the Tube Sheet. (Sample 3 of Figure 29.) Upper pair shows sectioning and resultant polished and etched sample. The series of photomicrographs at OD areas A - J was taken to determine the localized extent of tube stretching during removal by measurements of openings of the grains. The OD is at the left in the cross sections and the primary flow was upward.
