DOCKET NO. 50-266
FINAL REPORT OF STEAM GENERATOR TUBE INSPECTION
POINT BEACH NUCLEAR PLANT UNIT 1

MICROSCOPIC AND OTHER EXAMINATIONS OF
NUCLEAR STEAM GENERATOR TUBING REMOVED
FROM POINT BEACH NO. 1 IN MARCH 1980

RE-EVALUATION OF EDDY CURRENT TAPES FOR TUBES R19C37, R30C41, R26C53, R30C44, R28C38, R32C42, R22C46, AND R30C57

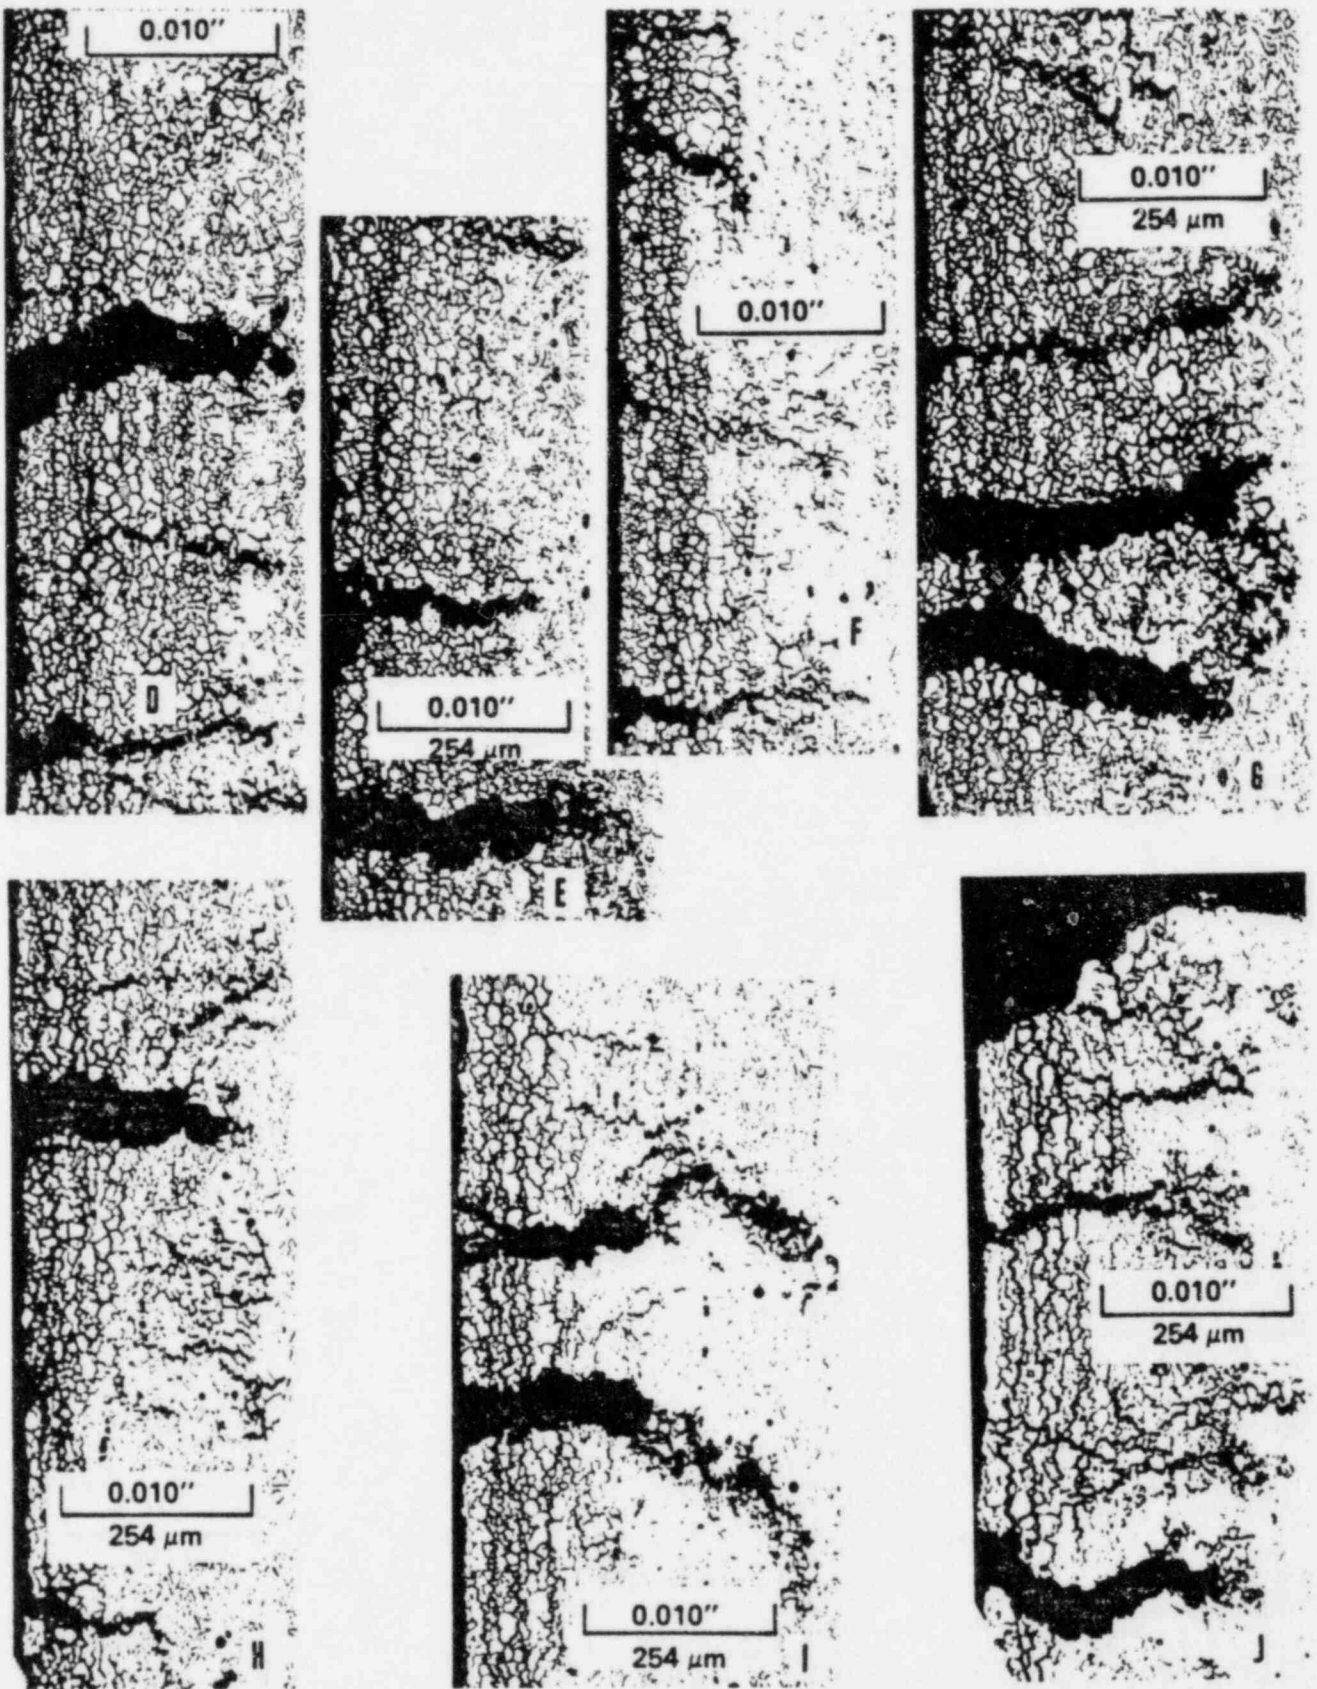
FIGURE 41. B(19-37), Longitudinal Section within Tube Sheet. Continuation of Figure 40; OD Areas D - J.

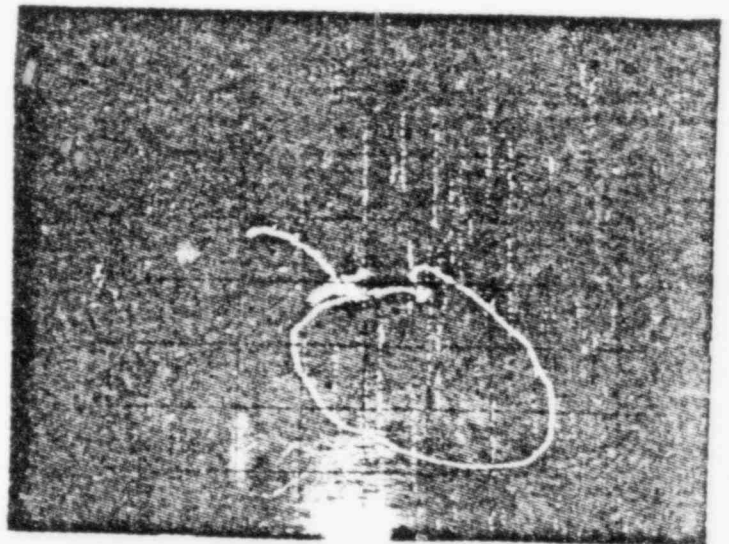
Another small volume indication, 1/2" below the top of the tube sheet, which has also been traced back to March 1975 has remained essentially the same. The equivalent hole diameter is 0.080 inches and the length <0.10 inches.

WEP - POINT BEACH NO. 1
S/G B INLET
R30C41 - 1/2" BELOW TOP OF TUBESHEET

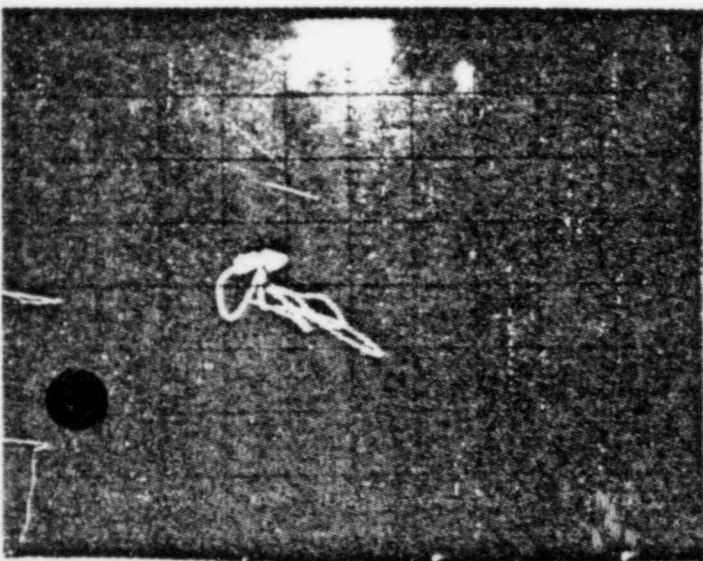
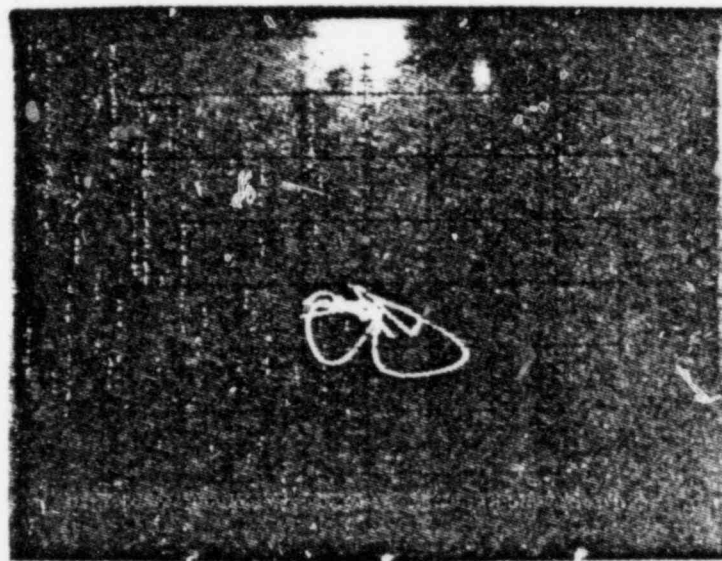
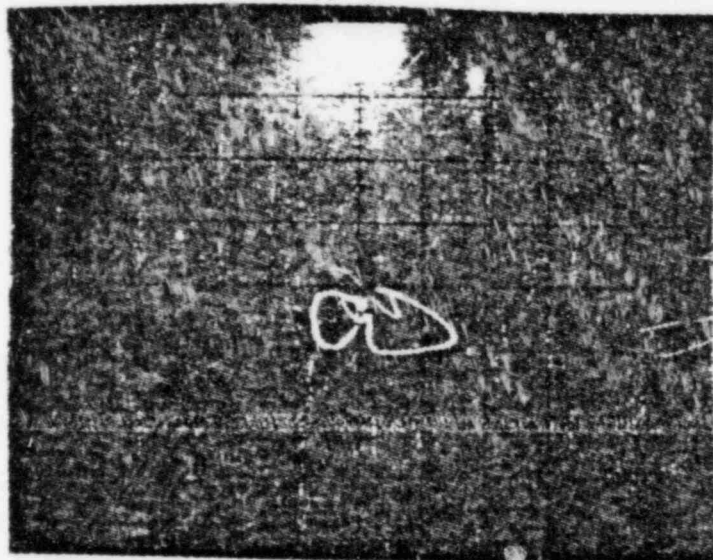
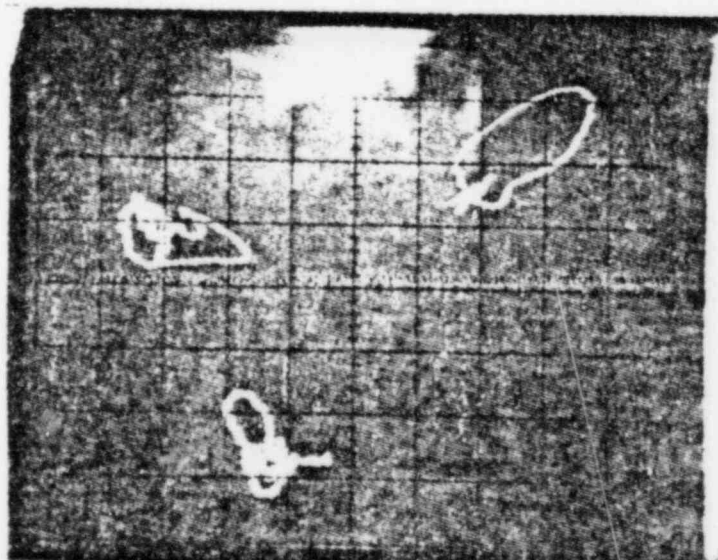
FIG. 4

This indication is located at the tube/tube sheet interface and has been masked by the tube sheet entry signal. Use of multiple frequency techniques make the indication quite visible. Progression of this indication cannot be traced other than to note distortion of the tube sheet signal back to December 1975. The equivalent hole diameter is 0.055 inches and the length is <0.68 inches.

WEP - POINT BEACH NO. 1
S/G B INLET
R30C44 = TUBESHEET

Bottom = Mix
83%
Top of Tubesheet

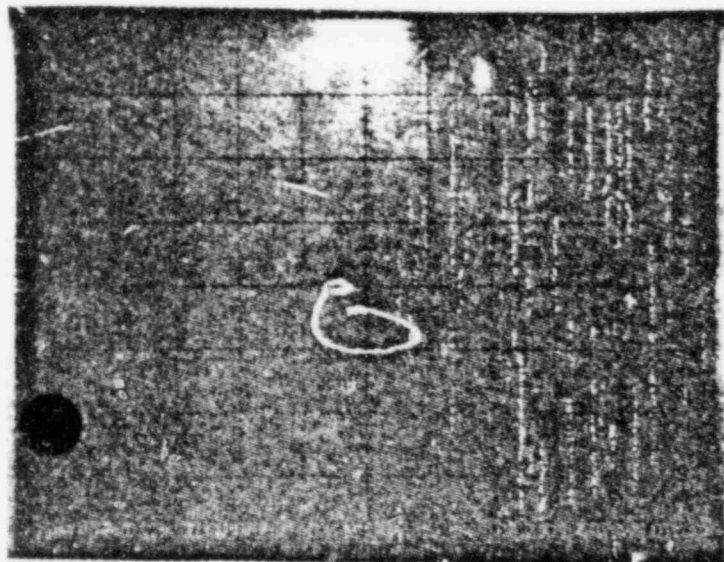
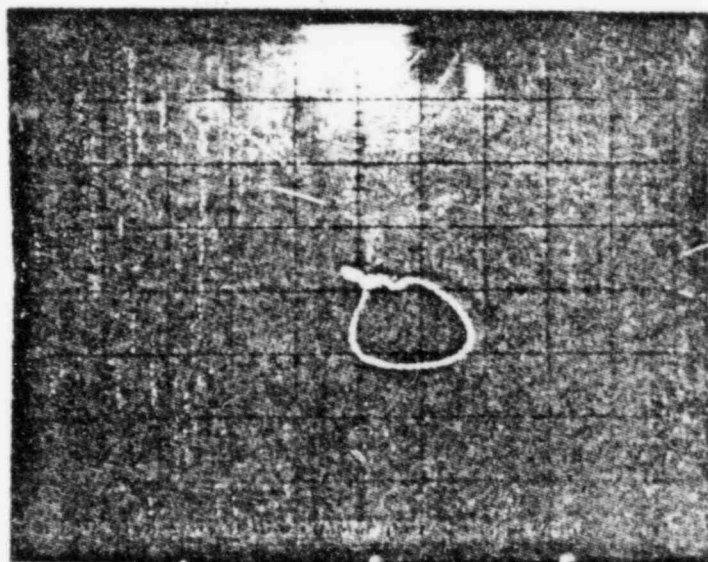
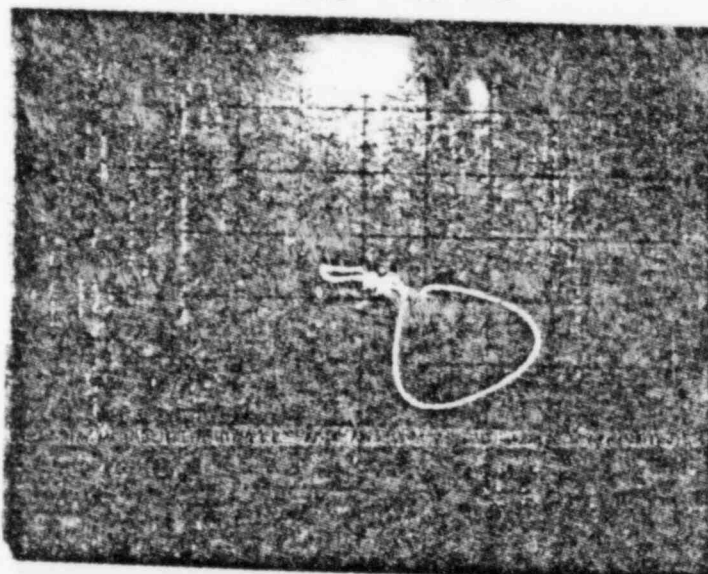
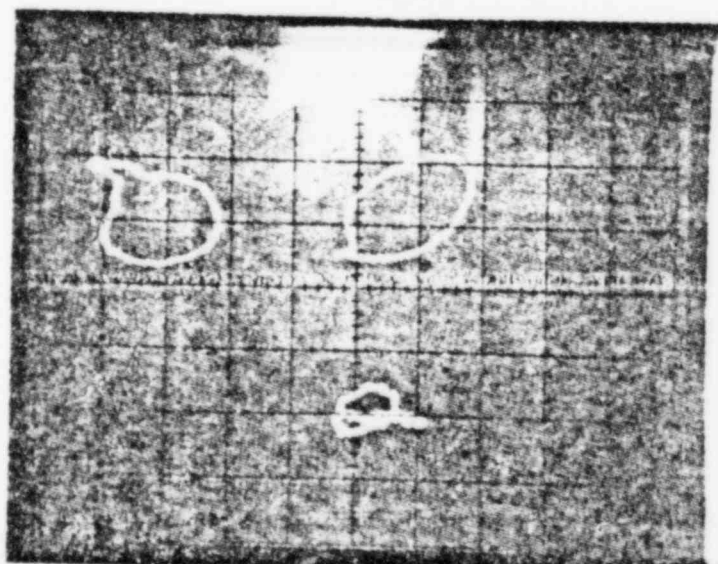
FIG. 6

The same as R30C44 above. The equivalent hole diameter is 0.108 inches and the length is <0.20 inches.

WEP - POINT BEACH NO. 1
S/G B INLET
R28C38 = TUBESHEET

Bottom = Mix
45%
Top of Tubesheet

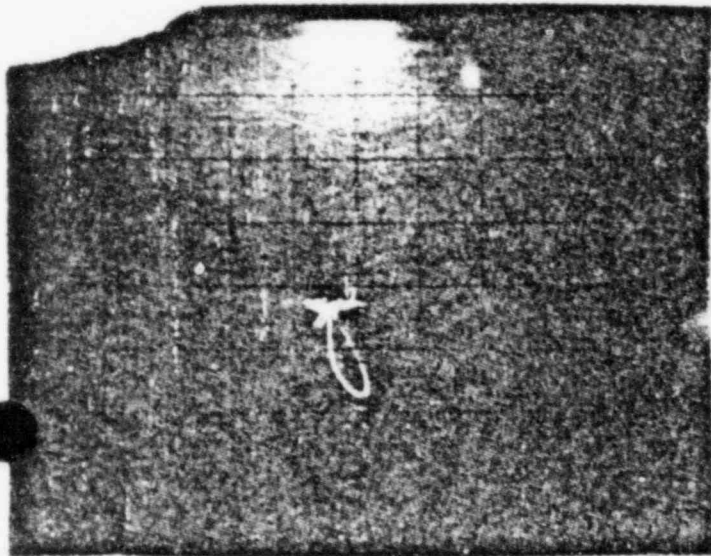
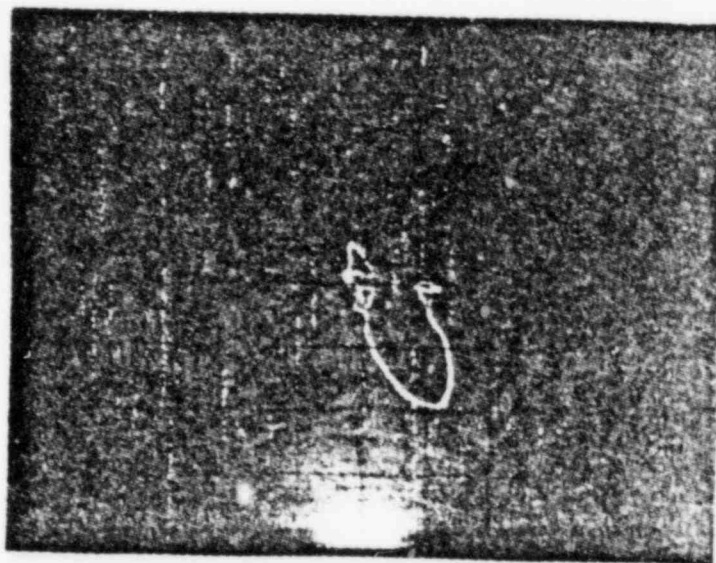
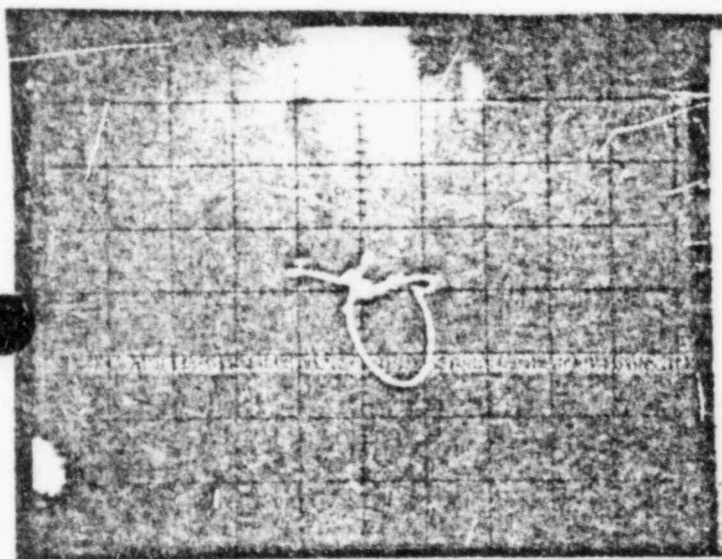
The same as R19C37 above with traceability to March 1975 and remaining essentially the same since then. The equivalent hole diameter is 0.061 inches and the length is <0.29 inches.

WEP - POINT BEACH NO. 1
S/G B INLET
R32C42 - TUBESHEET

TOP LEFT - 400 kHz
TOP RIGHT - 100 kHz
BOTTOM - MIX
61 1/2" ABOVE TUBESHEET

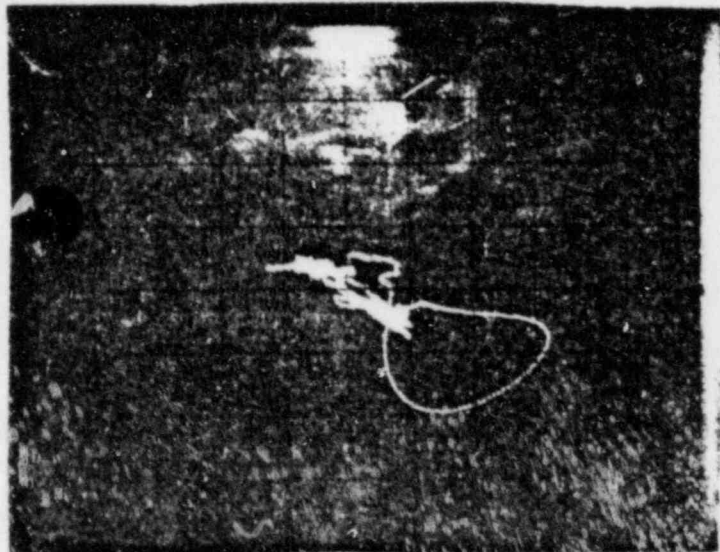
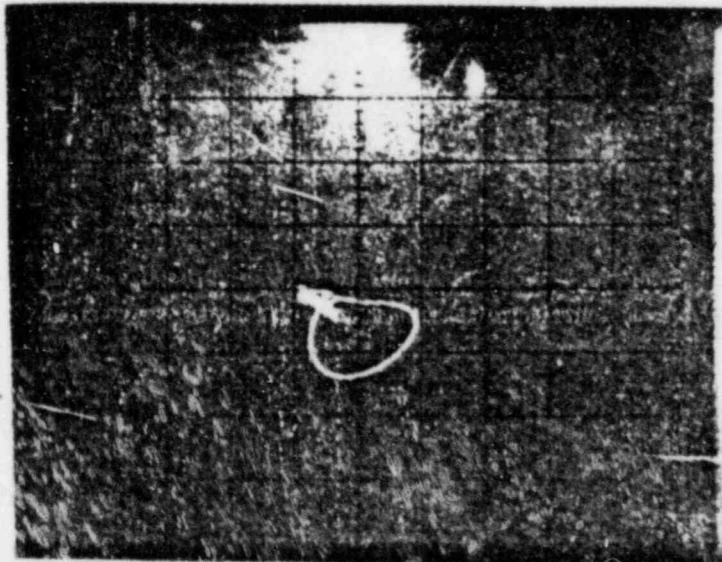
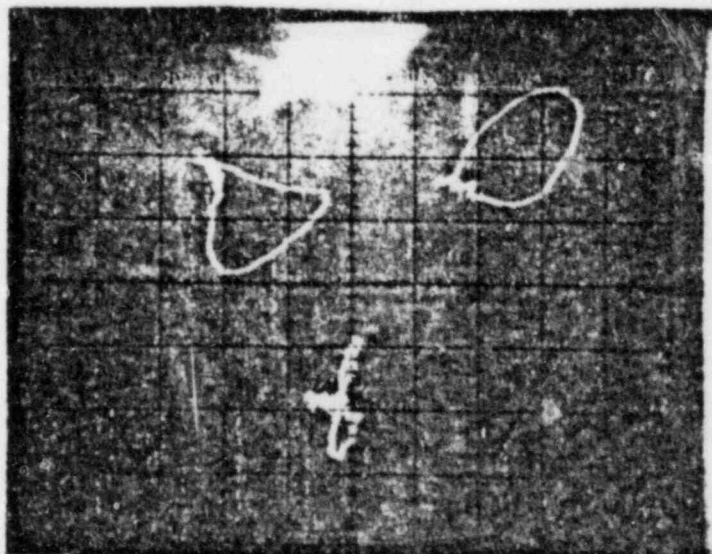
FIG. 7

The same as R30C44 above. The equivalent hole diameter is 0.083 inches and the length is <0.29 inches.

R22C46 = TUBESHEET

Bottom = Mix
55%
Top of Tubesheet

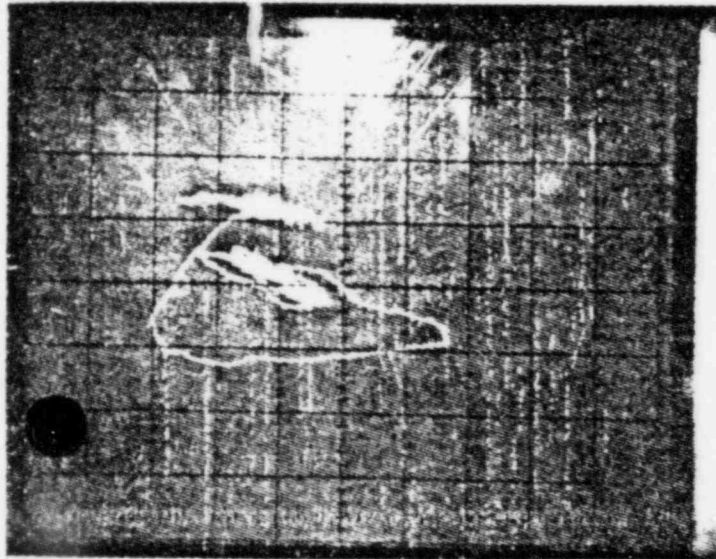
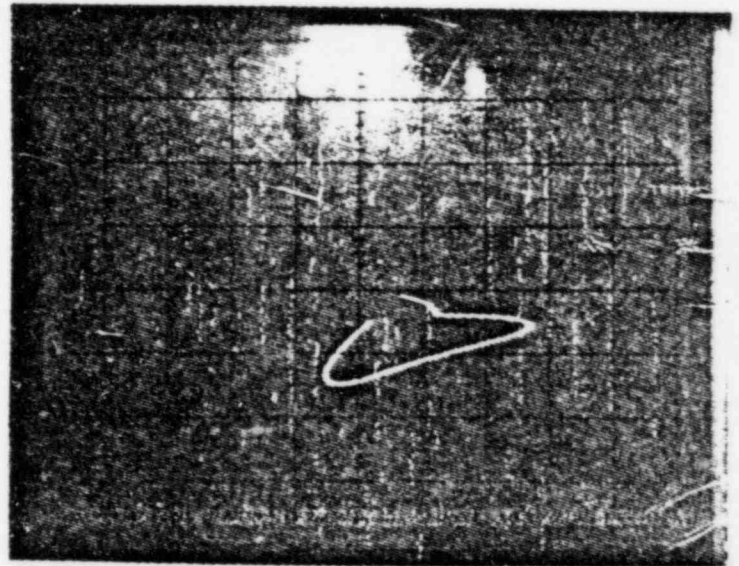
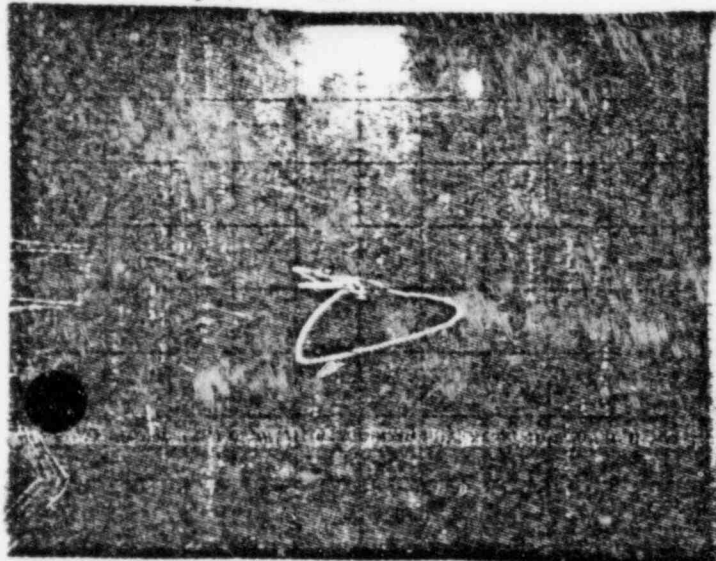
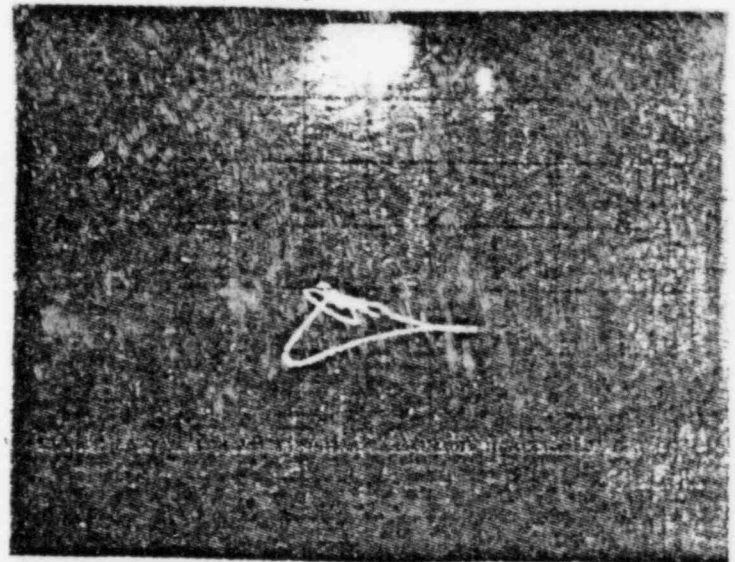
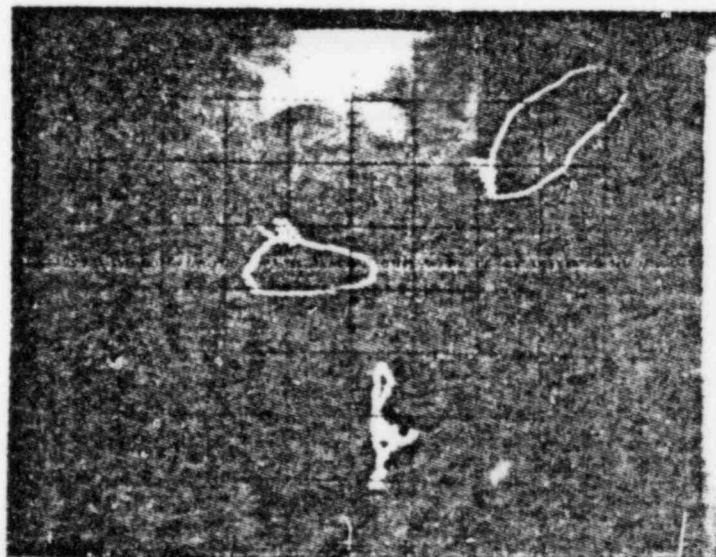
FIG. 8

The same as R30C44 above. The equivalent hole diameter is 0.058 inches and the length is <0.53 inches.

WEP - POINT BEACH NO. 1
S/G A INLET
R30C57 = TUBESHEET

Bottom = Mix
80%
Top Of Tubesheet
