February 18, 1982  
ANPP-20213-GHD/BSK

Subject: Final Report - DER 81-25  
A 50.55(e) Report Relating to Bingham-Willamette  
Auxiliary Feedwater Pumps Could Not Be Rotated  
By Hand For Maintenance During Storage  
File: 82-019-026  
D.4.33.2

FINAL REPORT - DER 81-25  
DEFICIENCY EVALUATION 50.55(e)  
ARIZONA PUBLIC SERVICE COMPANY (APS)  
PVNGS UNITS 1, 2 AND 3

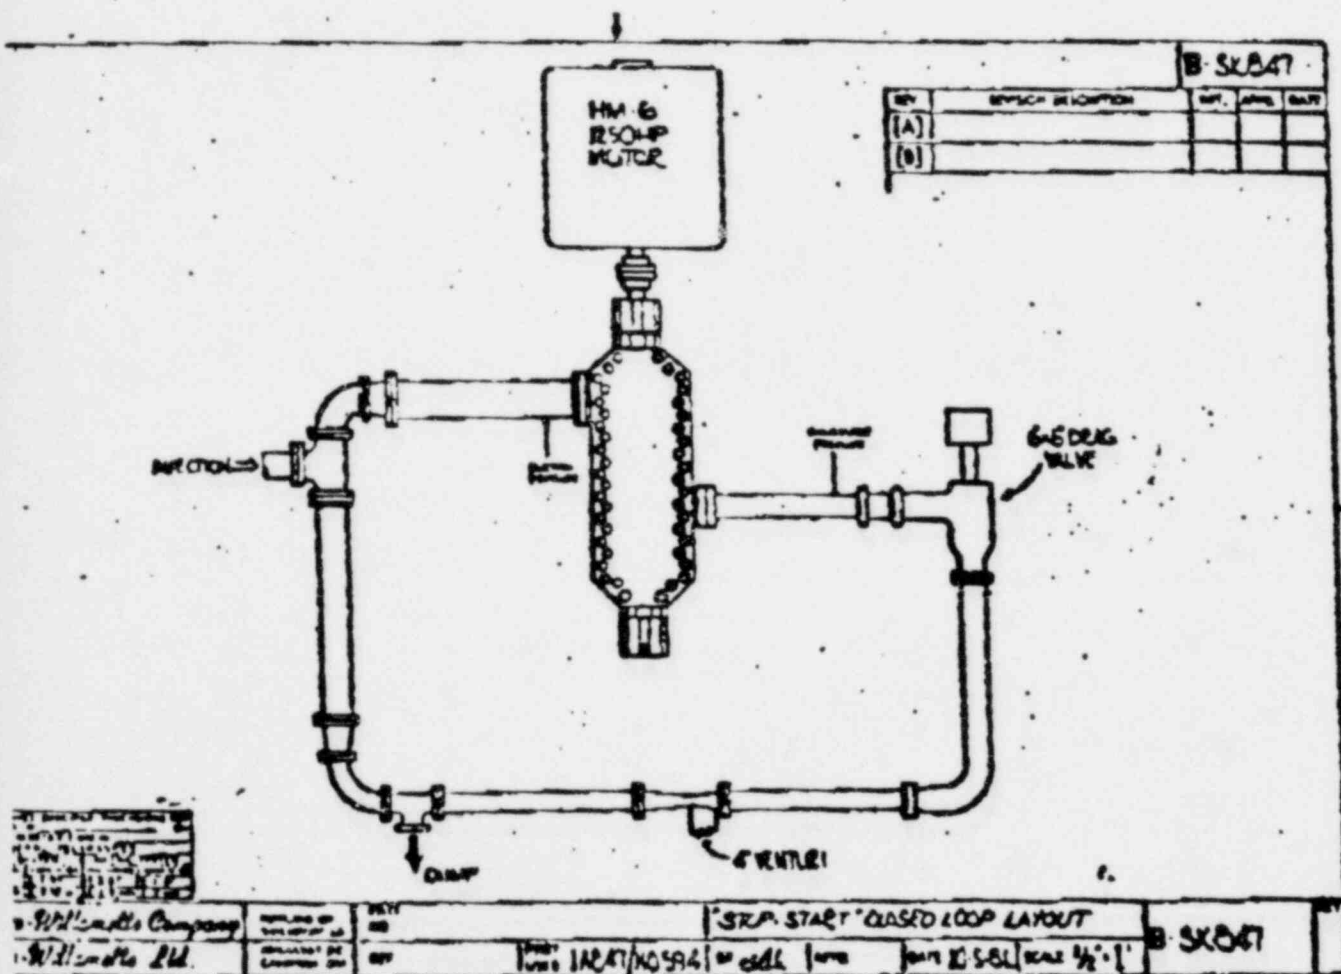
Sketch B-SK-247 is included as a general schematic of the BVC test loop.
