July 19, 1994
NG-94-2659

Subject: Duane Arnold Energy Center
Docket No: 50-331
Op. License DPR-49
Licensee Event Report #94-006, Rev. 01

Reactor Water Cleanup Isolation Due to Incomplete Valve Closure Caused by Position Indicator Obstruction

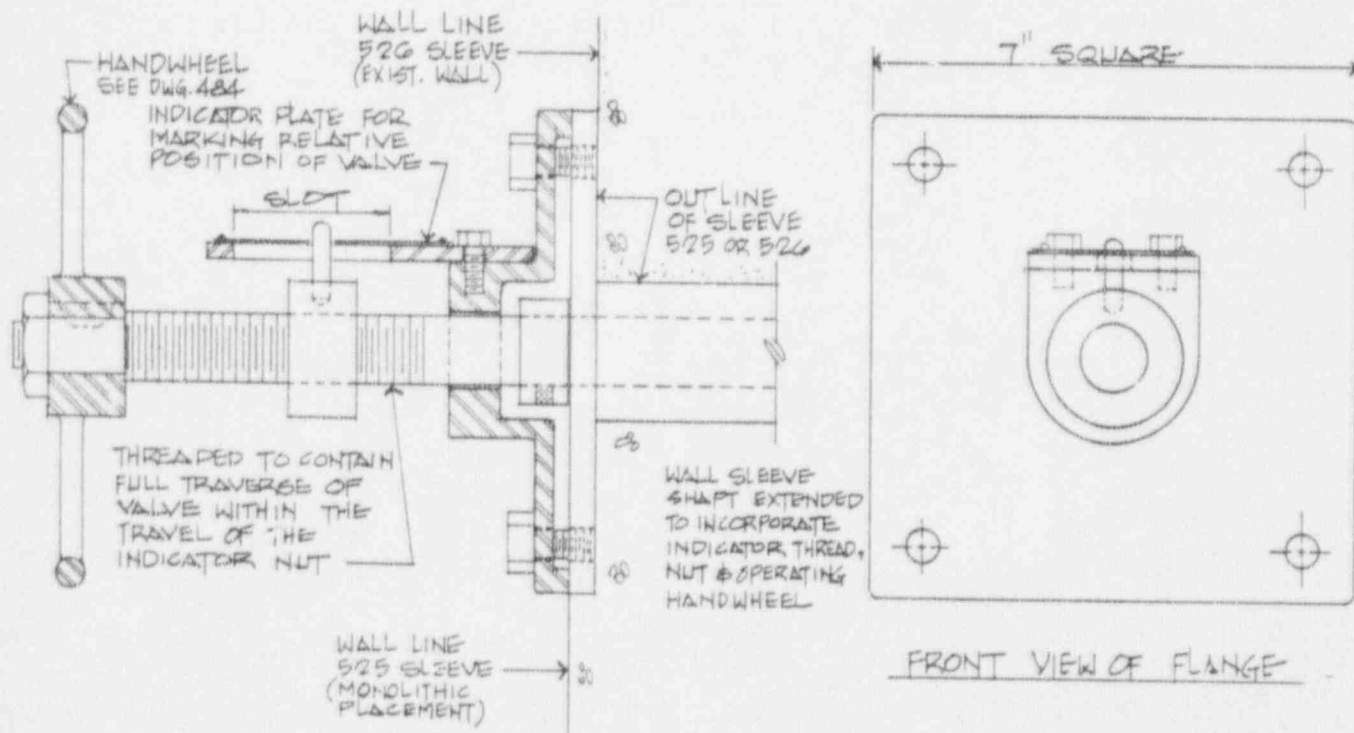
Figure 1

The cause of this event was the remote position indicator on the Roto Hammer valve extension for the "A" RWCU pump discharge valve preventing full valve closure. The position indicator, when at the end of its travel, was able to draw the stem of the remote handwheel tight, simulating valve closing torque (See Fig. 1). This and the fact that it also indicated closed, misled the operator into believing the valve was closed.

A contributing factor to the indicator problem was an improper set up of the indicator nut during previous maintenance. The indicator had been previously broken and was replaced with a new pointer and indicator nut. This work was done with the system operating and the valve in the open position. Upon installation of the new indicator nut, it was adjusted to indicate open. Subsequent cycling of this valve has shown that the position indicator travel length is insufficient to allow for full valve travel. Also, because the critical function of this valve is to isolate the pump, the position indicator should have been set up with the valve in the fully closed position. These considerations were not understood at the time the maintenance was performed.

ROTO HAMMER COMPANY
VALVE OPERATING HANDWHEEL
WITH POSITION INDICATOR
MODEL 481 W (NUCLEAR)

2. The position indicator was repaired and modified on the "A" RWCU pump discharge valve. The modification eliminated the possibility of the position indicator inhibiting full valve travel. This action was completed on June 28, 1994.

3. An evaluation of the remaining valves in the plant that have similar reach rods and indicators was performed to determine generic corrective actions. As a result of the evaluation, removal of the indicator plate and pointer will be performed to all the valves with the same type valve extensions, including the "A" RWCU pump discharge valve. This action will be completed by September 30, 1994.
