LONG ISLAND LIGHTING COMPANY

SHOREHAM NUCLEAR POWER STATION

SNRC-692

Control Room Design Review
Shoreham Nuclear Power Station - Unit 1
Docket No. 50-322

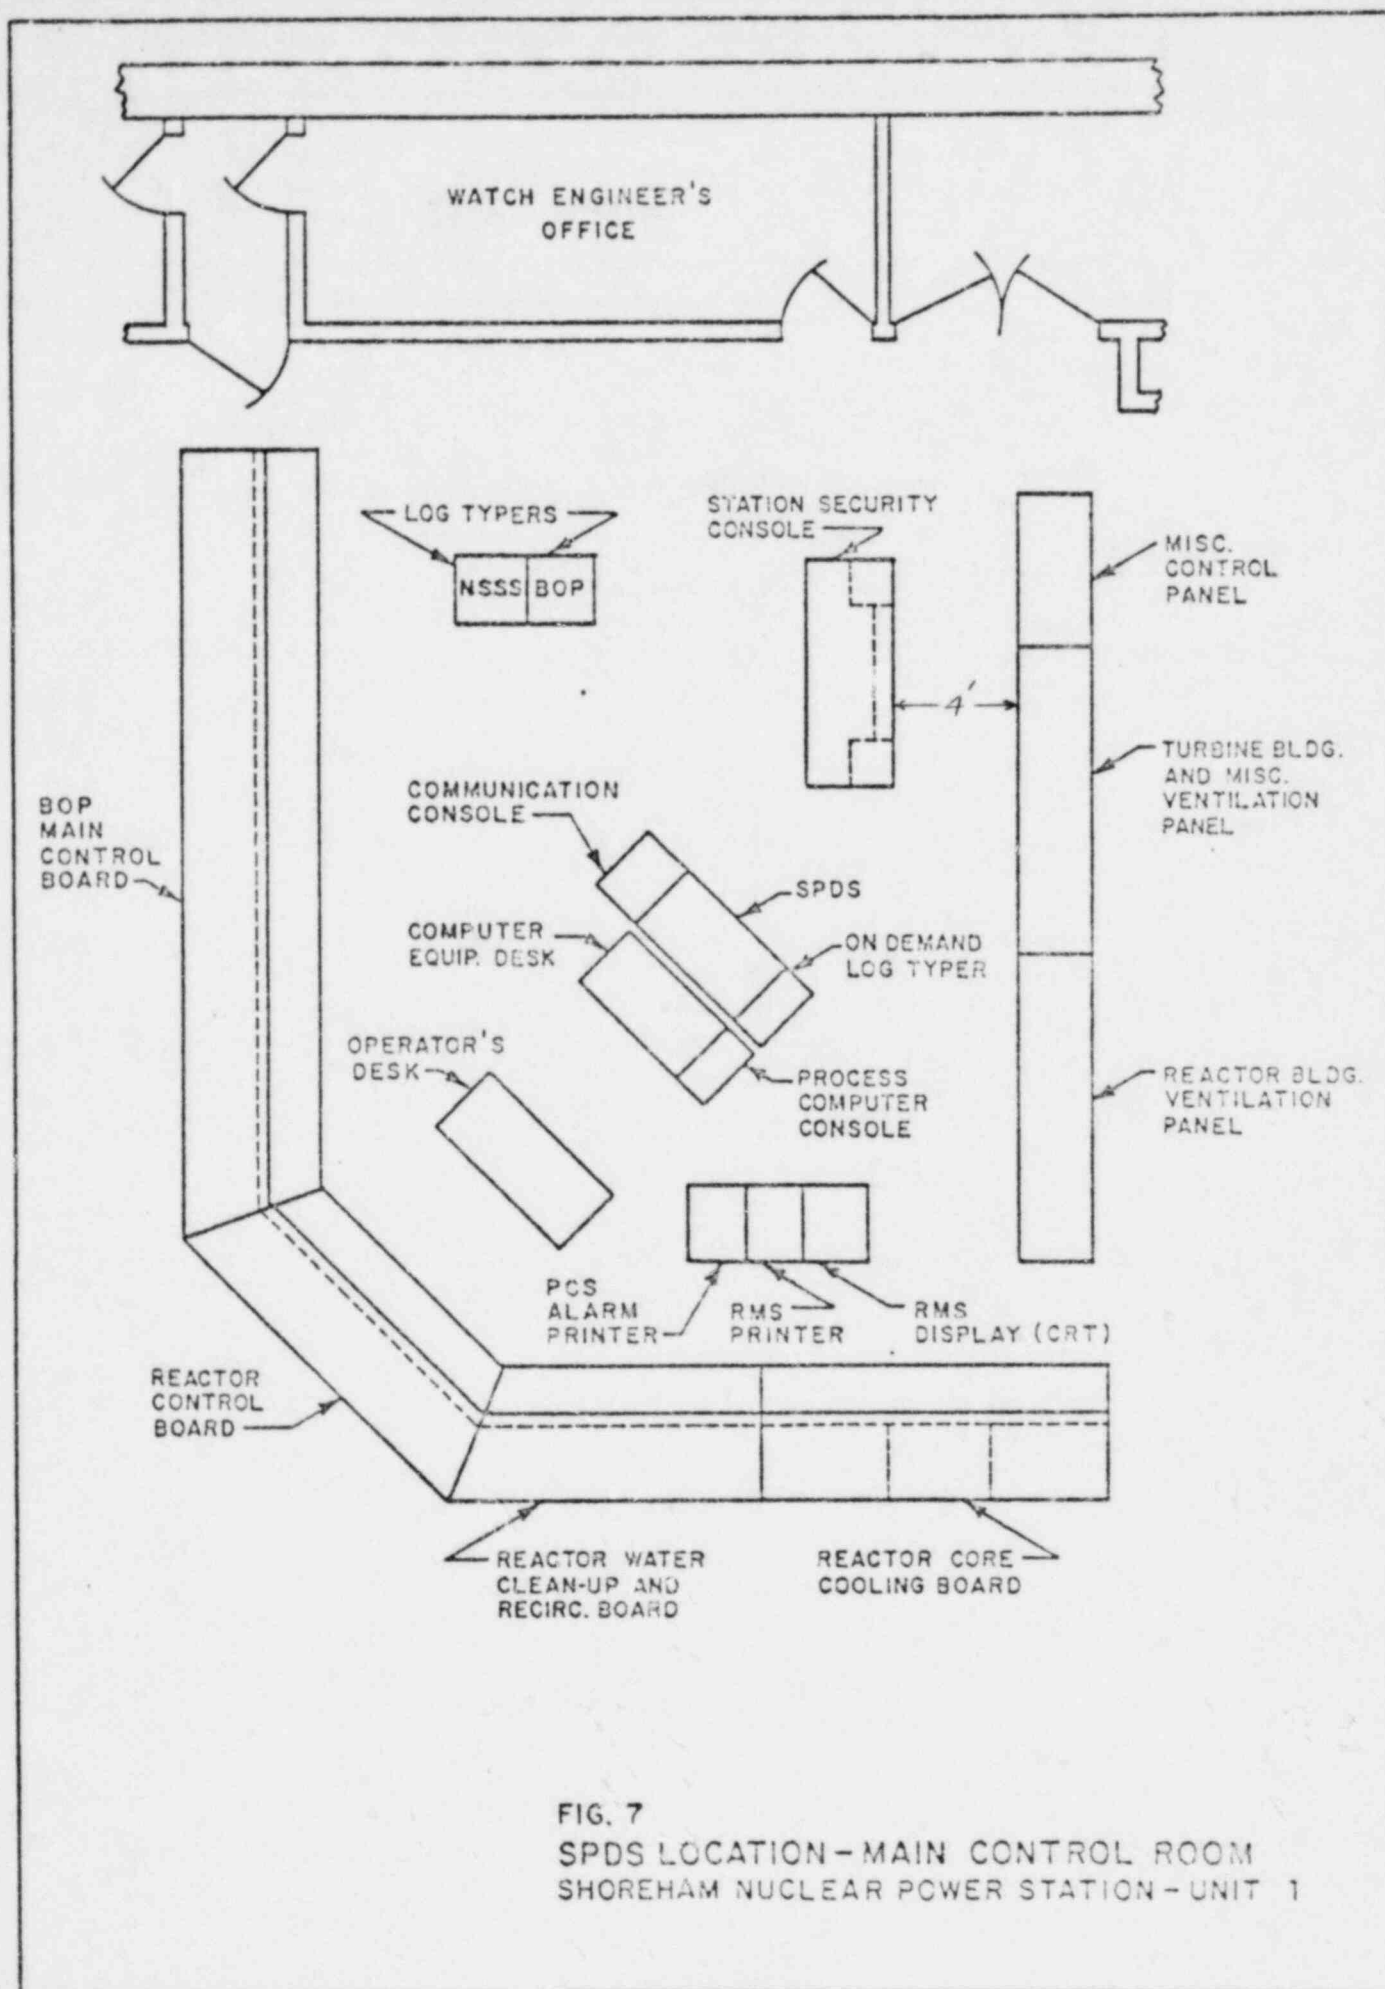
FIG. 7
SPDS LOCATION—MAIN CONTROL ROOM
SHOREHAM NUCLEAR POWER STATION—UNIT 1

- c) As shown in Figure 7, the SAS is located near the MXP panel (4' clearance). This panel is utilized primarily for certain "support system" controls and indication. Emergency operating procedures do not require the use of the MXP panel. During upset conditions the panel might be utilized by operating personnel for verification of support system response only. A specific task action analysis will be performed during the long term control room design review to further assure that physical interference does not exist between operations personnel and the SAS.
