REPORTABLE OCCURRENCE 82-034

FORT ST. VRAIN NUCLEAR GENERATING STATION
PUBLIC SERVICE COMPANY OF COLORADO
16805 WELD COUNTY ROAD 19 1/2
PLATTEVILLE, COLORADO 80651-9298

REPORT NO. 50-267/82-034.03-L-0

Emergency Feedwater to Helium Circulator
Water Turbine Drives - Loop 1

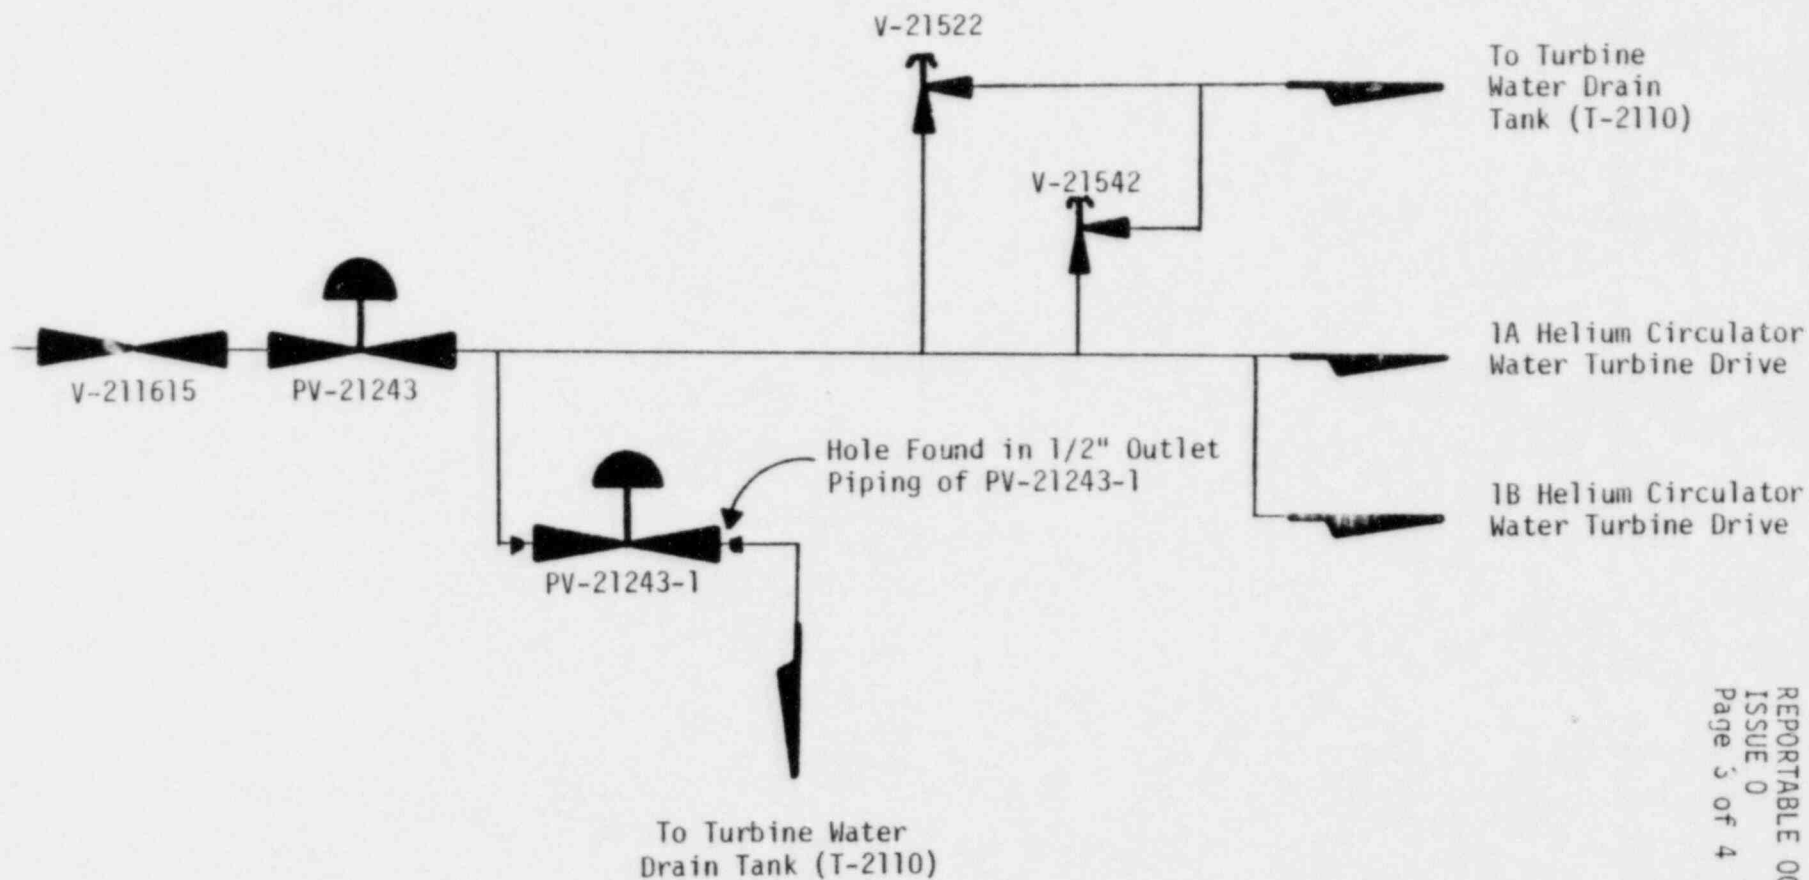
FIGURE 1

On August 14, 1982, PV-21243-1 (Loop 1 emergency feedwater pelton wheel drive header pressure control valve) was reported to have a body-to-bonnet flange leak. This leak did not affect the system control as PV-21243 (upstream of PV-21243-1) was still operational. PV-21243-1 had previously been suspected of having internal seat leakage also.

The leakage observed at PV-21243-1 was found to be from a minute hole on the 1/2" outlet piping of PV-21243-1. Due to the location and direction of the leakage, it was first thought to be emitting from the body-to-bonnet area.

The internal leakage was due to normal wear of the seat and disc seating surfaces.

PV-21243-1 was disassembled, and repairs were made to the internals and the affected section of outlet piping. The piping was replaced with an acceptable replacement which has a thicker wall than the original section.
