SUBJECT: Calvert Cliffs Nuclear Power Plant
Unit No. 1; Docket No. 50-317; License No. DPR 53
Licensee Event Report 94-004, Revision 01
Excessive Corrosion of Incore Instrumentation Flange Components

LICENSEE EVENT REPORT (LER)

FACILITY NAME (1) Calvert Cliffs, Unit 1										DOCKET NUMBER (2) 05000 317			PAGE (3) 1 OF 07				
TITLE (4) Excessive Corrosion of Incore Instrumentation Flange Components																	
EVENT DATE (5)			LER NUMBER (6)				REPORT DATE (7)			OTHER FACILITIES INVOLVED (8)							
MONTH	DAY	YEAR	YEAR	SEQUENTIAL NUMBER	REVISION NUMBER	MONTH	DAY	YEAR	FACILITY NAMES				DOCKET NUMBERS(S)				
02	21	94	94	-- 004 --	01	07	29	94					05000				
														05000			
OPERATING MODE (9)		5		THIS REPORT IS SUBMITTED PURSUANT TO THE REQUIREMENTS OF 10 CFR (Check one or more) (11)

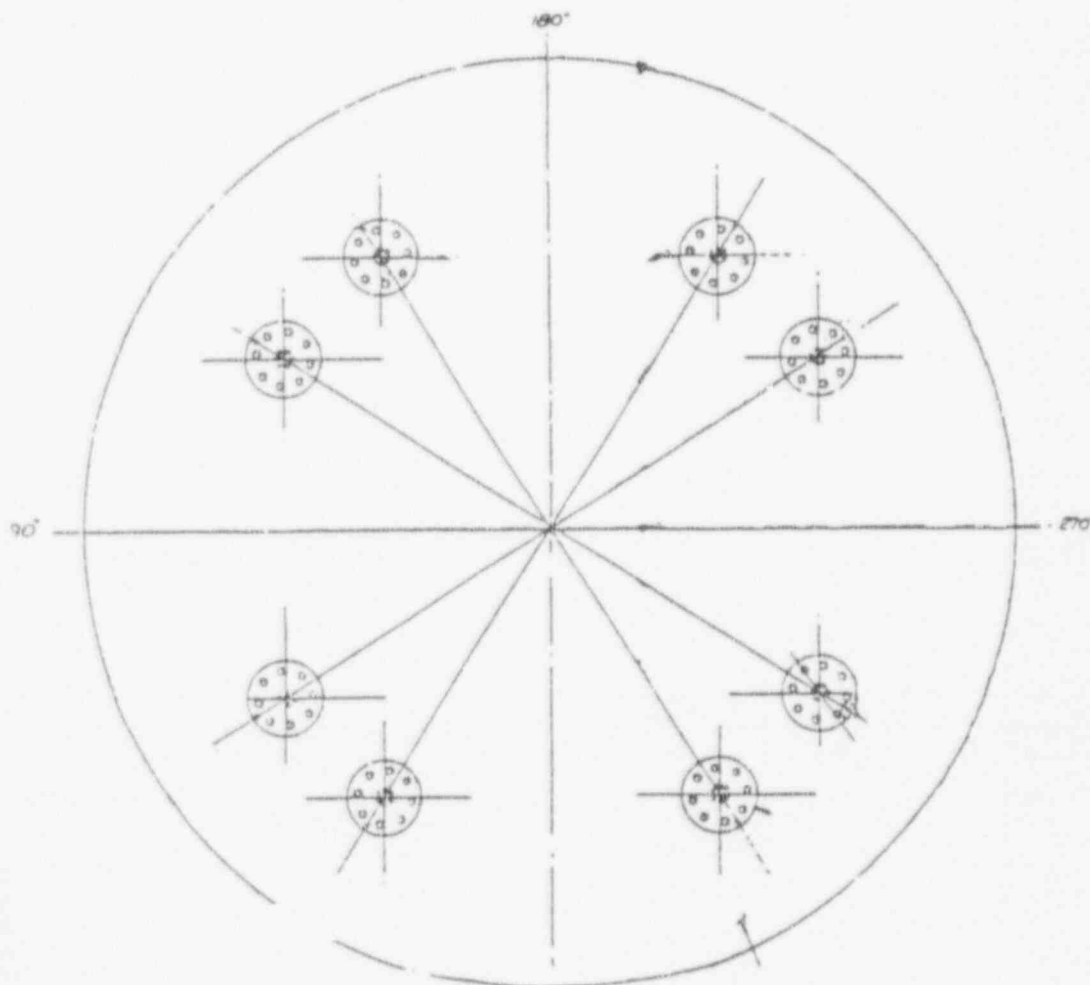
FIGURE 1

PLAN VIEW INDICATING LOCATION AND ORIENTATION
OF ICI FLANGES ON PRESSURE VESSEL CLOSURE HEAD

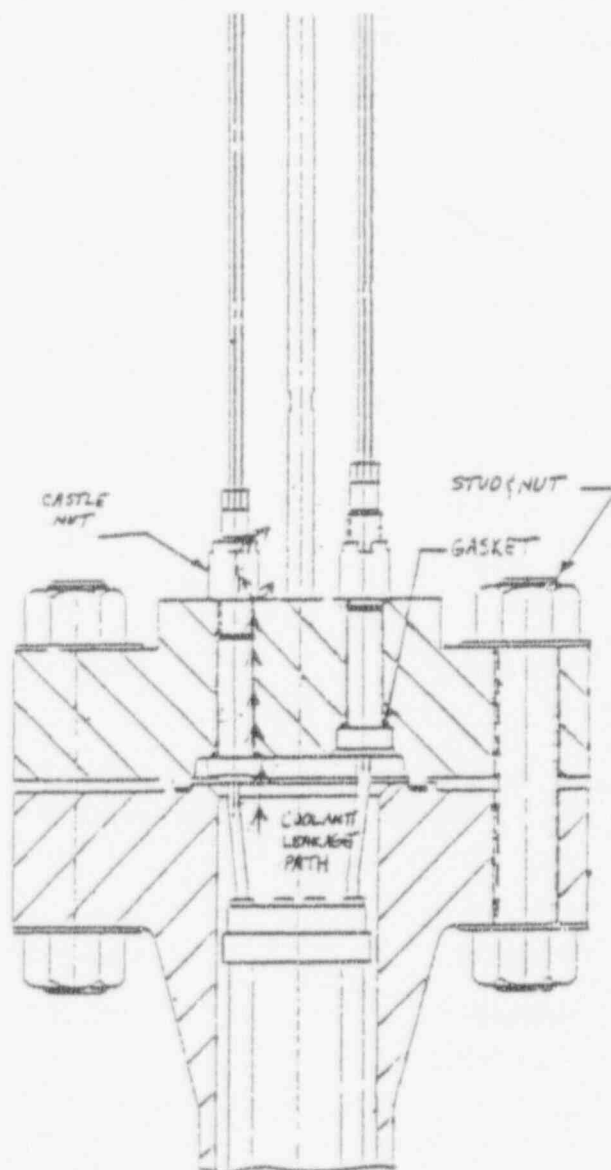
FIGURE 2

Each of the eight ICI flange assemblies consists of an upper and lower half secured together with eight 13 inch long 1-3/4 inch diameter studs secured by a 1-3/4 inch heavy hex nut (see Figures). The nuts are made of ASTM A 194 Grade 2H carbon steel and the studs are made of ASTM A 193 Grade B7 carbon steel. In this specific case, three adjacent studs were degraded: one was failed, and two were significantly corroded. An engineering analysis was performed by an engineering consulting firm to investigate the failure sequence of the ICI assembly, and to consider the possibility of an undetected progression of stud corrosion until catastrophic failure. The analysis concluded the ICI flange would first start to open when approximately two adjacent studs fail. Leakage would start to occur when half of a third stud is degraded and would be approximately 16 gpm. With three failed studs, the maximum stress on the remaining studs is below yield stress. Thus, with a leak of 16 gpm, there is no catastrophic failure of the ICI assembly. This level of leakage is well within the capacity of the charging pumps and would be apparent to operators, allowing them to take mitigating actions and safely shutdown the reactor. In the unlikely event of catastrophic joint failure, the effects would be bounded by the Calvert Cliffs loss-of-coolant accident analyses.

ICI FLANGE ASSEMBLY
