Subject: Final Report - DER 83-23
A 50.55(e) Reportable Condition Relating to
Main Steam Isolation Bypass Valves Will Not Close In The
Required Time
File: 83-019-026; D.4.33.2

FINAL REPORT - DER 83-23
DEFICIENCY EVALUATION 50.55(e)
ARIZONA PUBLIC SERVICE COMPANY (APS)
PVNGS UNITS 1, 2 & 3

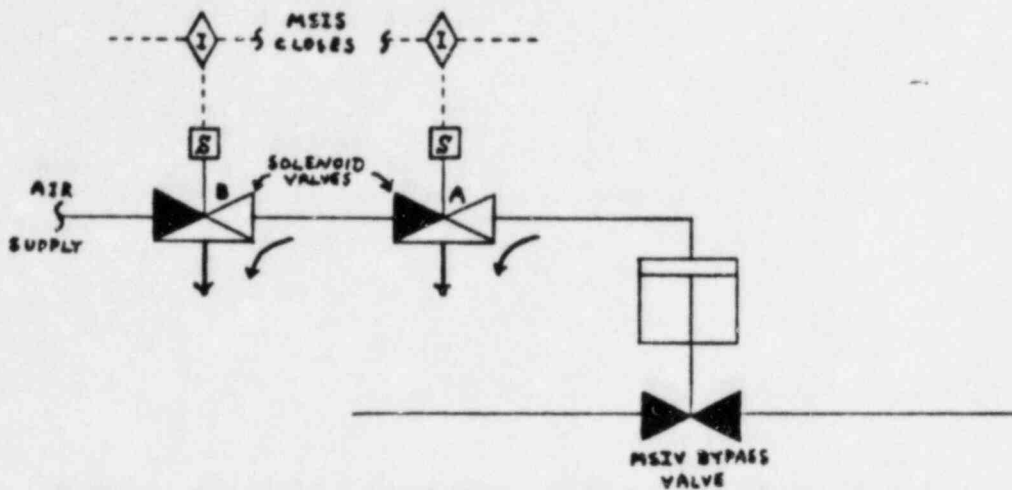
NORMAL: Solenoid Valves Open, MSIV Bypass Valve Closed

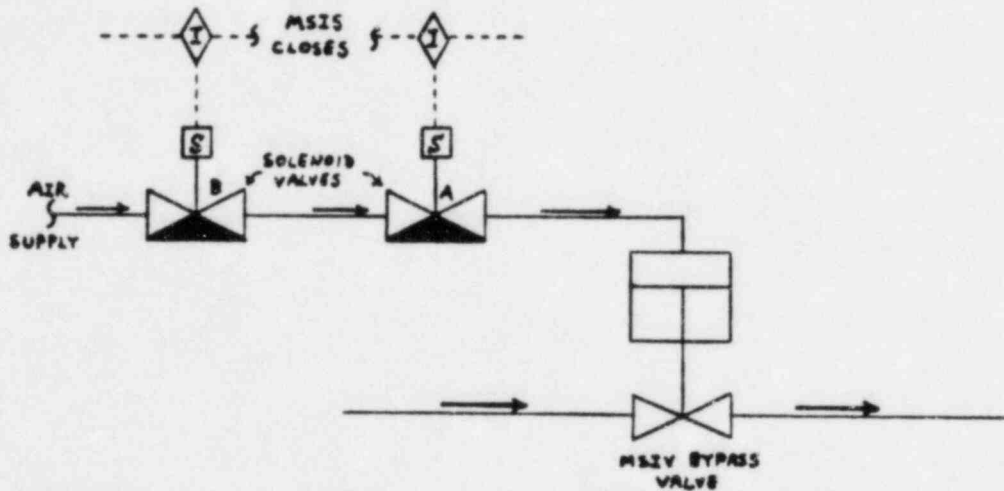
STARTUP: Solenoid Valves Closed, MSIV Bypass Valve Open

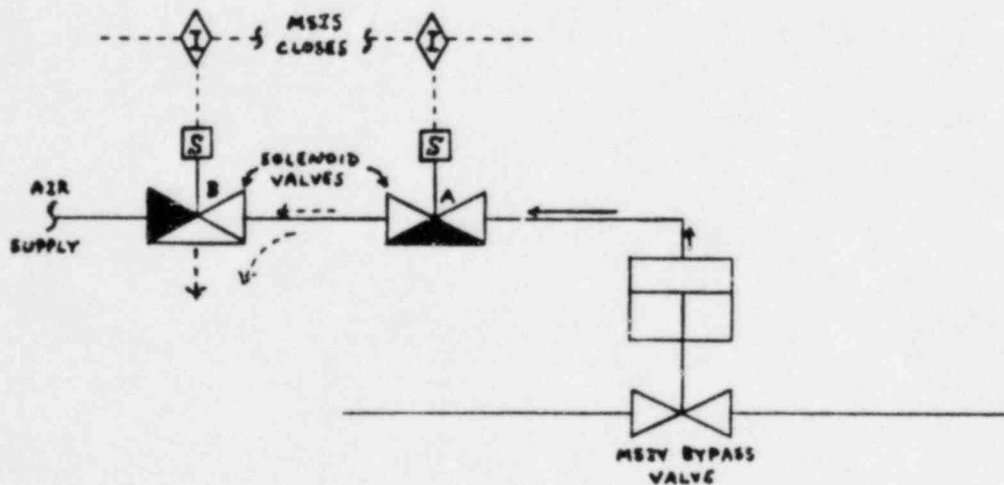
For the MSIV bypass valve to close, air pressure in the bypass valve actuator (supplied via the solenoid valves) must be released. Conceptually, this would occur upon tripping either one or both solenoid valves, as the tripped solenoid valve(s) vent(s) the pressurized air in the bypass valve actuator to the building environment. During testing, solenoid valve B was deenergized with solenoid valve A intentionally left energized (i.e., simulated binding of solenoid valve A), thus requiring venting of the pressurized air through solenoid valve A to the solenoid valve B vent port. This simulated failure revealed that solenoid valve A, if not tripped, would restrict reverse air flow, thereby delaying the decrease in air pressure in the MSIV bypass valve actuator necessary for bypass valve closure.

Should solenoid valve A fail to trip upon being deenergized, the MSIV bypass valve would not close within five (5) seconds as committed to in licensing documents. This condition constitutes a violation of the Combustion Engineering design interface requirements for the Main Steam System. Additional analysis of this requirement and revision to project licensing documents are not being performed since the condition is being corrected. The subject deficiency is thus evaluated as reportable under the requirements of 10CFR50.55(e) since, if left uncorrected, it could potentially affect the safety of operations of the plant and it represents a significant deficiency in final design.

POTENTIAL PROBLEM: Solenoid Valve 'A' Remains Open, Restricting Reverse Air Flow to be Vented by Solenoid Valve 'B'

- 1) Design Change Packages 1SJ-SG-067, 2SJ-SG-067 and 3CJ-SG-067 have been issued to correct this deficiency. Solenoid valve A will be replaced with a four-way type valve (ASCO NPS344A72E). This replacement solenoid valve design provides for reverse air flow.
- 2) Bechtel's Controls Systems Discipline has determined the subject deficiency to be an isolated case.
- 3) Bechtel Power Corporation is issuing a Problem Investigation Request alerting other Bechtel projects of this potential deficiency.
