B&W OWNERS GROUP

BOLTING TASK FORCE

SUMMARY REPORT OF
NUCLEAR REGULATORY COMMISSION/
BABCOCK & WILCOX OWNERS GROUP
MEETING ON
REACTOR VESSEL INTERNALS BOLTING
MAY 6, 1983

SUMMARY REPORT OF
NUCLEAR REGULATORY COMMISSION /
BABCOCK & WILCOX OWNERS GROUP
MEETING ON
REACTOR VESSEL INTERNALS BOLTING
MAY 6, 1983
BAW 1784

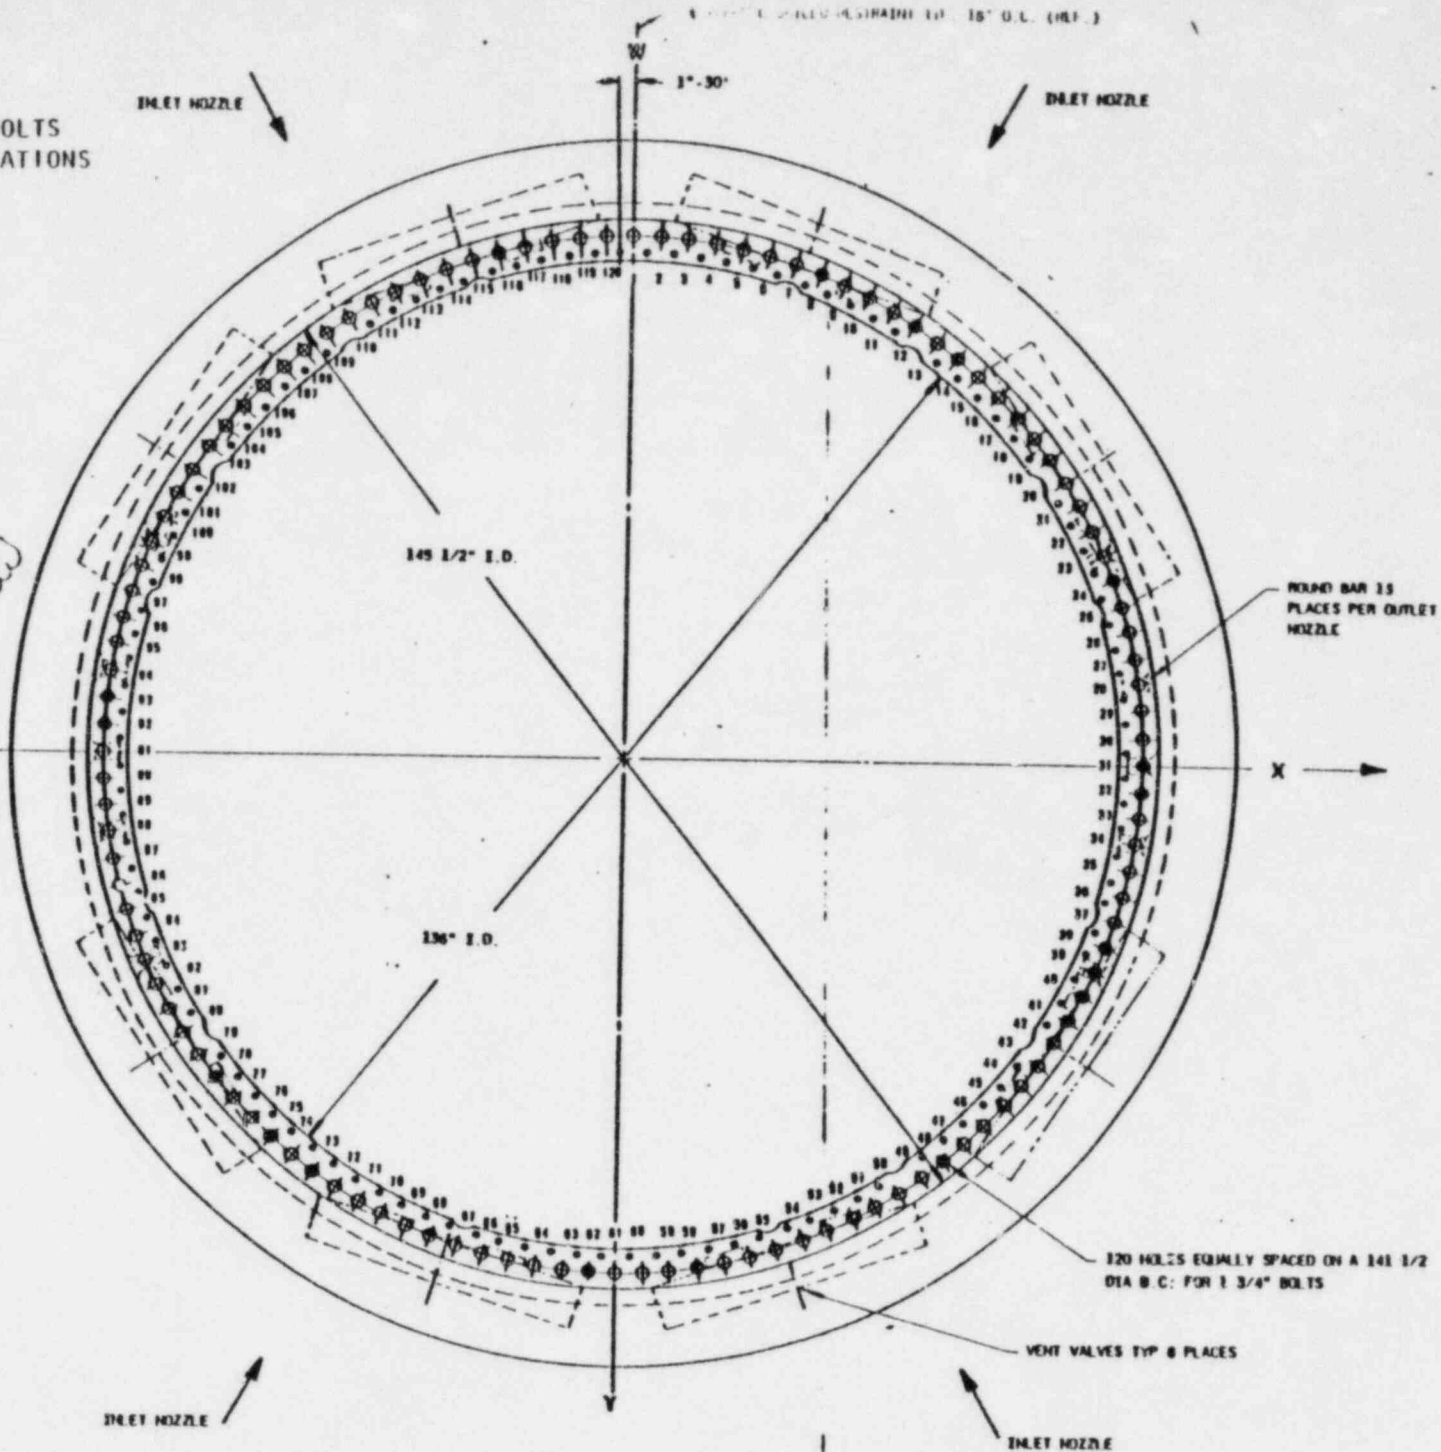
FIG. 3.1

Denotes bolts sent
for Laboratory
Examinations

Two bolts (Bolt Nos. 41 & 116) that showed abnormal indications and one bolt that showed no indications (Bolt 79) from the upper core barrel ring were examined in the laboratory. All three bolts were visually and ultrasonically examined in the laboratory. Metallographic examinations were made on one good bolt and one bolt with cracking. SEM/EDX fracture surface examination was made of bolt 116.

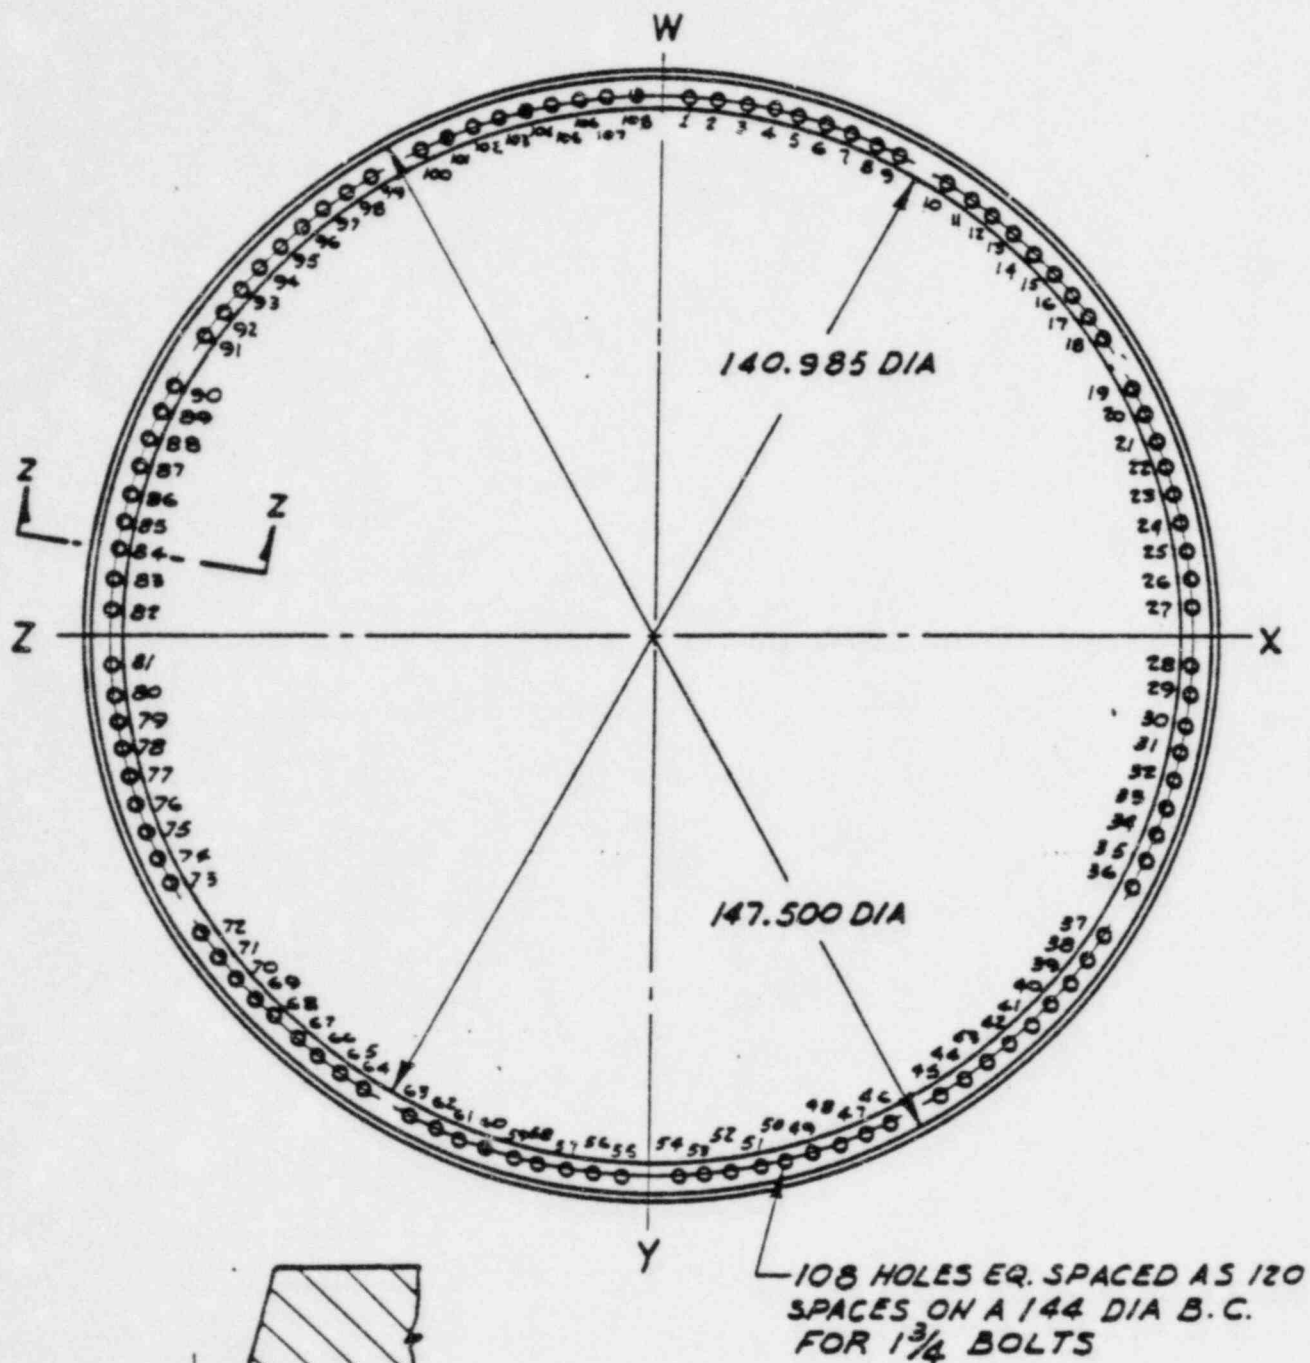
FIG. 3.3

**CORE BARREL/LOWER GRID BOLT LOCATIONS
CRYSTAL RIVER-3**

BOLTS WITH ABNORMAL INDICATIONS
BOLT NO.

60
101
104
108

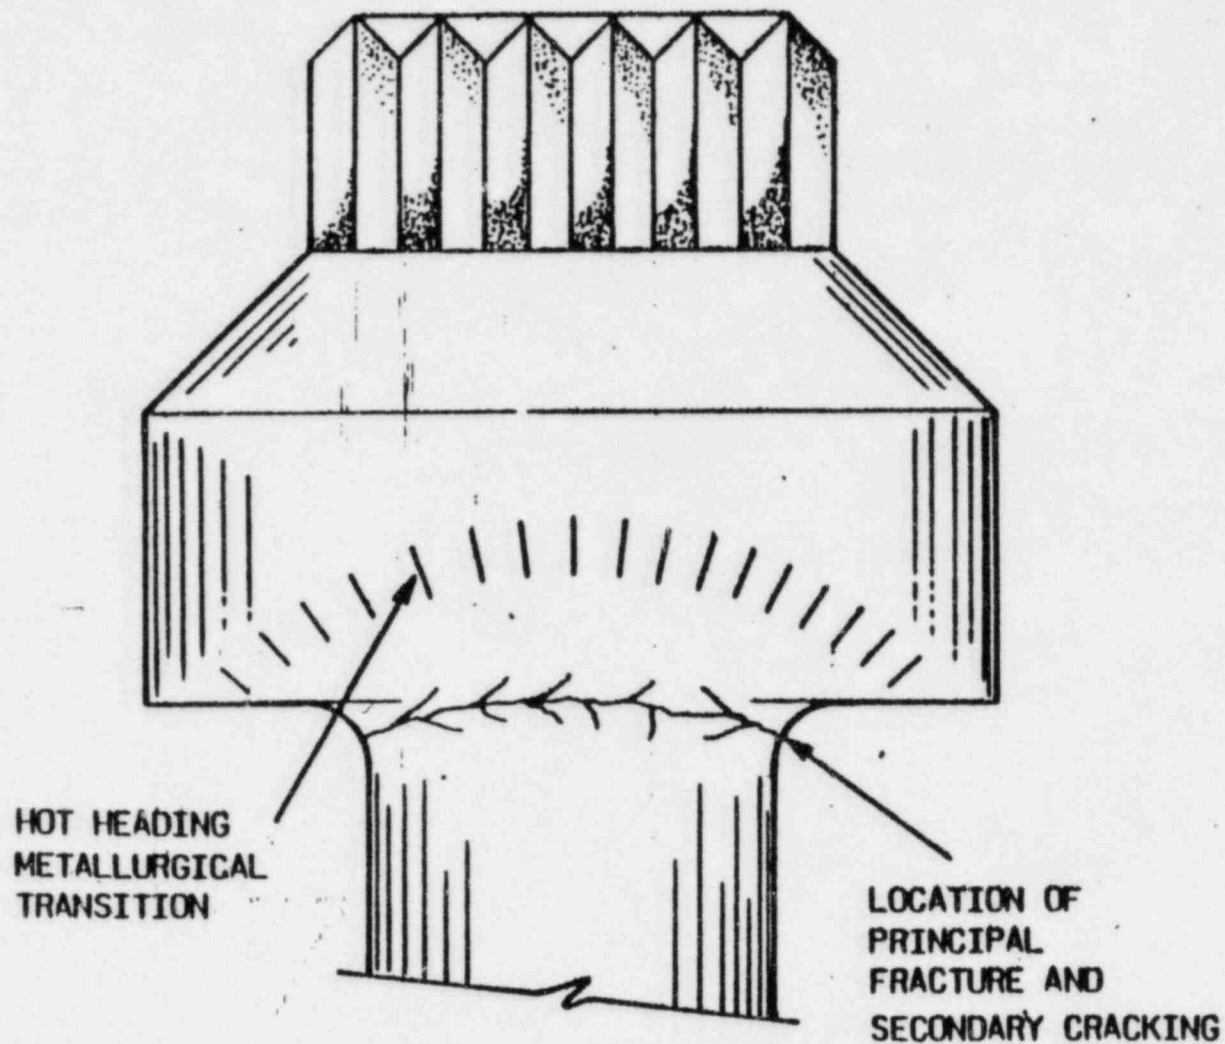
FIG. 3.5

The results of the examination of the two cracked bolts showed both bolts to have cracking initiated in the head to shank transition region similar to that found in the lower thermal shield bolts and that the cracking propagated through 95% of the shank area (see Figure 3.5) the cracking noted was typical of intergranular fracture and showed extensive secondary cracking.

These results led to the conclusion that Rancho Seco UCB failures are typical of previously noted LTS bolt failures. It was also judged that the flaw in the bolt that showed no indications by site UT was an anomaly not associated with the other bolt failures and is metallurgically inert showing no evidence of cracking or propagation and no significant loss of load carrying capability.

SKETCH OF UPPER CORE BARREL BOLT
SHOWING LOCATION OF FRACTURE

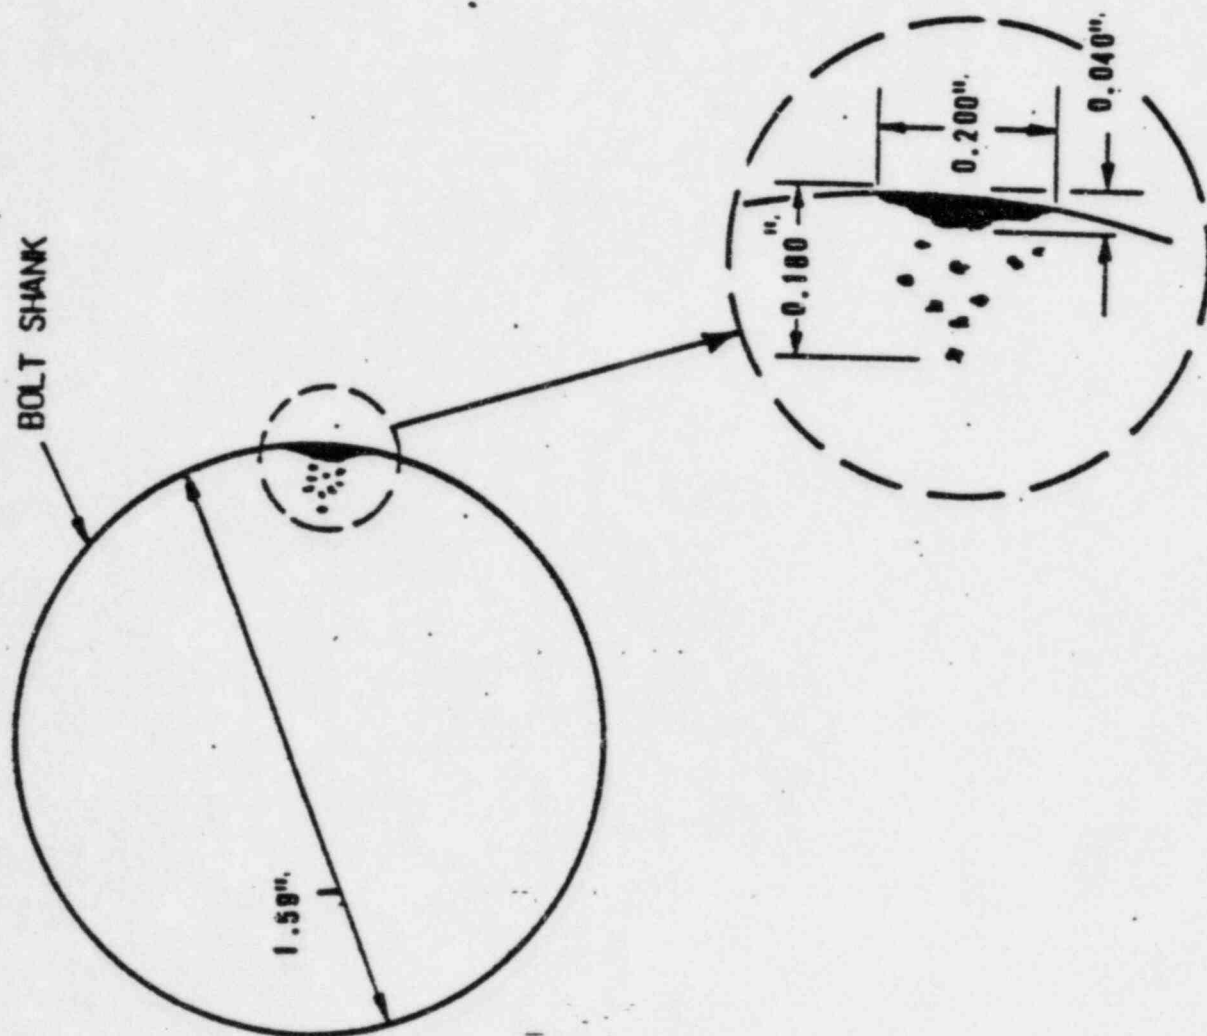
Fig. 3.6

Bolt 79, the bolt showing no indications by field UT, was fluorescent penetrant tested and SEM/EDX examined. Small flaws containing localized deposits were noted in the upper shank region, see Figure 3.6. The surfaces between the flaws opened by ductile rupture when pulled apart. The flaw was not intergranular in nature and showed no secondary cracking. The flaw size was well below the minimum 15% site UT calibration standard and, therefore, would not be expected to be noted by the field UT examination.

RANCHO SECO UPPER CORE BARREL
BOLT #79

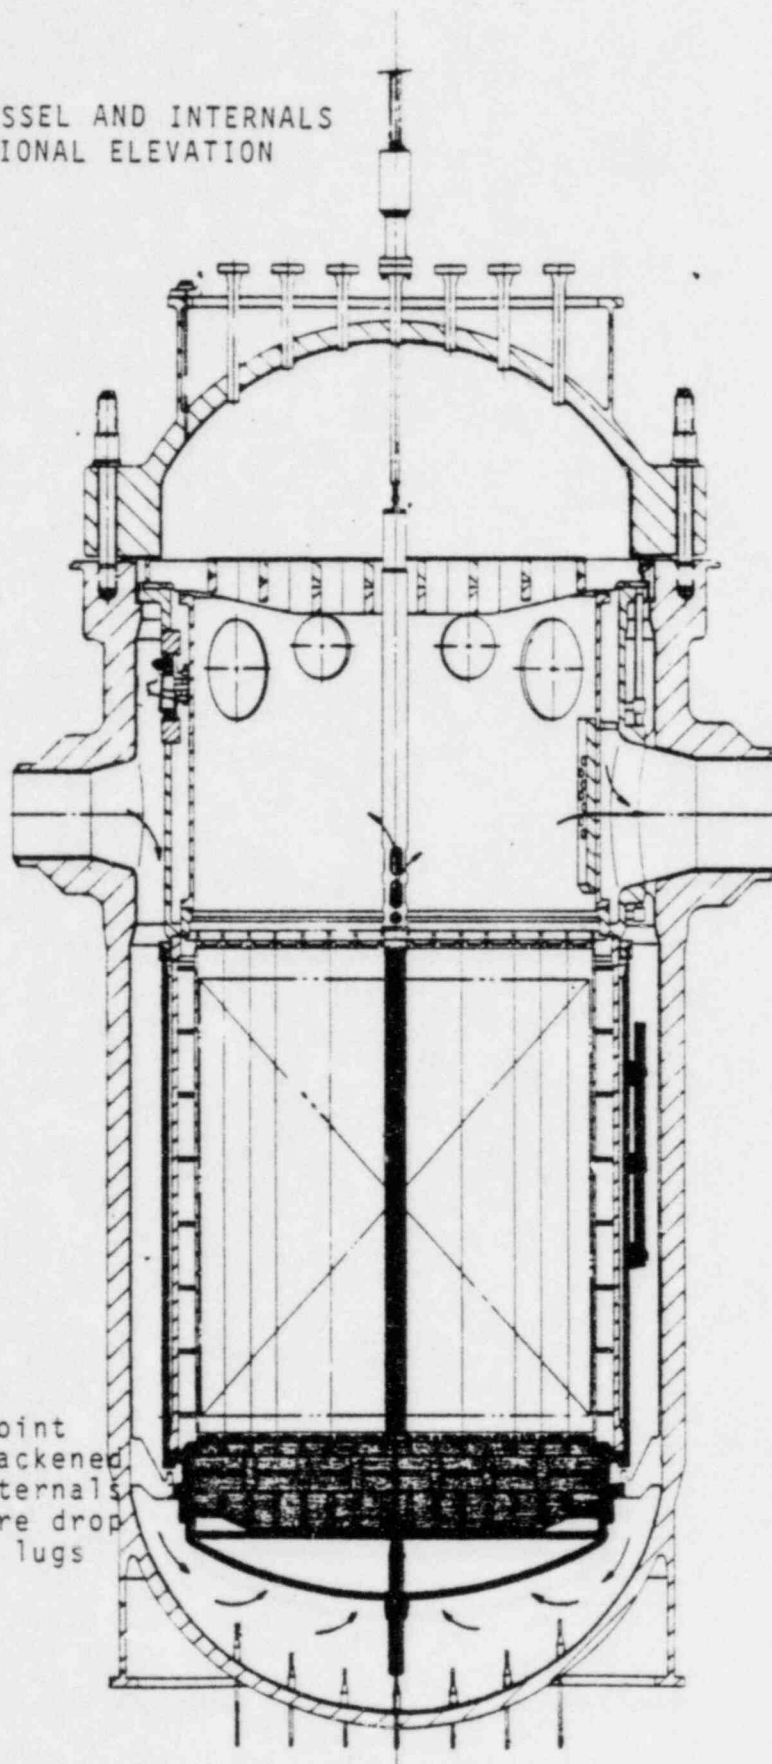
Fig. 4.4

Similar conclusions can be reached for failure of the lower core barrel joint since the considerations are the same for this failure mode as for the UCB joint failure, with only two exceptions. Since the core barrel to core support shield joint remains intact no core bypass flow is expected and the load on the guide lugs is reduced by the weight of the core barrel. Figures 4.4 and 4.5 depict the lower core barrel joint failure and in the core dropped condition.

With LCB Joint
failure blackened
part of internals
and the core drop
onto guide lugs

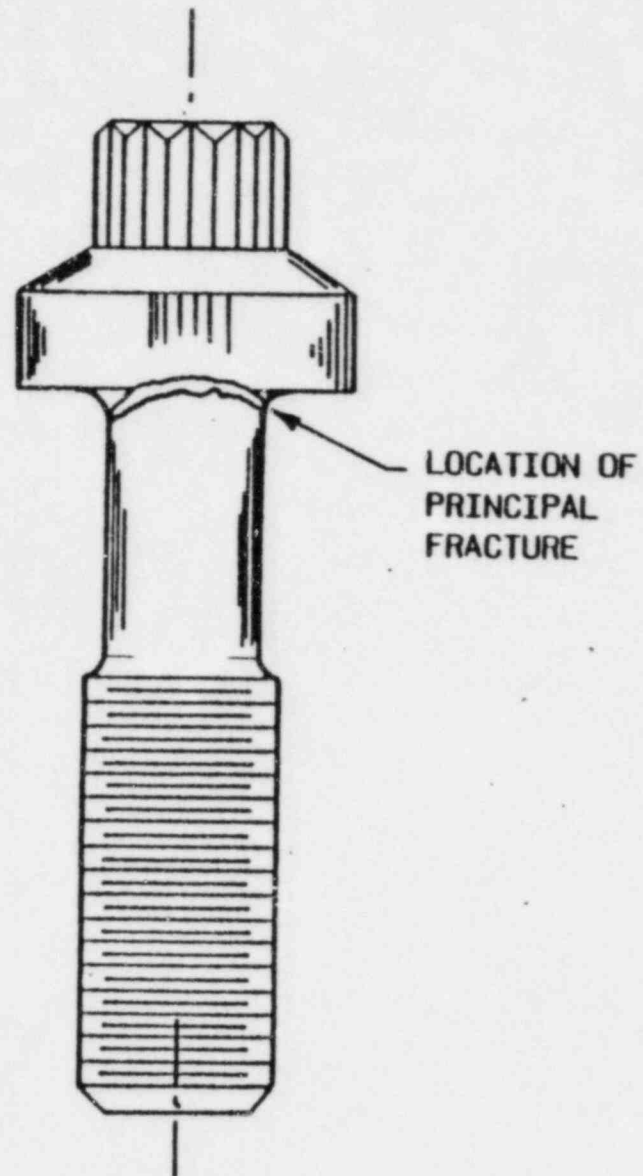
All failures noted in the LTS bolts from Ocone 1&2 were in the head to shank transition region and were attributed to intergranular stress assisted cracking. Also, no cracking was detected in the thread regions. It was also concluded that bolts that were acceptable by site UT were verified to have no flaws by laboratory examinations.

SKETCH OF LOWER THERMAL SHIELD BOLT
SHOWING LOCATION OF FRACTURE

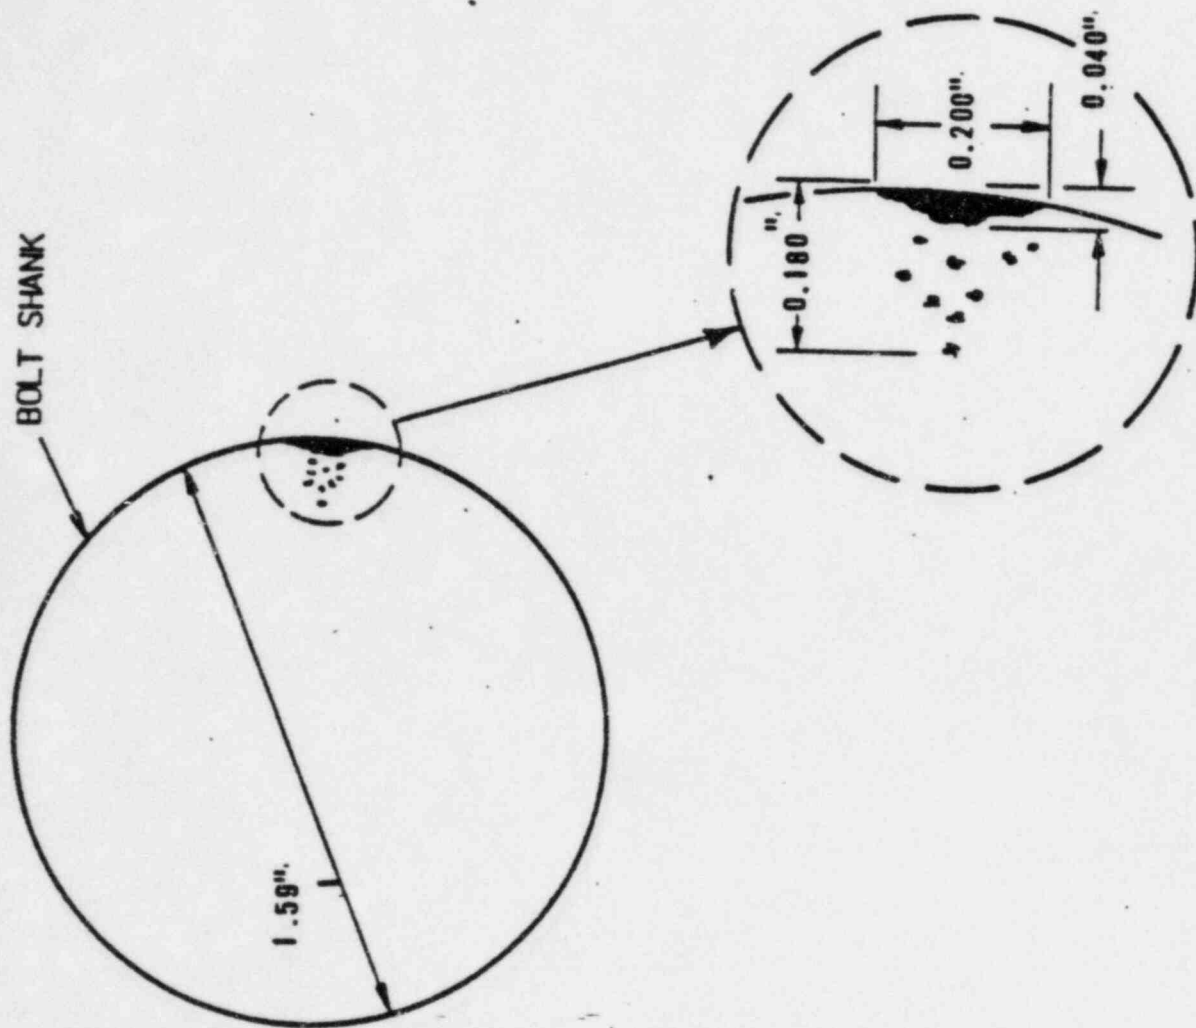
1. FLAW CONTAINS LOCALIZED DEPOSITS
2. FLAW IS NOT INTERGRANULAR IN NATURE.
3. NO SECONDARY INTERGRANULAR CRACKING WAS OBSERVED.
4. SURFACES BETWEEN FLAWS OPENED BY DUCTILE RUPTURE WHEN PULLED APART.
5. TOTAL FLAW SIZE MUCH LESS THAN 15% SITE U/T CALIBRATION STANDARD.

RANCHO SECO UPPER CORE BARREL
BOLT #79

1. RANCHO SECO UPPER CORE BARREL BOLT FAILURES ARE TYPICAL OF PREVIOUS BOLT FAILURES.
2. BOLT #79 FLAW IS AN ANOMALLY AND NOT ASSOCIATED WITH BOLT FAILURES. THE FLAW IS METALLURGICALLY INERT SHOWING NO EVIDENCE OF PROPAGATION.
