## LICENSEE EVENT REPORT (LER)

MONTICELLO NUCLEAR GENERATING PLANT

Instantaneous Trip of 480 VAC MCCBs Do Not Meet  
Acceptance Criteria Due to Manufacturer's Design

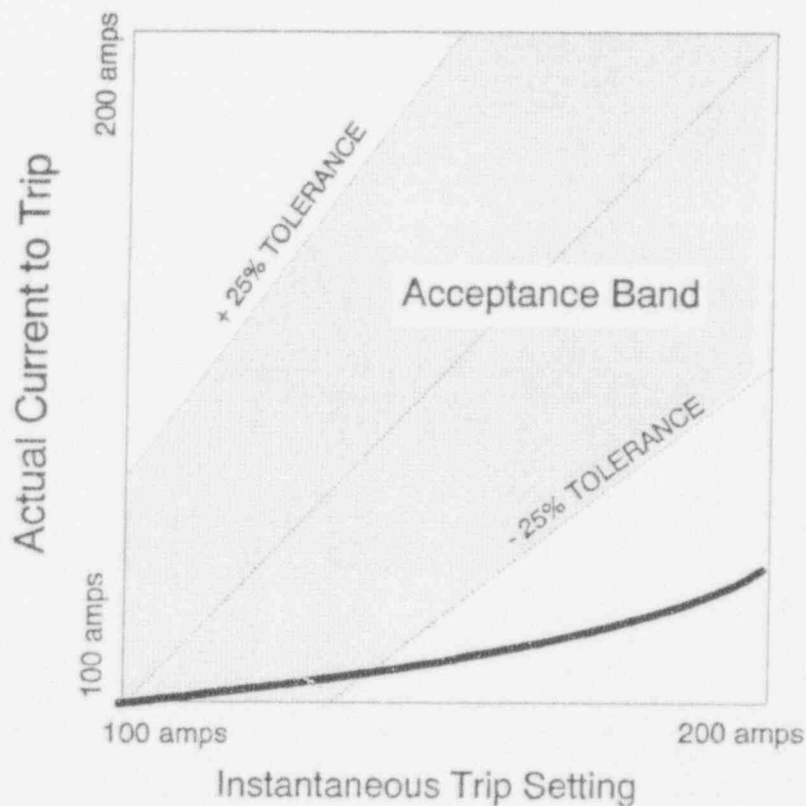
## Instantaneous Trip Setting vs Actual Current to Trip

During subsequent testing of the instantaneous trip, breakers were found to deviate from the trip setpoint at higher settings. The deviation was small for low set points and increased as the setpoint was increased (See attached Figure). The results were consistent for each pole (phase) tested. Spare breakers of the same model number were tested; all of which produced nearly identical results. Two additional Klockner Moeller molded case circuit breaker models (including a breaker procured in 1993) were tested and exhibited similar characteristics. These other models, however, were not outside of allowed tolerances. The testing was performed by experienced plant electricians in accordance with the requirements of UL (Underwriters Laboratory) Standard 489. The results were confirmed by an independent testing laboratory.

The primary cause of this event is believed to be the design of the molded case circuit breaker. All Klockner Moeller 480 VAC molded case circuit breakers exhibited the trend shown in the attached figure. The trend was consistent between phases, models and manufacturing period. Breakers manufactured by others did not exhibit this trend. The issue identified does not appear to be the result of degrading equipment. Breakers procured in 1993 exhibited similar characteristics to those procured in 1982. Test data taken in 1982 appears to correspond to current data. Test results were very consistent from pole to pole and from breaker to breaker. These facts lead to the conclusion that age is not a cause of this characteristic.
