BRUNSWICK STEAM ELECTRIC PLANT, UNIT NO. 1
DOCKET NO. 50-325 / LICENSE NO. DPR-71
PERFORMANCE OF NONDESTRUCTIVE EXAMINATION OF FEEDWATER
NOZZLES AND SAFE ENDS DURING THE B109R1 REFUELING OUTAGE

BRUNSWICK STEAM ELECTRIC PLANT, UNIT 1 NRC DOCKET NO. 50-325 OPERATING LICENSE NO. DPR-71 UNIT 1 NONDESTRUCTIVE EXAMINATION RESULTS FEEDWATER NOZZLES AND SAFE ENDS

DOCUMENT NO. EER 93-0462 REV. NO. 0DESCRIPTION OF TITLE: Evaluation of Unit 1 Feedwater Spargers

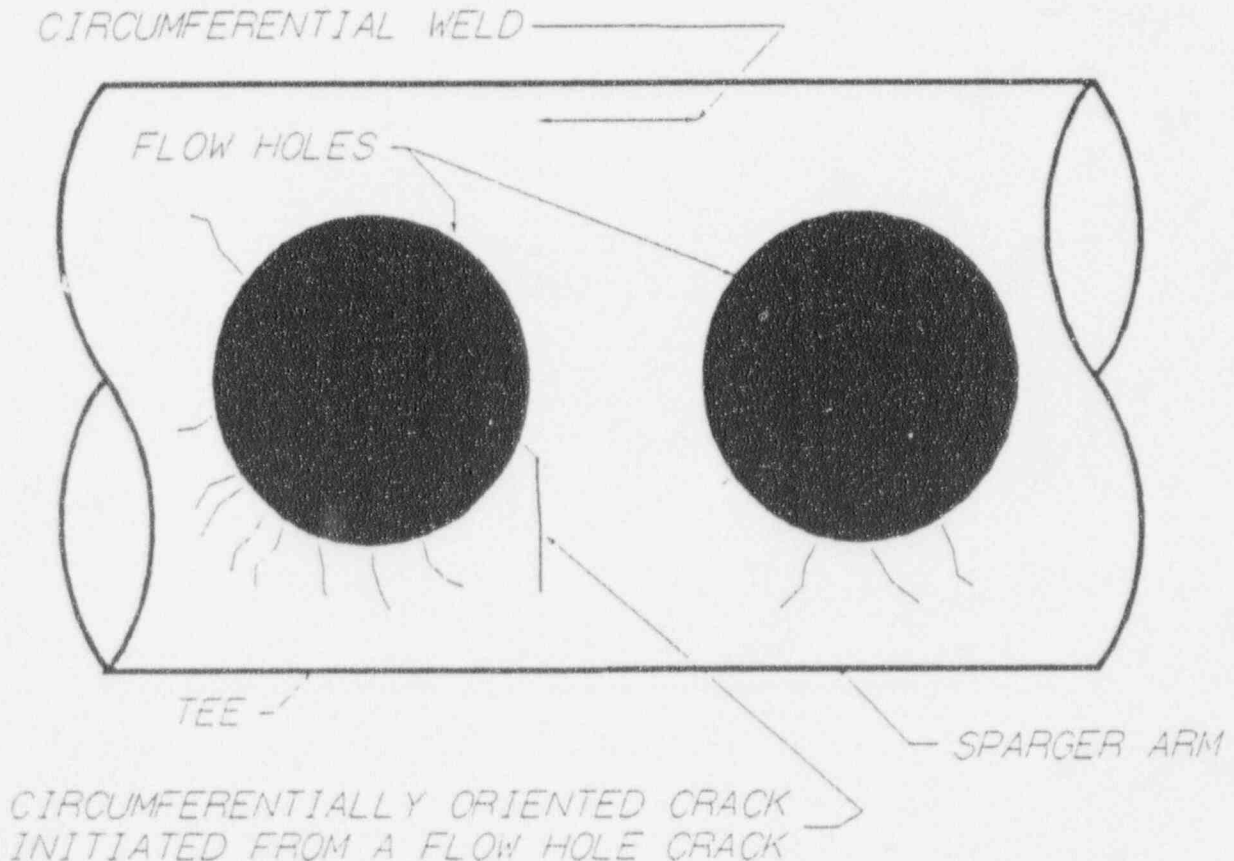
Figure 1 - Typical Circumferentially Oriented Crack

- 2.2.1 Table 1 summarizes the non-destructive examination results of the eight welds connecting the sparger arms to the tee. Six of the sparger-arm-to-tee welds had circumferentially oriented LP indications on the outside diameter surface. The longest indication was 2.25" long on the left side of the 135° azimuth tee. Based upon the previous Unit 2 examination, it was assumed that all of the outside diameter LP indications represented through-wall cracks; therefore, these six welds were subsequently UT examined

Figure 1 shows the orientation of the circumferential cracking, which is the same as in the previously examined Unit 2, i.e., all of the cracks are on the flow hole side of the sparger. The cracks are growing downward following the heat affected zone of the circumferential weld.

growth rate predicted by GE in Ref. 3 is 3.16" per operating cycle for a similar indication. The maximum predicted length of a crack before structural failure would occur was 14.1".) The longest existing crack found in Unit 1 was 2.5 inches, thus, there is a total margin of 11.6" of additional crack growth (14.1" minus 2.5") before structural failure of the joint is predicted. Based upon Ref. 3, the longest Unit 1 flaw would be approximately 5.7" (2.5" plus 3.2") at the end of the next cycle. It is therefore acceptable to operate for an additional cycle with the existing feedwater spargers. The longest existing crack will not reach critical flaw size in the next operating cycle.
