Southern Nuclear Operating Company

July 29, 1994

Joseph M. Farley Nuclear Plant
Response to NRC Safety Audit of the
Service Water Pond Dam on February 2 & 3, 1993

Response to NRC Safety Audit of the
Service Water Pond Dam on February 2 & 3, 1993

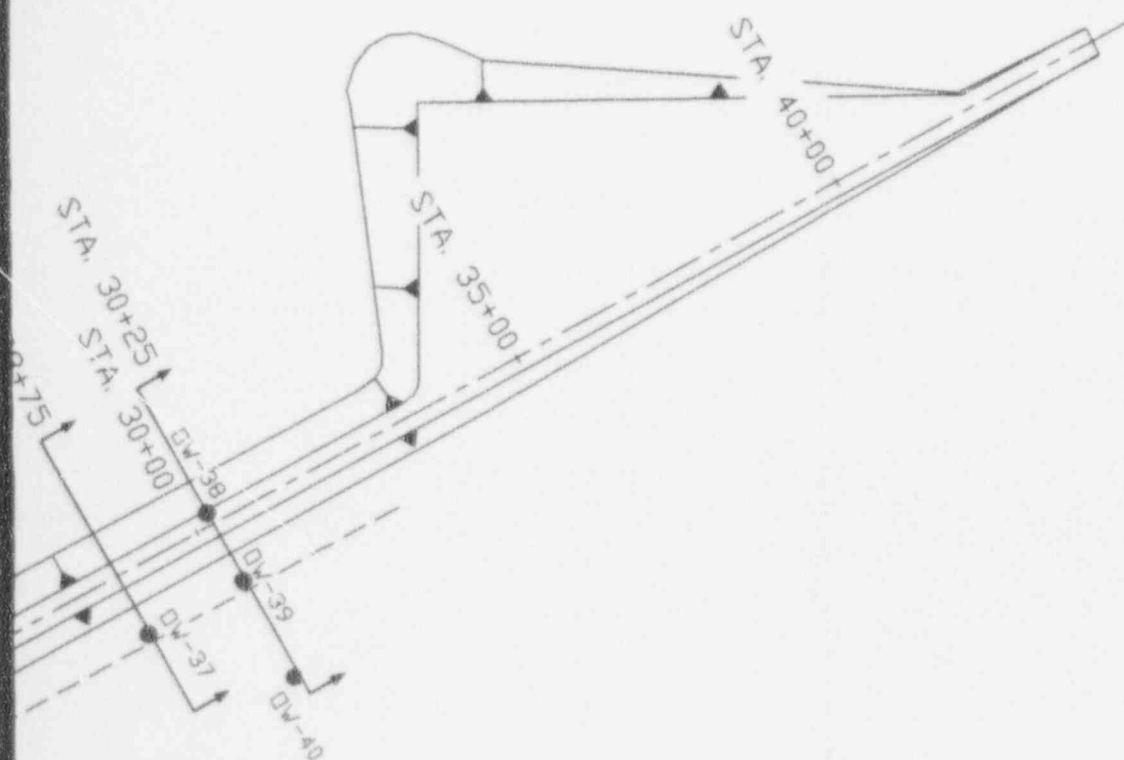
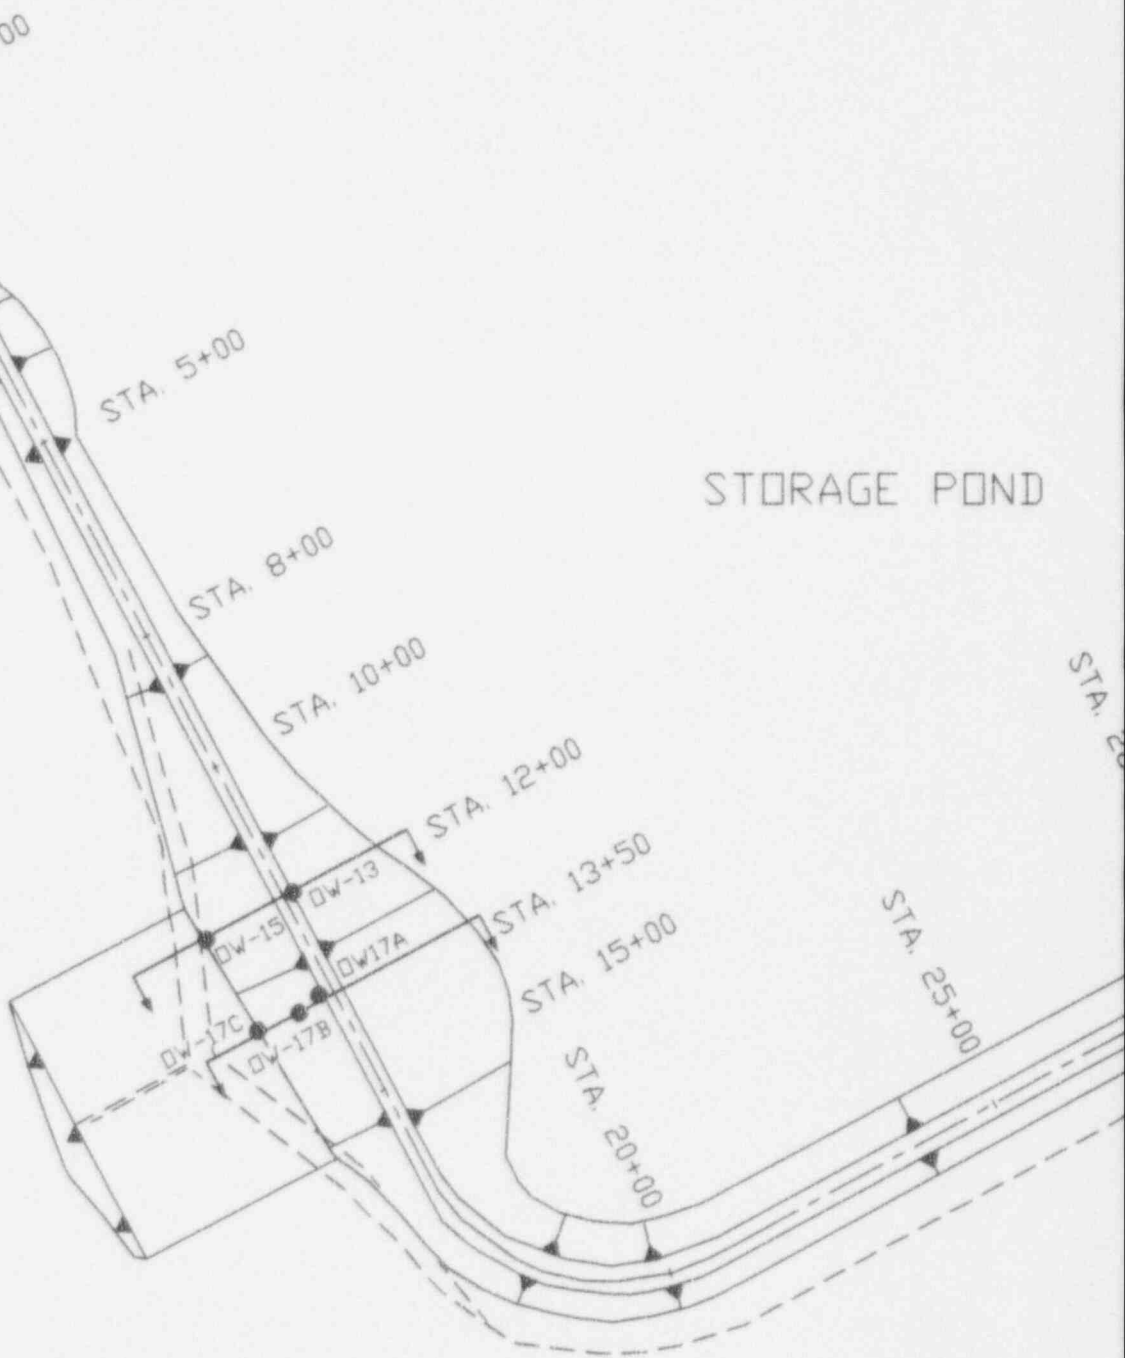
FIGURE 1
PLAN OF STORAGE POND
DAM AND DIKE
SCALE: $3/8" = 1' - 0"$

| Figure | Description |
|---|--|
| 1 | Plan view showing observation well locations. |

A plan view showing the storage pond dam and dike and the location of the various observation wells referenced in the following discussion is included as Figure 1.

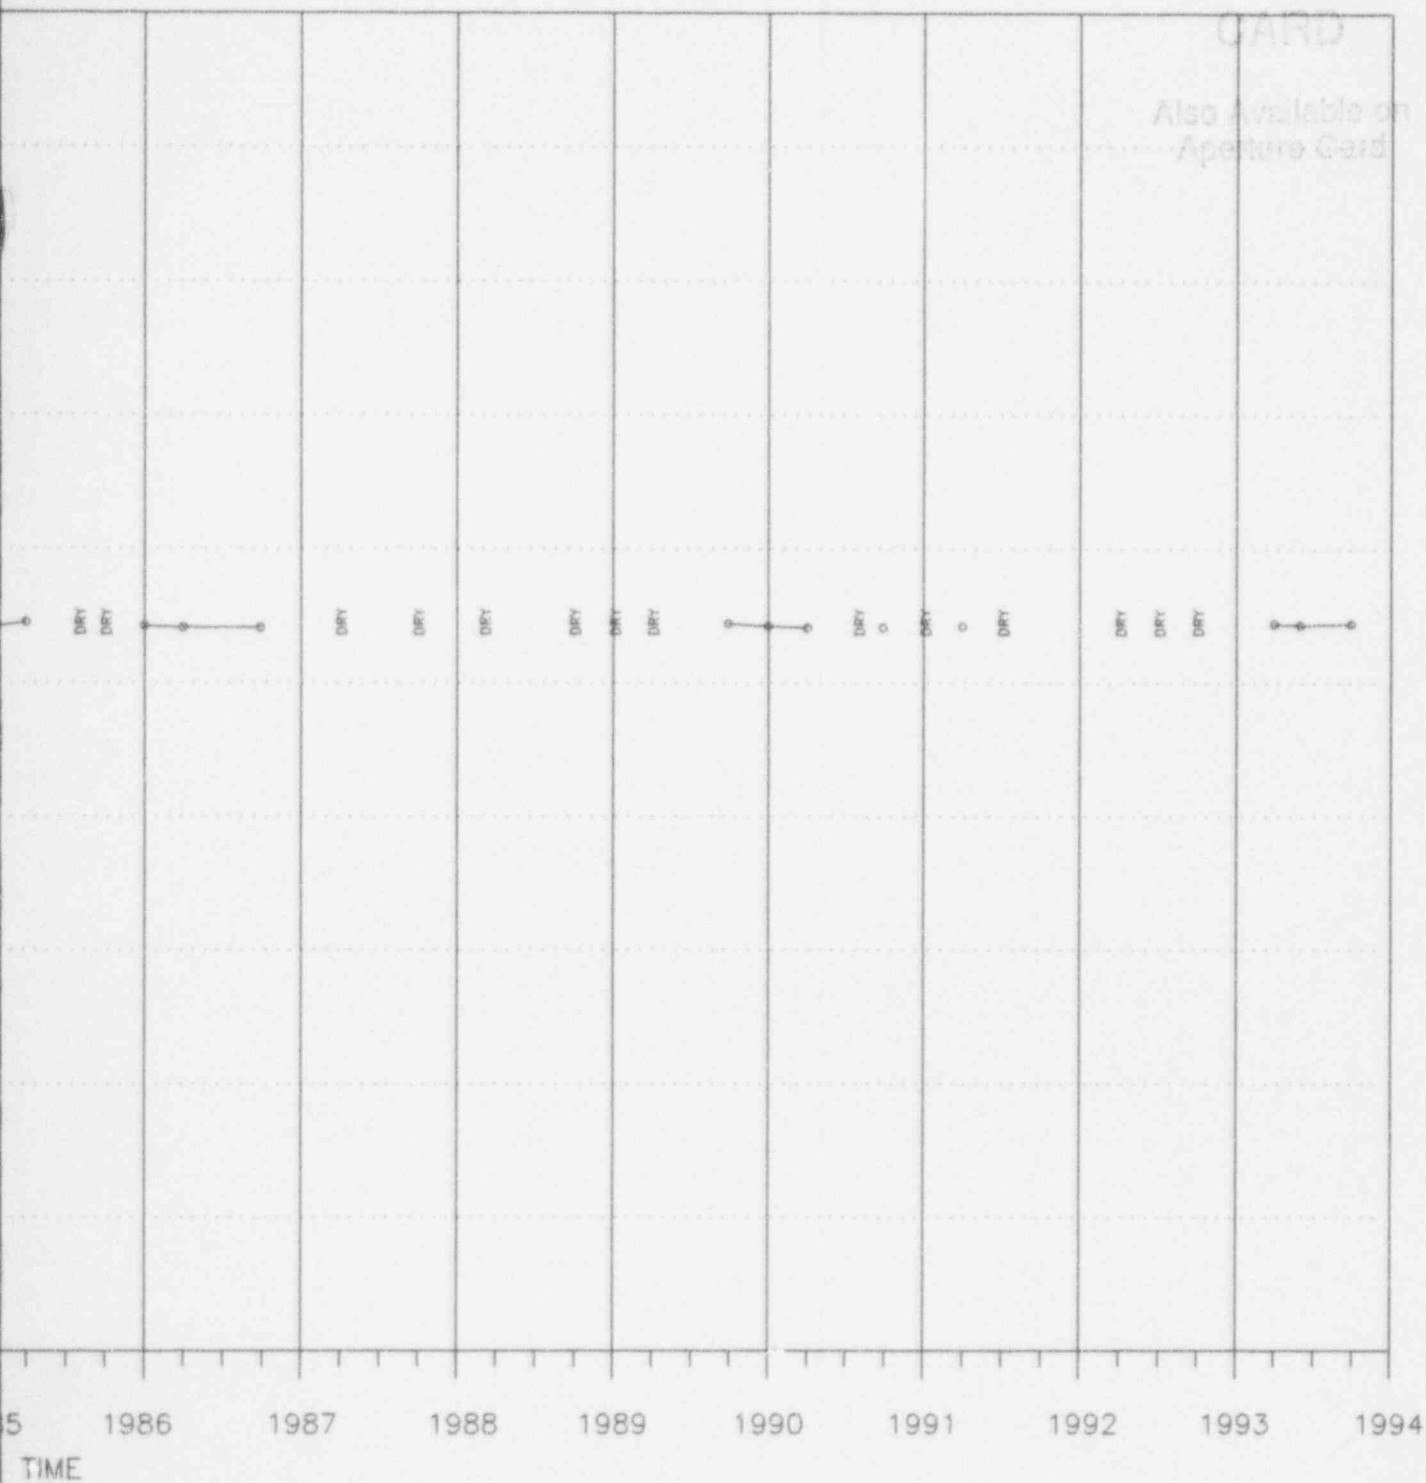
FIGURE 5
OBSERVATION WELL OW-17B

| Figure | Description |
|---|--|
| 5 | Time-line plot of observation well OW-17B. |

Further evidence of a localized effect is seen in the time-line plots and dam cross-sections for other wells adjacent to OW-17C. The time-line plot, Figure 5 for OW-17B (located 50 feet upstream of OW-17C at the same station) shows no actual water level in that well over the years of reservoir operation. All points shown on Figure 5 are mud readings at the bottom of the well rather than piezometric water surface readings. The time-line plots for wells OW-13, 15 and 17A show water levels consistently below the expected design phreatic surface. Consistently low water levels in downstream well OW-18 (located 150 feet downstream of OW-17C at Station 13+60) adds further confirmation of a localized condition.

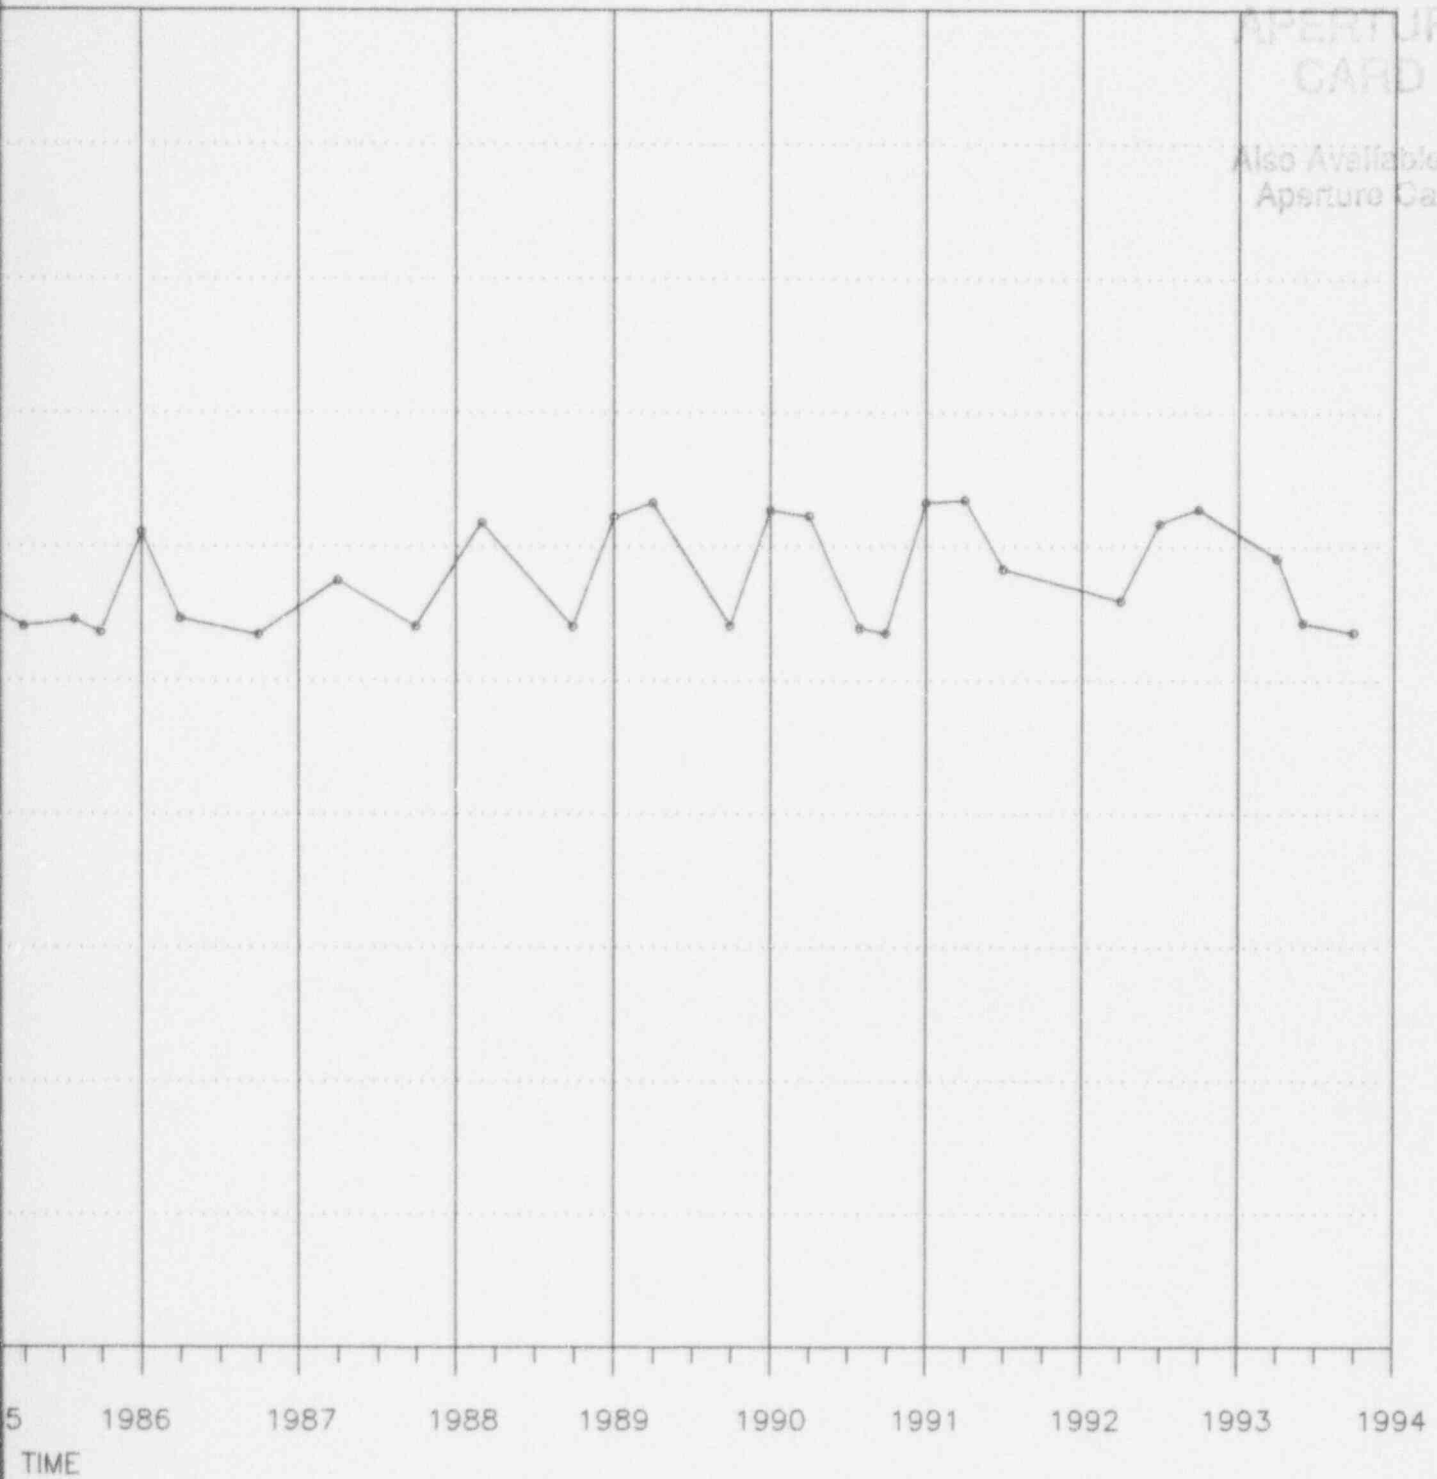
FIGURE 6
OBSERVATION WELL OW-17C

| Figure | Description |
|---|--|
| 6 | Time-line plot of observation well OW-17C. |

SNC has concluded from its review of historical well readings that the high water level observed in OW-17C is due to localized rain accumulation rather than seepage through the embankment. SNC will continue to monitor well readings per plant procedure FNP-0-ETP-4381. Additional monitoring is not considered necessary. The discussion below provides additional details of SNC's evaluation of this action.

An examination of the time-line plots, Figures 5 and 6 indicates that the high water level being indicated in OW-17C is the result of localized rain runoff collecting at the toe of the dam rather than any reservoir effect. This is discussed below.

As shown on Figure 6, the time-line plot for OW-17C, the water levels within this well ranged from a minimum of approximate elevation 152.8 feet to a maximum at elevation 163.5 feet over the years of monitoring. Since the water levels within this well are not consistent over time, they are not considered to be a result of any reservoir influence.

The fluctuation of the water level readings do coincide with seasonal weather differences however. The high water levels have typically occurred in the first quarter of each year when there is more saturation from rainfall and little evaporation. The lower readings have typically occurred during the dry season of each year. It is worth noting that OW-17C is located at the toe of the maximum dam section. Runoff from the embankment concentrates in this area. In addition, all ground surfaces on the downstream side of the dam embankment also slope to this central region.

The actual phreatic surface at OW-17C would not affect the safety factors for the design failure surfaces presented in Figure 2B7-18 of the FSAR. There is a possibility that the higher phreatic surface may only slightly decrease the safety factor against a shallow failure surface through the downstream slope. However, none of the critical failure surfaces shown in Figure 2B7-18 of the FSAR are shallow circles, indicating that a shallow surface failure is unlikely and any possible decrease in that safety factor would be of no significance to design.

Based on engineering judgment of the Earth Science and Environmental Engineering group of Southern Company Services Engineering, the safety factors against a slope failure would not be affected by the isolated water level readings at OW-17C. The conservative design of the embankment and the localized nature of the observed condition indicates that additional formal analysis is not warranted or required.

SNC will continue the regular monitoring of water levels in wells related to the dam and dike per plant procedure FNP-0-ETP-4381. No additional testing or monitoring is deemed necessary.

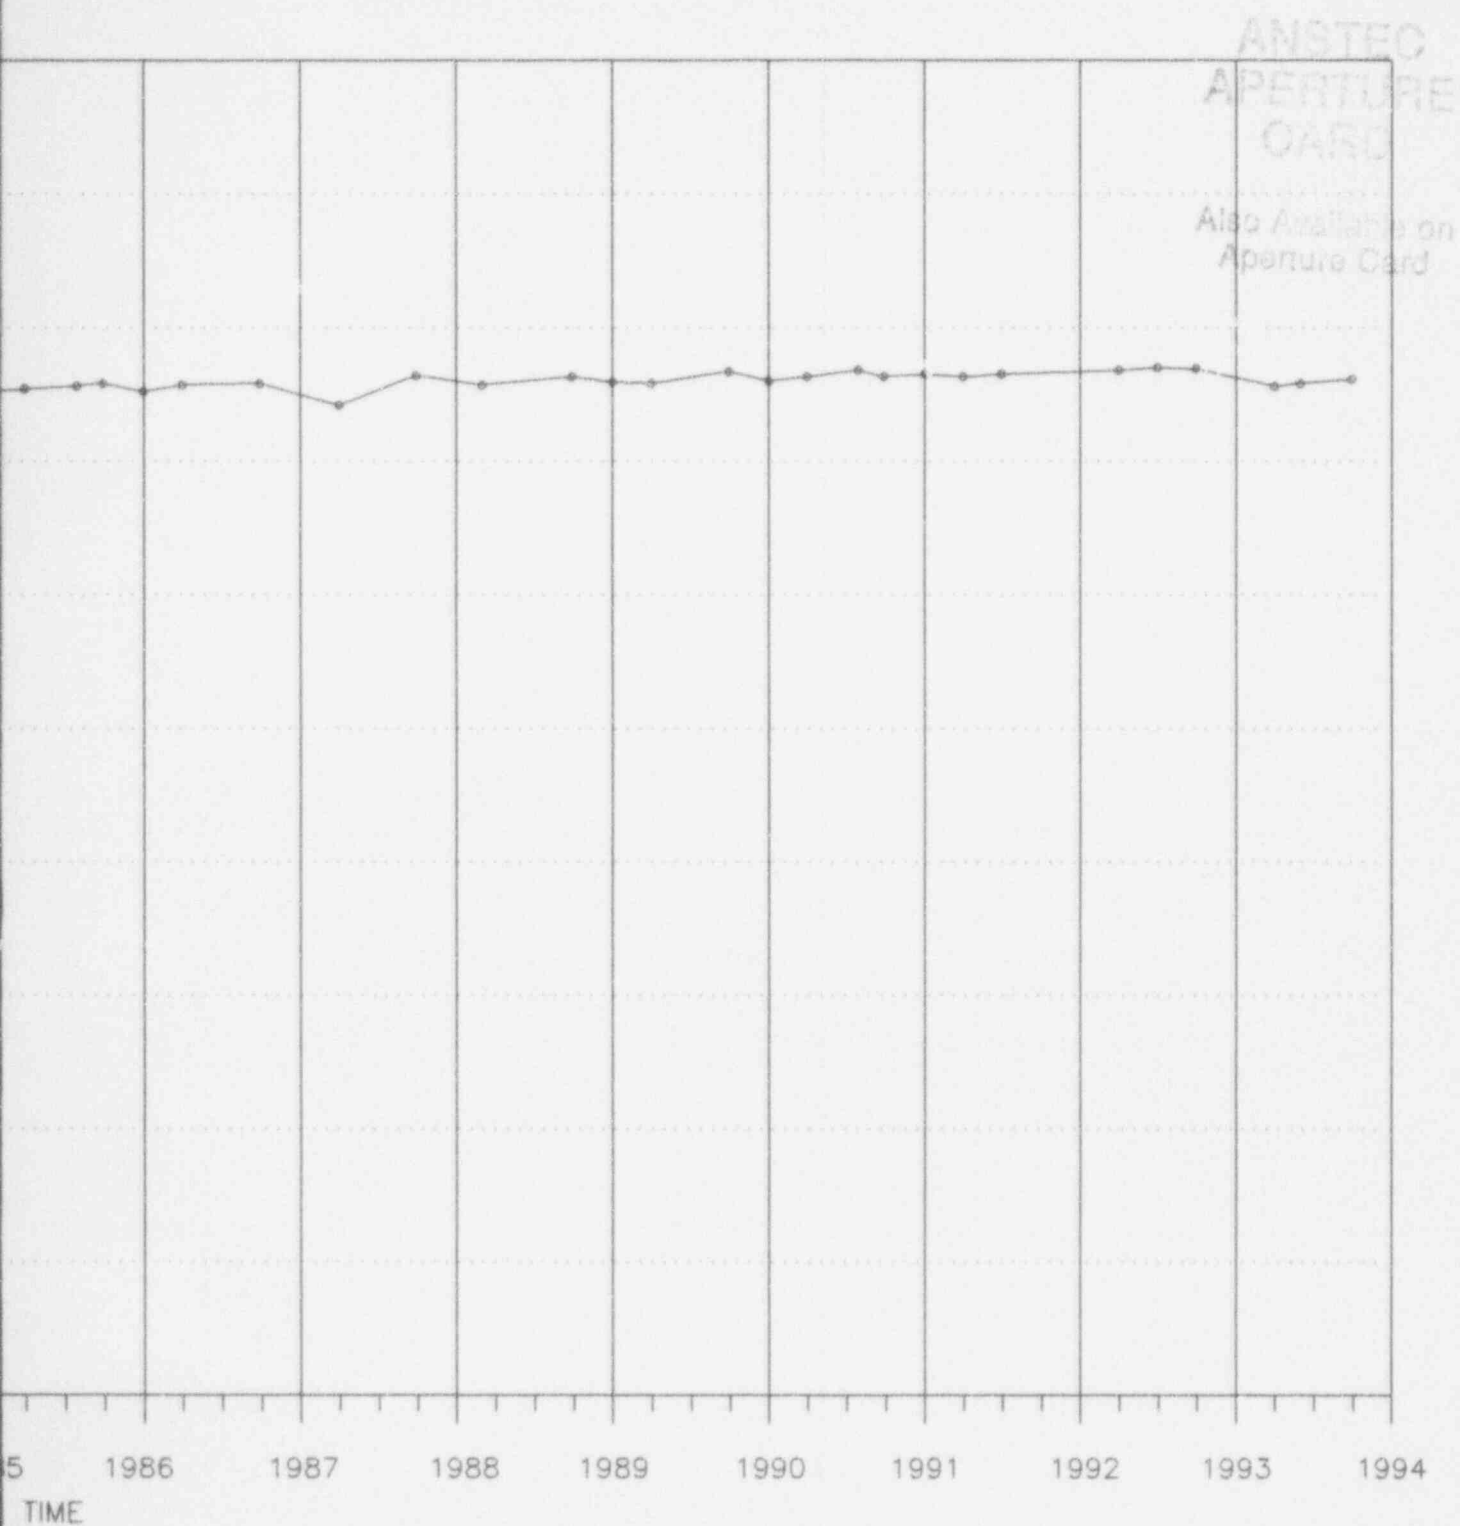
FIGURE 2
OBSERVATION WELL OW-13

| Figure | Description |
|---|--|
| 2 | Time-line plot of observation well OW-13. |

SNC has found that the water level measured in OW-13 since reservoir filling has been fairly constant and consistently within the design envelope. Thus no further discussion or analysis is required per this NRC question. The water level at OW-17C is outside the design envelope, but an engineering evaluation of this condition and the original embankment slope stability analysis concludes that the condition observed does not adversely affect the safety of the structure. Additional analysis is not considered necessary for the observed condition.

As shown on Figure 11, the actual phreatic surface for observation well OW-13 (and downstream well OW-15) is well below the design phreatic surface and thus does not affect the safety and stability of the embankment. No further discussion of OW-13 is required.

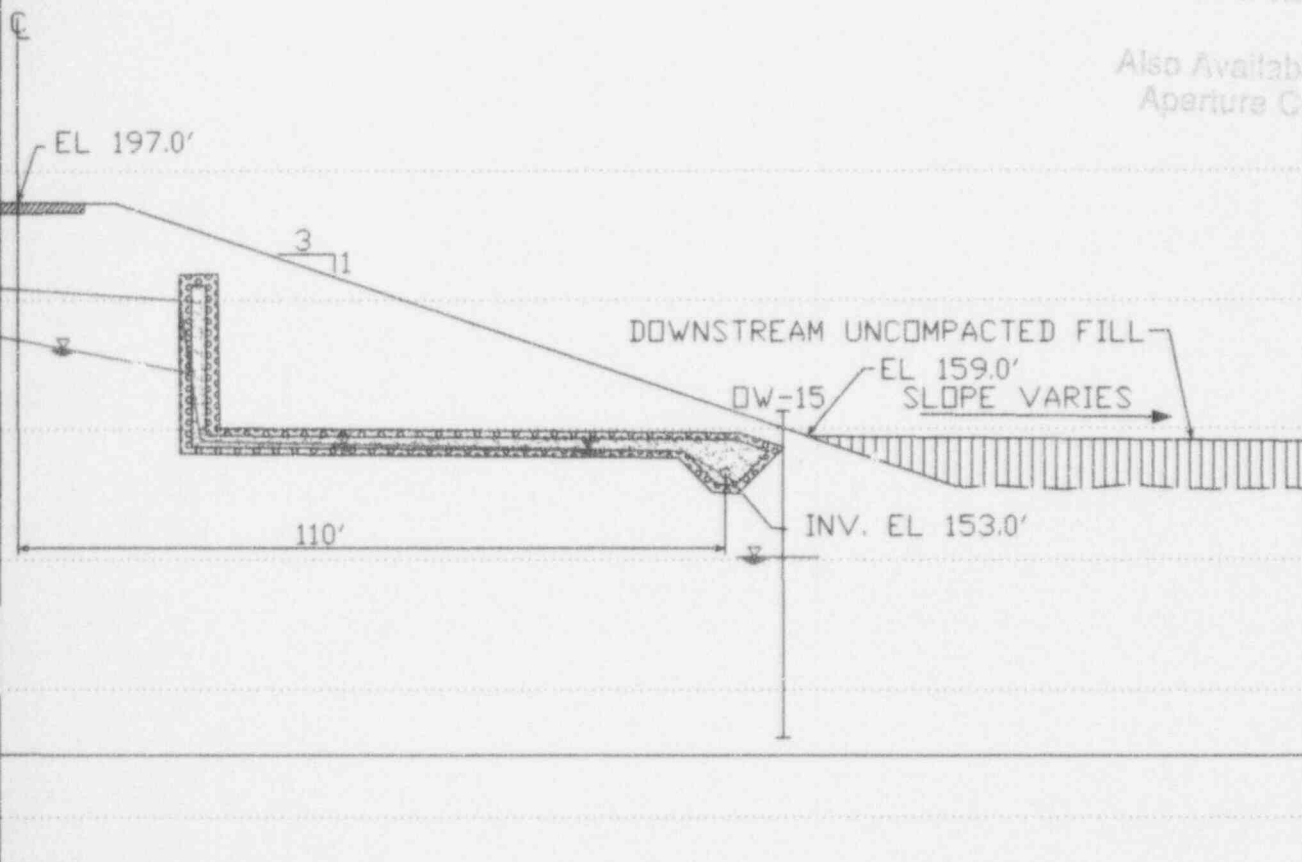
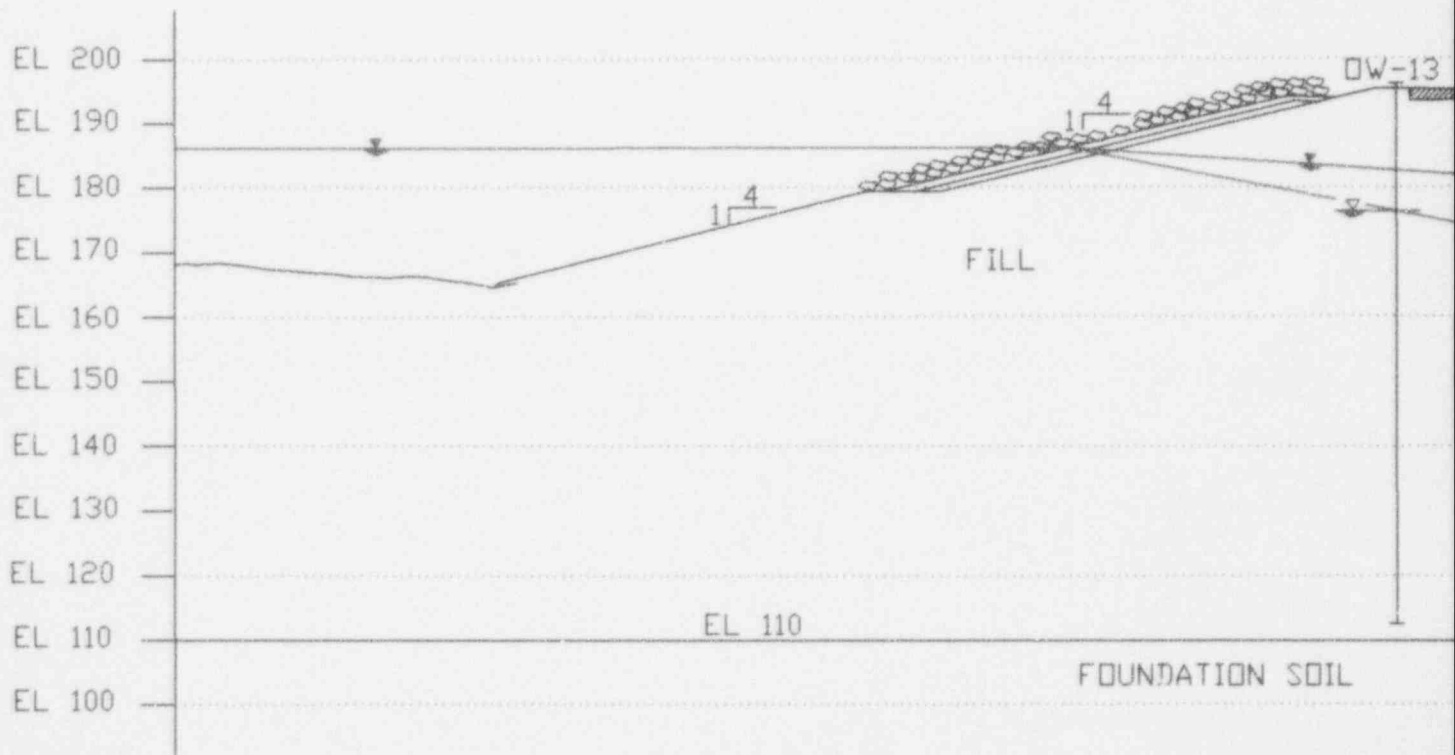
FIGURE 11
SECTION @ STA. 12+00

| Figure | Description |
|---|--|
| 11 | Cross-section of dam at Sta. 12+00 through observation wells OW-13 and 15. |

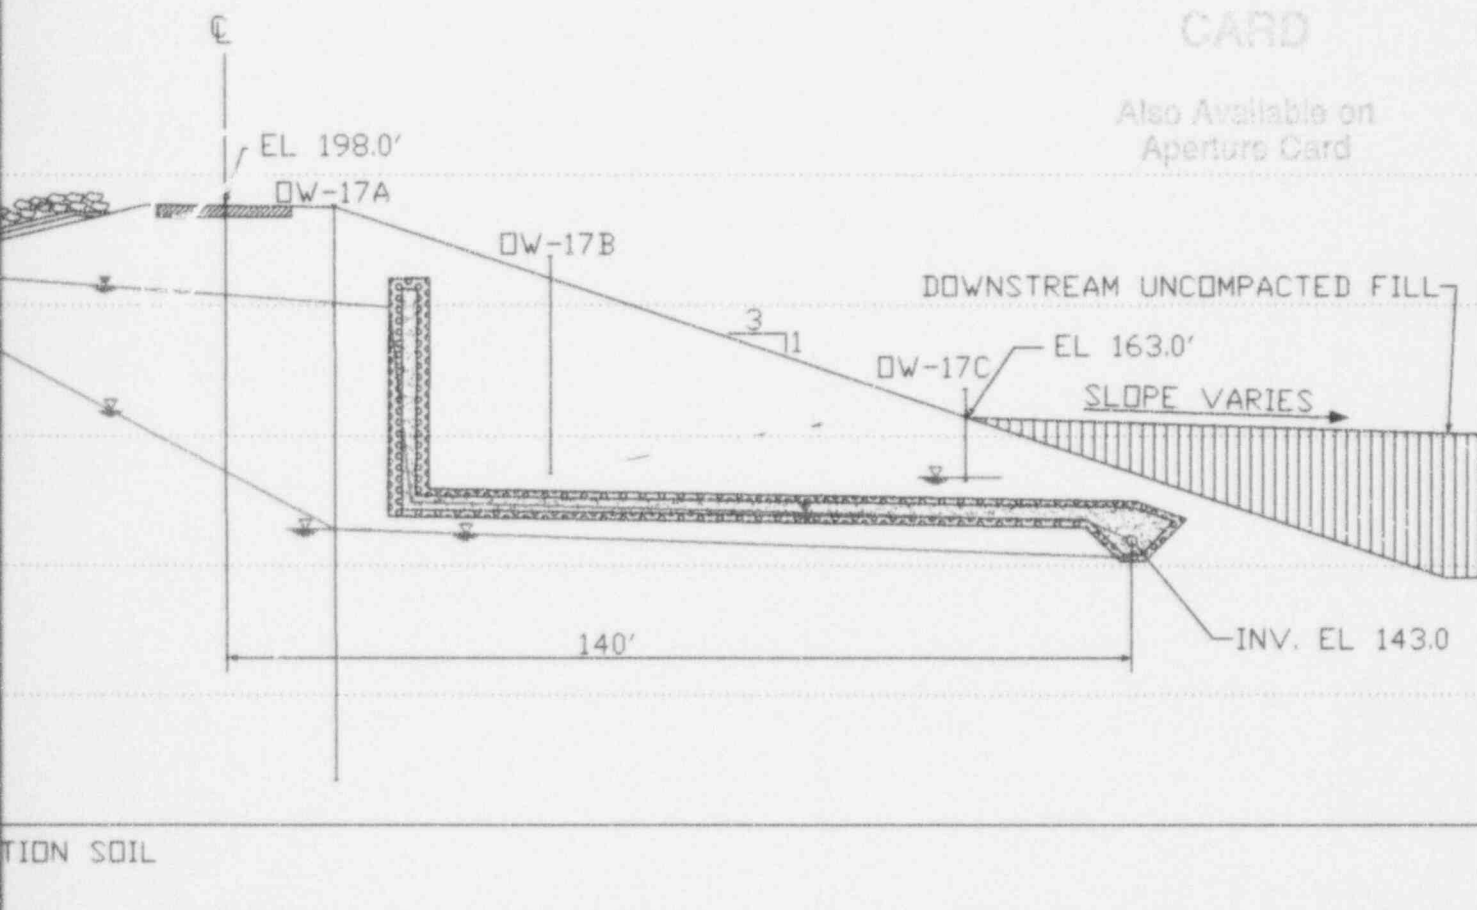
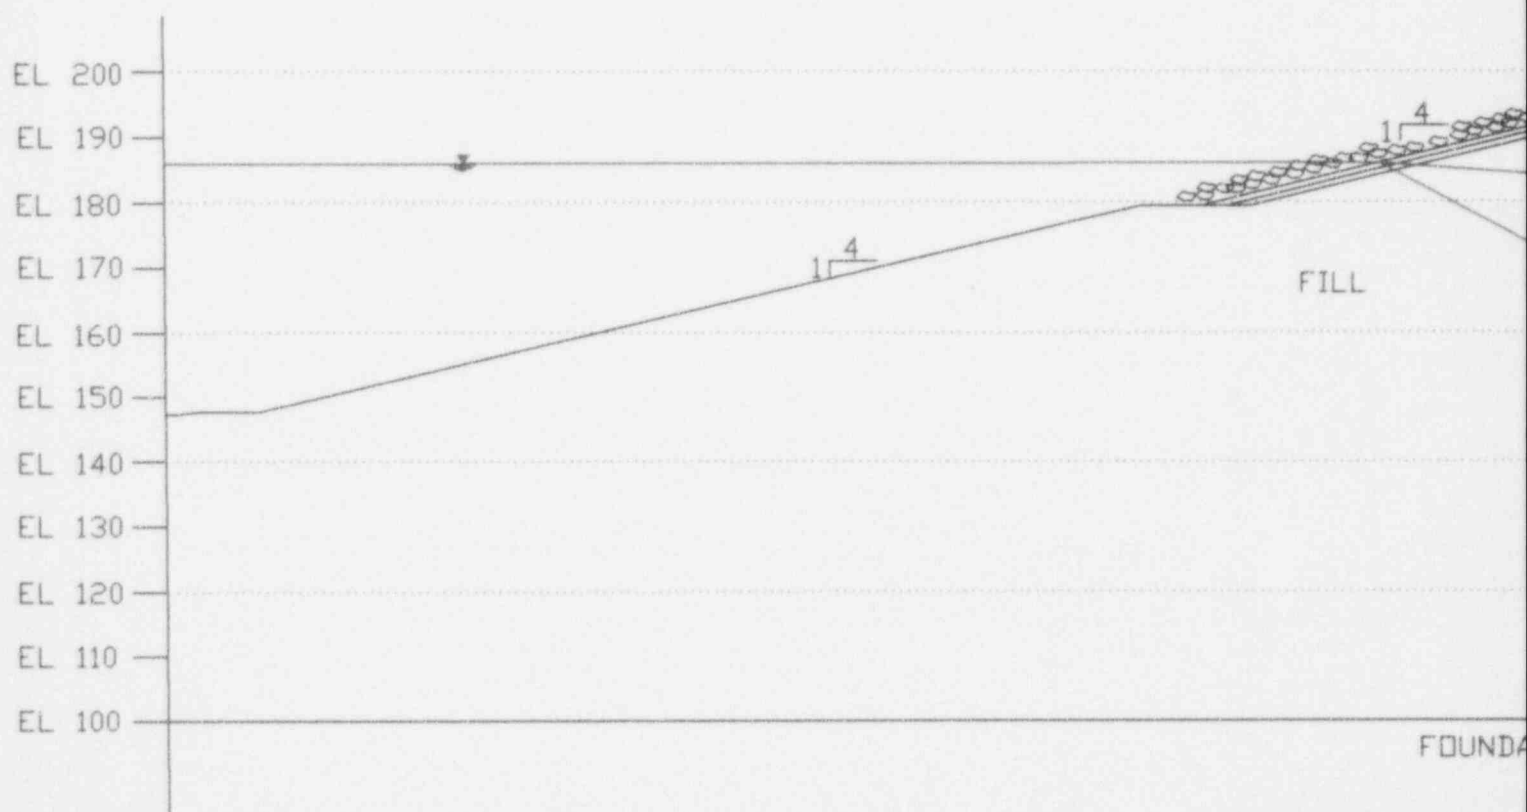
FIGURE 12
SECTION @ STA. 13+50

| Figure | Description |
|---|--|
| 12 | Cross-section of dam at Sta. 13+50 through observation wells OW-17A, 17B, and 17C. |

As shown on Figure 12, the tip of observation well OW-17C is at a higher elevation than the gravel drain through which the maximum design phreatic surface passes. Therefore, any water level reading made in this well will be higher than the design phreatic surface.

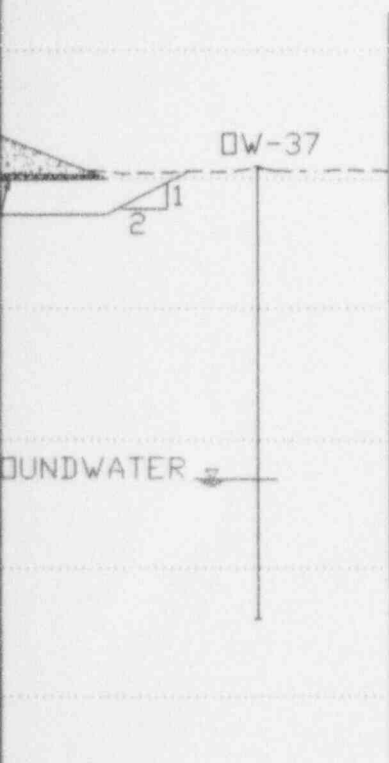
FIGURE 13
SECTION @ STA. 28+75

| Figure | Description |
|---|--|
| 13 | Cross-section of dam at Sta. 28+75 through observation well OW-37. |

As shown on the dam cross-sections, Figures 13 and 14, the most recent phreatic surface through the dam is well below the design phreatic surface at Stations 28+75 and 30+25. Time-line plots for the observation wells in the vicinity including OW-37 through OW-40 indicate that the measured water levels have actually trended downward since pond filling. These factors indicate that the observed wet condition is not due to any reservoir influence.

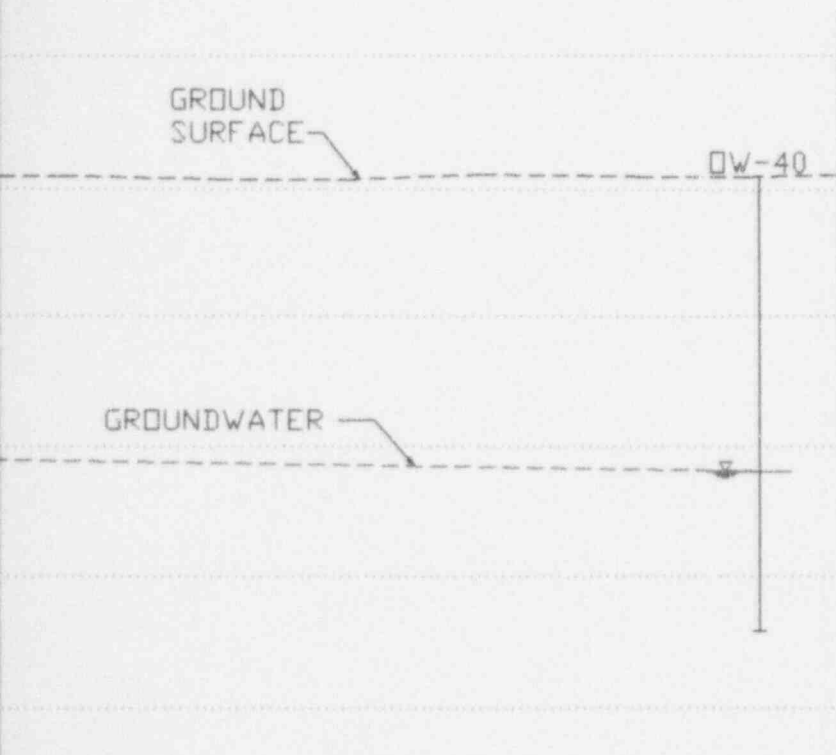
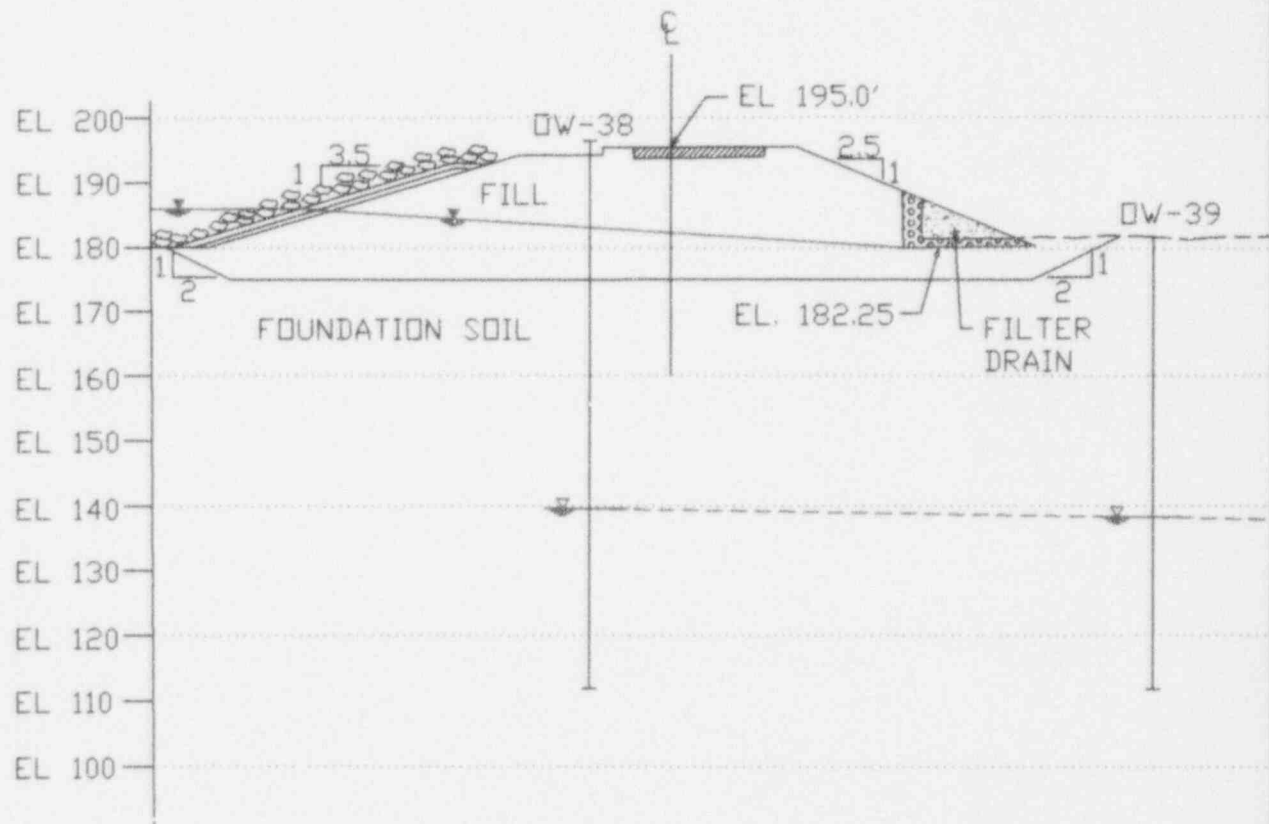
FIGURE 14
SECTION @ STA. 30+25

| Figure | Description |
|---|--|
| 14 | Cross-section of dam at Sta. 30+25 through observation wells OW-39 and 40. |
