Brunswick Nuclear Plant  
July 26, 1994

BRUNSWICK STEAM ELECTRIC PLANT, UNIT NO. 2  
DOCKET NO. 50-324 / LICENSE NO. DPR-62  
RESPONSE TO IE BULLETIN 80-13  
INSPECTION RESULTS OF BRUNSWICK UNIT 2 CORE SPRAY SPARGERS

RELEVANT PORTIONS OF ENGINEERING EVALUATION REPORT (EER) 94-0137

UNIT 2 CORE SPRAY INVESSEL PIPING EVALUATION FOLLOWING IVVI EXAMINATIONS

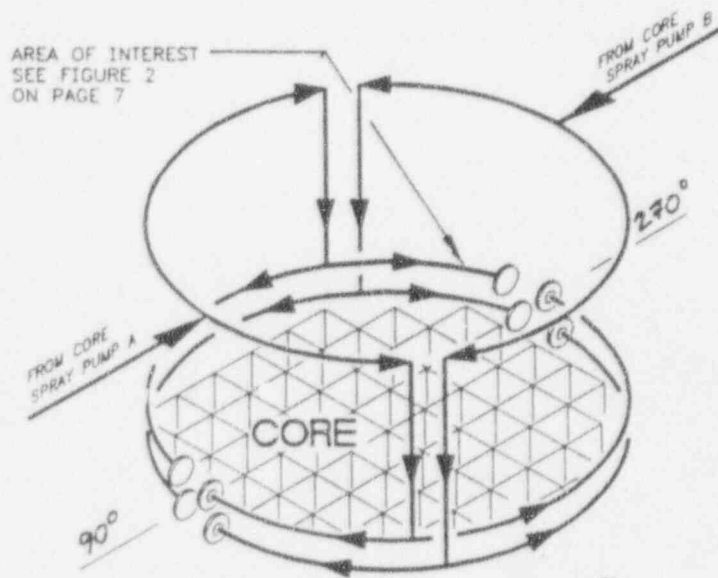
Figure 1 - Internal Core Spray Piping

- 2.1.1 During the performance of PT 90.1 on the A-loop Core Spray spargers a crack was found at a seal weld to flow nozzle coupling, extending radially from the toe of the weld to approximately 1/2" into the sparger base material. The nozzle coupling is the third fitting counter-clockwise from the 240° sparger support bracket. See Figures 1 & 2.

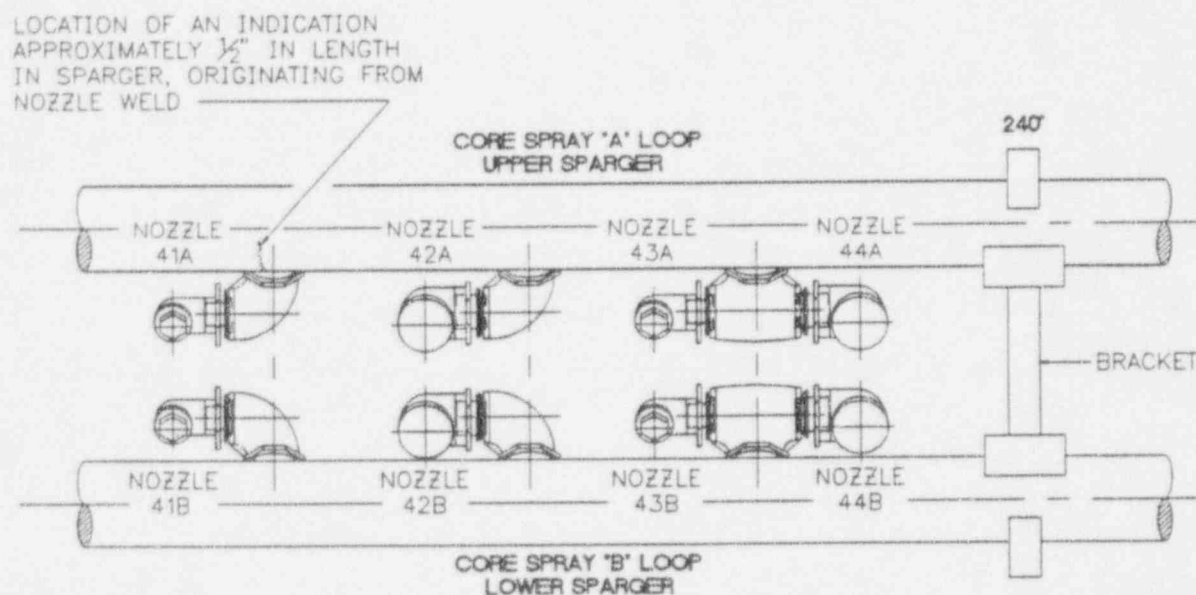
Figure 2 - Location of Linear Indication

- 3.2 For conservatism the crack is assumed to be through wall. The crack does not follow typical IGSCC cracking, i.e., the crack does not follow a circumferential path around the nozzle in the area of the heat affected zone, rather extends radially outward into the base material. The non-typical crack configuration is most likely the result of cold working in the base material during manufacturing of the sparger and the result of IGSCC. Thermal stresses in this part of the core are very low and Irradiation Assisted Stress Corrosion Cracking (IASCC) is not expected to be a contributor in the core spray spargers. An estimate of flux at the I.D. of the shroud wall for different elevations was performed for Unit 1 (Ref. 8). The estimated flux at +353.88" above vessel zero is less than  $1.5 \text{ E } 19 \text{ n/cm}^2$ . The industry accepted IASCC initiation threshold value is  $5.0 \text{ E } 20 \text{ n/cm}^2$  for low stress. Even though Unit 2 fluence is expected to be 25% higher ( $1.875 \text{ E } 19 \text{ n/cm}^2$ ) than Unit 1, the Unit 2 value is well below the threshold value required for IASCC initiation.

- 5.1 Based on previous analyses performed by General Electric Company (GE), the Unit 2 internal core spray piping is acceptable in the as-found condition for the next operating cycle of Unit 2. There is no postulated scenario involving the internal core spray piping that will affect the safe operation of the plant and all design margins for the core spray system will be maintained during the operating cycle.
- 5.2 The condition of the internal core spray piping does not impose any restrictions to plant operation for the next operating cycle.
- 5.3 The core spray piping is routinely examined every refueling outage as part of PT 90.1, therefore the piping/spargers will be reevaluated and/or repaired in Refuel Outage No. 11 (B212R1) based upon the results of the next examination.
