SUBJECT: Calvert Cliffs Nuclear Power Plant
Unit No. 2; Docket No. 50-318; License No. DPR 69
Licensee Event Report 94-003
Reactor Shutdown for Leak From Fatigue Crack in Safety Injection Tank Line

LICENSEE EVENT REPORT (LER)

TITLE (4)
Reactor Shutdown for Leak From Fatigue Crack in Safety Injection Tank Line

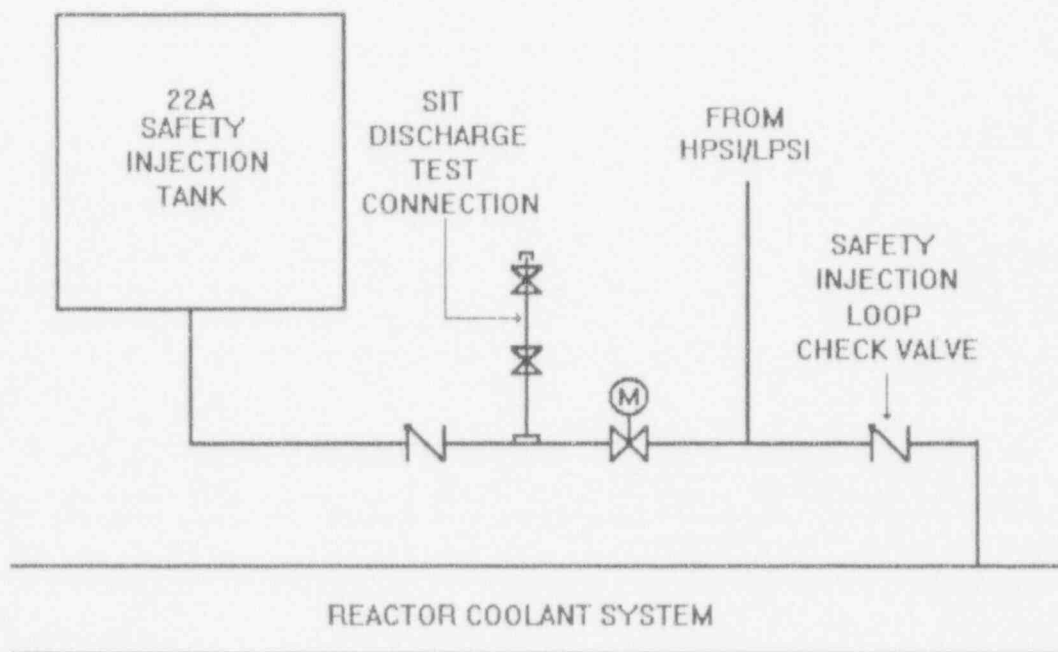
FIGURE 1

The SIT discharge test connection consists of a 3/4 inch segment of austenitic stainless steel schedule 160 pipe running from the SIT discharge line and socket welded to a 3/4 inch to 1 inch reducer attached to a 1 inch globe valve. The crack was located in this socket weld (see Figure 2). The line is isolated from the Reactor Coolant loop by the Safety Injection Loop Check Valve (see Figure 1).

22A SAFETY INJECTION TANK DISCHARGE LINE

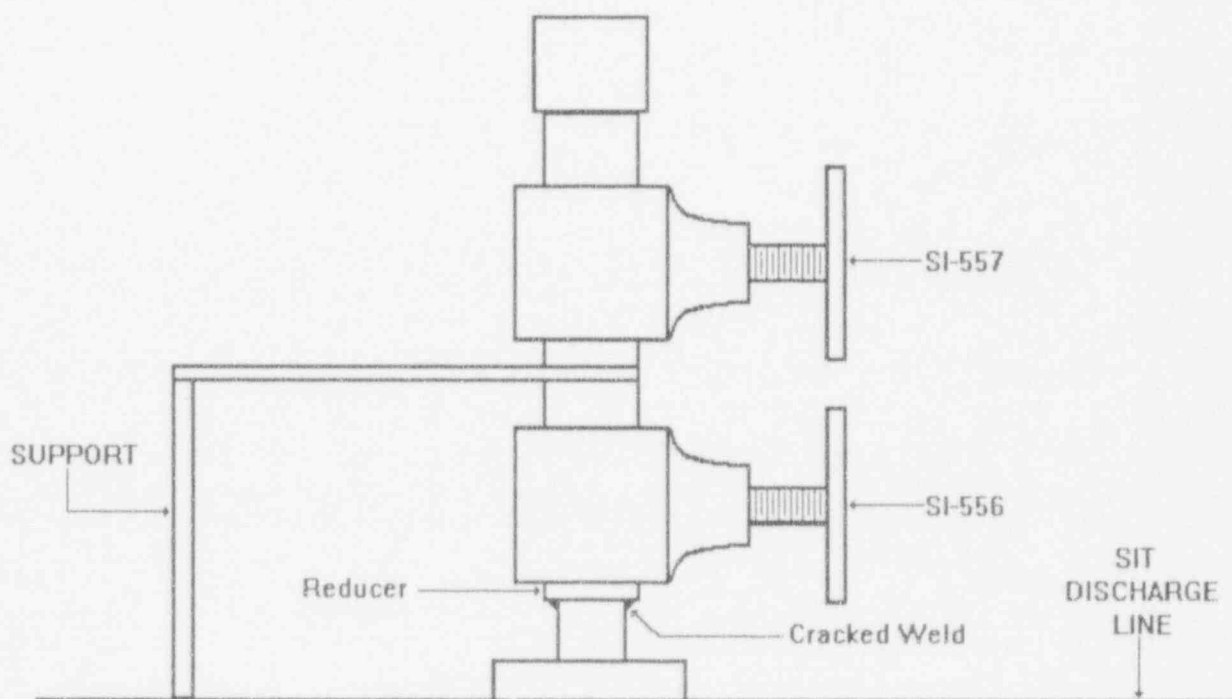
FIGURE 2

Metallurgical analysis of the cracked weld concluded that this was a high cycle fatigue failure. Visual examination of the fracture surface under low power magnification revealed faint clamshell marks indicative of fatigue. Vibration measurements were taken on the 22A SIT discharge test connection and compared to the other three SIT test connections in Unit 2. Vibration levels on the cracked line were 2-3 times higher than those on the similar lines. Engineering analysis indicates that, although the design and installation of the test connection fully met applicable code requirements, the configuration introduced a high potential for harmonic oscillation to occur, coinciding with the excitation frequency of the RCS. This would create a higher driving stress sufficient to account for the high cycle fatigue. Although vibration measurements were taken prior to repair of the test connection, these were not sufficient to confirm or deny harmonic oscillation. The vulnerability of the line to harmonic oscillation was not realized until after the measurements had been taken.

The 22A SIT discharge test connection was removed during the Spring 1993 Unit 2 Refueling Outage to allow for the replacement of the 22A SIT Outlet Check Valve. After the check valve was replaced, the line was rewelded in place. The placement of the support was slightly modified (it was within specified tolerances) at this time. It is suspected that these changes resulted in harmonic oscillation causing high cycle fatigue failure.

22A SAFETY INJECTION TANK DISCHARGE TEST CONNECTION

- A. The support for 22A SIT discharge test connection was redesigned and installed to reduce levels of vibration to an acceptable level.

Measurements following the modification confirmed that vibration was reduced and verified not to be in the harmonic region.
