Subject: Beaver Valley Power Station, Unit No. 1
Docket No. 50-334, License No. DPR-66
Request for Relief for a Non-Code
Repair on River Water Pipe 18"WR-16-151-Q3

DUQUESNE LIGHT COMPANY
Nuclear Power Division
Beaver Valley Power Station Unit No. 1

Request for Relief for a Non-Code Repair
on River Water Pipe 18"WR-16-151-Q3

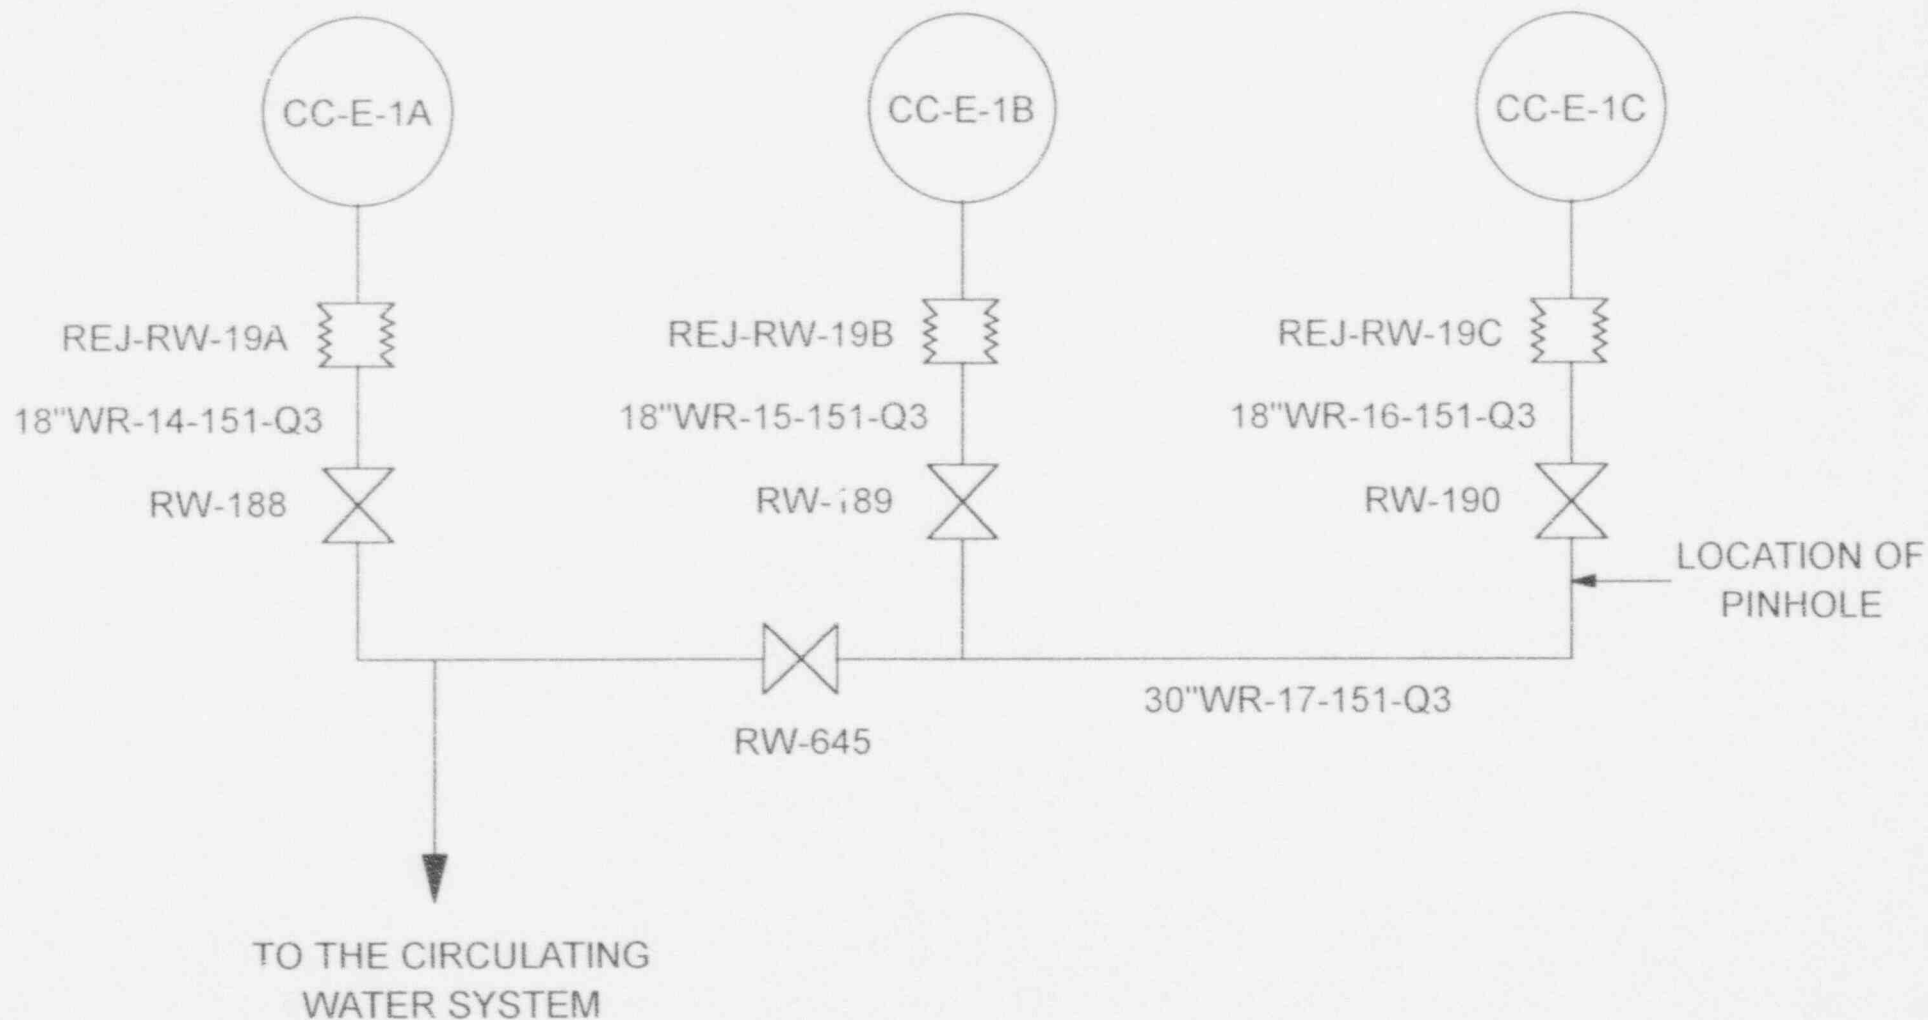
Figure 1
Simplified Drawing of River Water Discharge Piping
from the Component Cooling Water Heat Exchangers

The UT examinations showed a localized area of wall erosion downstream of RW-190. The cause of the erosion is theorized to be from cavitation occurring due to the throttling of RW-190 when CC-E-1C is in service.

Augmented UT examinations of the other locations most susceptible to the specific erosion mechanism identified were performed. These locations are downstream of RW-188 and RW-189 (See Figure 1). The UT examination of 18"WR-14-151-Q3 downstream of RW-188 did not identify any areas with a wall thickness below 0.348". The UT examination of 18"WR-15-151-Q3 downstream of RW-189 also identified a localized area of erosion. However, no areas were found with a wall thickness below the code required minimum thickness of 0.051".

Weekly UT examinations will be performed on the areas experiencing significant pipe wall erosion on 18"WR-15-151-Q3 and 18"WR-16-151-Q3. A UT examination of 18"WR-14-151-Q3 will be performed monthly. These UT examinations will continue until the piping is repaired in accordance with code requirements. The results of the periodic UT examinations will be evaluated to ensure that the piping is acceptable for continued service.
