Update Report:
Previous Report Date: 2-21-83

Facility: Unit No. 1

Event Date: January 23, 1983

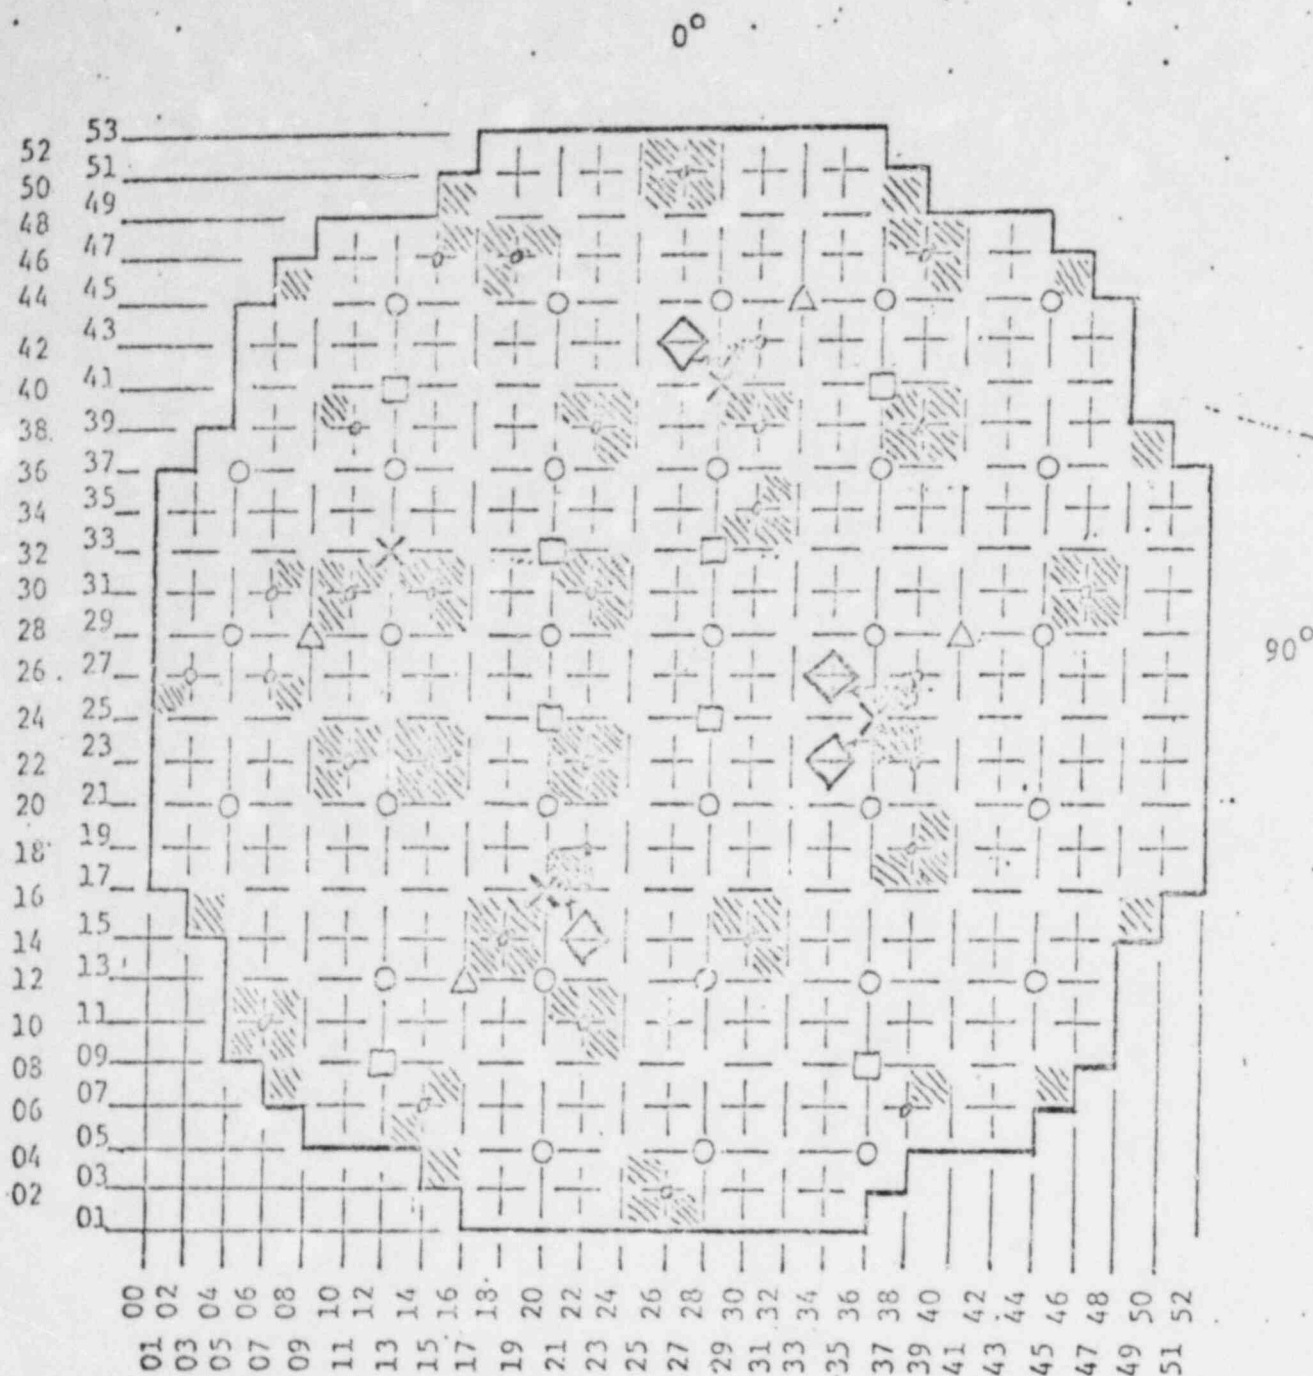
Figure 1 Core Arrangement (Top View) on 1-23-83

0 2 | While performing routine surveillance during an extended refueling outage, the control
0 3 | operator noticed that one fuel bundle was located around each of the following with-
0 4 | drawn control rods: 22-15, 34-23, 34-27, and 26-43. This event did not affect the
0 5 | health or safety of the public.
0 6 |
0 7 |
0 8 | Technical Specifications 3.9.10.2, 6.9.1.9b

The fuel handling procedure being used (FH-11) did not clearly define responsibility to ensure that control rods were inserted prior to fuel movement. The Brunswick Technical Specifications allow fuel movement with rods withdrawn in certain conditions (3.9.10.1 and 3.9.10.2). The Nuclear Engineer believed that the prerequisite Operations group sign-offs on Section K of GP-01 provided the required controls while the Operations personnel believed the fuel movement sheets generated by the Nuclear Engineer provided the controls.

NOTE: Arrows denote locations where fuel assemblies were moved to cells with control rods withdrawn.

The withdrawn control rods around which the four fuel bundles were placed were inserted within one hour. The delay in inserting these rods occurred because they were under clearance when the problem was identified. A verification was also performed on core fuel location and that all control rods with fuel in their cells were inserted.

1. Fuel will not be moved with any control rod withdrawn.
2. Require positive verification of control rod insertion prior to loading fuel into a cell.
3. Require the core status board not only reflect fuel location status, but also control rod blade status
4. Require that the movement sheets specify all core alterations and require SRO concurrence.
5. Provide specific instructions on the preparation of fuel movement sheets to ensure technical specification requirements and independent verification requirements are met.
