FLORIDA POWER CORPORATION
CRYSTAL RIVER UNIT 3
TENDON SURVEILLANCE PROGRAM

ENGINEERING EVALUATION REPORT
FOR THE
FIFTH TENDON SURVEILLANCE
INSPECTION PERIOD

Report Date: 20 JUNE 1994

Gilbert/Commonwealth
Reading, Pa.

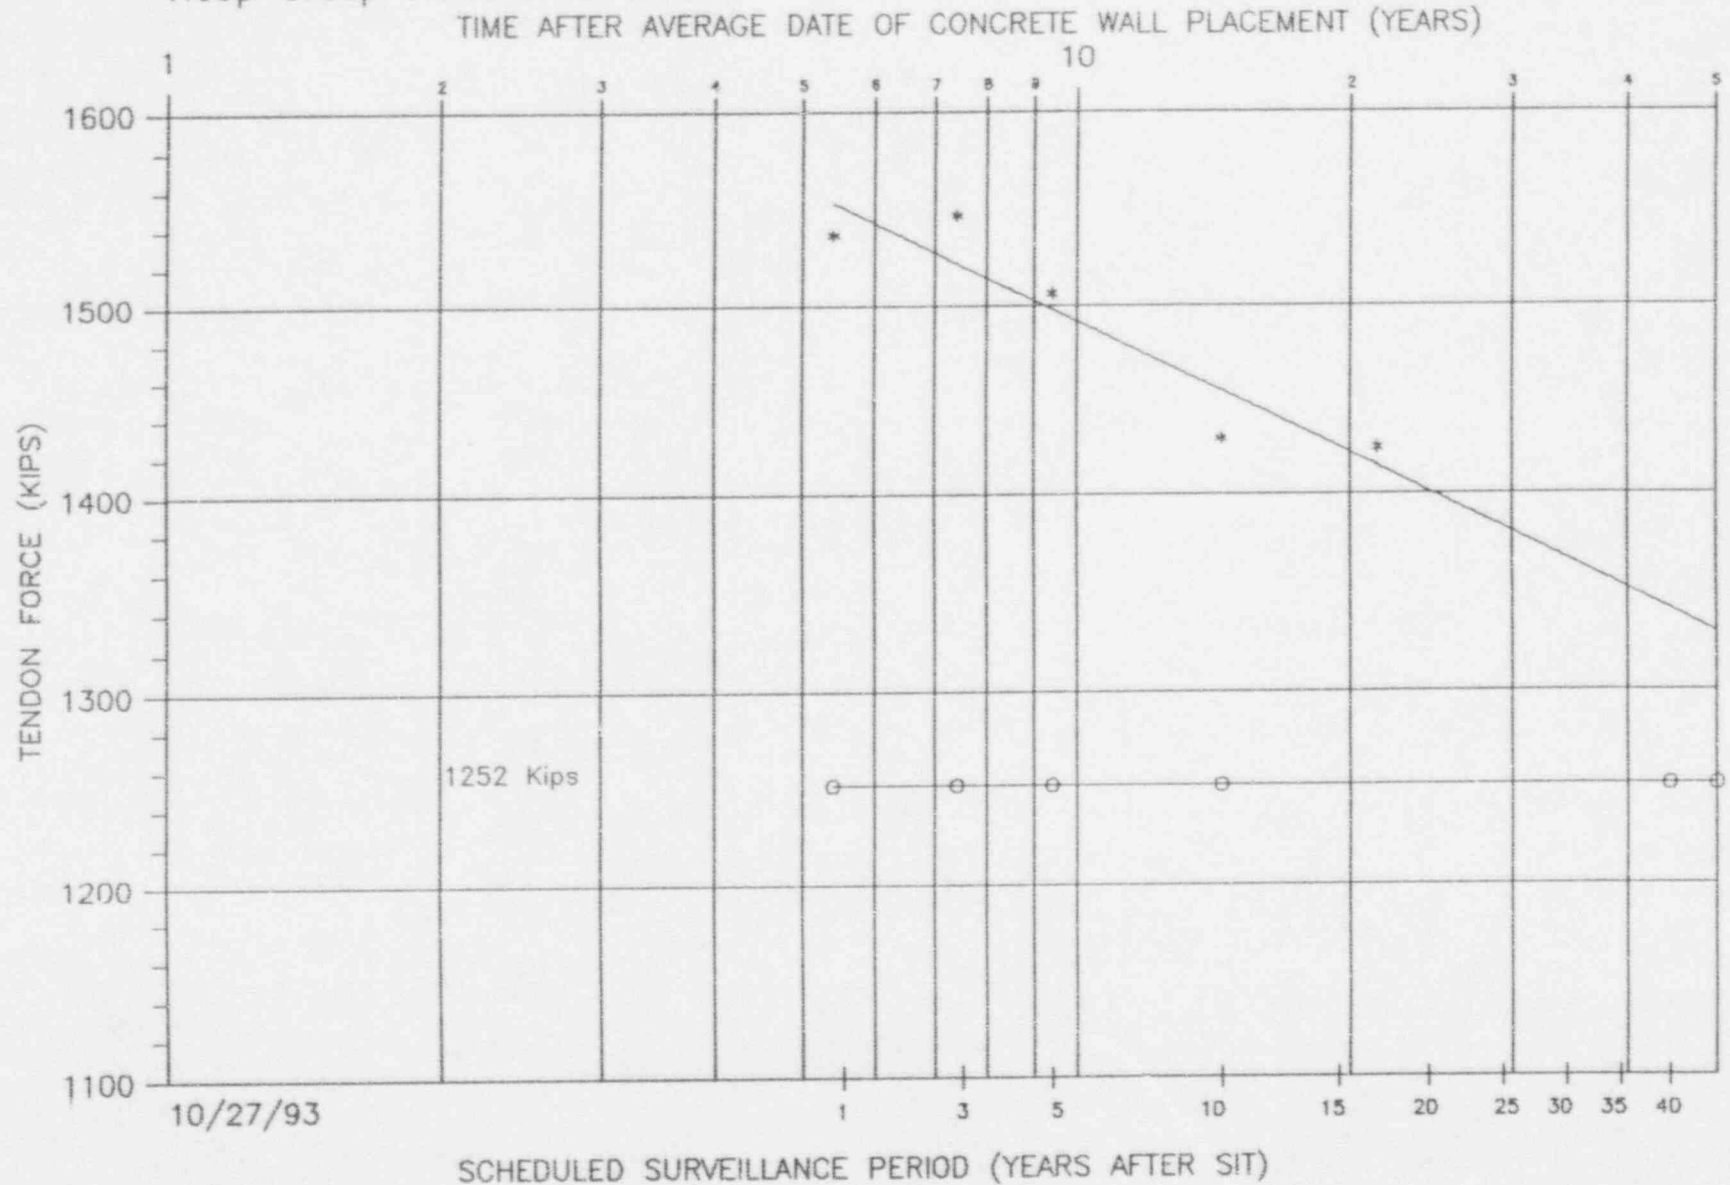
FIGURE 6.2

Figure 6.2 shows the plot of the regression line representing the overall trend of losses for the hoop tendons since the first surveillance. The data points have good correlation and the projected trend line at the end of the forty year plant life is above the minimum required prestress level of 1252 kips. The low prestress condition of two hoop tendons is reflected in the average for the current surveillance, and is therefore accounted for in this projection.
