Investigation of Shell Cracking on the Steam Generators at Indian Point Unit No. 3

Prepared by C. J. Czajkowski

Brookhaven National Laboratory

Prepared for
U.S. Nuclear Regulatory
Commission

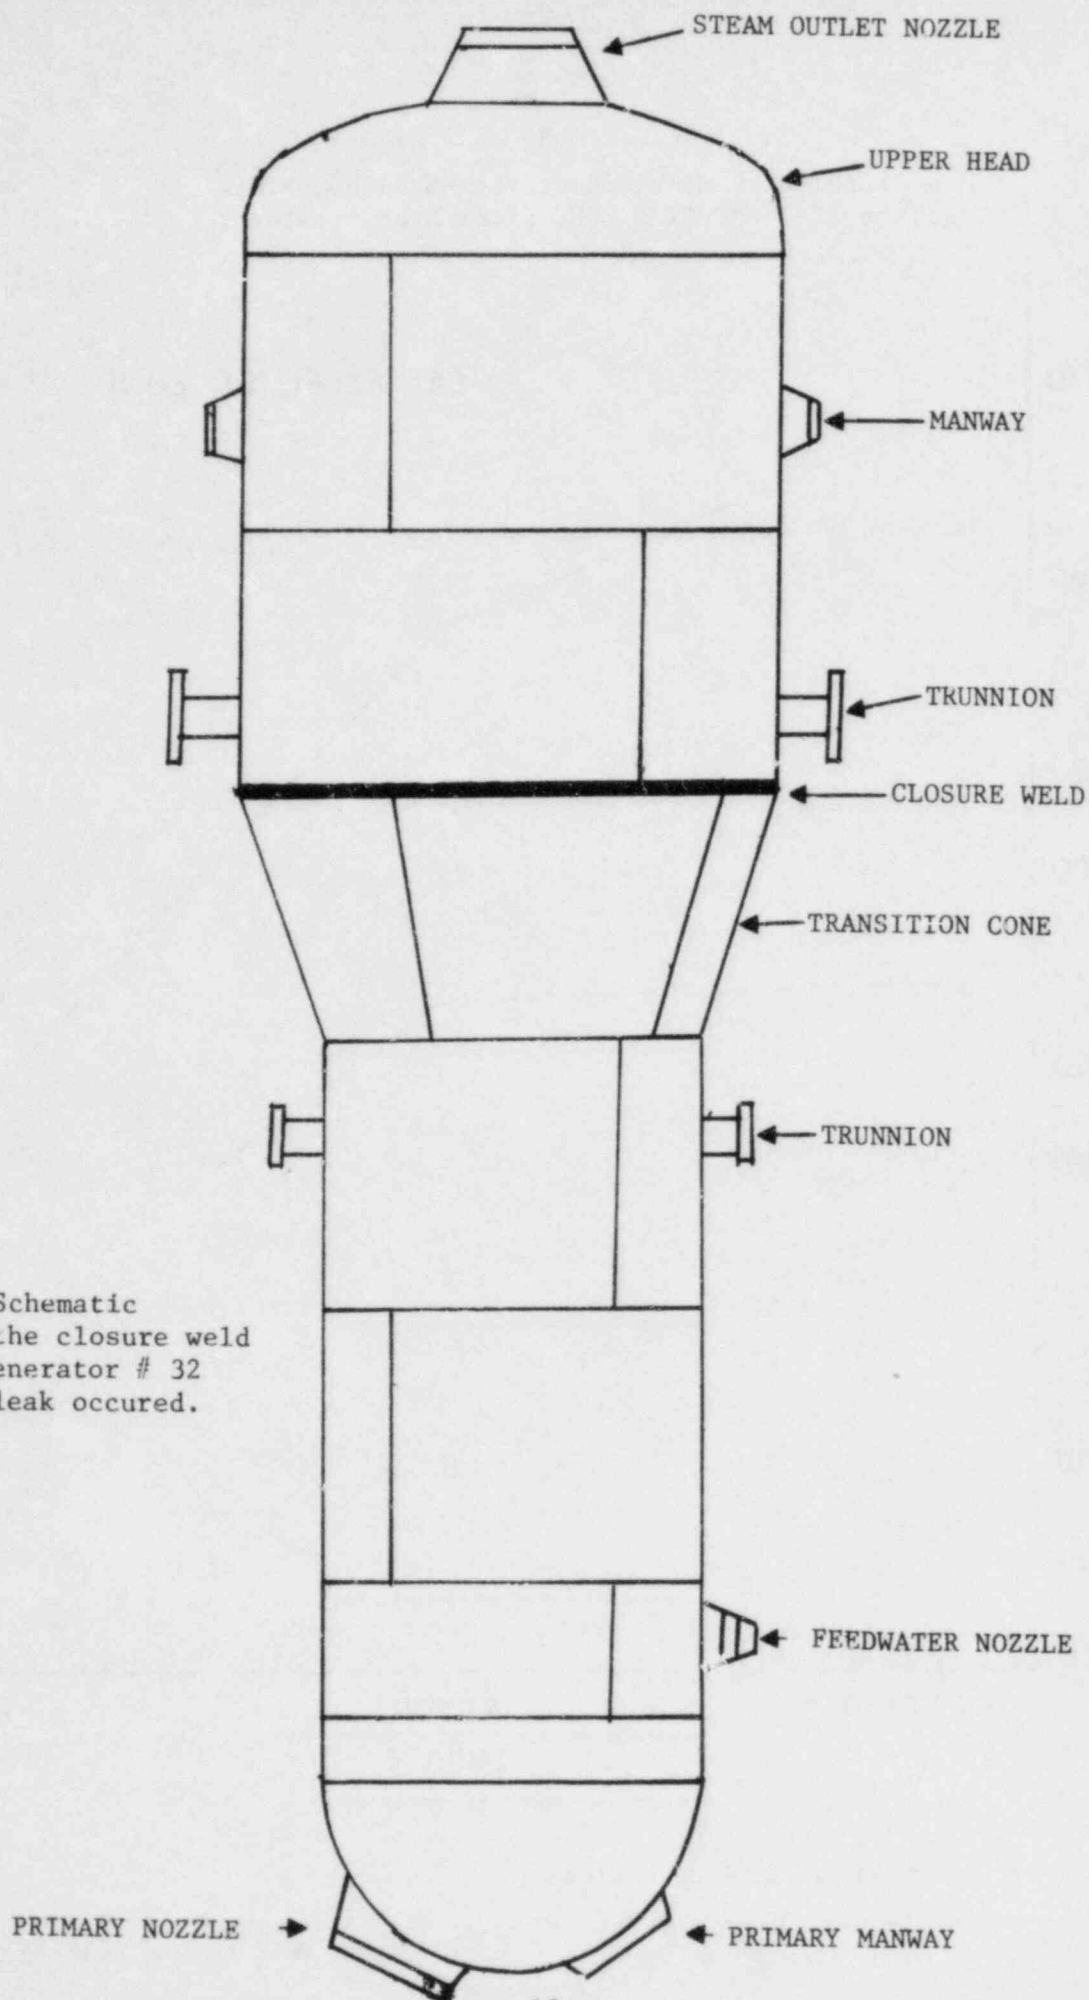
On March 27, 1982, during a refueling outage (with the reactor in a cold shutdown condition), a small leak was detected on the shell side of steam generator #32 at the Indian Point-3 Nuclear Power Plant. Further examination of steam generator #32 disclosed that the detected leak originated in the circumferential weld joining the transition cone to the upper shell (closure weld) of the steam generator (Figure 1).

Figure 1. Schematic depicting the closure weld of Steam Generator # 32 where the leak occurred.

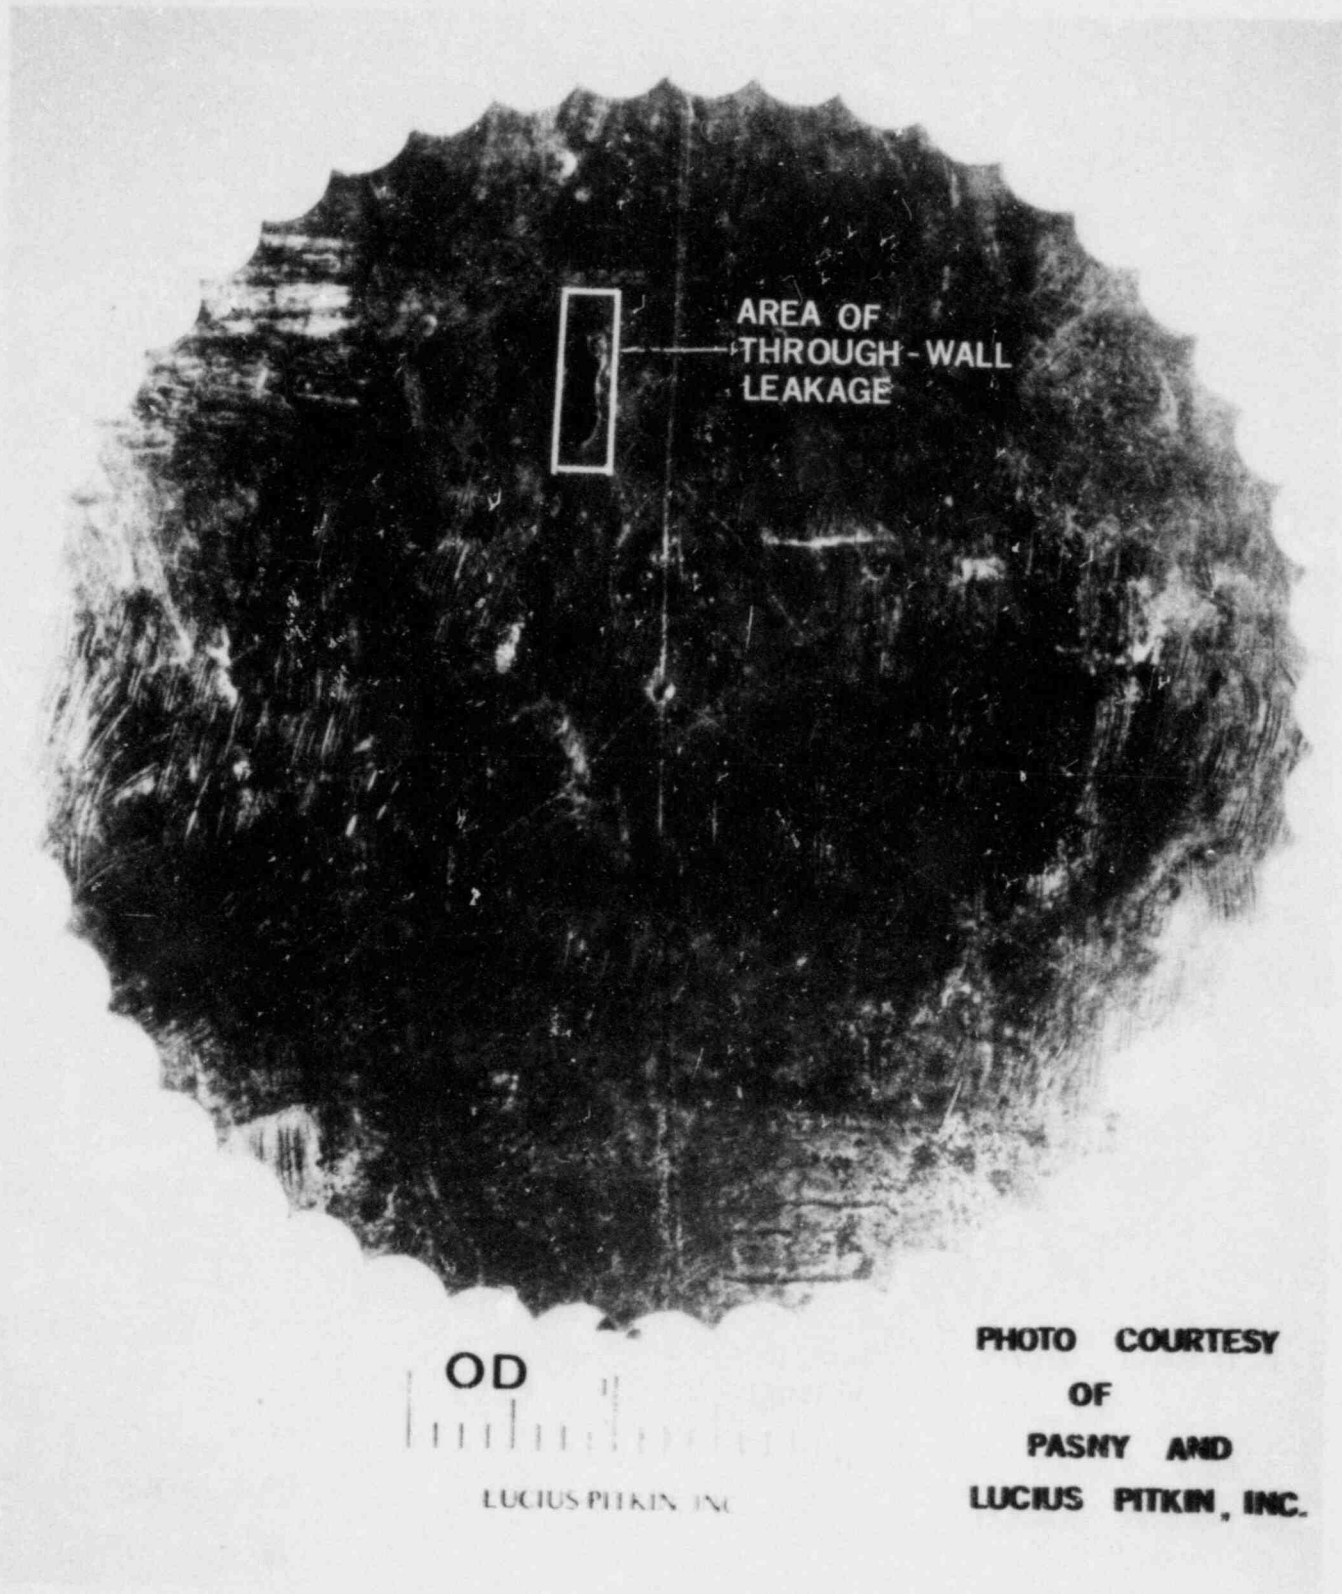
Closer examination of the area of the leak disclosed a hole on the outer surface of steam generator #32 approximately 16 mm long by 5 mm wide (Figure 2). The owner of Indian Point-3, Power Authority of the State of New York (PASNY), then instituted a nondestructive testing program consisting of visual inspection, ultrasonic examination, and magnetic particle examination of the affected welds. These examinations disclosed that the closure weld on each of the steam generators had in excess of 100 cracks associated with them, although the only through-crack was the "leaker" in steam generator #32. A significant amount of pitting (Figure 3) was also associated with the closure welds of the steam generator inside surfaces.

Figure 2. Photograph of 6" plug removed
from steam generator #32
showing the through wall "leaker"

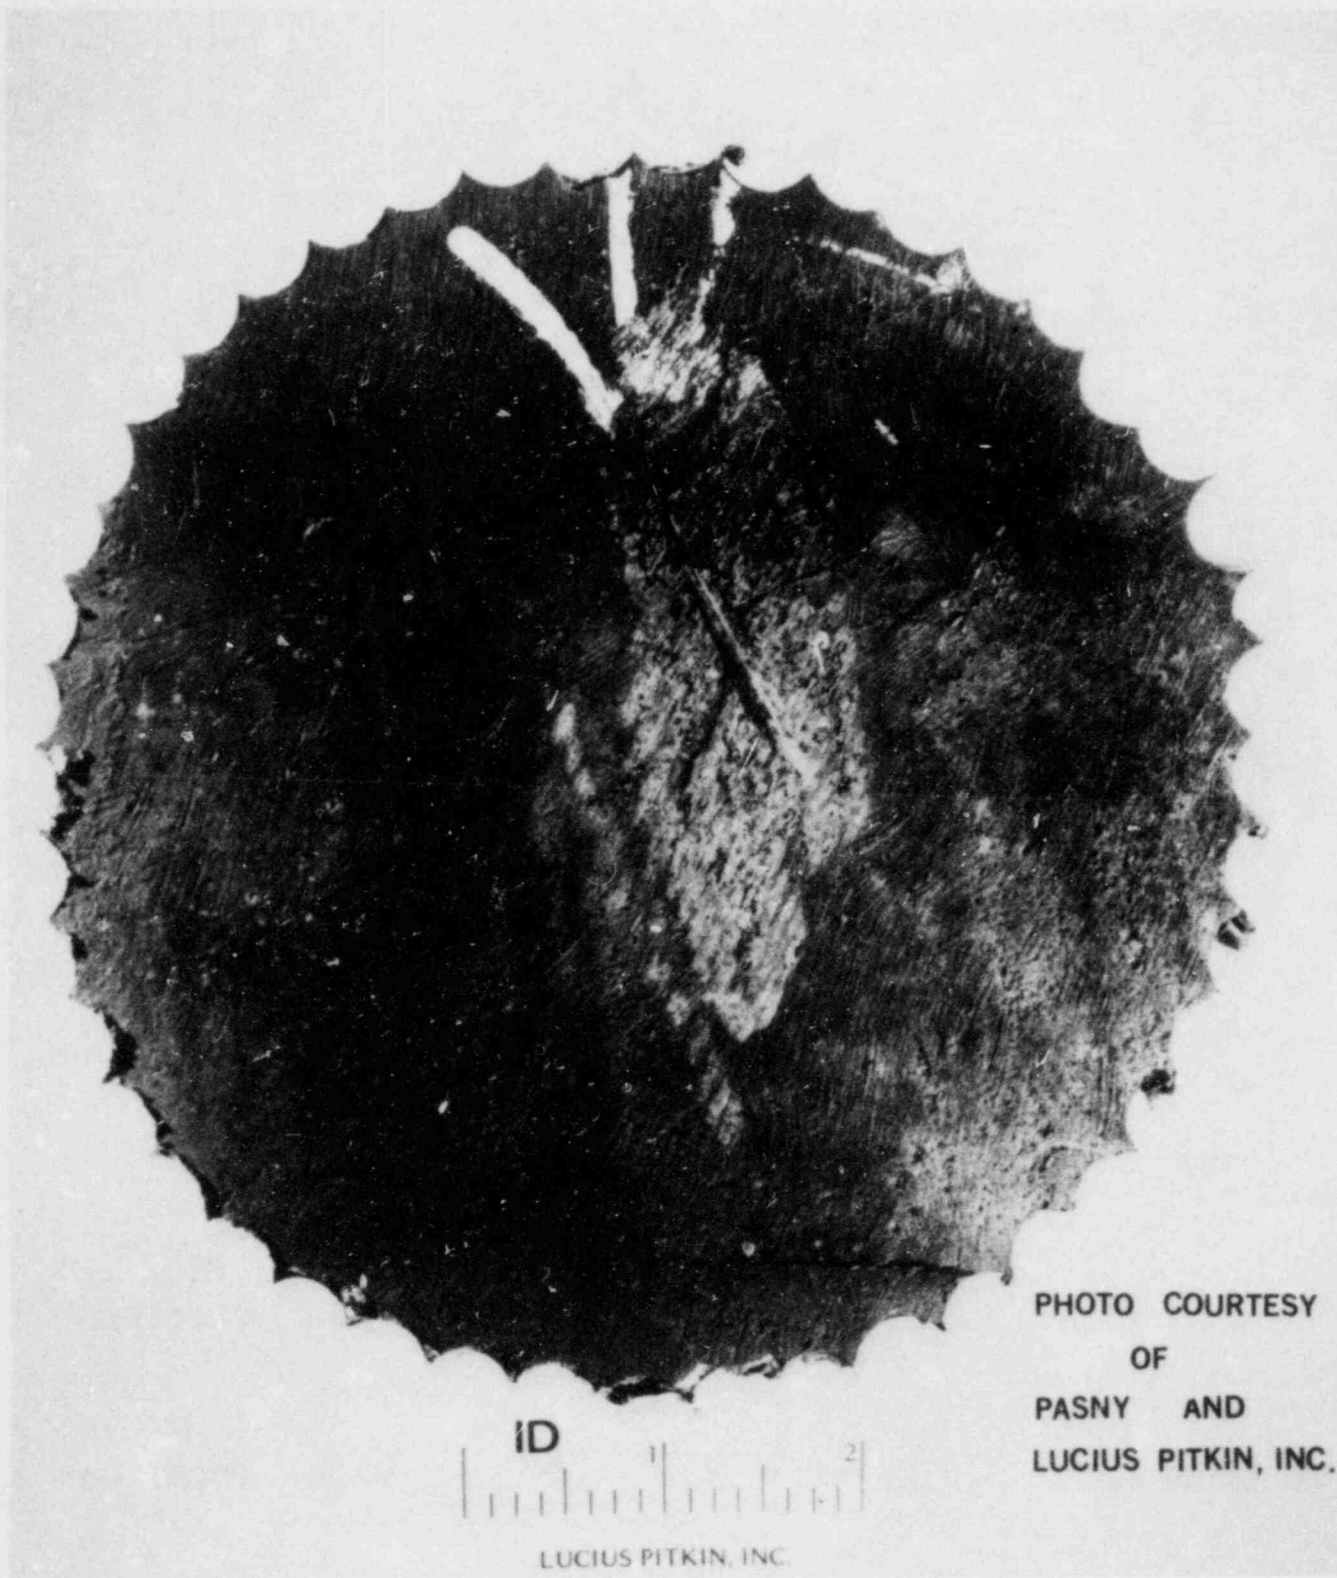
Figure 3. Photograph of the inside surface of steam generator #32 showing cracks and evidence of pitting.

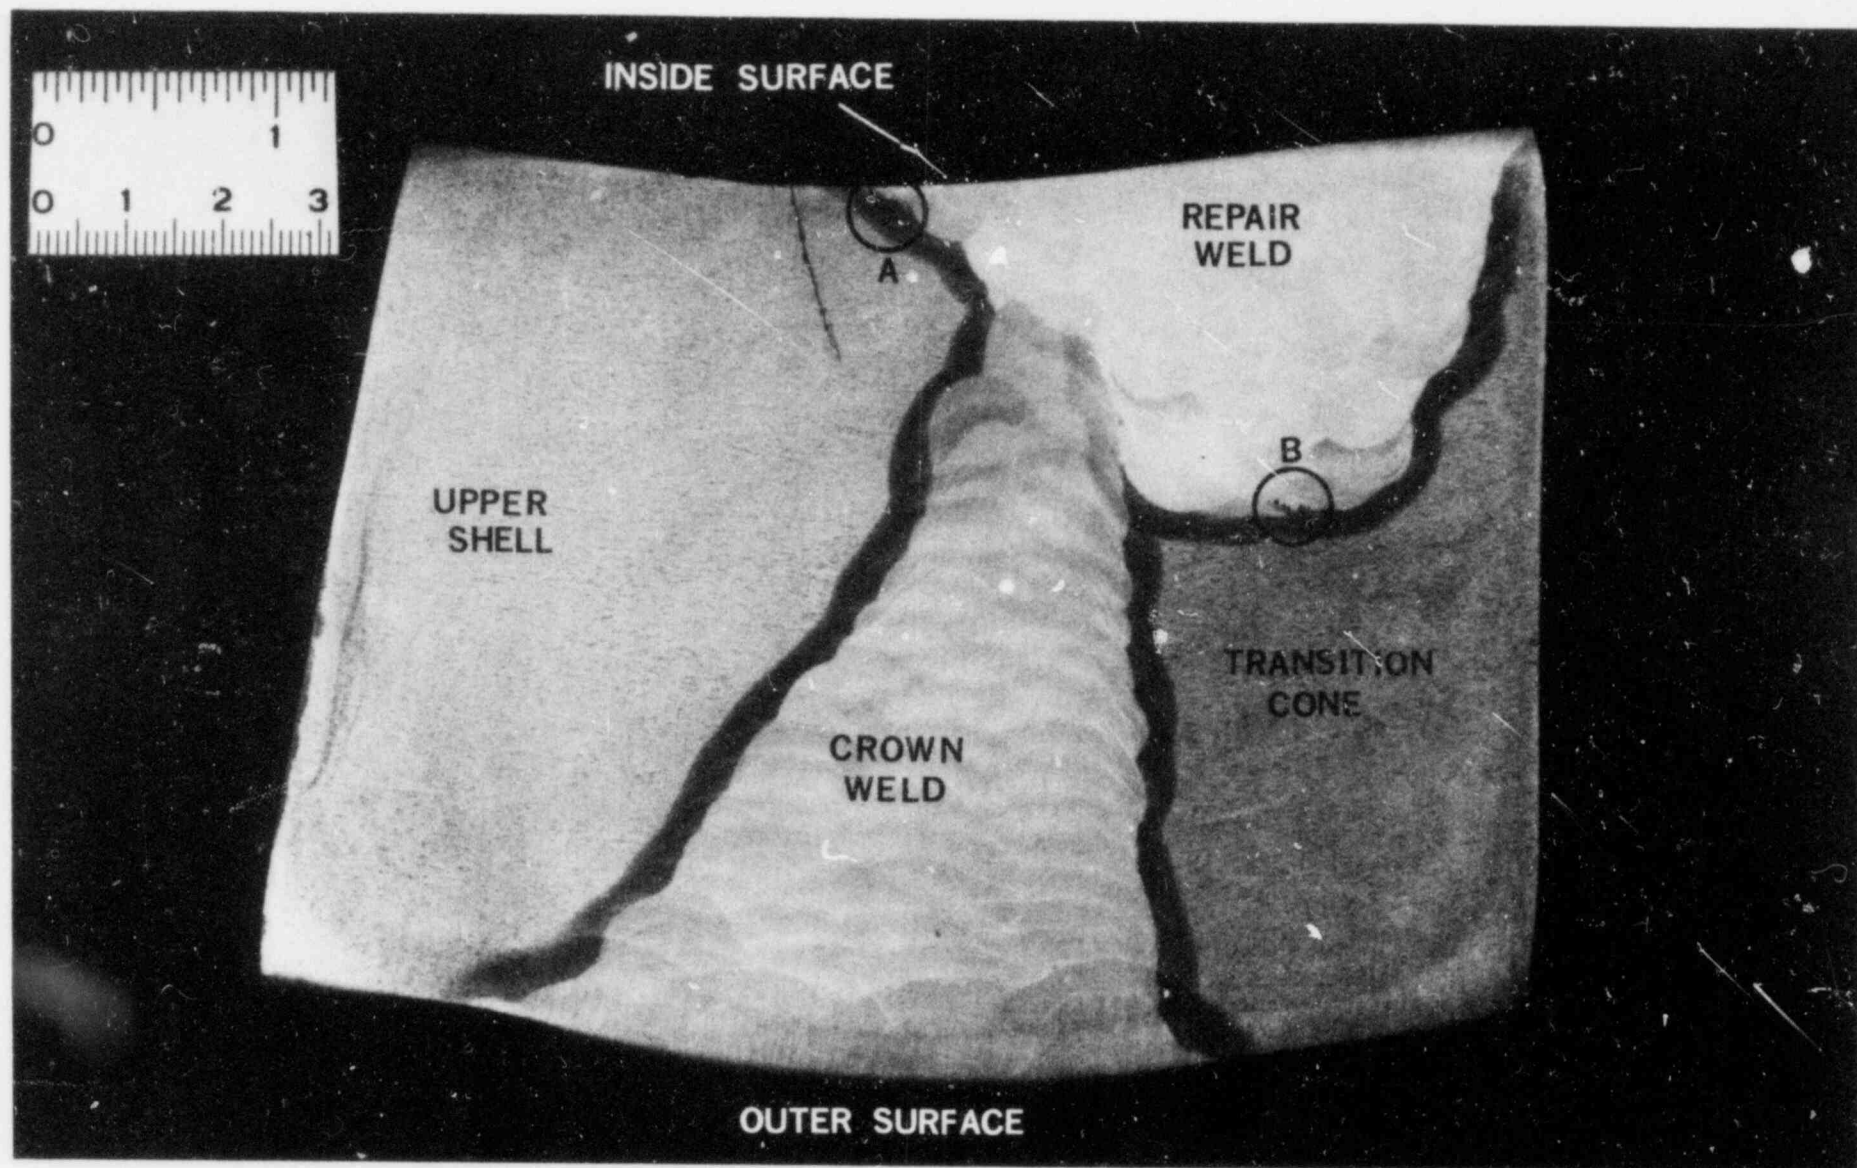
Figure 4 is a section of the 6" plug removed from steam generator #32. It is cut vertically, relative to the steam generator weld. The section was etched for one minute using a 10% ammonium persulfate + water etch. The multiple weld passes of the crown weld are clearly seen, as well as a large area of repair weld at the inside surface. A crack approximately 20 mm in length is visible on the upper shell side of the weld 6 mm away from the repair weld heat affected zone (HAZ). Circled section A in Figure 4 is an area of lack of fusion (higher magnification micrographs are in optical microscopy section) which did not appear to propagate. Area B is an area of porosity which is related to the original repair welding of the steam generator vessel.

Figure 4. Photograph of a cross-section of the 6" plug after etching. Evident in the photograph is the relative position of the crack to the weld. Additional areas of interest include Area A- a region of lack of fusion and Area B- a region of porosity.

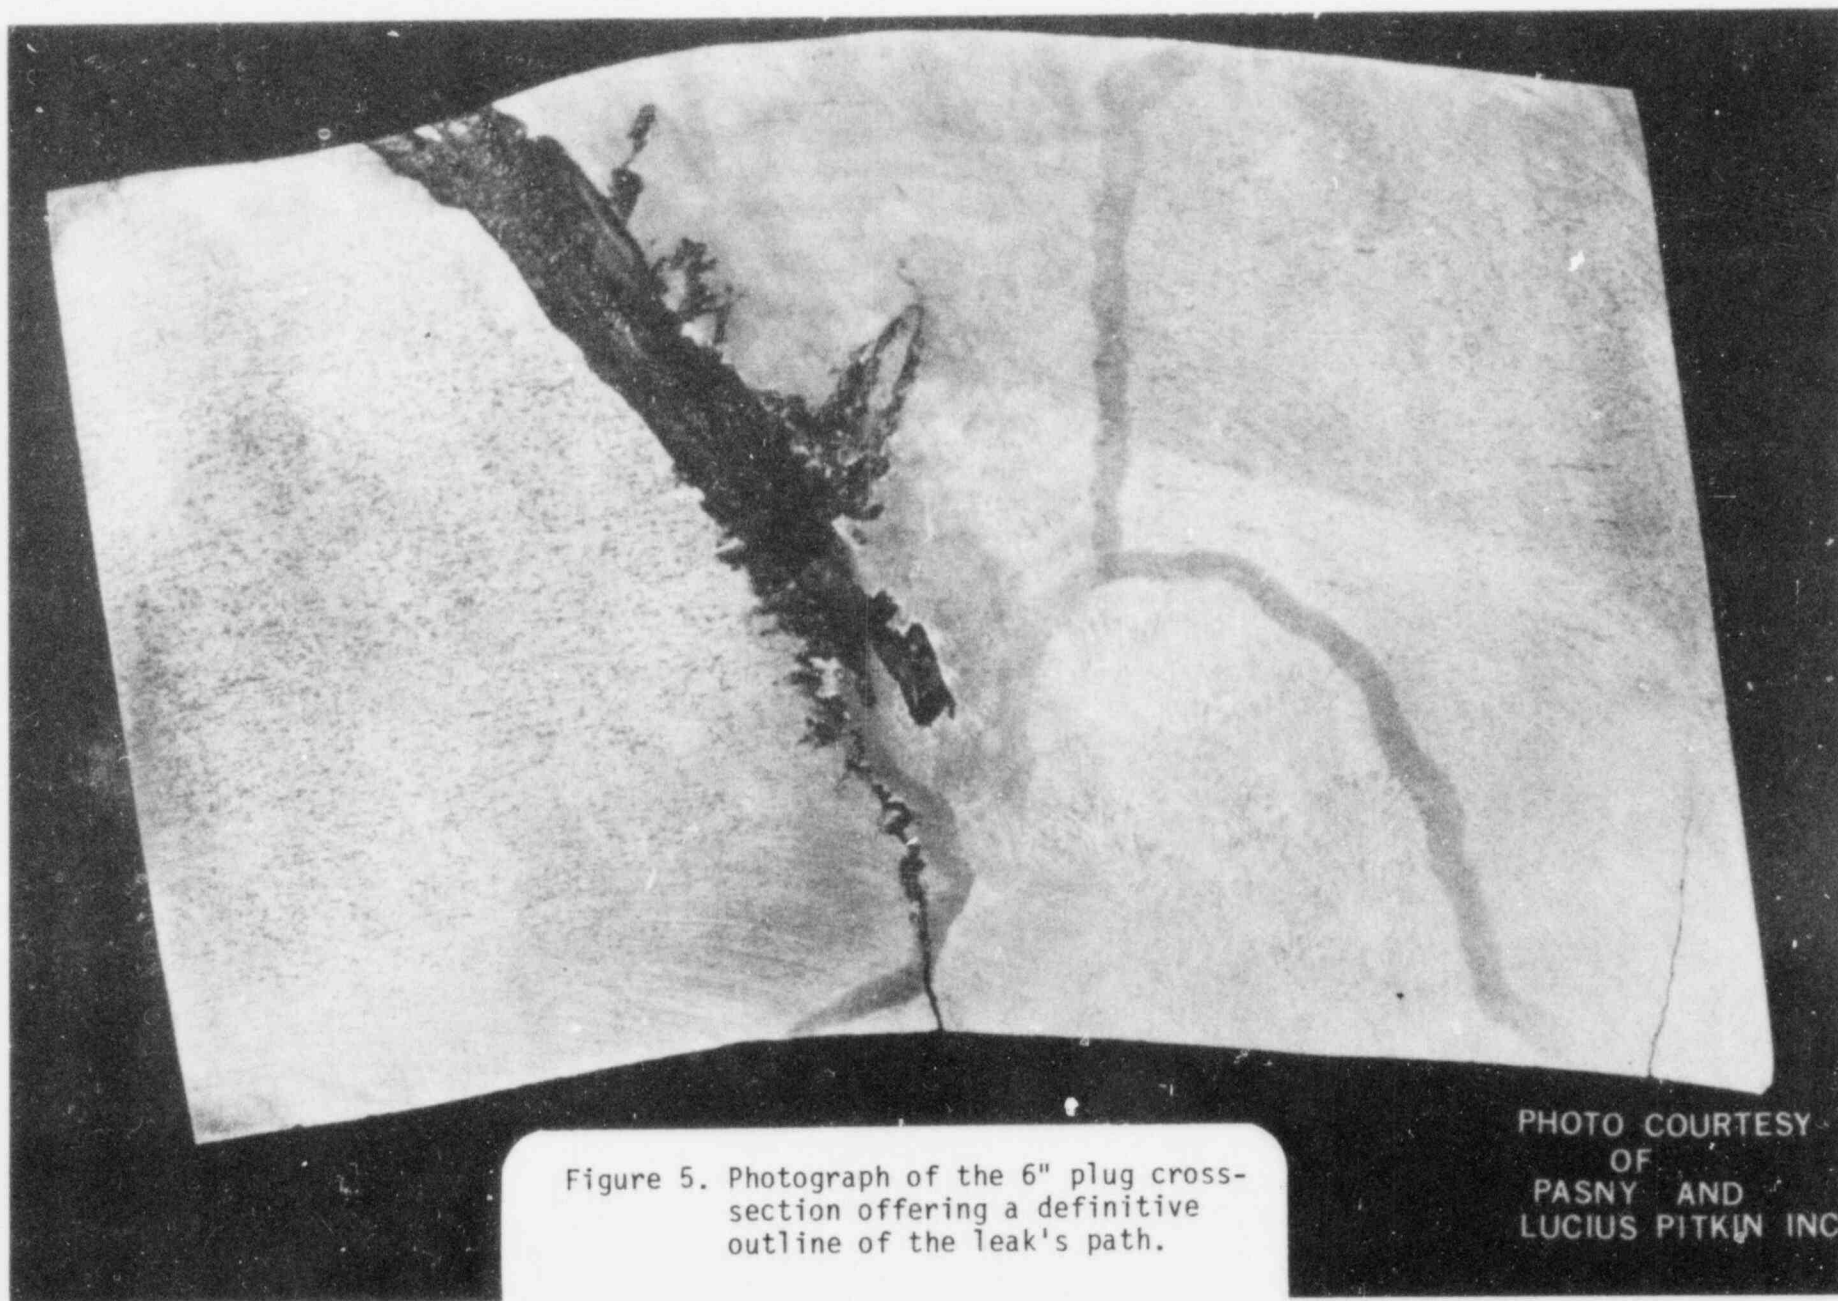
The actual path of the through wall "leaker" seemingly followed the weld heat affected zone and is clearly defined in Figure 5. The broadening of the crack near the outside surface of the steam generator is most probably the result of a steam channel erosion effect after the crack had breached the outer surface.

Figure 5. Photograph of the 6" plug cross-section offering a definitive outline of the leak's path.

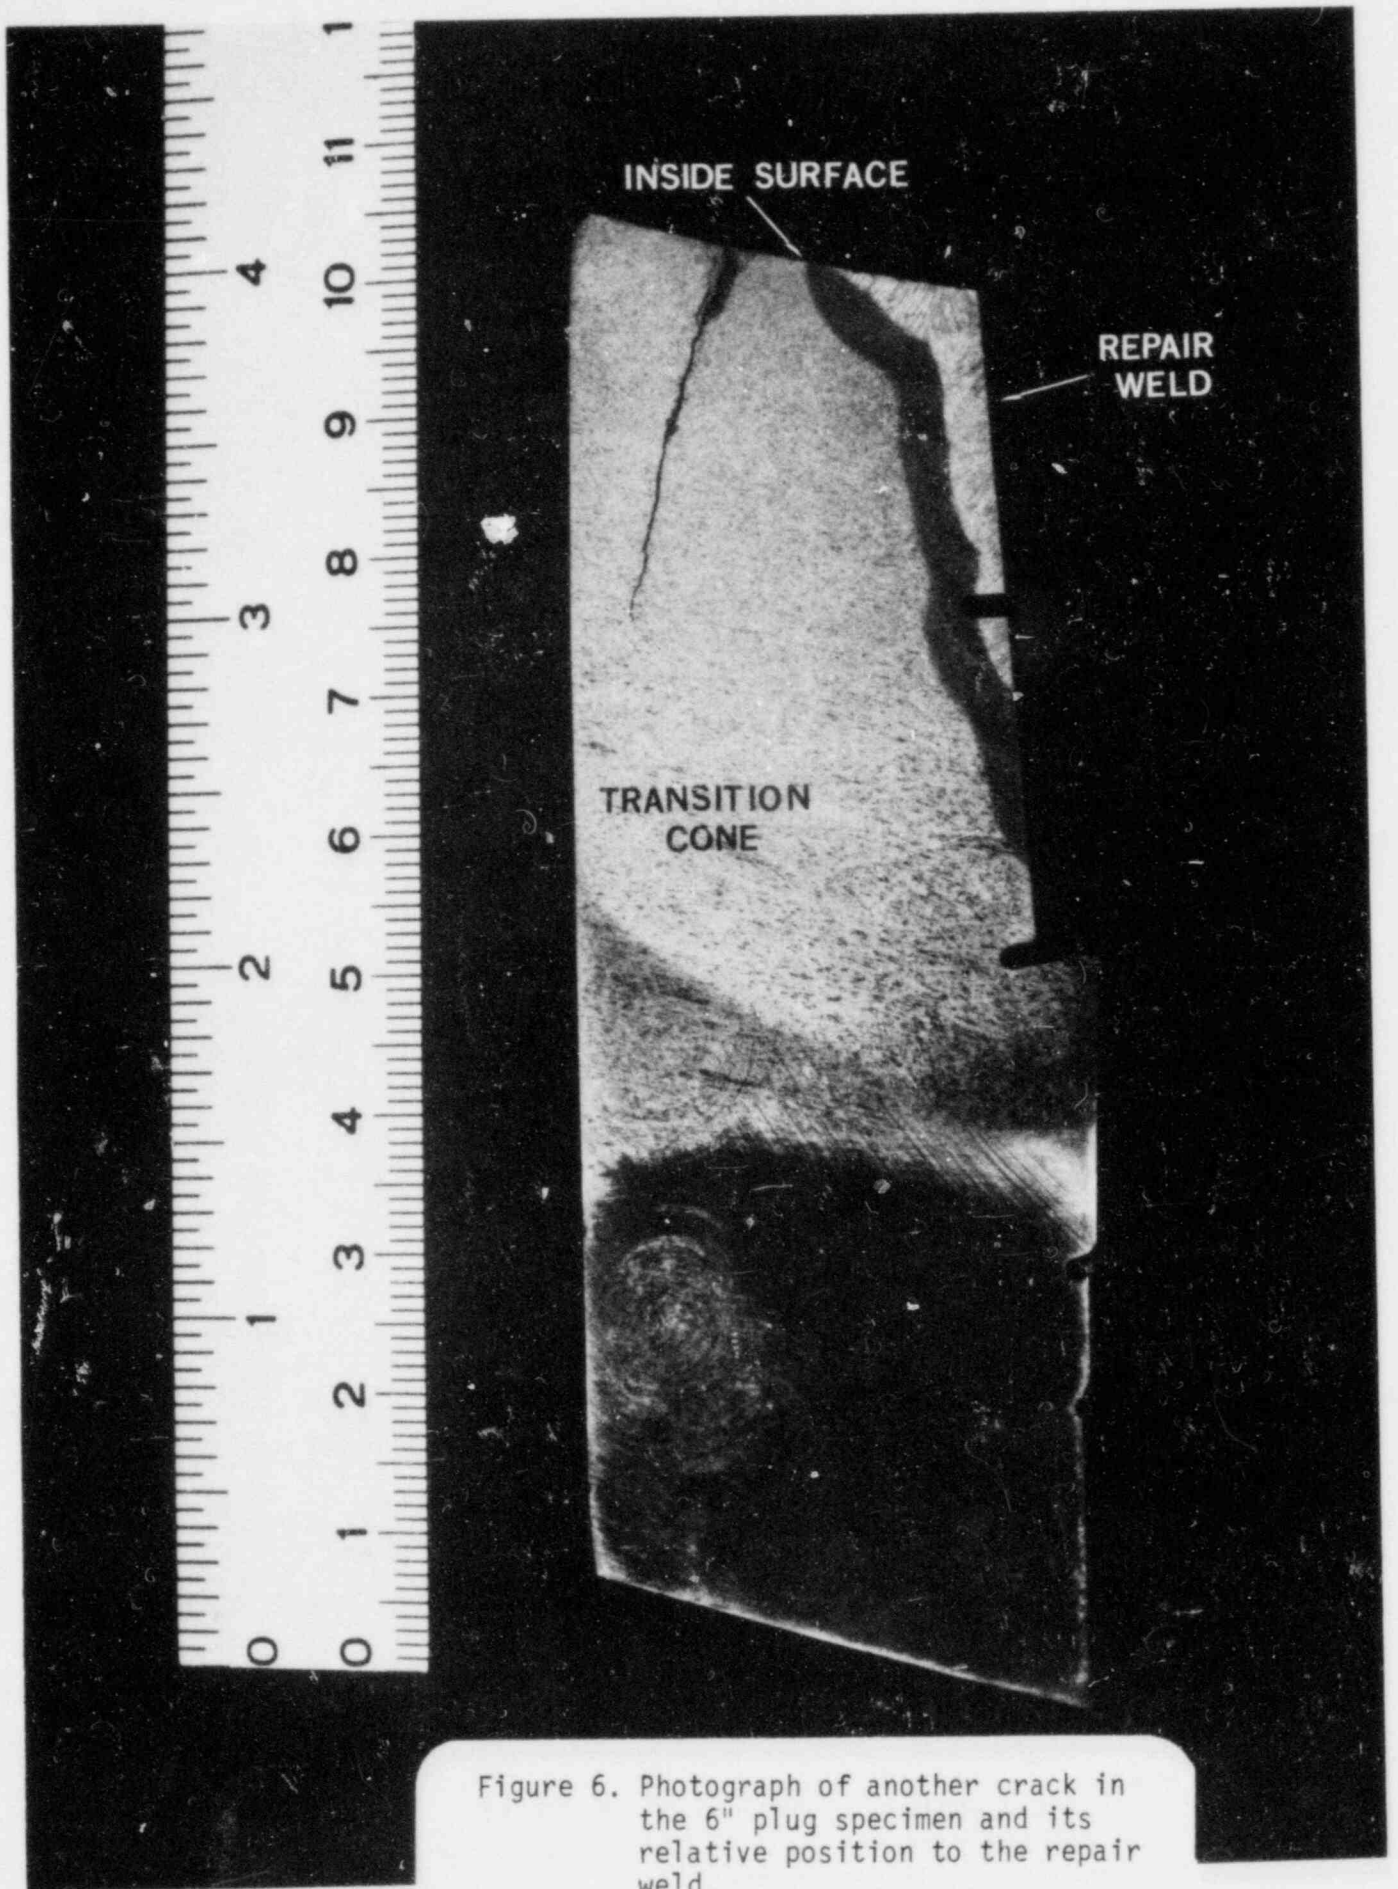
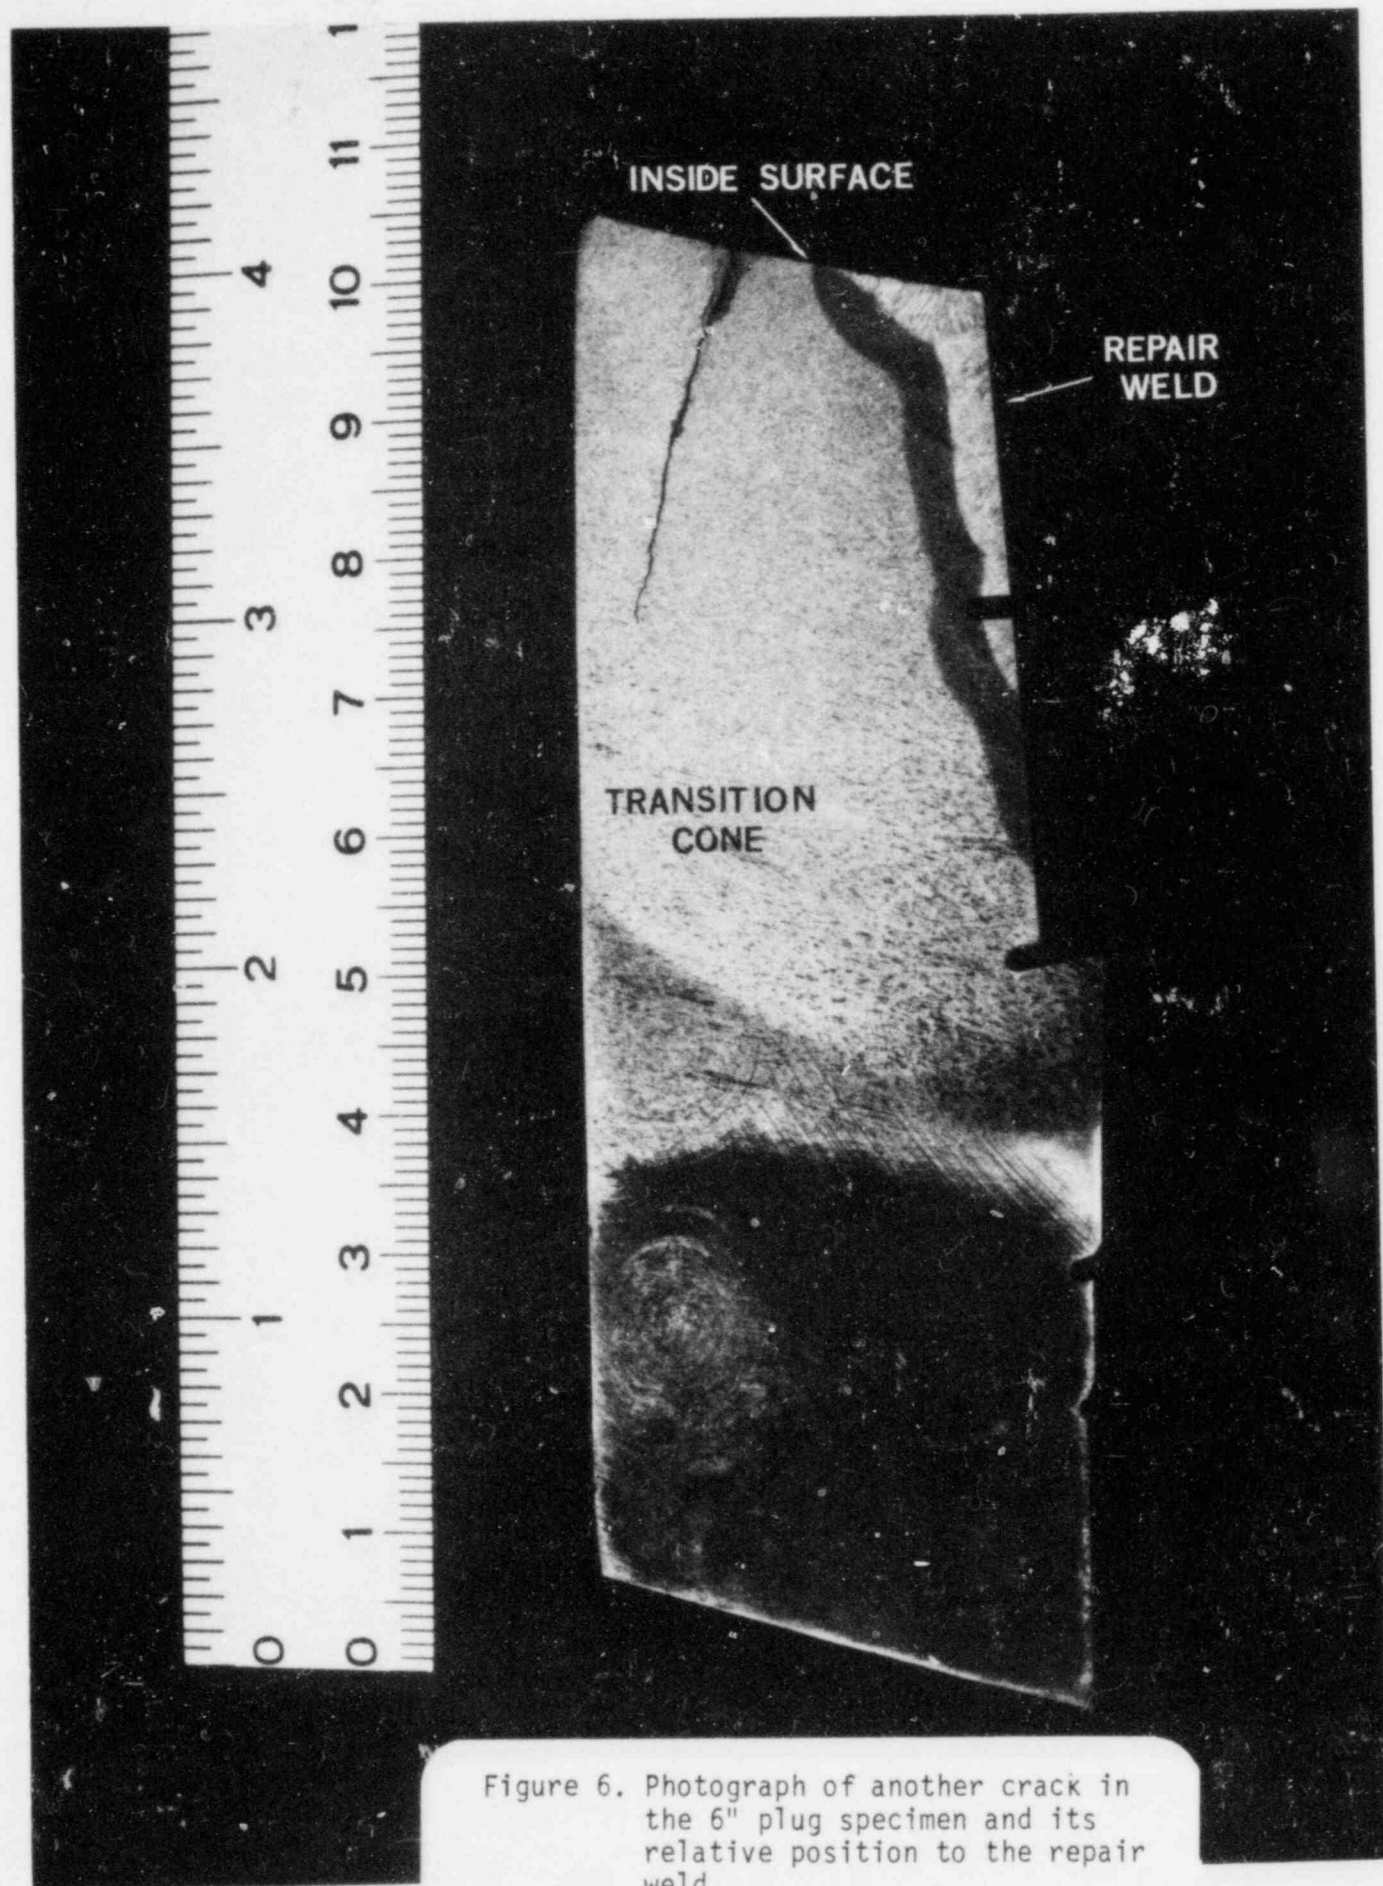
Figure 6 is a macrophotograph of another specimen received from Lucius Pitkin depicting the relative location of another crack to the repair weld area.

Figure 6. Photograph of another crack in the 6" plug specimen and its relative position to the repair weld.

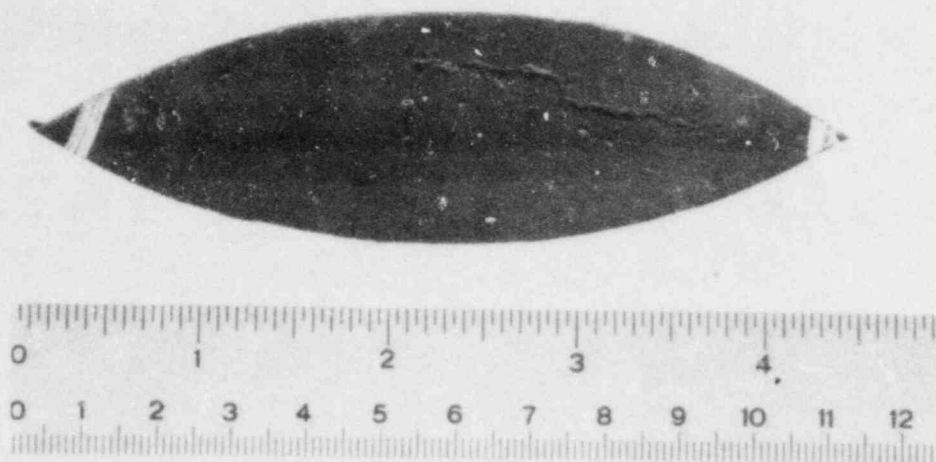
All three of the boat samples received from PASNY (Figures 7, 8 and 9) showed evidence of pitting on the inside surface of the steam generator, especially in the case of MT indications 44 and 46, whose cracks appeared as an array of pits following the crack outline.

Figure 7. Photograph of the top side
(inside surface) of the boat
sample MT #44 .

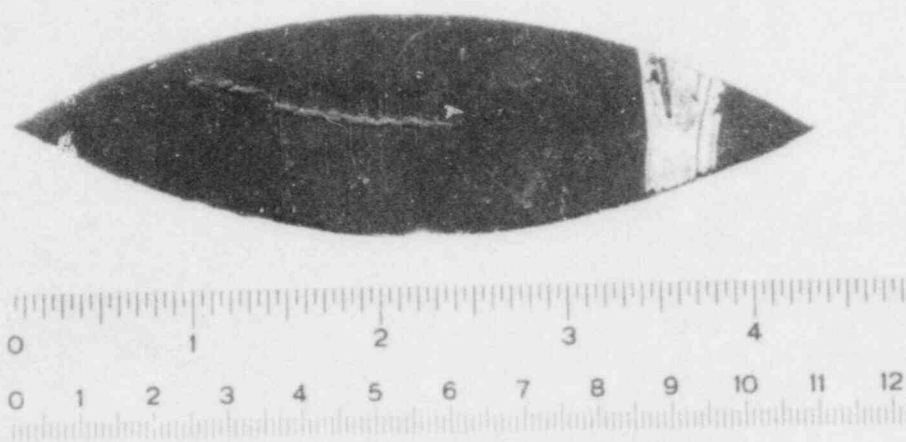
Figure 8. Photograph of the top side of
boat sample MT #46.

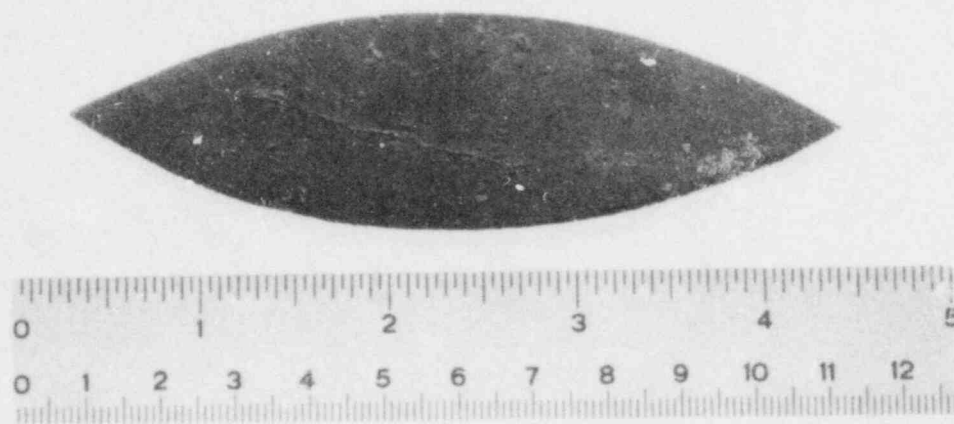
Figure 9. Photograph of the top side of
boat sample MT #37,38. Note the
extensive pitting .

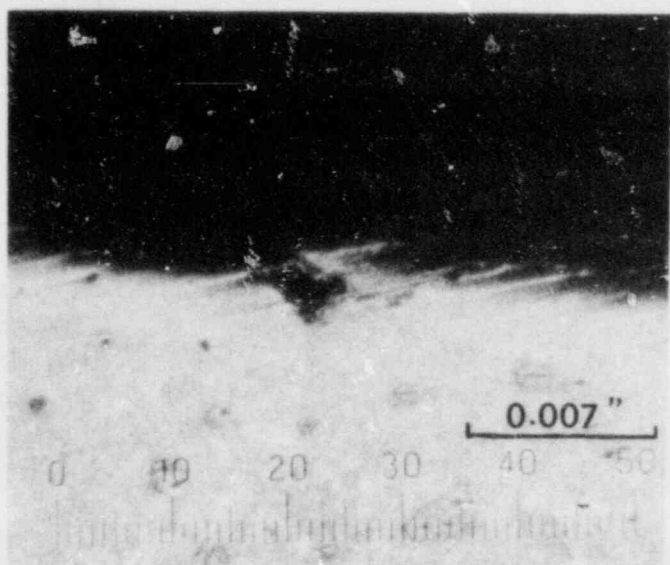
150X
 Figure 10. Optical photomicrograph of one of the pits seen with no crack associated with it.

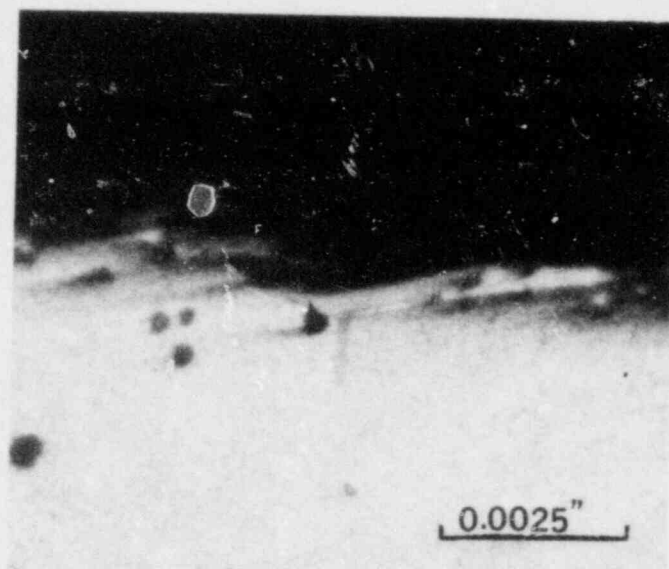
Some shallow pits had cracks associated with them (Figures 11 and 12). The cracks were tight and transgranular in nature, emanating at the bottom of the shallow pits. These cracks were continuous with virtually no branching evident. Other pits had shallow, opened-mouthed cracks associated with them (Figures 13 and 14). These cracks had the appearance of having a more active corrosion process associated with them than the predominantly transgranular ones. The microstructure surrounding these cracks was also a tempered martensite.

400X
 Figure 11. Optical photomicrograph of a shallow pit with a transgranular crack at the bottom of the pit.

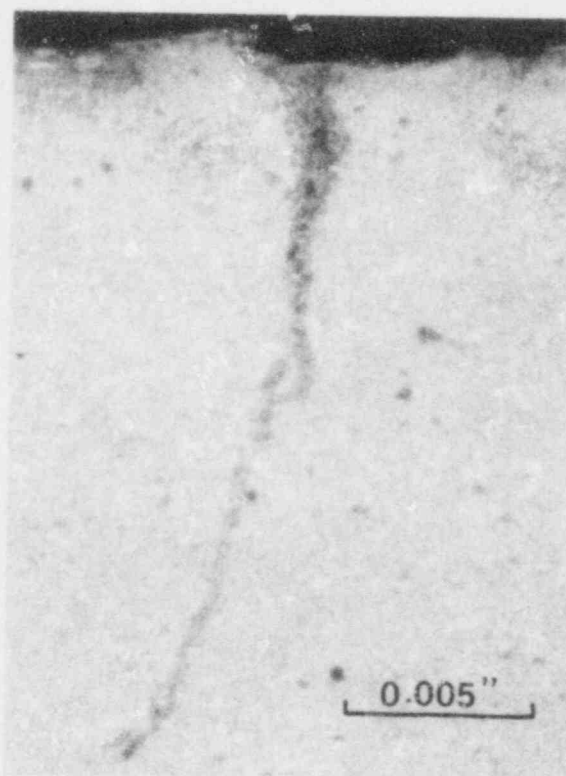
200X
 Figure 12. Photomicrograph of another transgranular crack. Note the lack of branching.

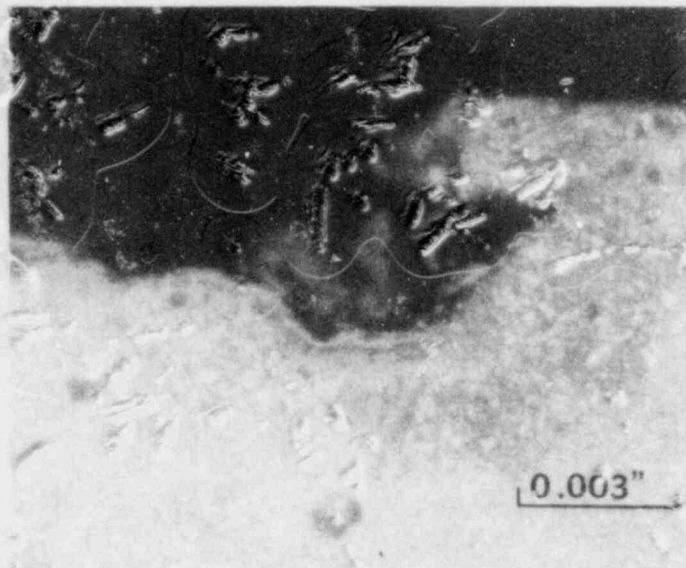
Figure 13. Photomicrograph of one of the shallow, open-mouthed cracks at the bottom of a pit.

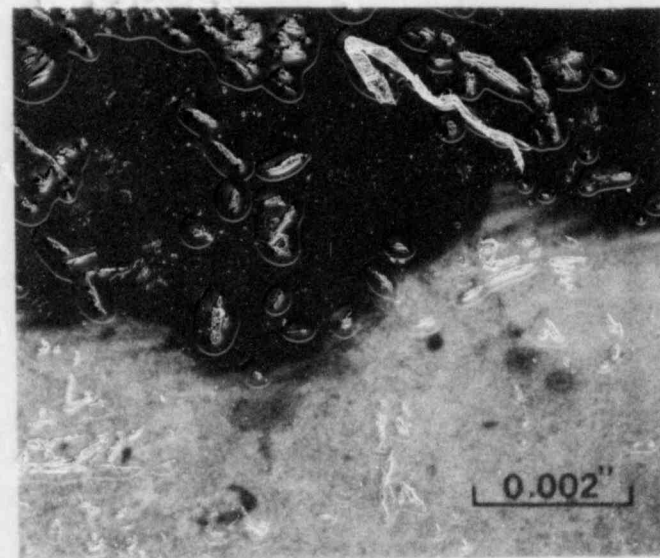
Figure 14. Another smaller crack found at the bottom of a pit.

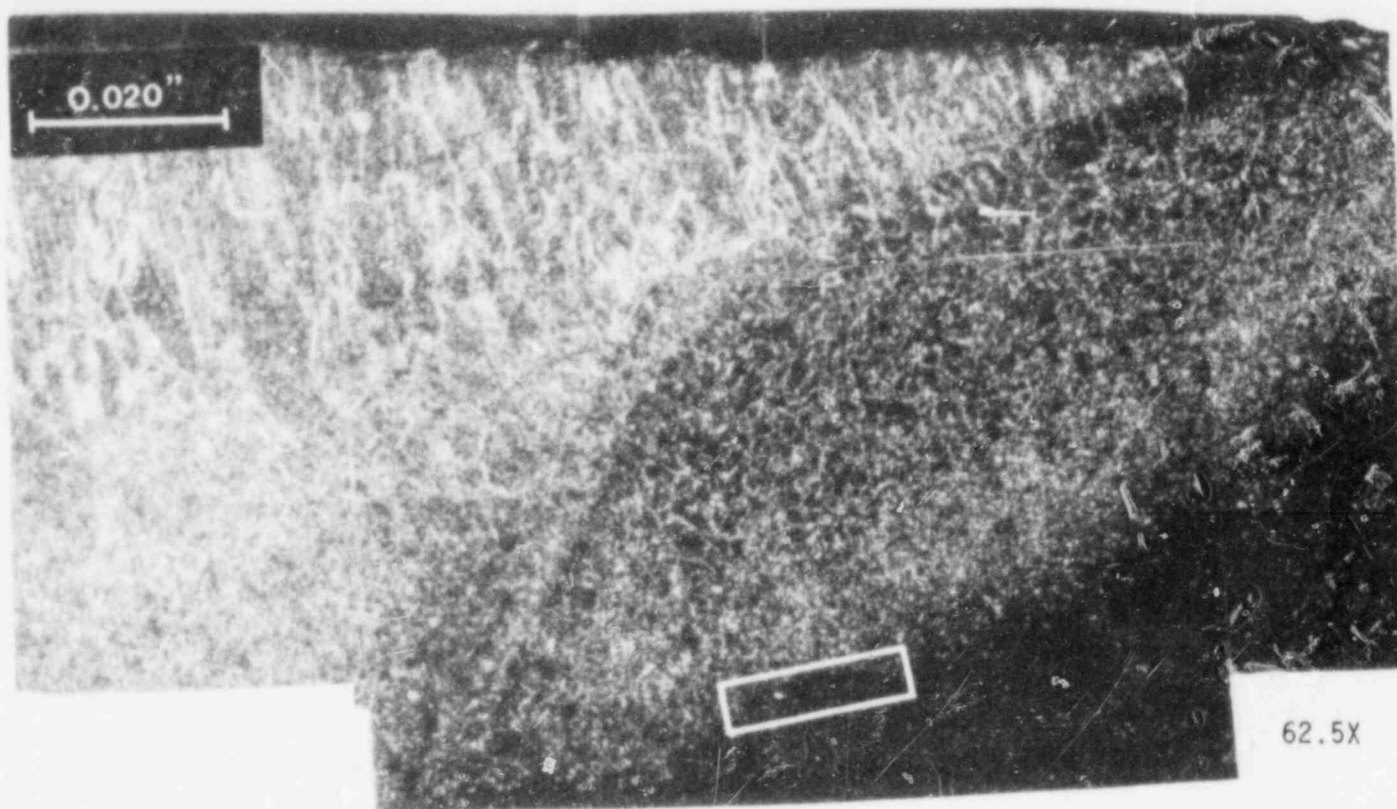
The area of lack of fusion in Figure 4 (area A) was also investigated. Figure 15 is a photomicrograph showing the area of lack of fusion (boxed area) in relation to the weld and heat affected zone of the repair weld. Figure 16 is a higher magnification photomicrograph showing that no subcracks are associated with the area of lack of fusion.

Figure 15. Photomicrograph depicting the area of "lack of fusion" shown in Figure 4 (Area - A).

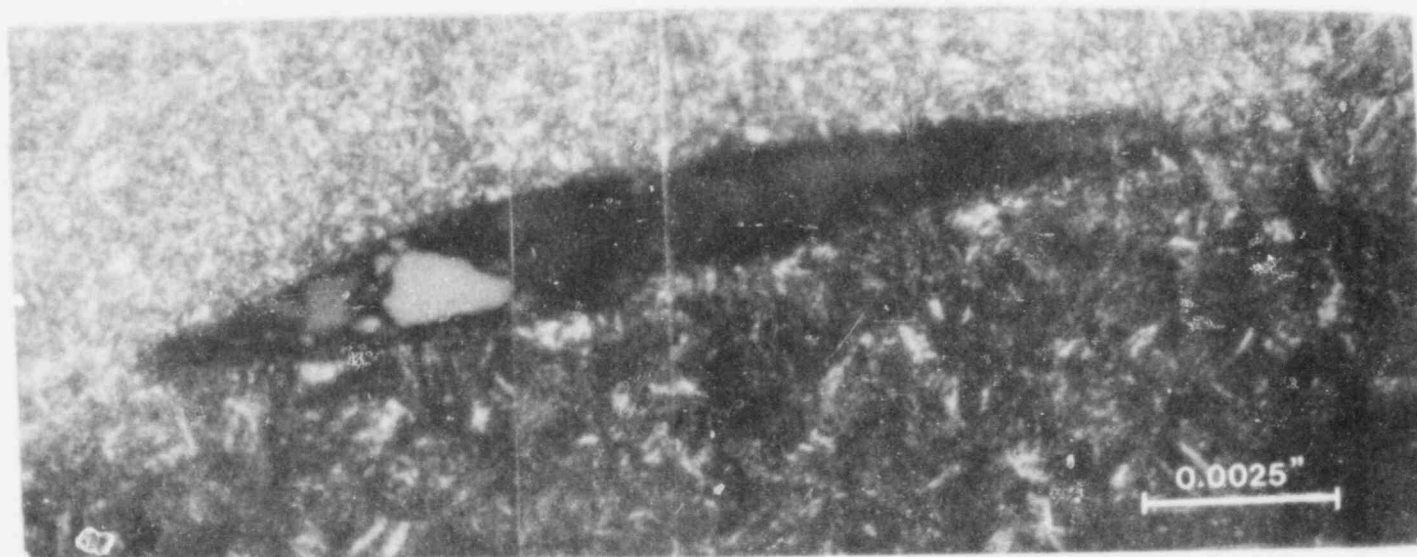
Figure 16. Higher magnification photomicrograph of the area of "lack of fusion" showing blunted ends and no additional cracking evident.
