Investigation of Shell Cracking on the Steam Generators at Indian Point Unit No. 3

Prepared by C. J. Czajkowski

Brookhaven National Laboratory

Prepared for
U.S. Nuclear Regulatory
Commission

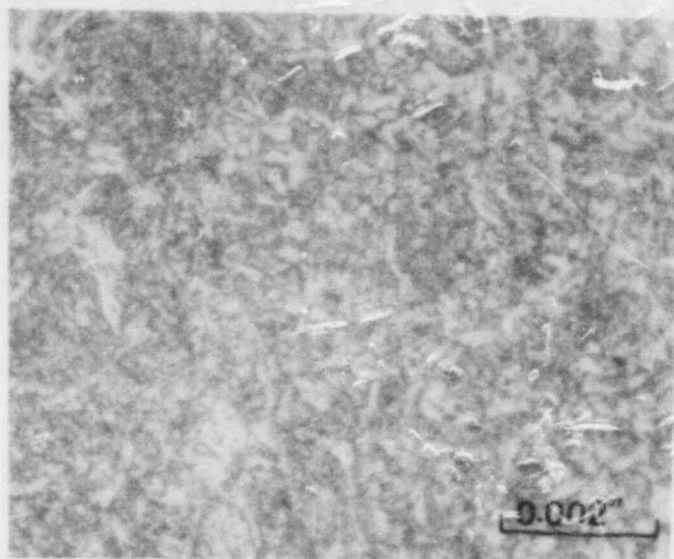
The microstructure of the various base metals (Figure 17), weld metals (Figure 18) and heat affected zones (Figure 19) from the 6" plug were examined. The base metal had a tempered martensitic structure consistent with A302 Grade B material. The weld metal had a dendritic structure which would be normal for both manually deposited shielded metal arc weld of E8018-C3 material and submerged arc welding. The heat affected zone of the plug weld had a more acicular structure normally associated with untempered martensite.

Figure 17. Photomicrograph depicting the base metal's structure as a tempered martensite.

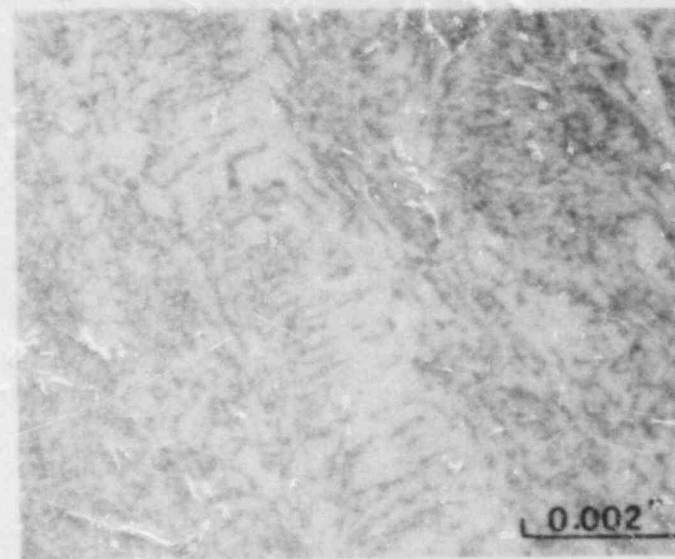
Figure 18. Photomicrograph of the weld metal, showing a characteristic dendritic structure.

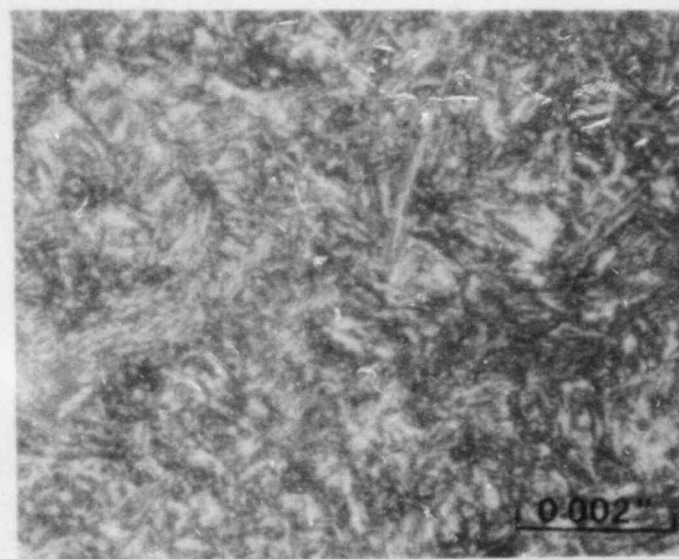
Figure 19. Photomicrograph of the 6" plug's heat affected zone -hard martensite.

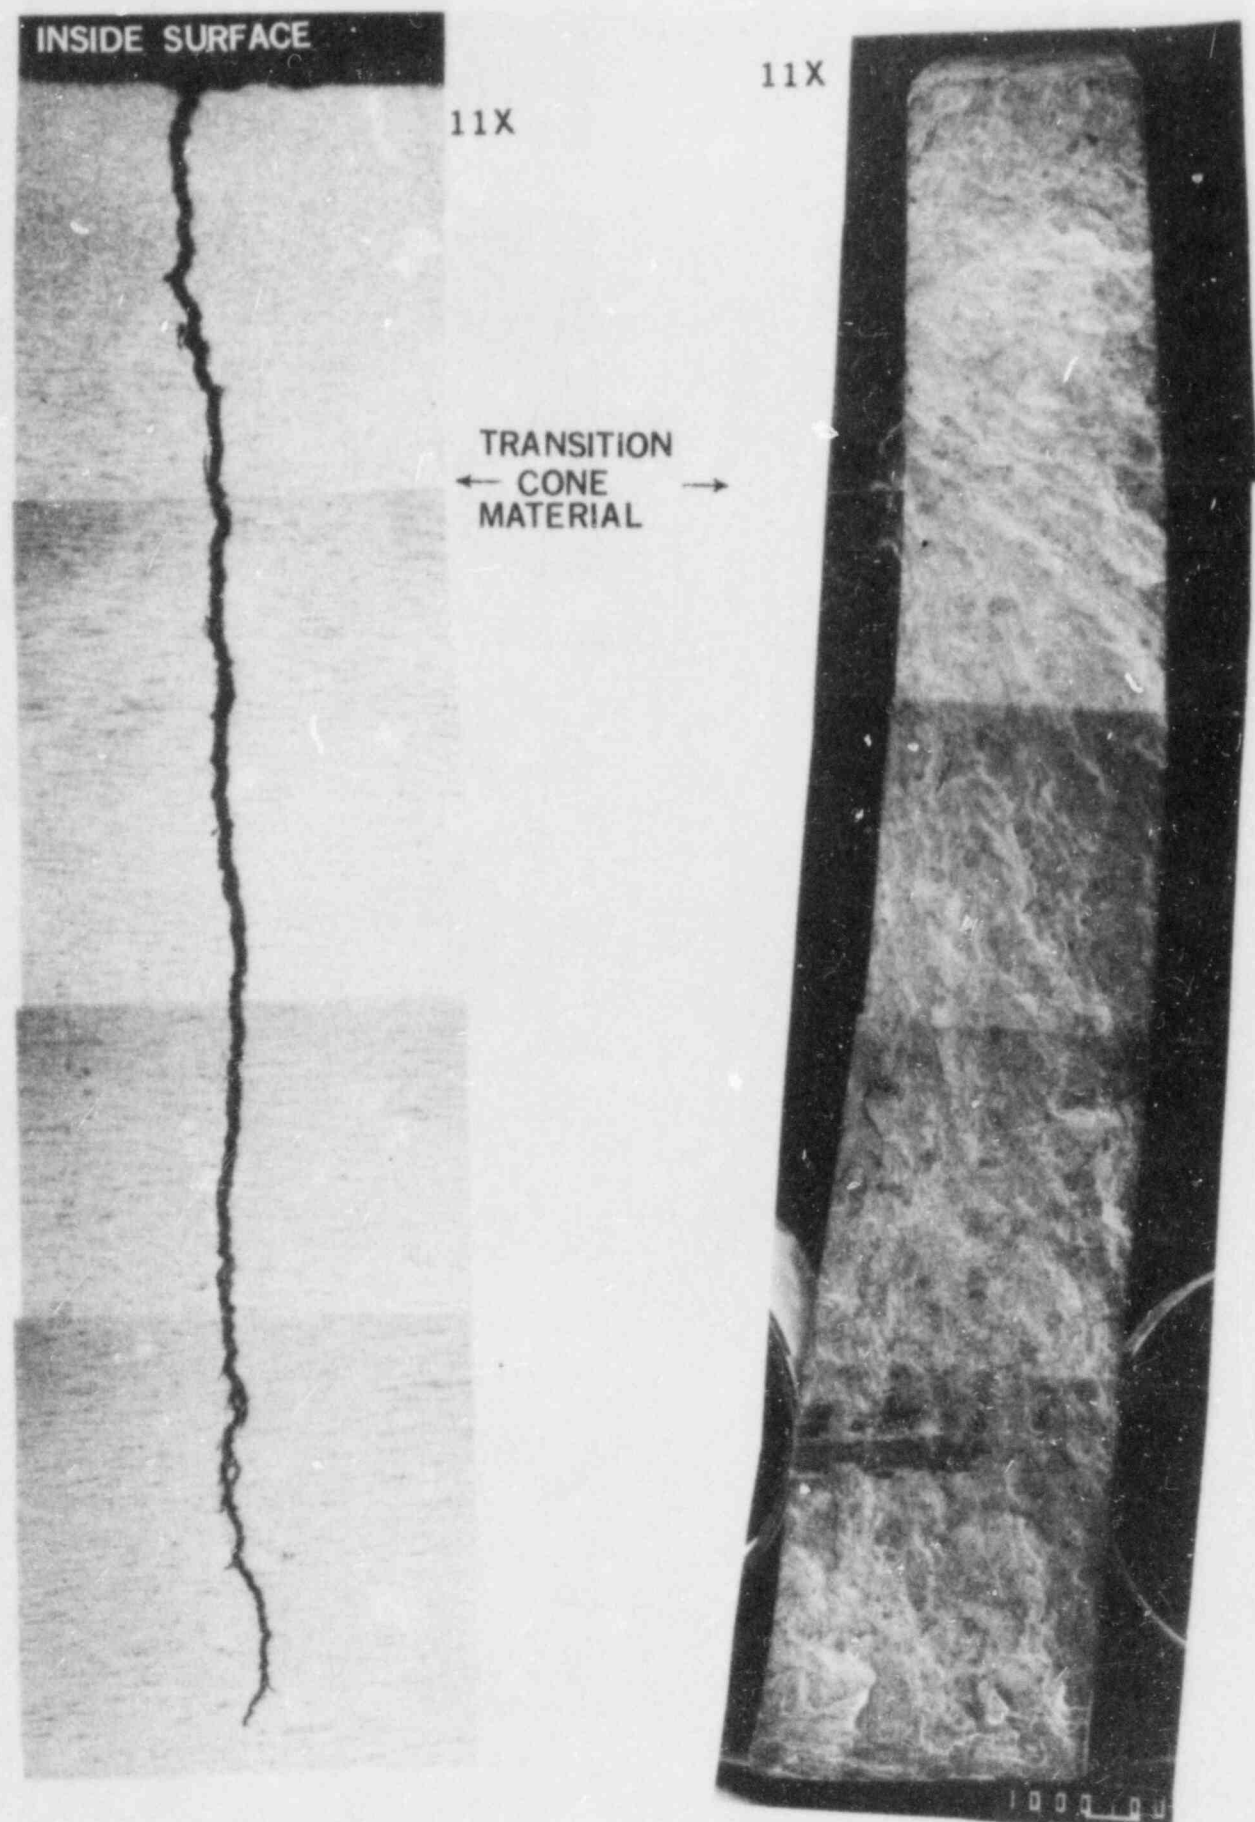
A comparison (Figure 20) photomicrograph/fractograph was made of the crack shown in the specimen in Figure 6. It is quite evident that the crack is transgranular with virtually no branching associated with it. Although there is no definitive heat affected zone visible in the immediate vicinity of this crack, there was a grain size difference between areas closer to the inner surface and those about mid-depth of the crack. This grain size difference is similar to that which would normally be associated with weld heat affected zones or those encountered with mechanically worked thick sections in materials. The fractograph clearly shows a non-continuous crack growth initiating from a point on the fracture surface not included on the fractograph due to the limited thickness of this particular specimen. The radiating lines in the upper section of the fractograph would normally point to the initiation site of the fracture.

Figure 20. A comparison between the optical photomicrograph and the fractograph of the crack shown in Figure 6. There is virtually no crack branching evident. Note the discontinuous nature of the fractograph.

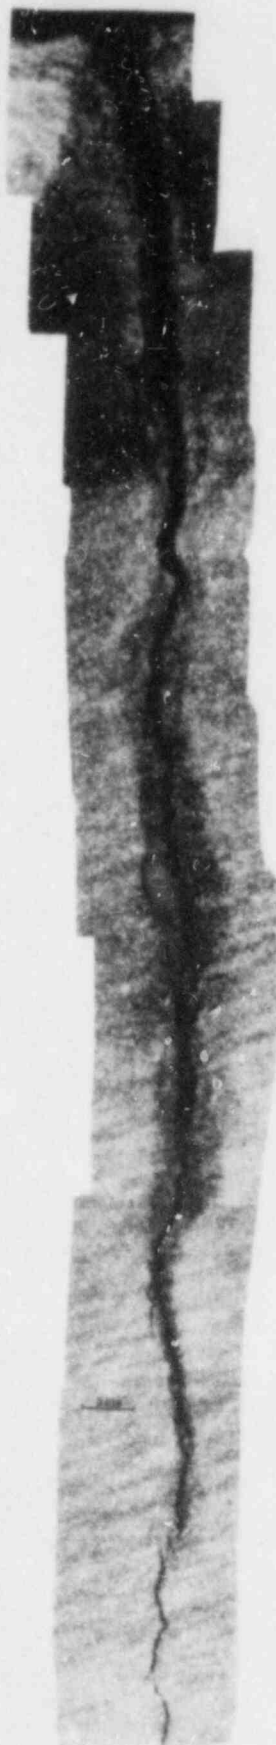
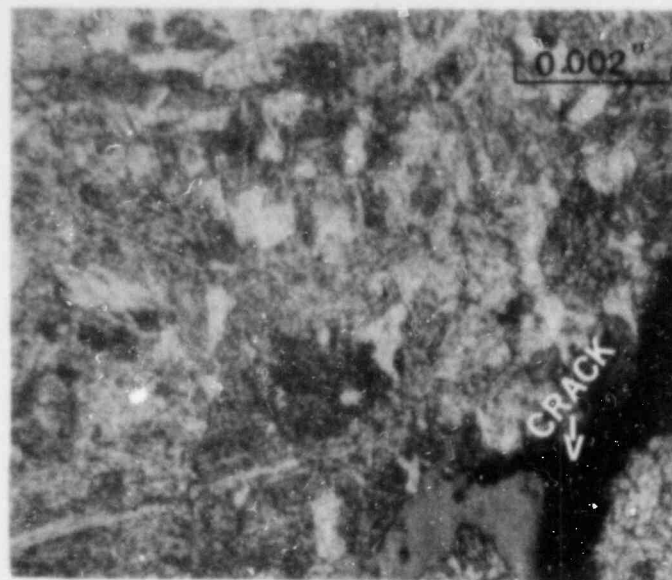
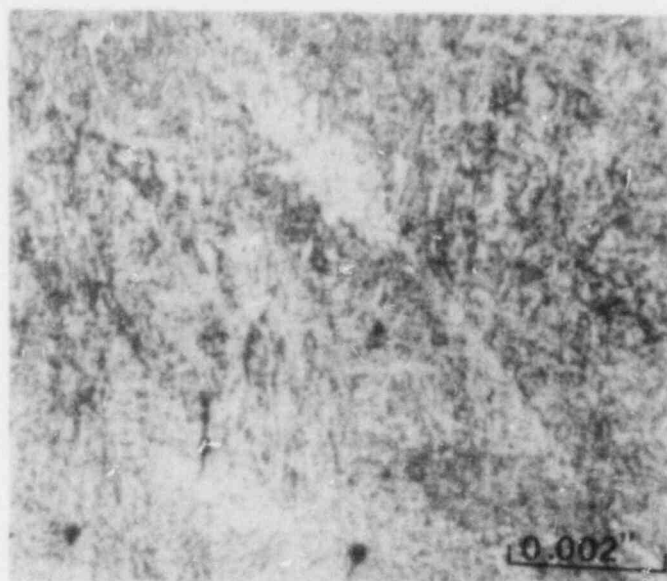
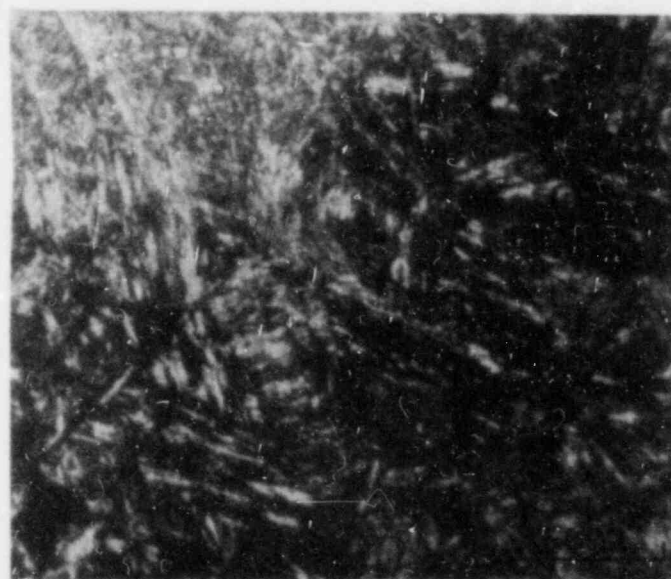
Optical cross sections were cut, mounted and etched from the three boat samples cut from steam generator #31. Figure 21 shows the crack identified as MT indication #37. The crack is extremely straight, transgranular, and exhibits virtually no crack branching. The crack appears to initiate at a pit on the inside surface of the specimen. The higher magnification photomicrographs of the weld metal (Figure 21a) shows a normal dendritic structure for E8018-C3 material. The base metal had a tempered martensitic structure (Figure 21b) which is also normal for the material condition. Figure 21c is a photomicrograph of the heat affected zone which has a more acicular structure not normally associated with the "tempered martensitic" condition, but more normally associated with untempered martensite.

Figure 21. Photomicrographs of the MT 37/38 crack. Higher mag. photos of the areas of interest are also shown.

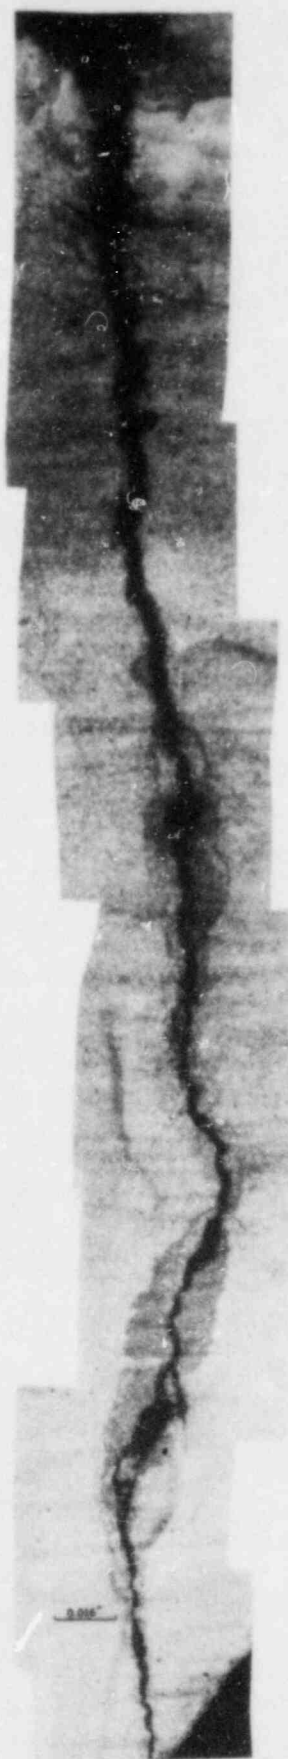
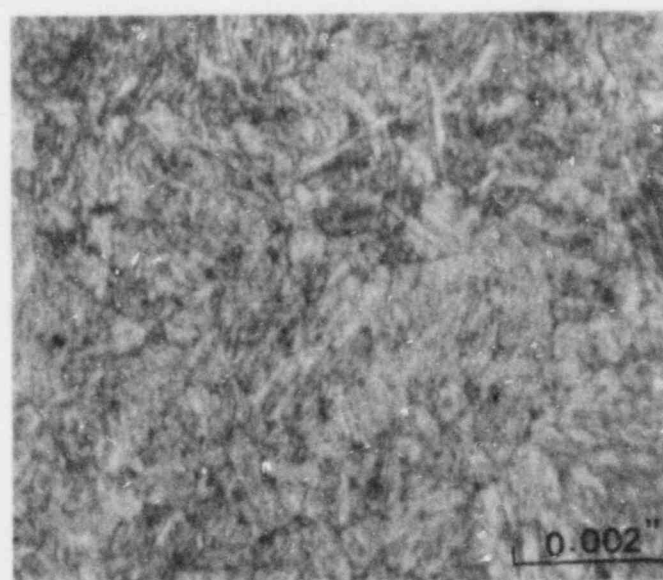
The cracks associated with MT indications 44 (Figure 22) and 46 (Figure 23) were both associated with surface pits and were transgranular with very little branching evident. Both cracks exhibited arrests along their length where it appears that the corrosion process was dominant for some period of time. The higher magnification photomicrographs (Figures 22a,b,c, and 23a,b,c) of the base metal, weld metal and heat affected zone structure of these two cracks correspond to the same observations noted previously on MT indication #37.

Figure 22. Photomicrographs of the MT 44 crack. Higher mag.photos of the areas of interest are also shown.

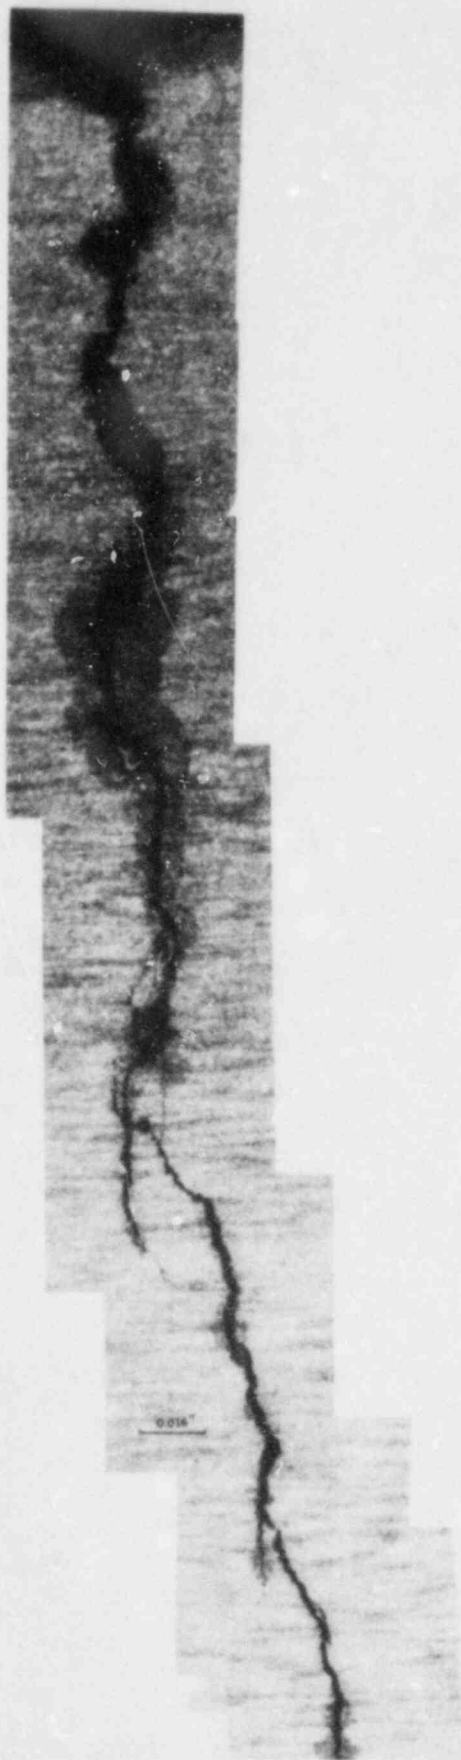
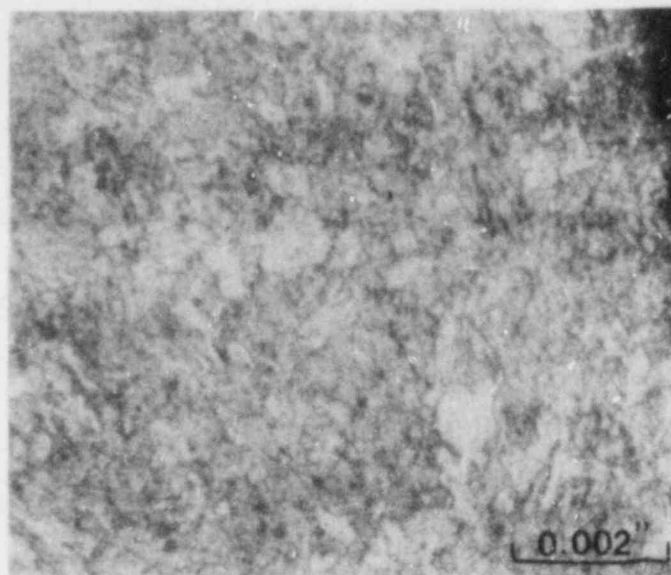
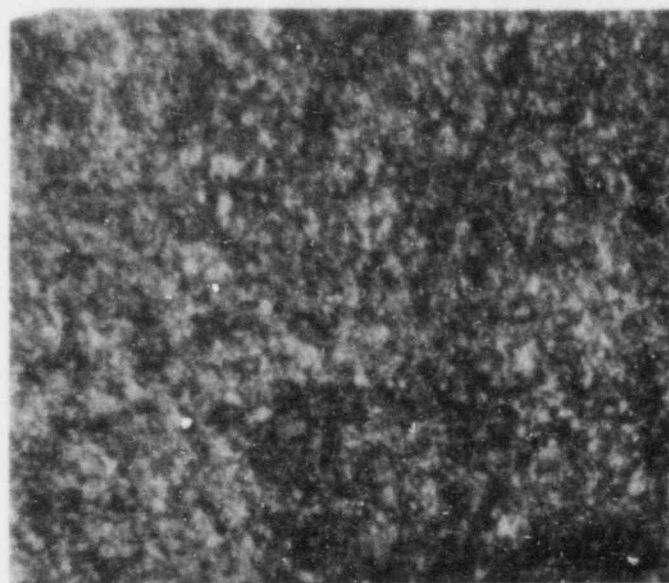
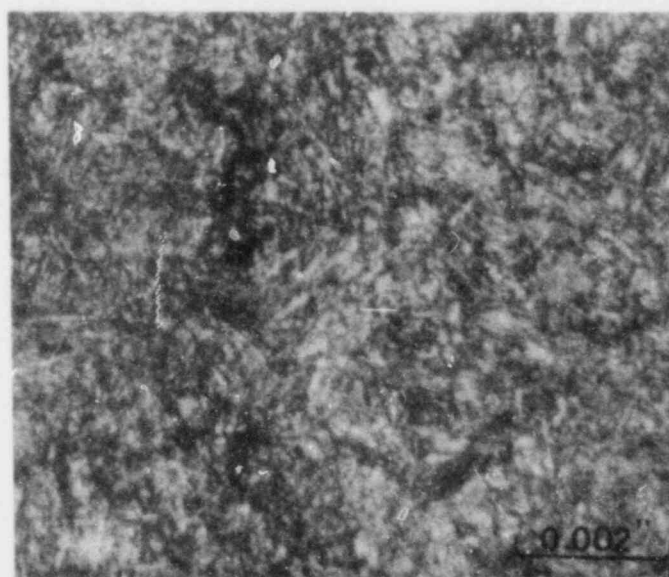
Figure 23. Photomicrographs of the MT 46 crack. Higher mag.photos of the areas of interest are also shown.

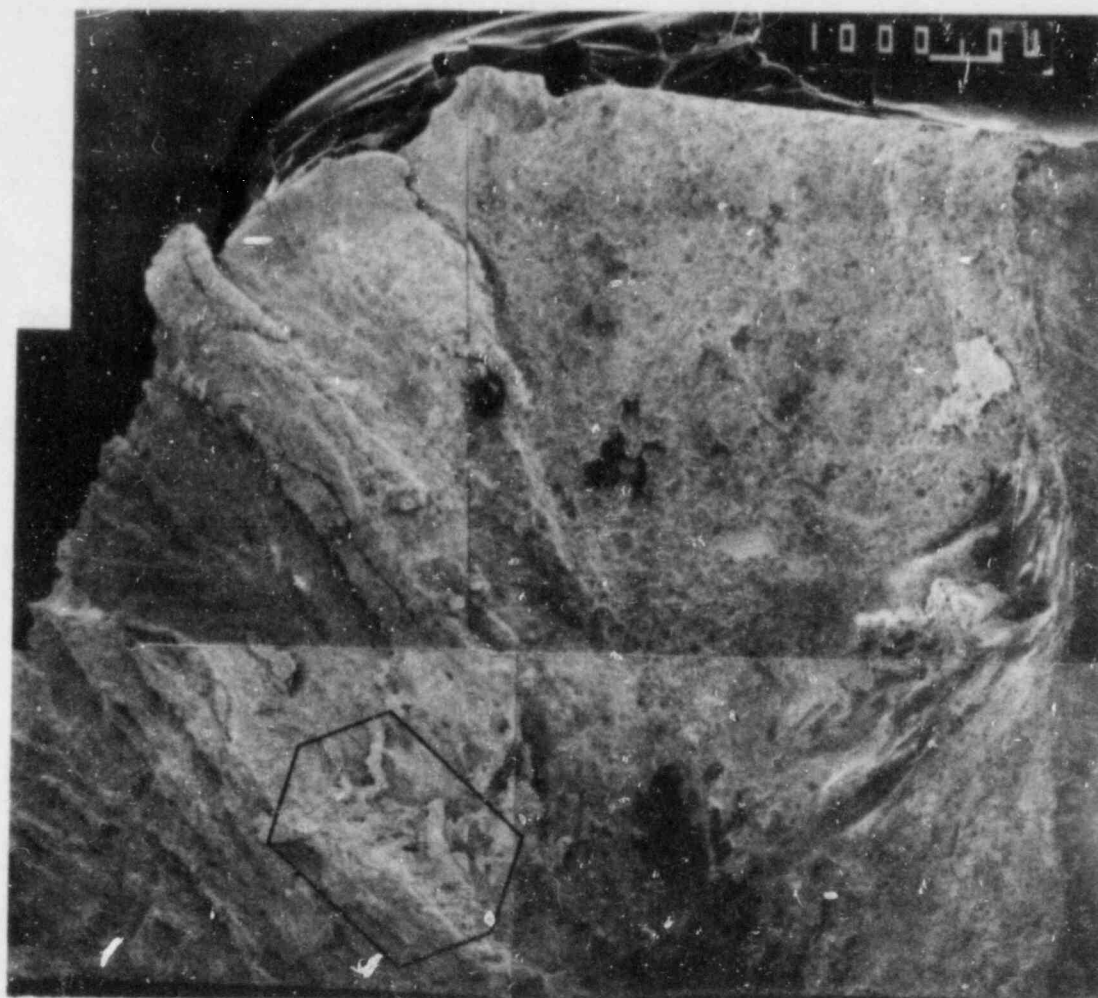
The first plug specimen examined was from the area of the through hole "leaker" (Figure 24). Salient features of the surface were virtually nonexistent due to the erosive environment of the leaking secondary fluid. This particular specimen had visible copper colored deposits in evidence after electrolytic cleaning. These deposits were confirmed by EDS as copper, with zinc also in evidence (Figures 25a and 25b).

Figure 24. SEM fractograph of the fracture face of an area of the "through wall leaker". The boxed area is one of the deposited copper locations.

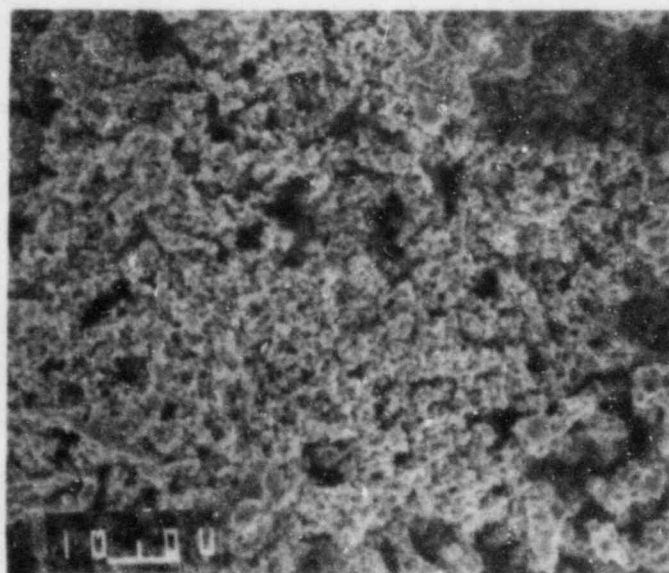
Figure 25a. Higher magnification photo of the copper deposit.

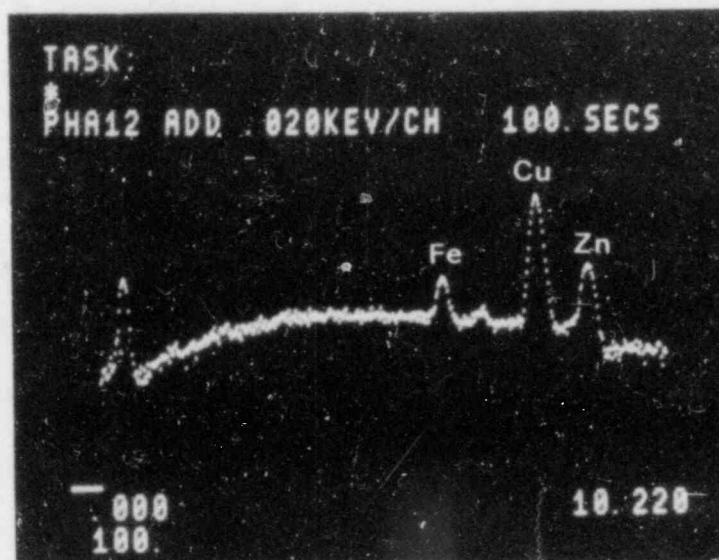
Figure 25b. EDS scan of the deposit in 25a showing a definite copper and zinc peak in addition to iron.

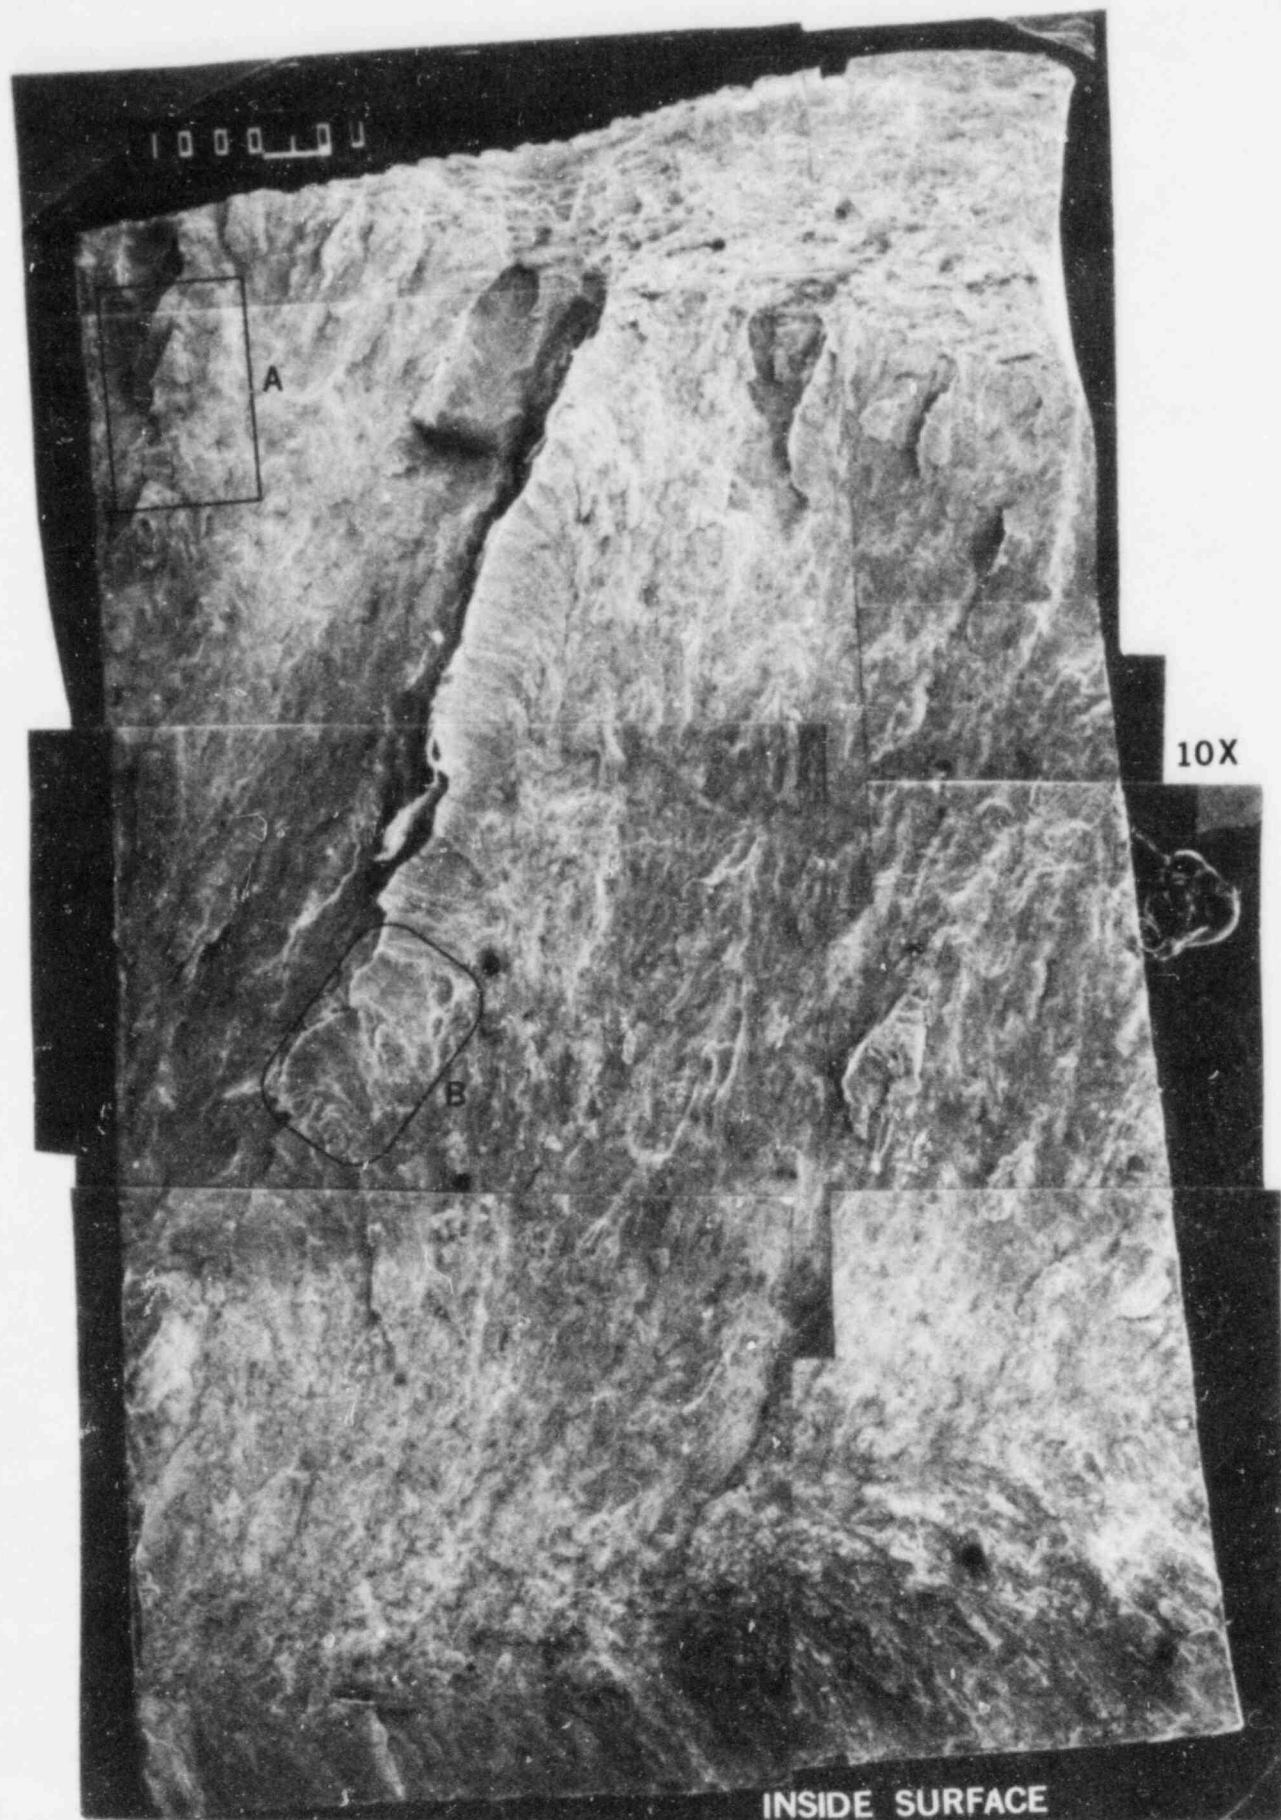
The second specimen examined (Figure 26) exhibited a transgranular fracture face with the "wood-like" appearance normally associated with progressive or fatigue-type fractures. Higher magnification scrutiny of the fracture face disclosed an area of possible fatigue interaction (Figures 27a-27d). The structure of low alloy steels makes a positive identification of fatigue striations extremely difficult. Area B of this fracture face (Figures 26) appears to be an area where the crack started to change its direction of growth, due to the effect of a dominant stress field, perhaps the vessel's hoop stress.

Figure 26. Low magnification SEM fractograph of one of the fracture faces associated with the 6" plug sample. Area "A" is an area of possible fatigue interaction while location "B" is an area of crack redirection.

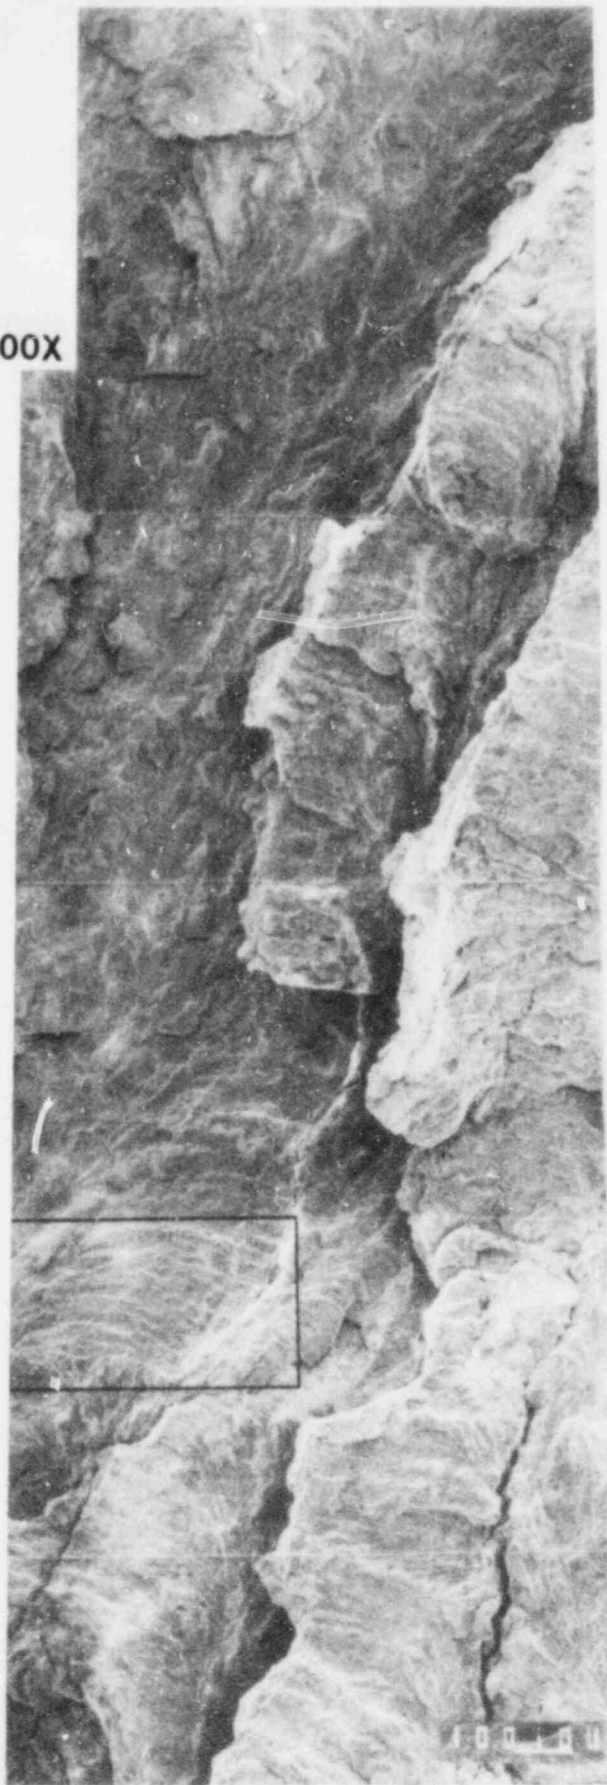
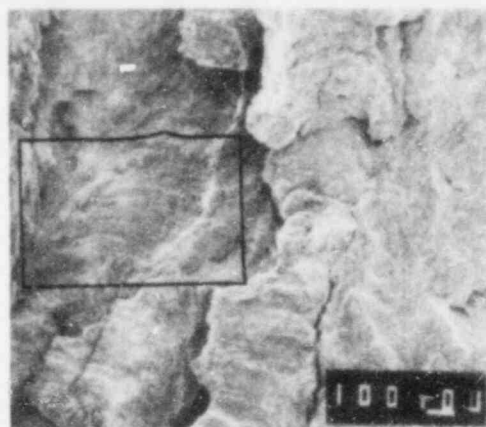
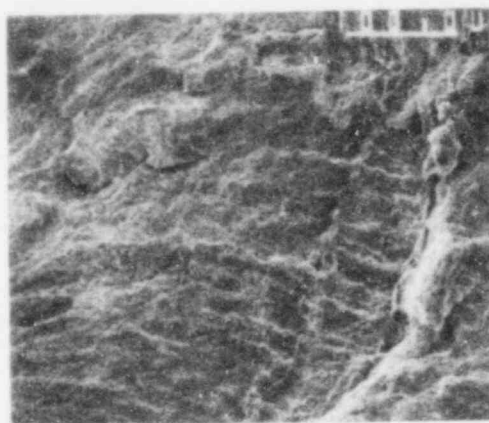
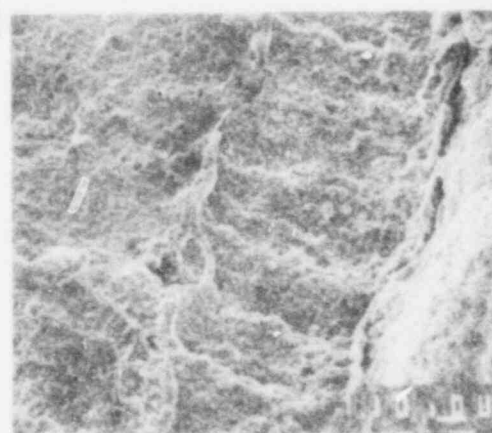
27c. Higher magnification photo of same area showing definite regular spacing of striations.

Figure 27a. Fractograph of the area "A" in Fig.26 showing possible fatigue striations. Note the intimation of progressive fatigue characteristics.

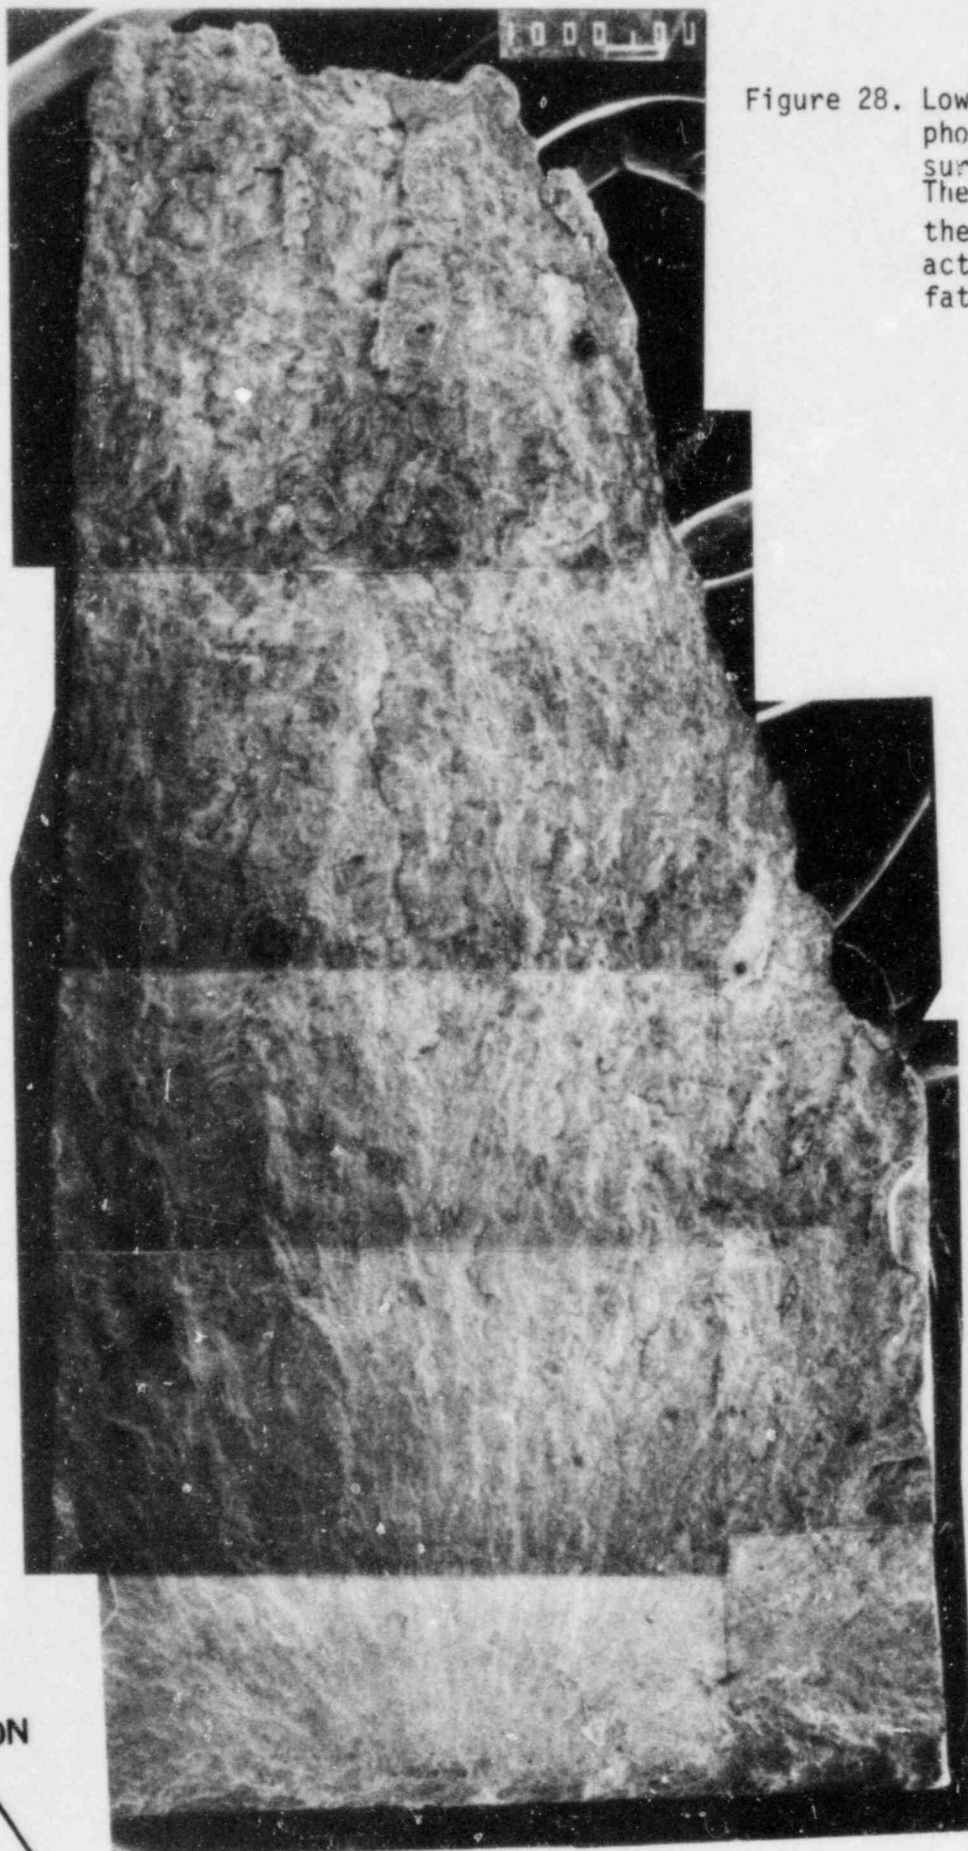
The third fracture face examined from the plug coupon (Figure 28) also displayed a fracture face characteristic of fatigue fractures. This particular fracture initiated at pits which were quite evident in the fractograph. Figure 29 is a fractograph of the same fracture surface, which clearly shows "beach marks" in evidence. These again are indicative of "fatigue-type" fractures.

Figure 28. Low magnification SEM photo of another fracture surface from the 6" plug. The photo clearly depicts the type of surface characteristic of progressive fatigue.

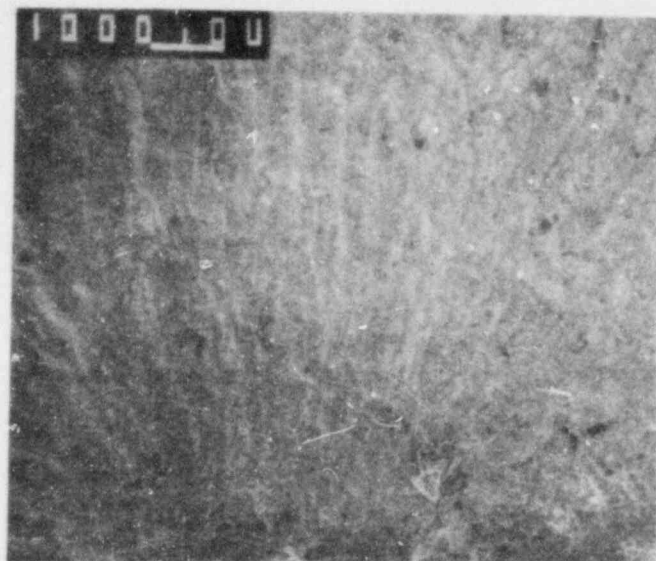
10X
Figure 29. An SEM fractograph showing definite indications of "beach marks" on the fracture surface.

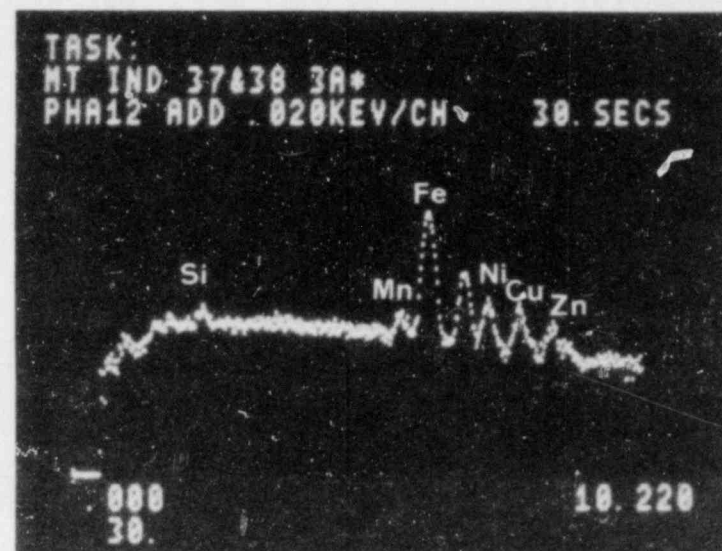
Figure 30. EDS scan of the fracture surface of specimen MT 37/38, depicting the typical elements found on the surface of the fracture.

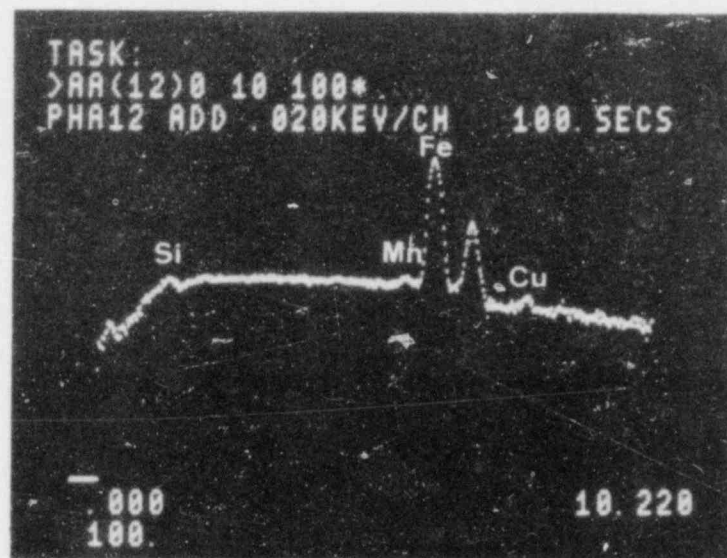
Figure 31. EDS scan of the fracture surface of specimen MT 44 for typical elements present.

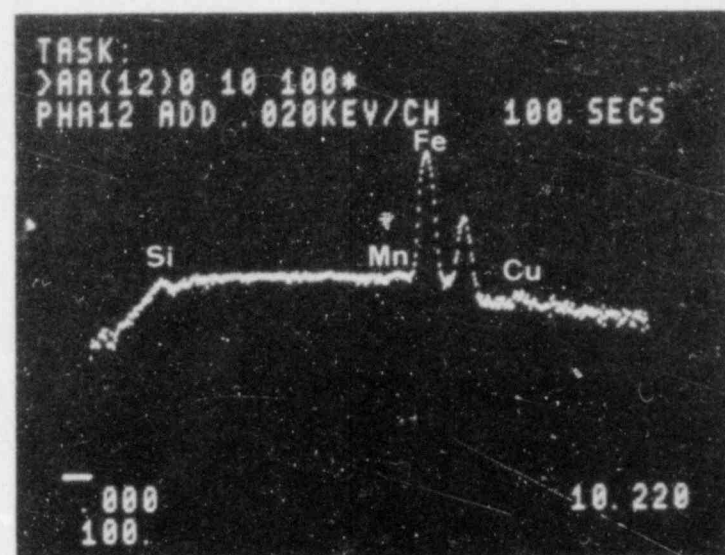
Figure 32. EDS scan for chemical constituents on specimen MT 46 fracture face.

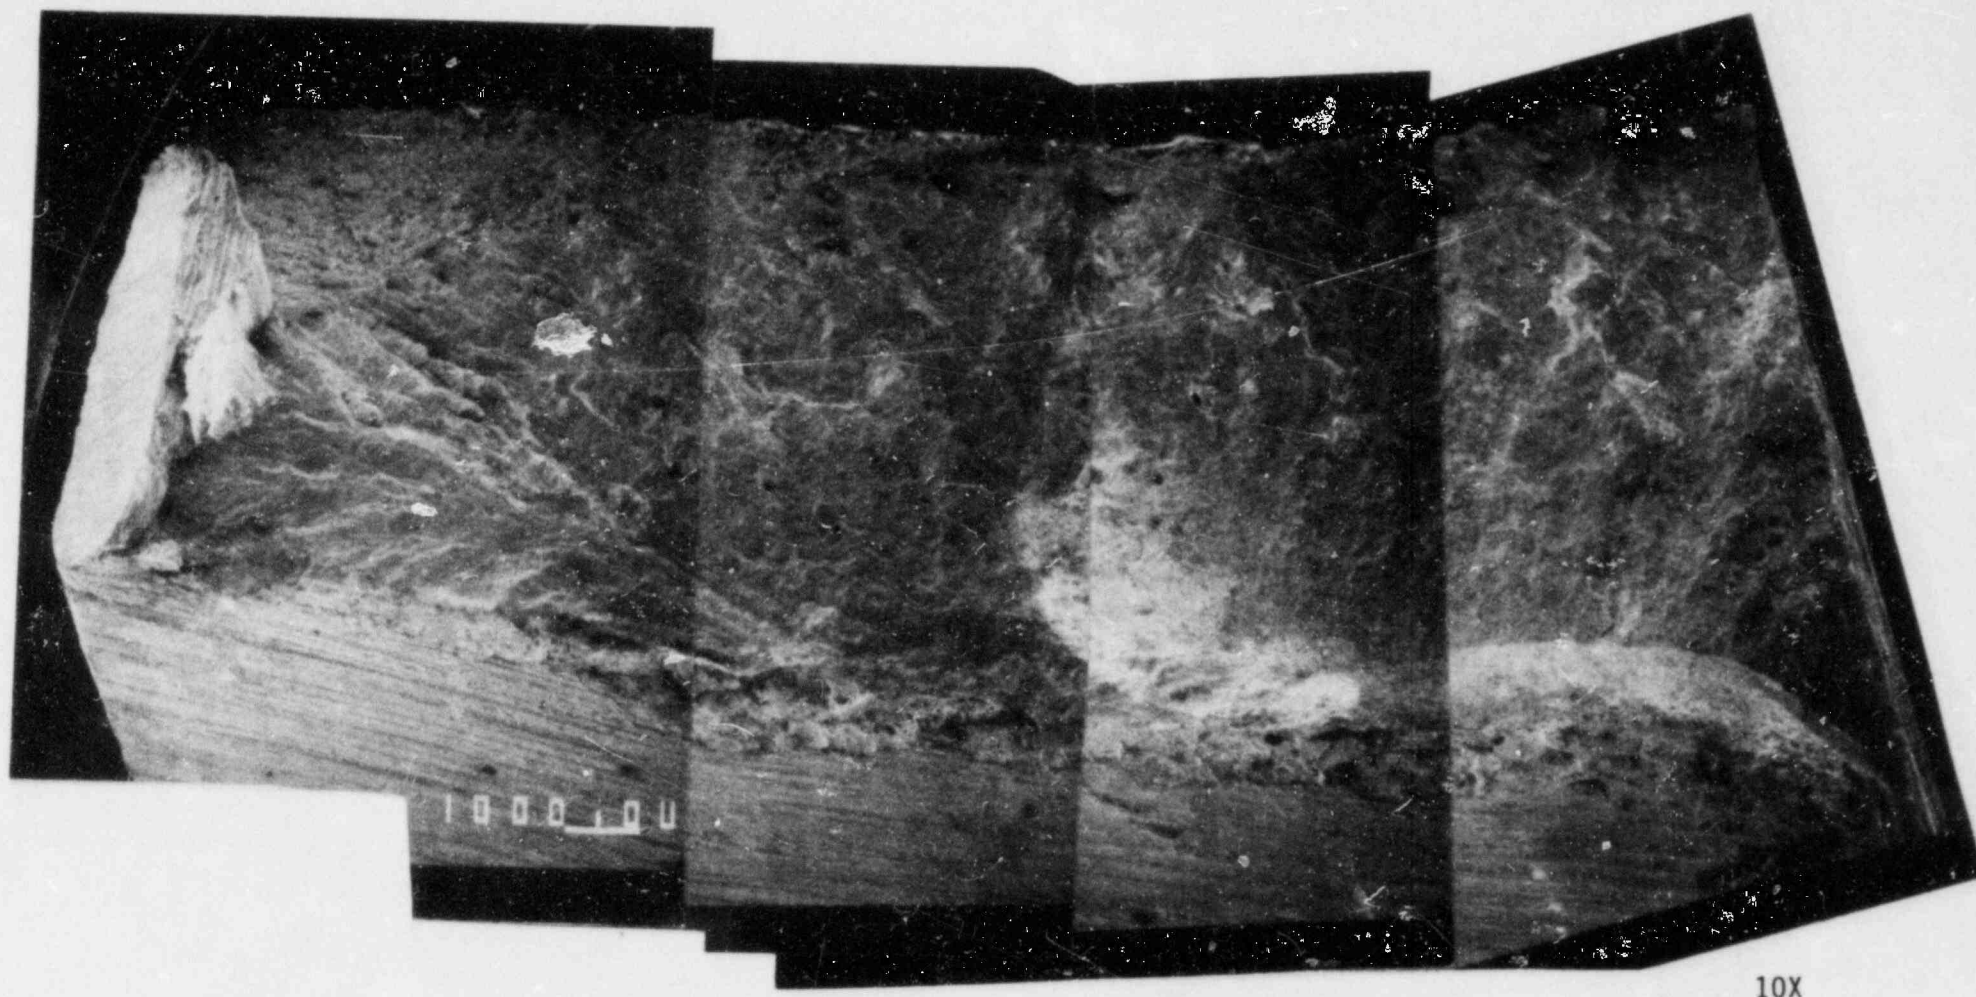
Figure 33. Low magnification fractograph of the fracture face on specimen MT 44, after electrolytic cleaning. The initiation site of the fracture originated on the inside surface of the steam generator, where a considerable amount of pitting is visible.
