Investigation of Shell Cracking on the Steam Generators at Indian Point Unit No. 3

Prepared by C. J. Czajkowski

Brookhaven National Laboratory

Prepared for
U.S. Nuclear Regulatory
Commission

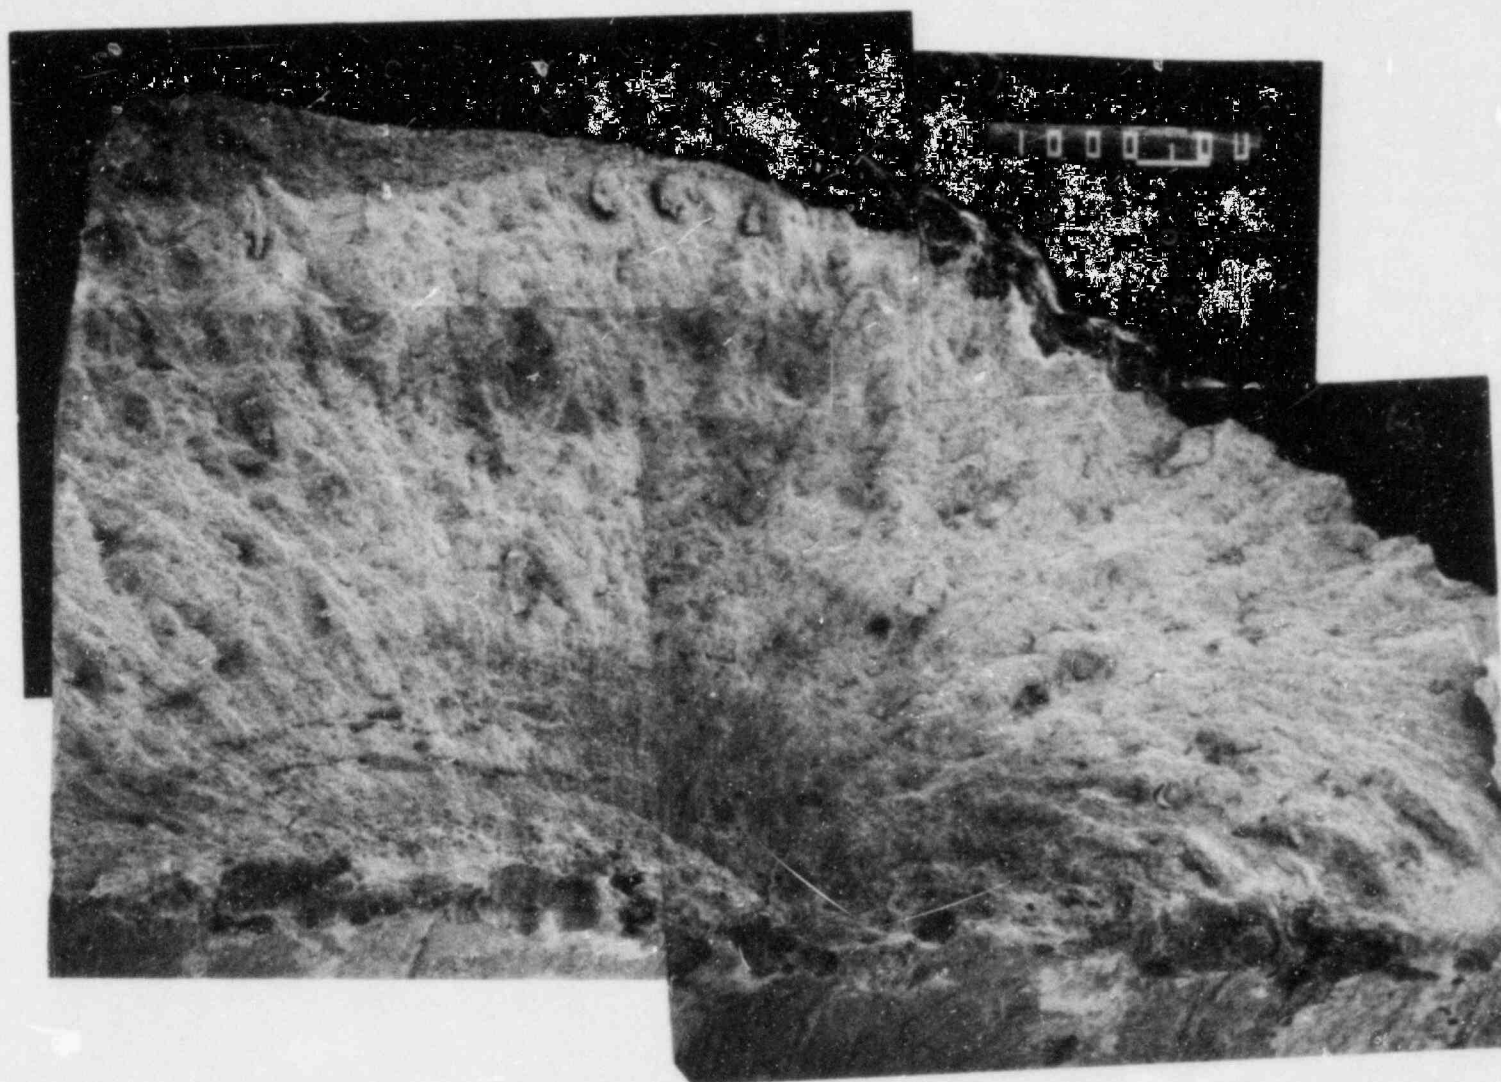
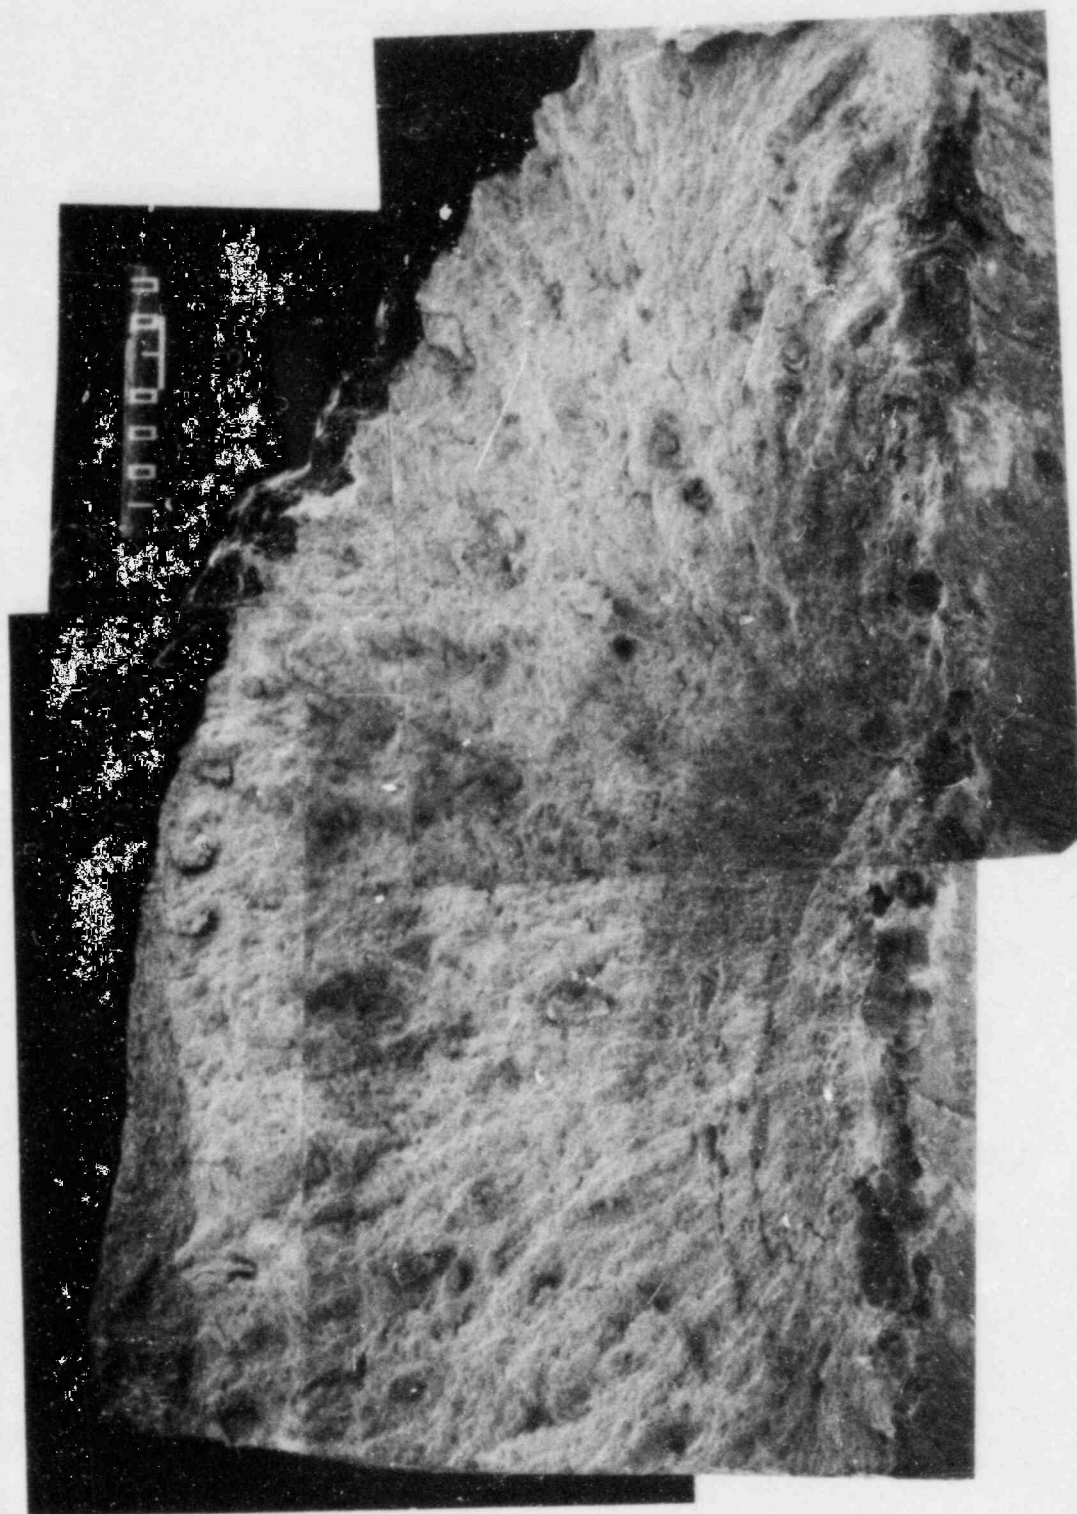
Figure 34. SEM fractograph depicting the fracture face of specimen MT 46. The photograph clearly shows the crack initiated at pits on the inside surface of the steam generator and has the general characteristics of a progressive or fatigue-like fracture.

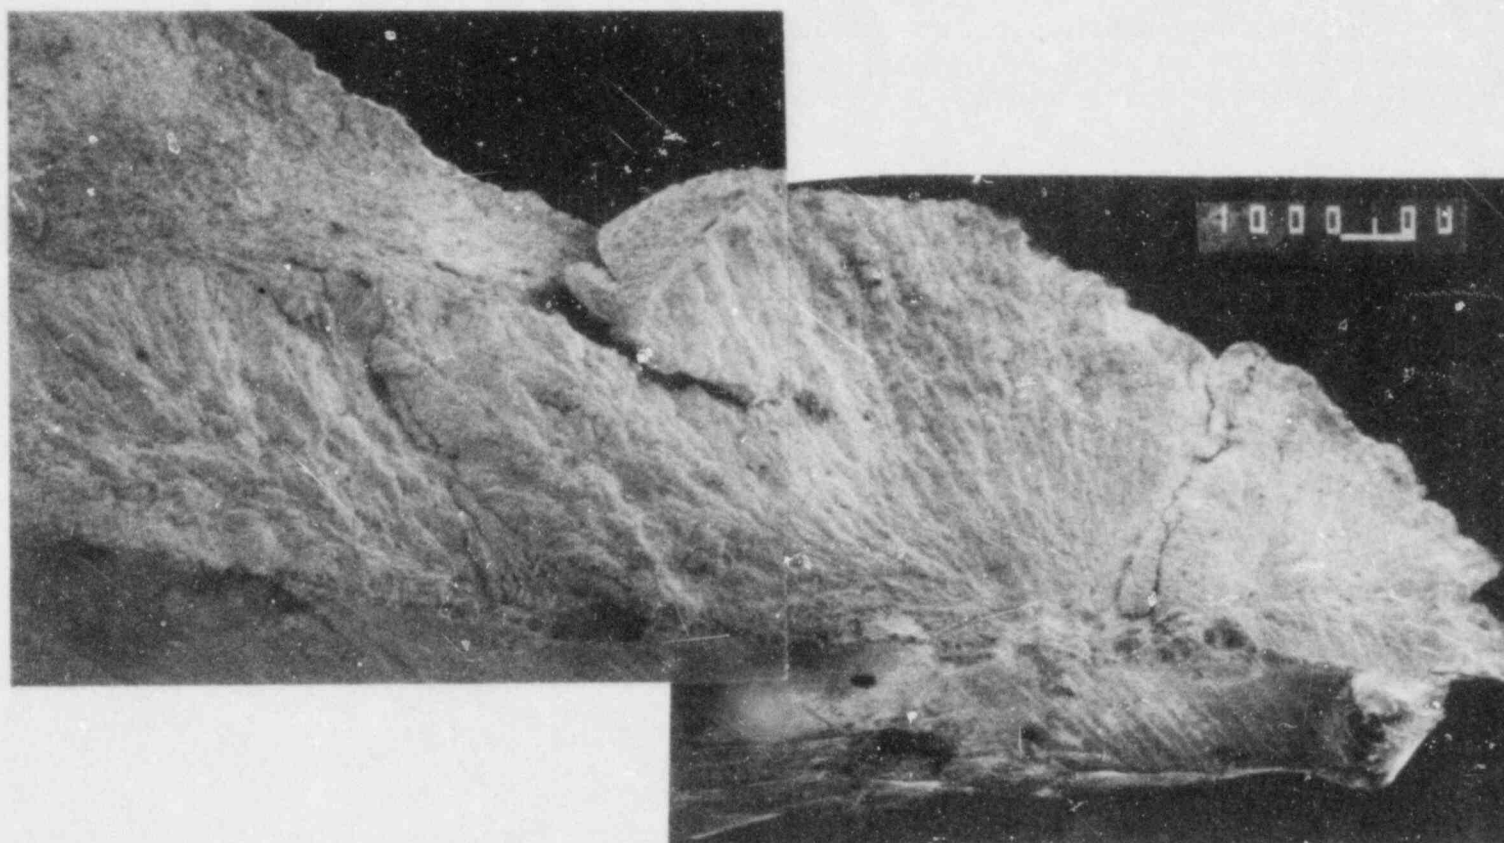
Figure 35. Fractograph of the fracture face on specimen MT 37/38. The fractograph clearly has the "wood-like" structure characteristic of progressive or fatigue cracking. The photo also shows the initiation site to be on the steam generator's inside surface and apparently emanating from surface pitting.

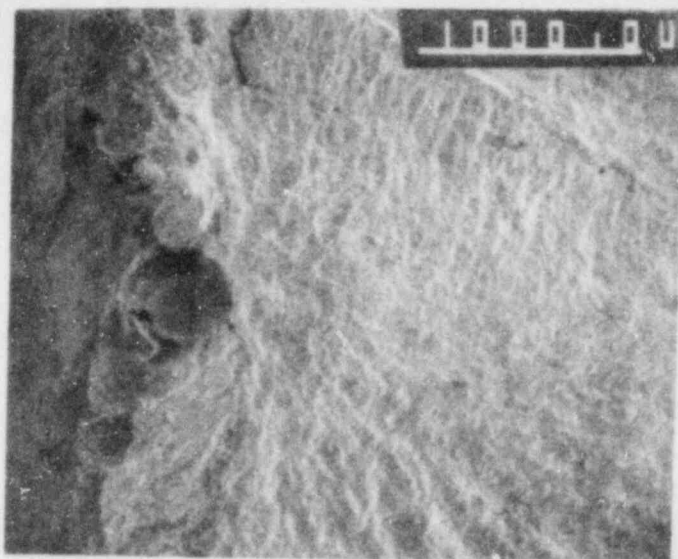
Figure 36. SEM photo of the initiation site for specimen MT 37/38 showing the fatigue-like nature of the crack.

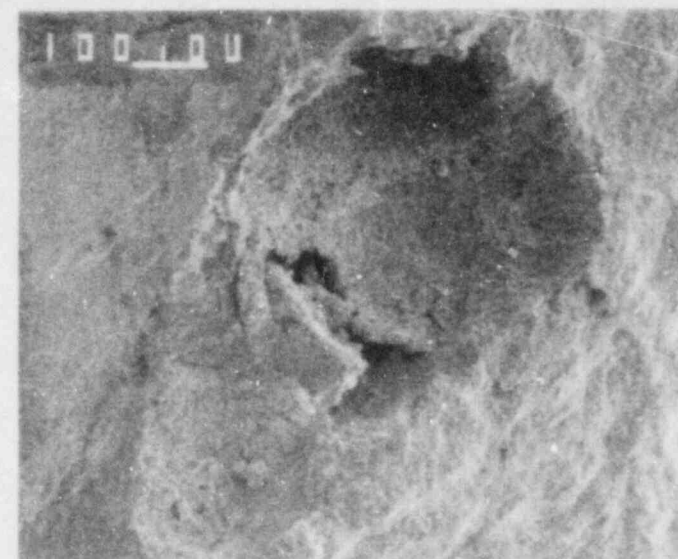
Figure 37a. Higher magnification photo of the pit in Fig. 36.

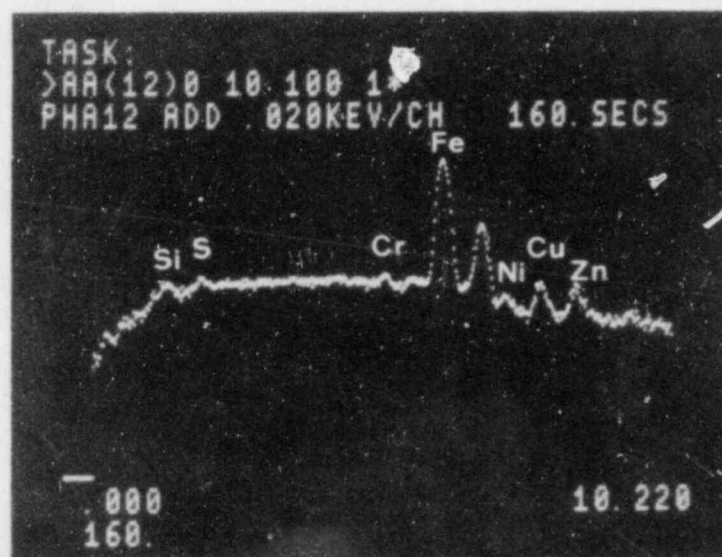
After electrolytic cleaning, the fracture faces for the three boat samples were examined. All three fractures exhibited transgranular features with the wood-like characteristics of fatigue fractures (Figures 33, 34 and 35). Additionally, the fractures had varying degrees of pitting associated with the initiation points of the fracture. An EDS scan of the area of initiation on fracture face MT indication 37/38 indicated Fe, Cr, Ni, Si, S, Cu and Zn (Figures 36, 37, and 37a).

37b. EDS scan of the fracture surface of MT 37/38 showing constituents found near the initiation point.

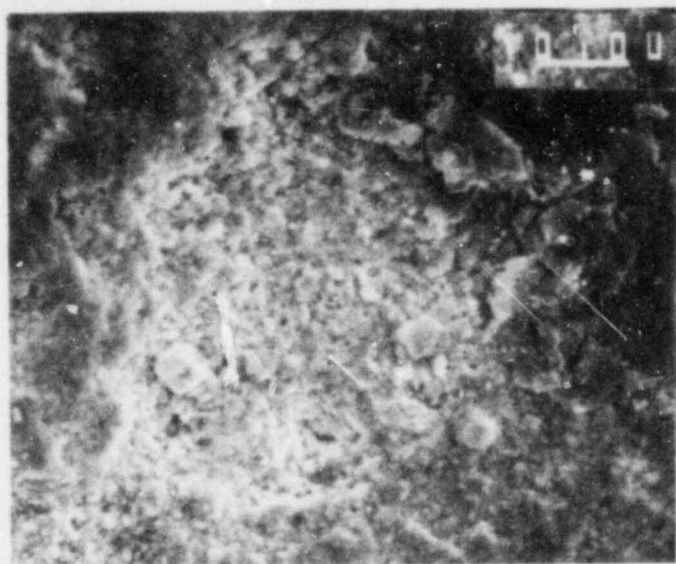
Other pits were examined at the mouth of the cracks (Figures 38-40). Only the pit in Figure 38a exhibited additional elements present other than the typical ones of Fe, Mn, Ni, Cu and Zn. This pit also had present Al, Si, Cl and K. It is also interesting to note that the EDS analysis of the pit in Figure 40a had a difference in composition between the rim of the pit and the interior portion of the pit. The difference was evidenced by the element nickel not being present on the pit's rim but is present on the pit's interior surface.

1200X
Figure 38a. SEM photo of the start of a pit
found on the fracture face of
specimen MT 44.

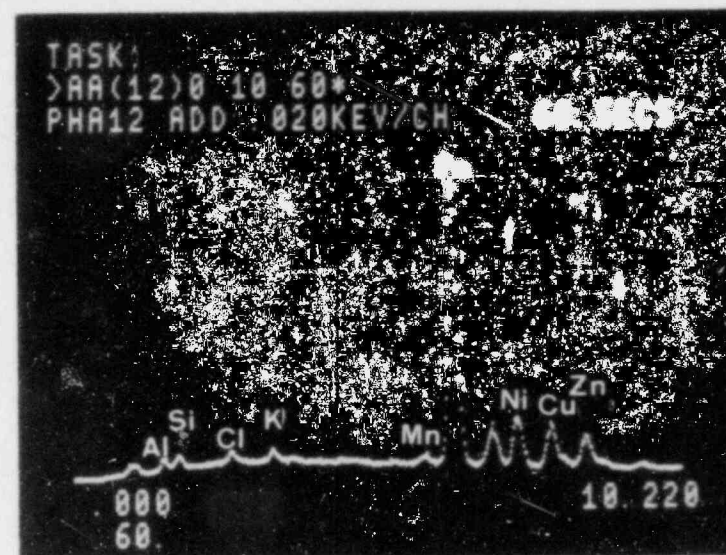
38b. EDS scan of the elements found in the
vicinity of Fig. 38a.

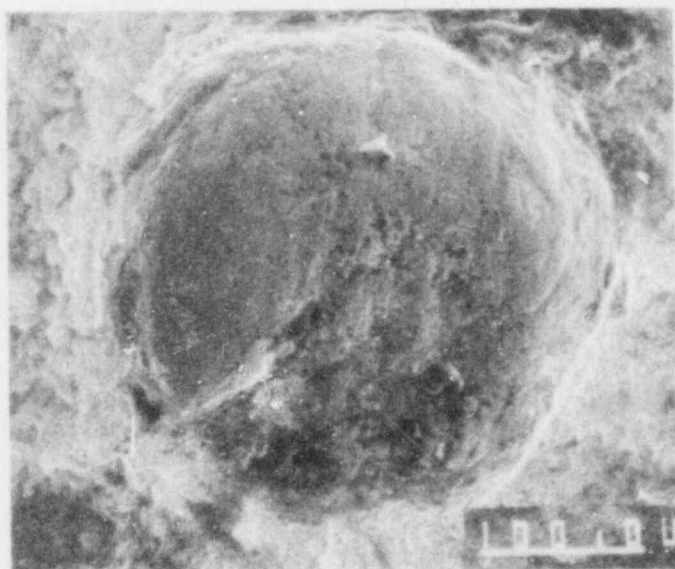
220X
Figure 39a. SEM photo of a pit found on the
specimen MT 46.

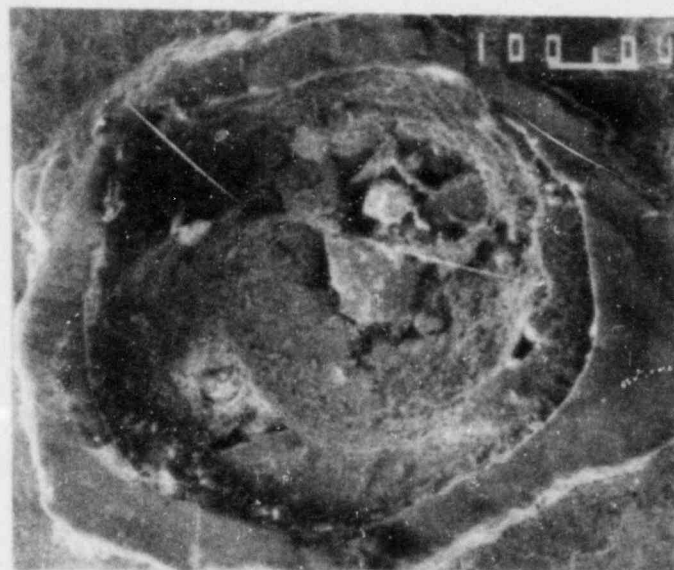
Figure 40a. SEM photo of a pit found on the inside surface of the MT 37/38 specimen.

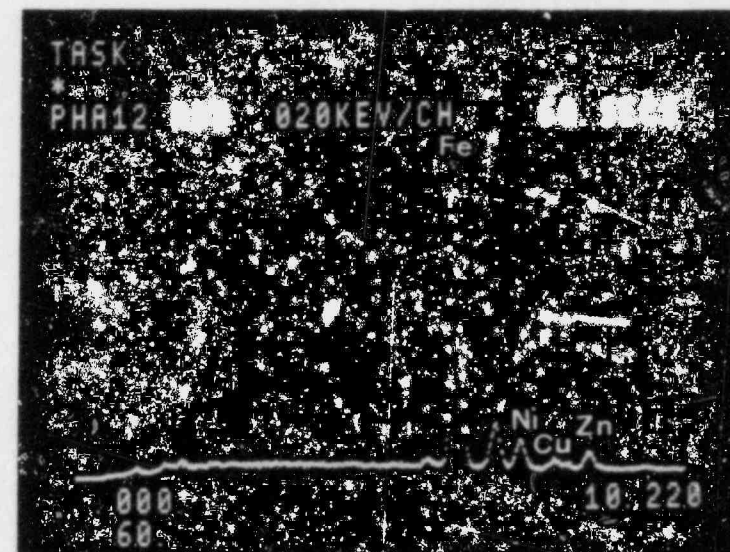
40c. EDS scan of the interior of the pit. Note the presence of Ni on this scan.
