Babcock & Wilcox

Subject: 10 CFR 21 Report

Loose Terminal Board Locking Clips

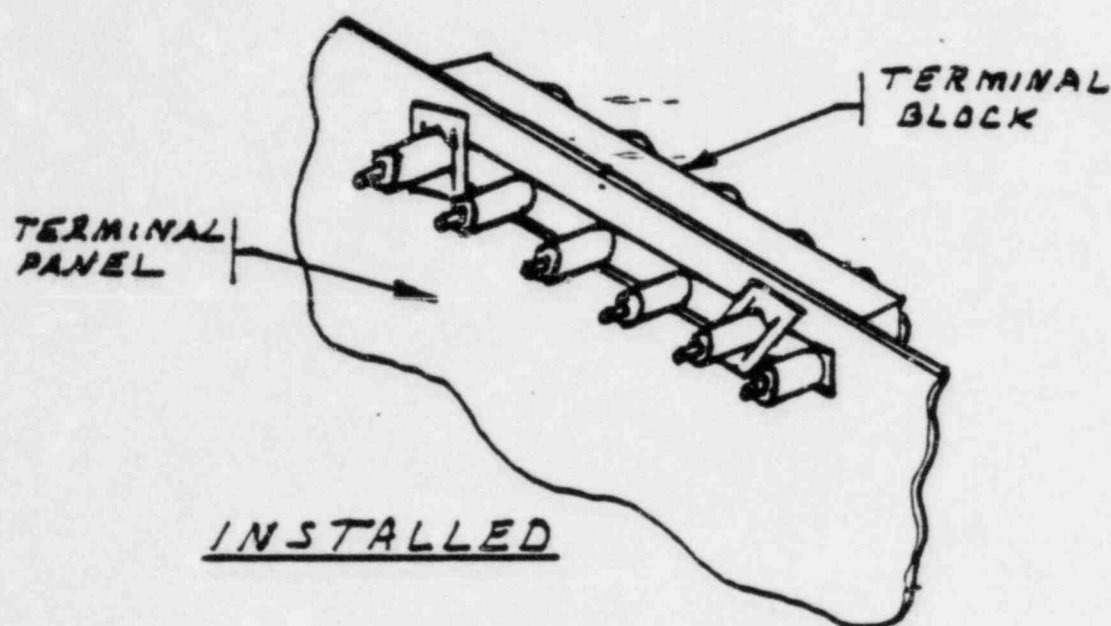
Loose clips were discovered during a cursory inspection of instrument cabinets at Oconee Unit 1 by Duke personnel. The clips, which are Tinnerman Push-On Speed Nuts, catalog No. C 7818-014-67, are used to secure the terminal blocks to the rear terminal panels of instrument cabinets. A speed nut or clip is a thin rectangular strip of spring steel, approximately 1/2"x 5/8", with a central hole. The strip has a slight curvature and is perforated to form 2 jaws that grip the post on which the clip is placed in such a manner as to allow the clip to be pressed on but to resist removal from the post. The speed nut is pushed on over the insulated post which surrounds each terminal on the system wiring side of the panel (see attached sketch). The following discrepancies were discovered at Oconee Unit 1:

TINNERMAN SPEED NUT
USED AS A TERMINAL
BLOCK FASTENER

B&W has advised Duke Power Company (letter No. ONS-82-118 dated August 20, 1982) to locate and remove all speed nuts No. C7818-014-67 (aluminum finish) and replace them with speed nuts No. C185-014-4 (dull, dark finish). There are significant differences between the two fasteners in inside dimensions, material thickness and material hardness. The superior properties of No. C185-014-4 have led to its current exclusive use by Bailey Controls Company (BCCo).
