WASHINGTON PUBLIC POWER SUPPLY SYSTEM
NUCLEAR PROJECT NO. 2
DOCKET NO. 50-397
LICENSE NO. CPPR-93
10CFR50.55(e) CONDITION #258
RHR HEAT EXCHANGER INSTALLATION

INTERIM REPORT

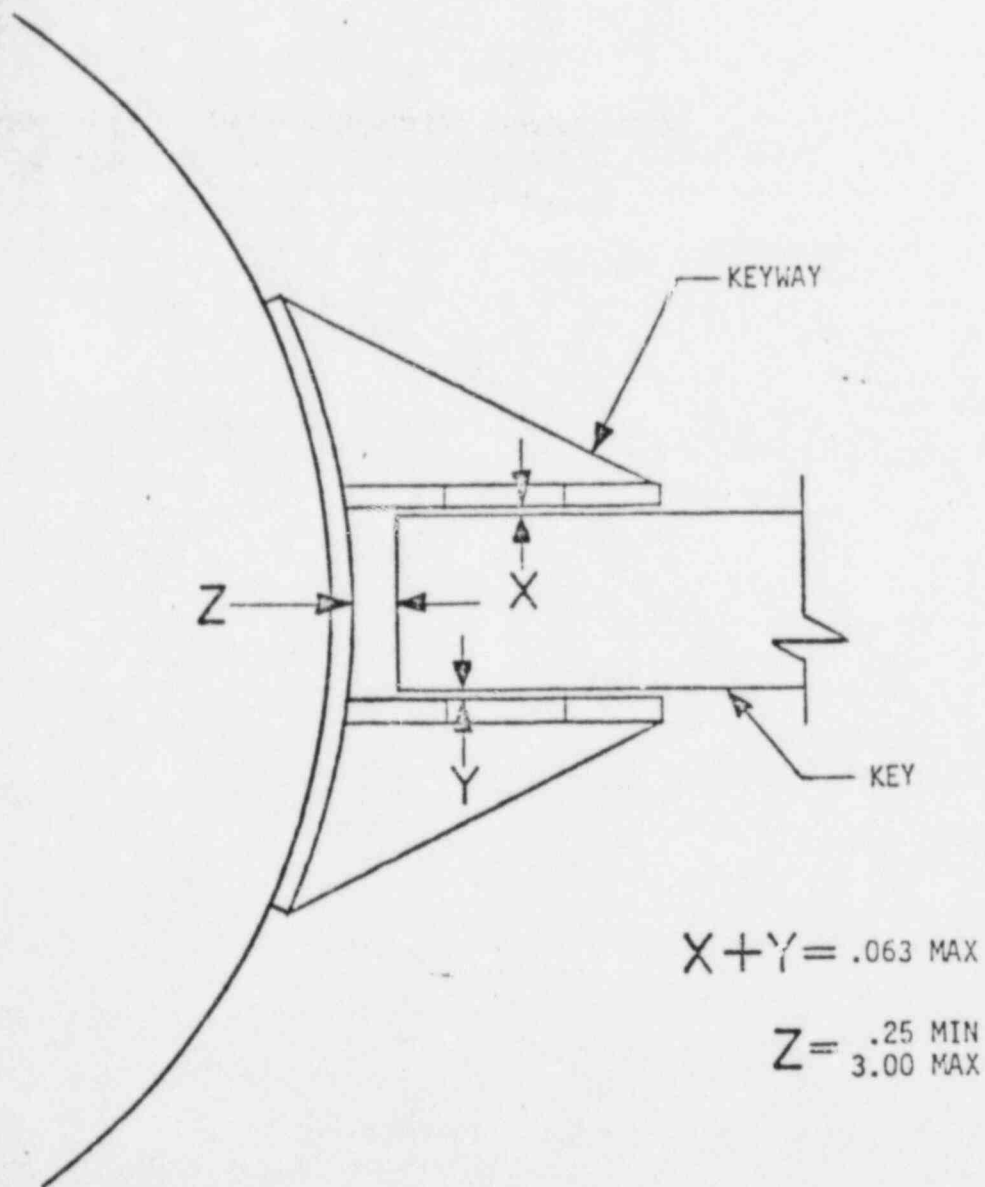
FIG. 5-1

The requirements for shims on the RHR heat exchangers (Ref. Attachment 3) at the bottom support are to transfer shear forces into the baseplate, and at the top keyway brackets to control movement, both conditions imposed by a seismic event. The absence of the shims would impose undefined loads into the building support structure, the heat exchangers supports and connected piping, which is unacceptable.

KEY TO KEYWAY FITUP

The contractor review determined that an open PED (215-CS-2677, dated April 8, 1980) existed concerning shimming the top keyway (guide) which indicated the contractors (WBG/Bechtel) were aware of shimming requirements in this area, although they had never been implemented.

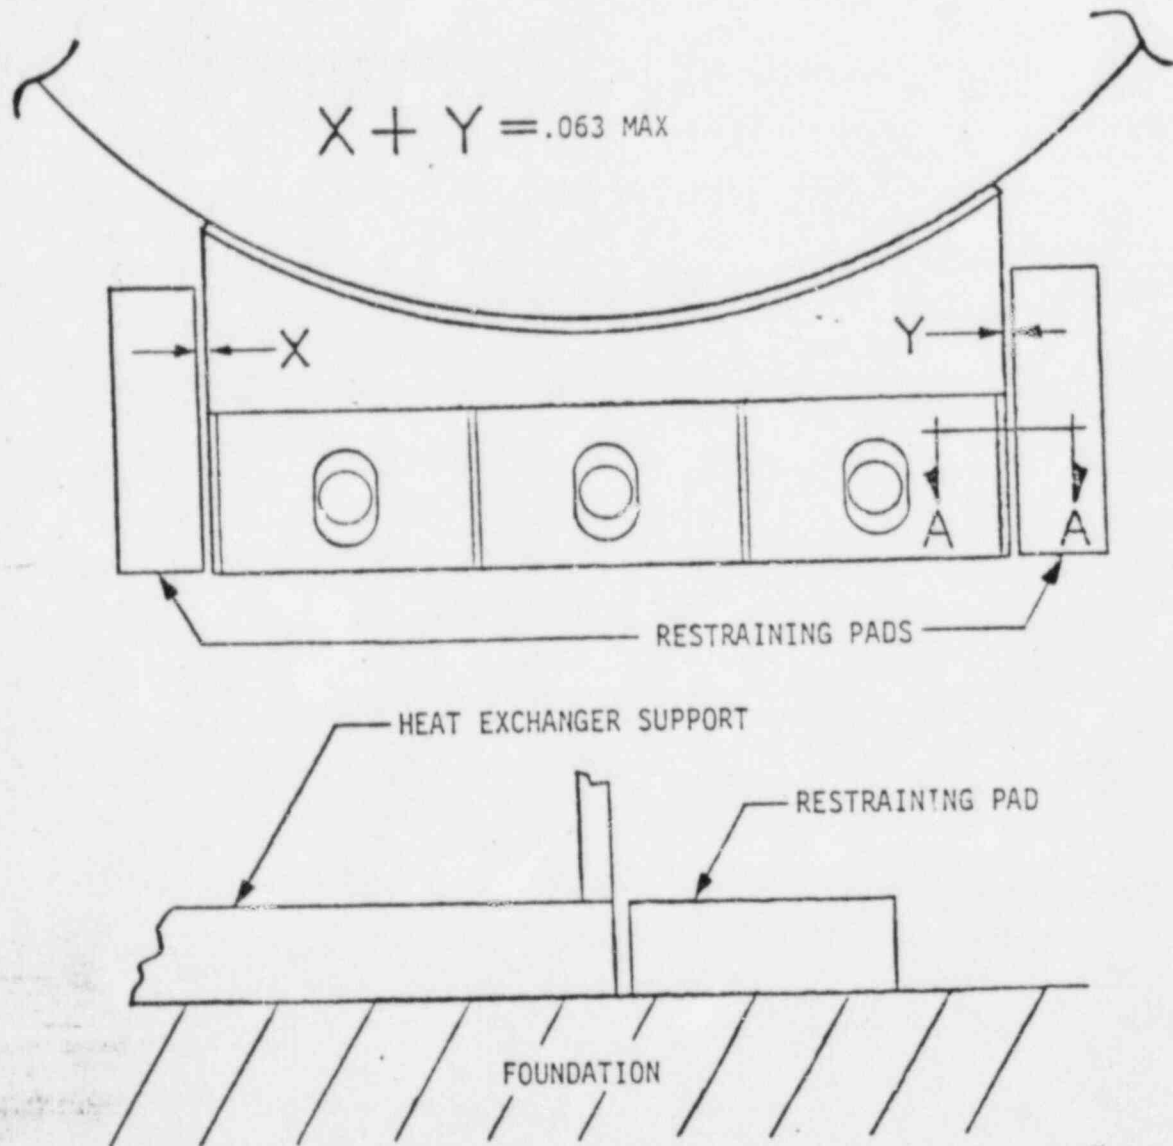
SECTION A-A

SUPPORT RESTRAINING PADS

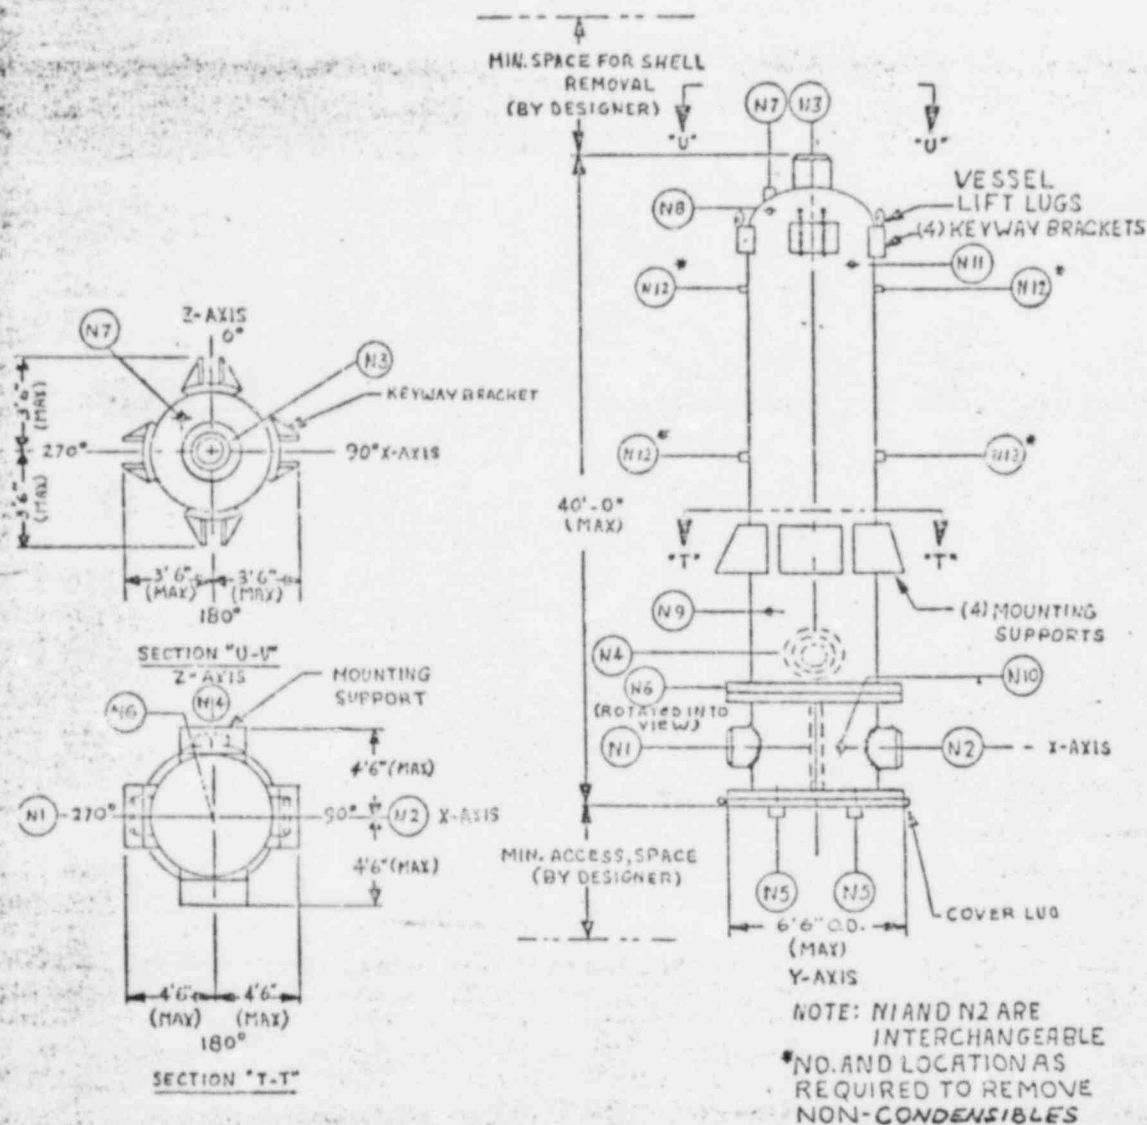
FIGURE 1
RHR HEAT EXCHANGER

The RHR system has been subjected to an independent design review. A review of the RHR heat exchanger installation package identified that the installation requirements of General Electric specification 22A5233 "Installation Instruction for RHR Heat Exchanger" were not complied with. Requirements for shims to be placed to meet the requirements of FIG. 5-1 and 5-3 (attached) had not been implemented. Field inspection verified that the shims had in fact not been installed as required.

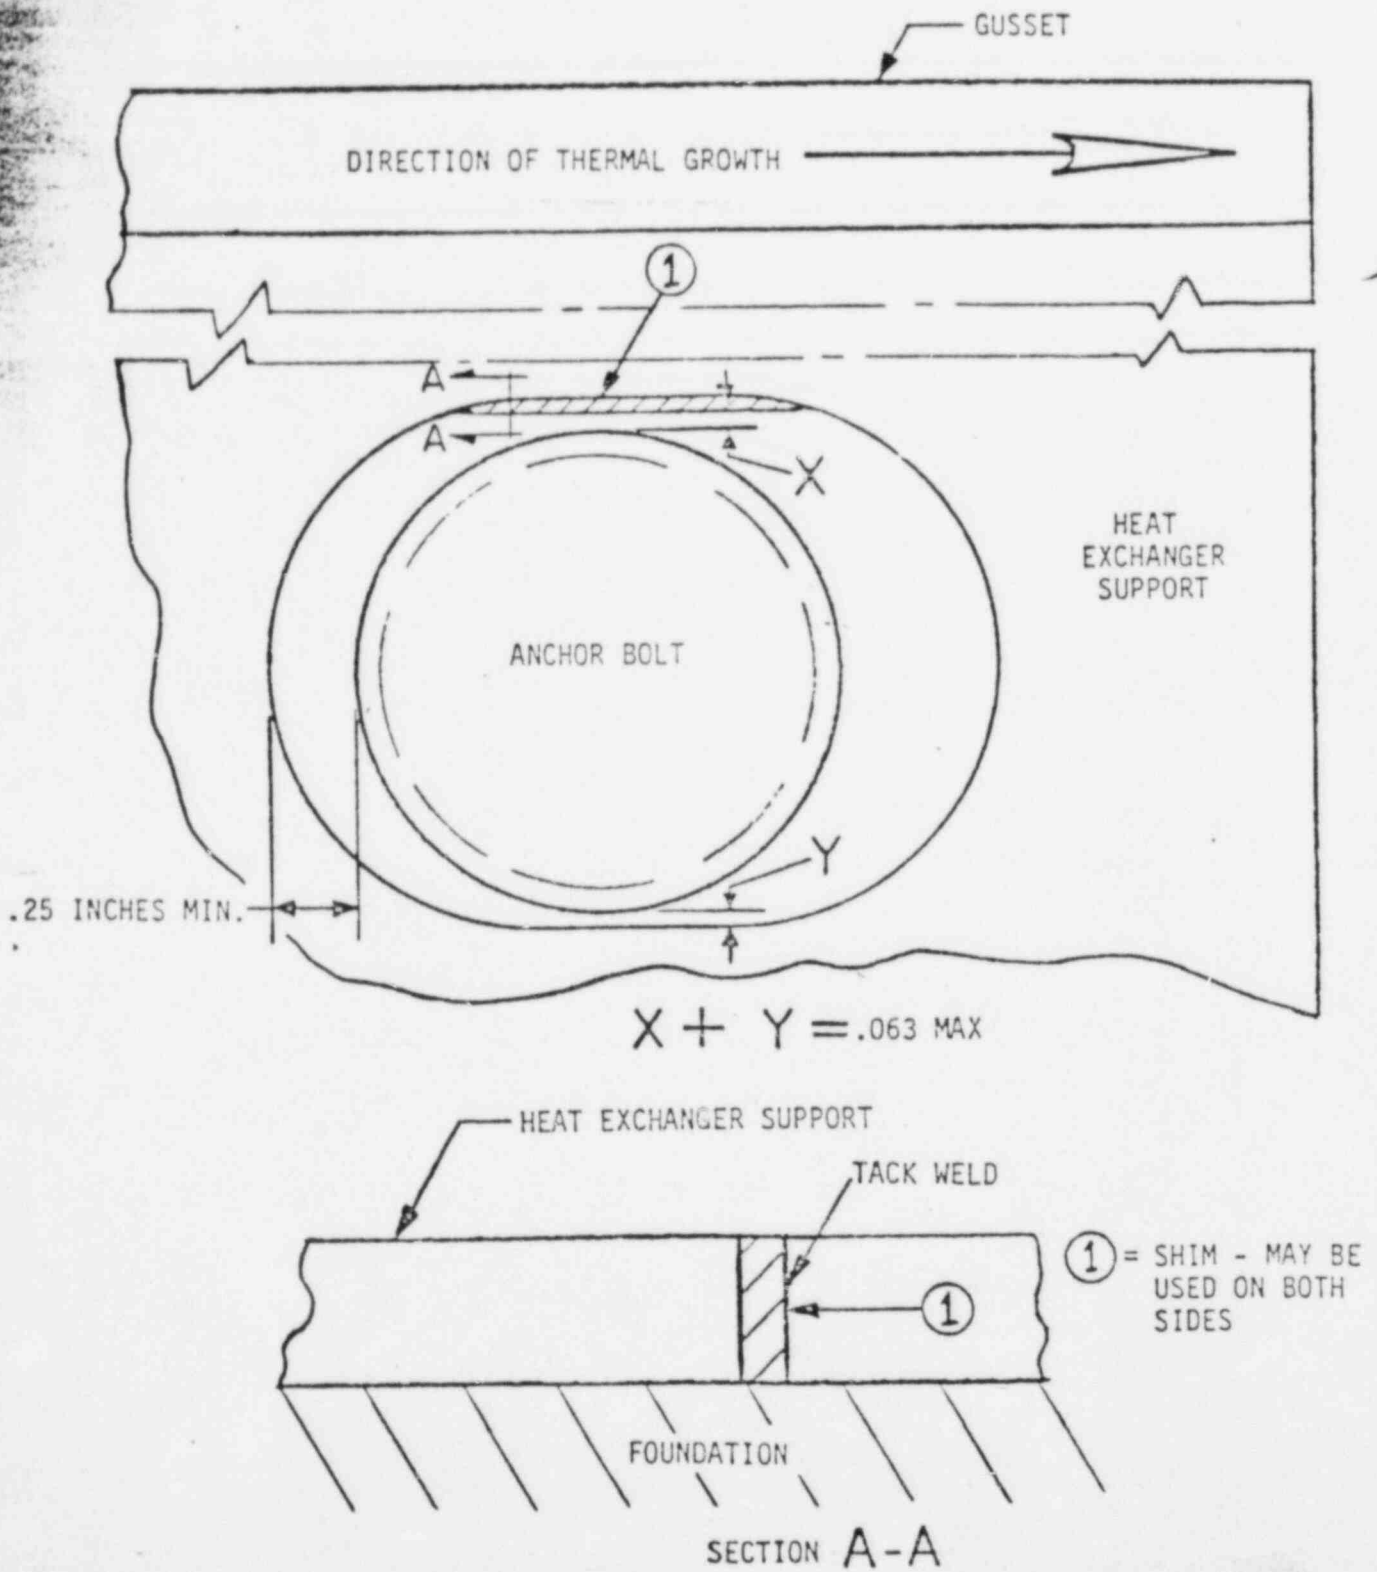
ANCHOR BOLT SHIMMING METHOD

Due to the status of construction on the baseplates, Burns and Roe issued PED 215-CS-P531 to install new shear plates in lieu of the shims indicated in FIG. 5-2 (attached). The contractor has completed implementation of these PED's (215-CS-2677 and 215-CS-P531) and is also conducting an extensive review of the equipment installation and align records. Three hundred eighty-three (383) equipment packages have been identified for review and sixty-three (63) have been completed as of June 20, 1983.
