SNUPPS

SUBJ: Significant Deficiency Report (SDR)
83-03 re Design and Installation of
U-Bolt Restraints

SDR 83-03
Significant Deficiency Report (10CFR50.55e)
on the
Design and Installation of
U-Bolt Restraints
for
SNUPPS Projects

Attachment A: SGN-2, Small Pipe Standard Supports

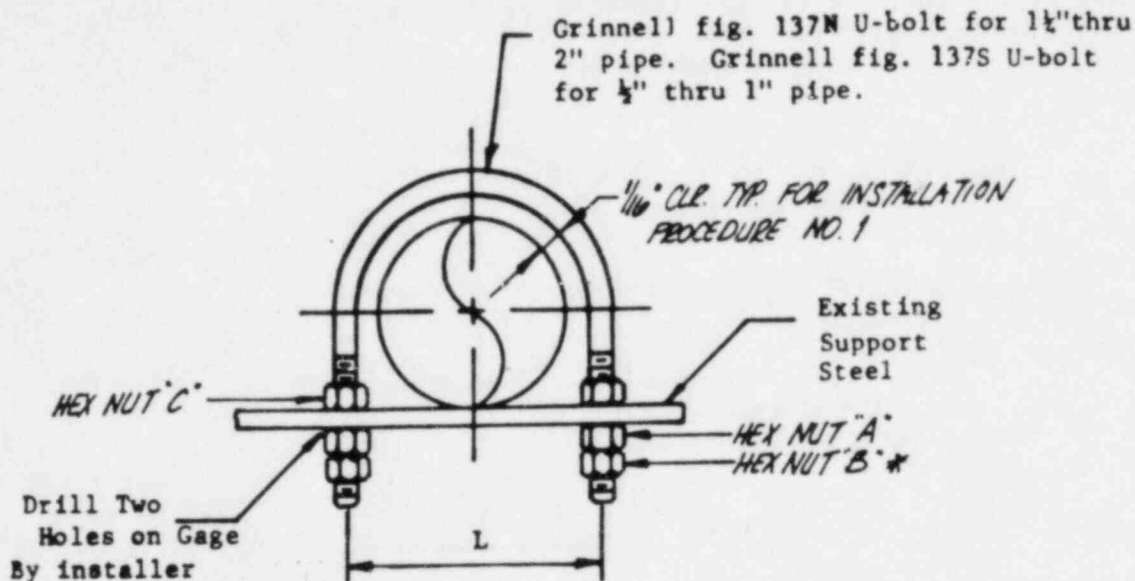
The problem was initially created by a conflict between two design drawings prepared by Bechtel in early 1979, both of which are required for installation of small piping U-bolt restraints. One drawing, which contains pipe support configurations, pictorially depicts a double nut arrangement on the underside of the U-bolt to function as a positive locking mechanism. Another drawing, called out on the first drawing as a reference for installation details, indicated only a single nut on the underside of the bolt. The

Constructor at both jobsites utilized the second drawing for field installation with the result that only a single nut was provided. This conflict in design detail with the seismically designed, non-safety-related restraints required for small piping systems was identified in mid-1982 and necessary design document changes were made last September to eliminate the conflict and to bring both design documents into conformance with the approved design basis. Revised design details providing for a double-nut locking arrangement for required II/I and seismically-designed, nonsafety-related, small piping system restraints were released to both jobsites at that time.

* NUT B REQUIRED FOR "Q" AND SEISMIC SUPPORT APPLICATIONS ONLY.

Measures are being initiated at both jobsites to identify all seismically-designed U-bolt restraints requiring a double nut locking mechanism, and to install the additional nut (jam nut) where required. This effort will be completed on a prioritized basis consistent with current construction schedules. In addition, installation procedures for Callaway Site have been corrected to call out the jam nut. The large pipe restraints with incorrect design features are in process of revision and will be reissued by the end of February, 1983. All other supports utilizing the U-bolt restraint mechanism have been examined by the Architect-Engineer and are verified to be of correct design.

1. INSTALL NUTS 'A' & 'C' ON BOTH SIDES OF EXIST. SUPPORT STEEL & U-BOLT. HAND TIGHTEN UP TO SUPPORT STEEL.
2. INSTALL NUT 'B' AND LOCK IN PLACE. (WHEN APPLICABLE)
