In the Matter of)
LONG ISLAND LIGHTING COMPANY) Docket No. 50-322 (OL)
(Shoreham Nuclear Power Station,)
Unit 1))

AFFIDAVIT OF
RICHARD A. PRATT

FAILURE ANALYSIS REPORT
TRANSAMERICA DELAVAL INC. ENGINE & COMPRESSOR DIVISION

<u>Customer</u>	<u>Engine No.</u>	<u>Part or Assembly No.</u>	<u>RMR No.</u>	<u>Date</u>	<u>F.A. No.</u>
LILCO	74010/012	03-360-03-OF	9496	March 28, 1983	0150

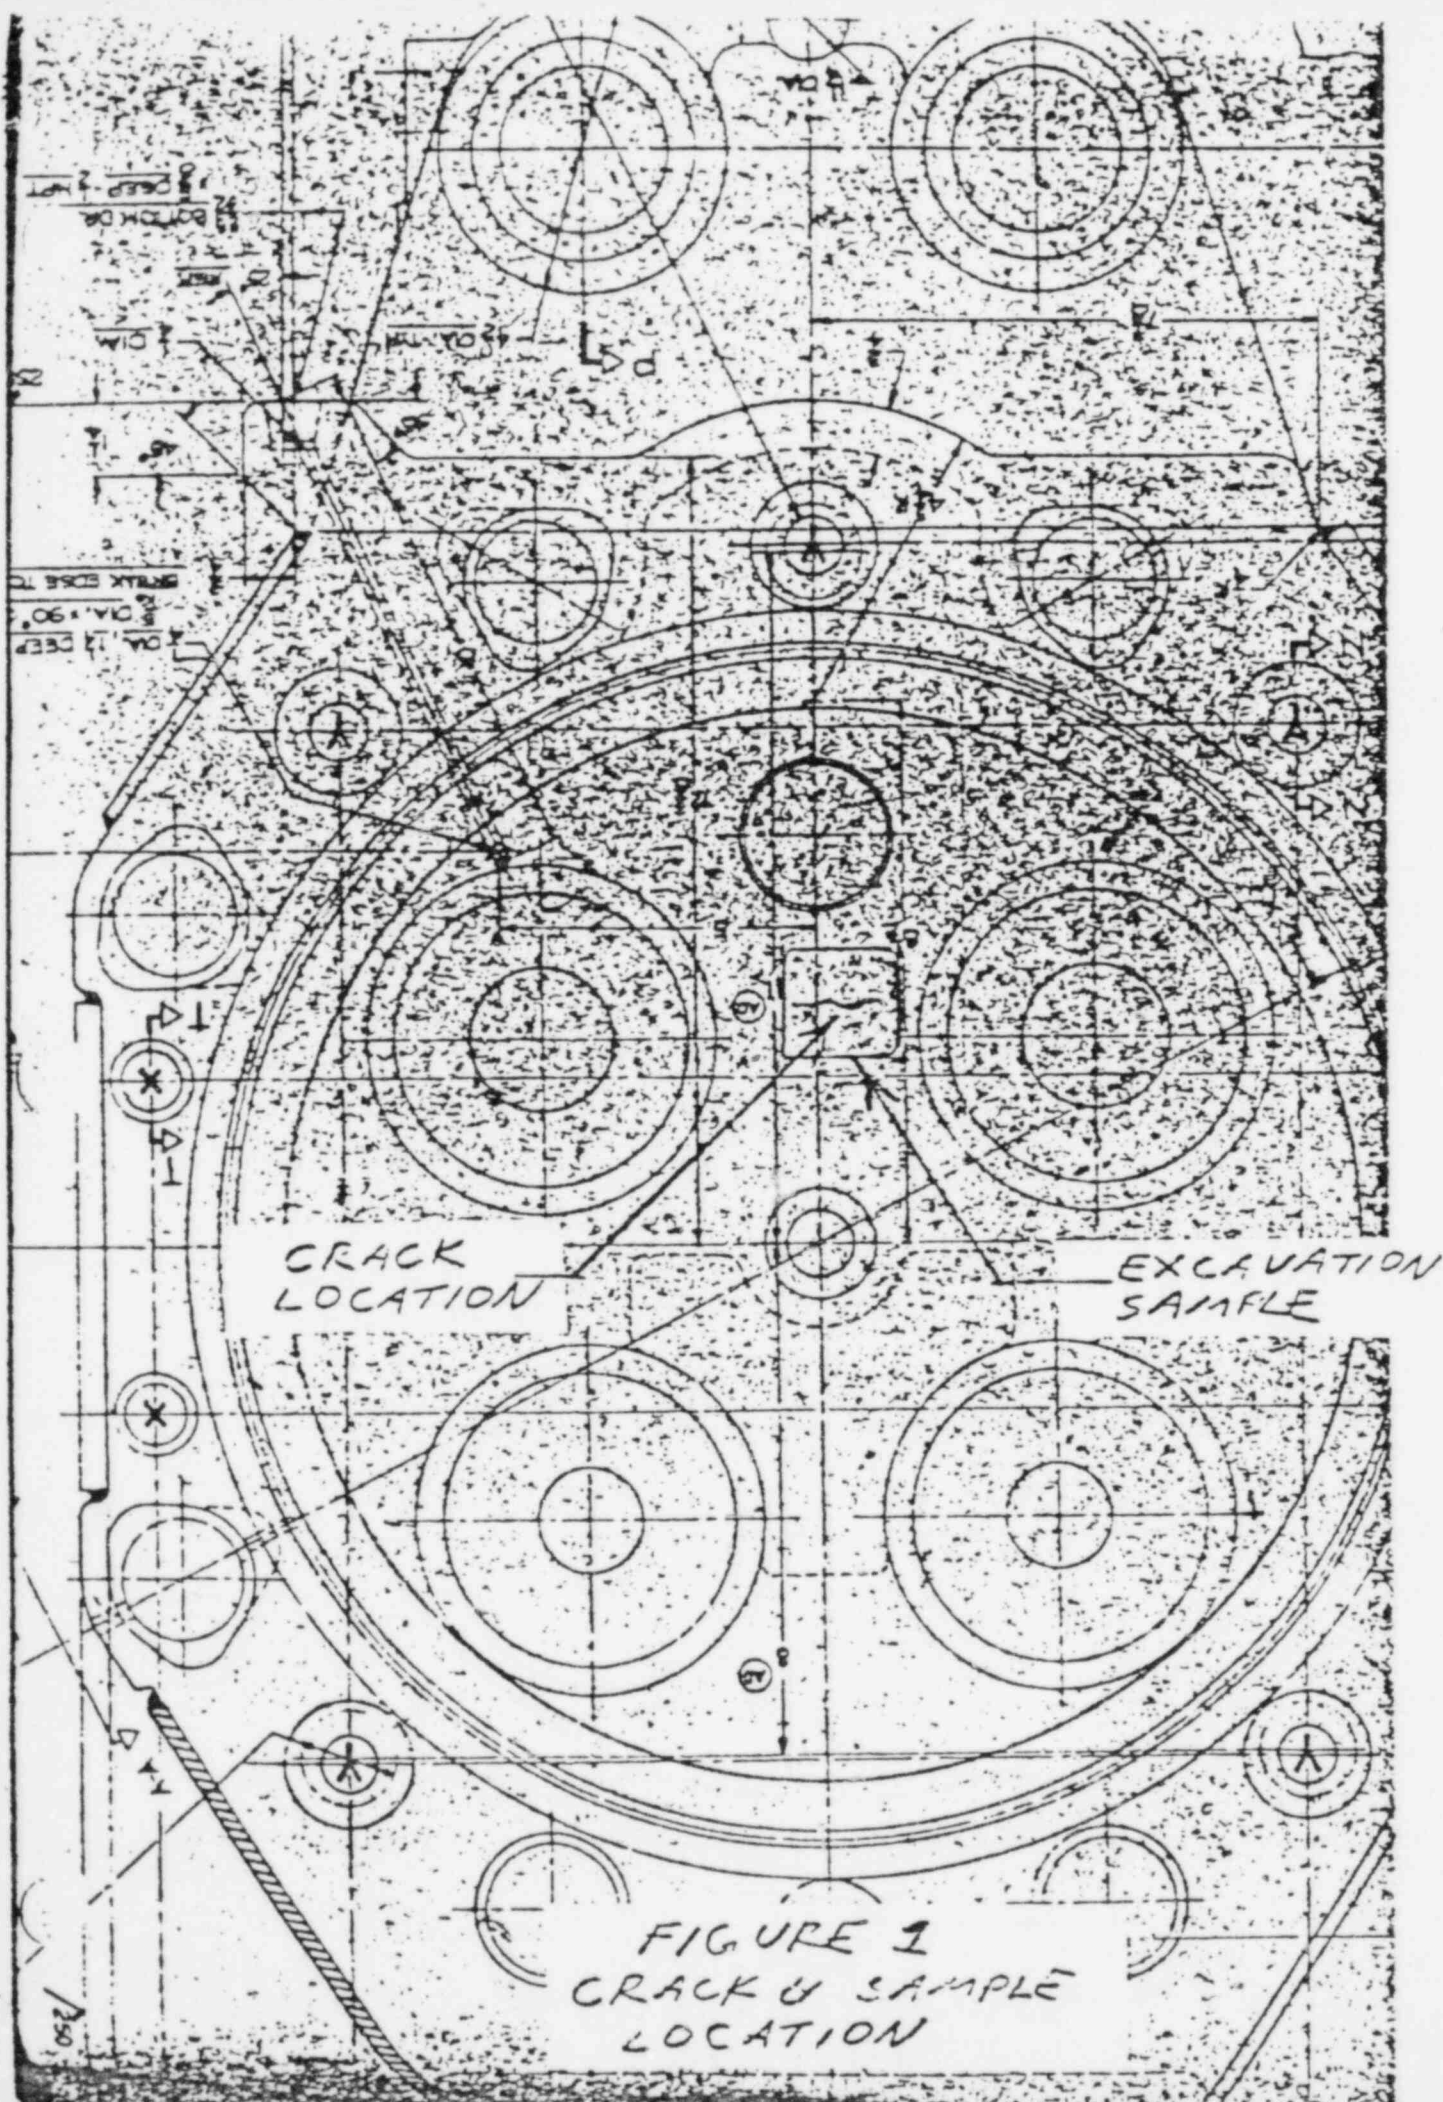
3. The head was then hydrostatically tested at 100 psi. A seepage leak was noted and marked between the intake and valve seats (see figure 1).
4. A 1-3/4" X 2-3/16" section of the fire deck containing the crack was removed from the fire deck by milling.

5. After a visual inspection, the sample was forced open. Microscopic inspection revealed a quench crack (hot tear), which probably resulted from shrinkage of the casting during cooling. (See Photo 1). The tear covered about 80% of the sample section. Products of oxidation and corrosion filled the cracked region, typical of a hot tear. Microscopic examination confirmed this crack ran in all three planes. There was no evidence of propagation of the crack past the original hot tear, nor was there any sign of fatigue failure.

6. The sample section measured 7/16" thick. Drawing specification for this section is 3/4". Evidently, a core print broke off, allowing the core to float and the fire deck section was cast thin. This thin section cooled at a more rapid rate than the surrounding metal and the hot tear resulted. Ultrasonic testing confirms the fire deck is thin in other areas also.

Typically, cracks in the fire deck are not encountered between the intake valve seats. Something unusual must happen, such as the core print breaking, for a hot tear to occur. Sporadic hot tears were encountered in cylinder heads manufactured in the early and mid 1970's. Subsequent improvements in casting techniques (gating, chills, new risers, etc.) have effectively eliminated this problem.

These heads were not originally stress relieved and were hydr-tested at a lower pressure (75 psi). Thus, the hot tear went undetected. With stress relief, higher pressure hydro test, ultrasonic testing and other current production/inspection techniques - such a defect would normally be detected.

The failure of this head is attributed to a casting defect, undetected in the manufacturing process, which evidenced itself only after considerable firing cycles had occurred. Prevention/detection of such defects has improved, so they are now located and corrected in the manufacturing process.

7. The thin section will be milled out of the fire deck and material of the correct thickness will be welded in place. Since the head is dispositioned as suitable for repair, further destructive testing will not be done.

This crack would not have caused a catastrophic failure of the engine or compromised its ability to carry full load, as the water leak rate is very slow. The head is repairable, and will be processed under the factory cylinder head rework program.
