Voluntary Report under
10 CFR Part 50,
Section 50.73

MONTICELLO NUCLEAR GENERATING PLANT
Docket No. 50-263 License No. DPR-22

Structural Beam Connections Associated With the Cable
Spreading Room Floor Found to be Different Than Design

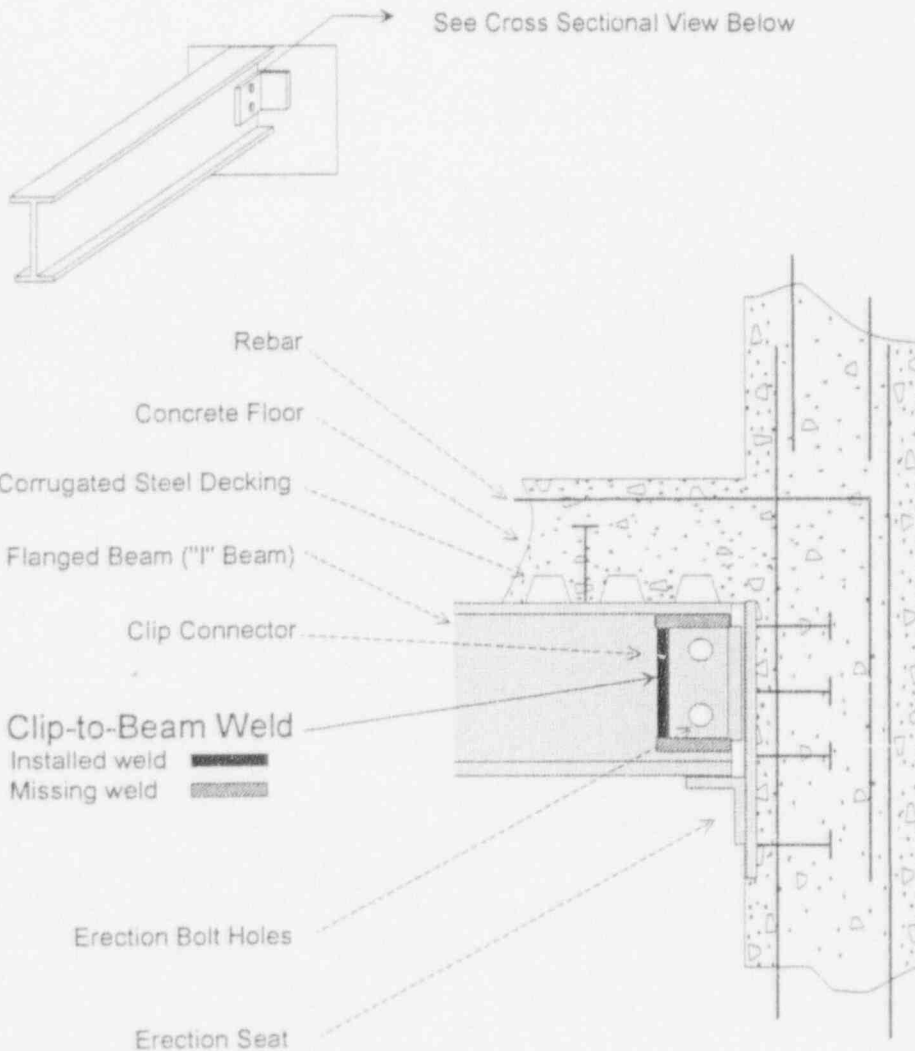
**TYPICAL CABLE SPREADING ROOM FLOOR
FIELD WELDED BEAM CONNECTIONS**

This type of connection is shown in Figure 1. The original design specified a full weld between the clip and the beam, e.g., a vertical weld and a top and bottom weld. The engineer identified several beams in the Cable Spreading Room floor that did not have the top and bottom horizontal weld (only the vertical weld). Discussions with an individual on the original construction team indicated that documentation approving this variance may exist. A review of the original plant Field Change Requests and Design Change Requests did not locate any documentation of this variance.

During original construction (1968), the construction workers that welded the clips to the beams and girders did not install the clips in accordance with the specified design.

2. At the same time the additional analysis was being conducted, high strength bolts (A325) were purchased to be placed in the erection bolt holes (See Figure). These bolts were added to five of the higher stressed connections to increase their load carrying capacity by developing friction type connections. It was later determined that the connections did not require the high strength bolts to be operable.
3. Other areas of the plant were reviewed to see if similar non-conforming field welds existed on field welded beam connections. Most of the field connections in the plant were found to be similar to the Cable Spreading Room floor, i.e., not in conformance with the specified design. Most of the welded connections (approximately 80%) are shop welds with which we have found no discrepancies.
