ATTACHMENT 1
ANO-2 CYCLE 2 REFUELING OUTAGE
FUEL EXAMINATION RESULTS
MARCH 17, 1983

ATTACHMENT 1
ANO-2 CYCLE 2 REFUELING OUTAGE
FUEL EXAMINATION RESULTS

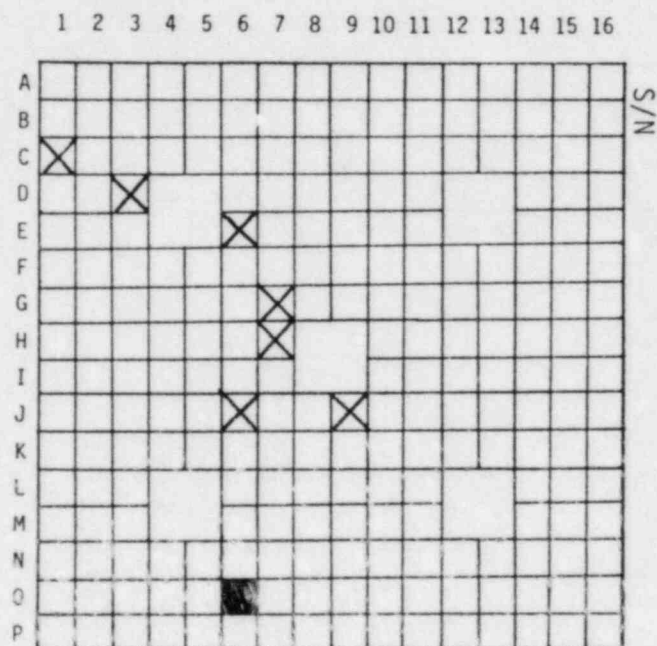
Assembly AKC 212

Table I lists all of the leaking assemblies detected and gives further details of the reconstitution effort. Figures 1a and 1b present the locations of the leaking rods, and the other rods that were replaced. Also shown are the locations of two inadvertant rod interchanges that occurred during fuel assembly reconstitution.

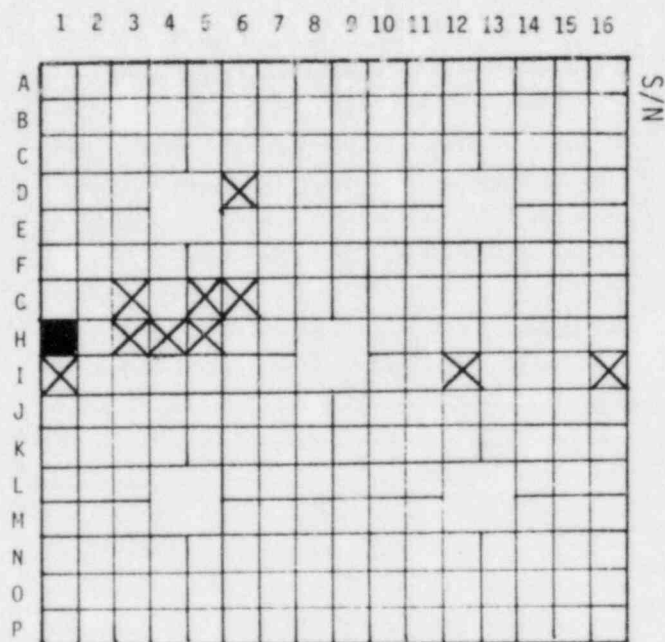
Assembly AKC 401

A perforated fuel rod was observed on the East face of this assembly. The peripheral fuel rod, number 8, was heavily hydrided approximately 5-1/2 inches below the centerline of Grid 8. The hydrided region extended axially approximately 3/4 to 1 inch and 360° circumferentially. The rod was completely separated into two pieces at the damaged region. No apparent cause of the rod perforation was discernable. This assembly was reconstituted and re-inserted into the core for Cycle 3 exposure.

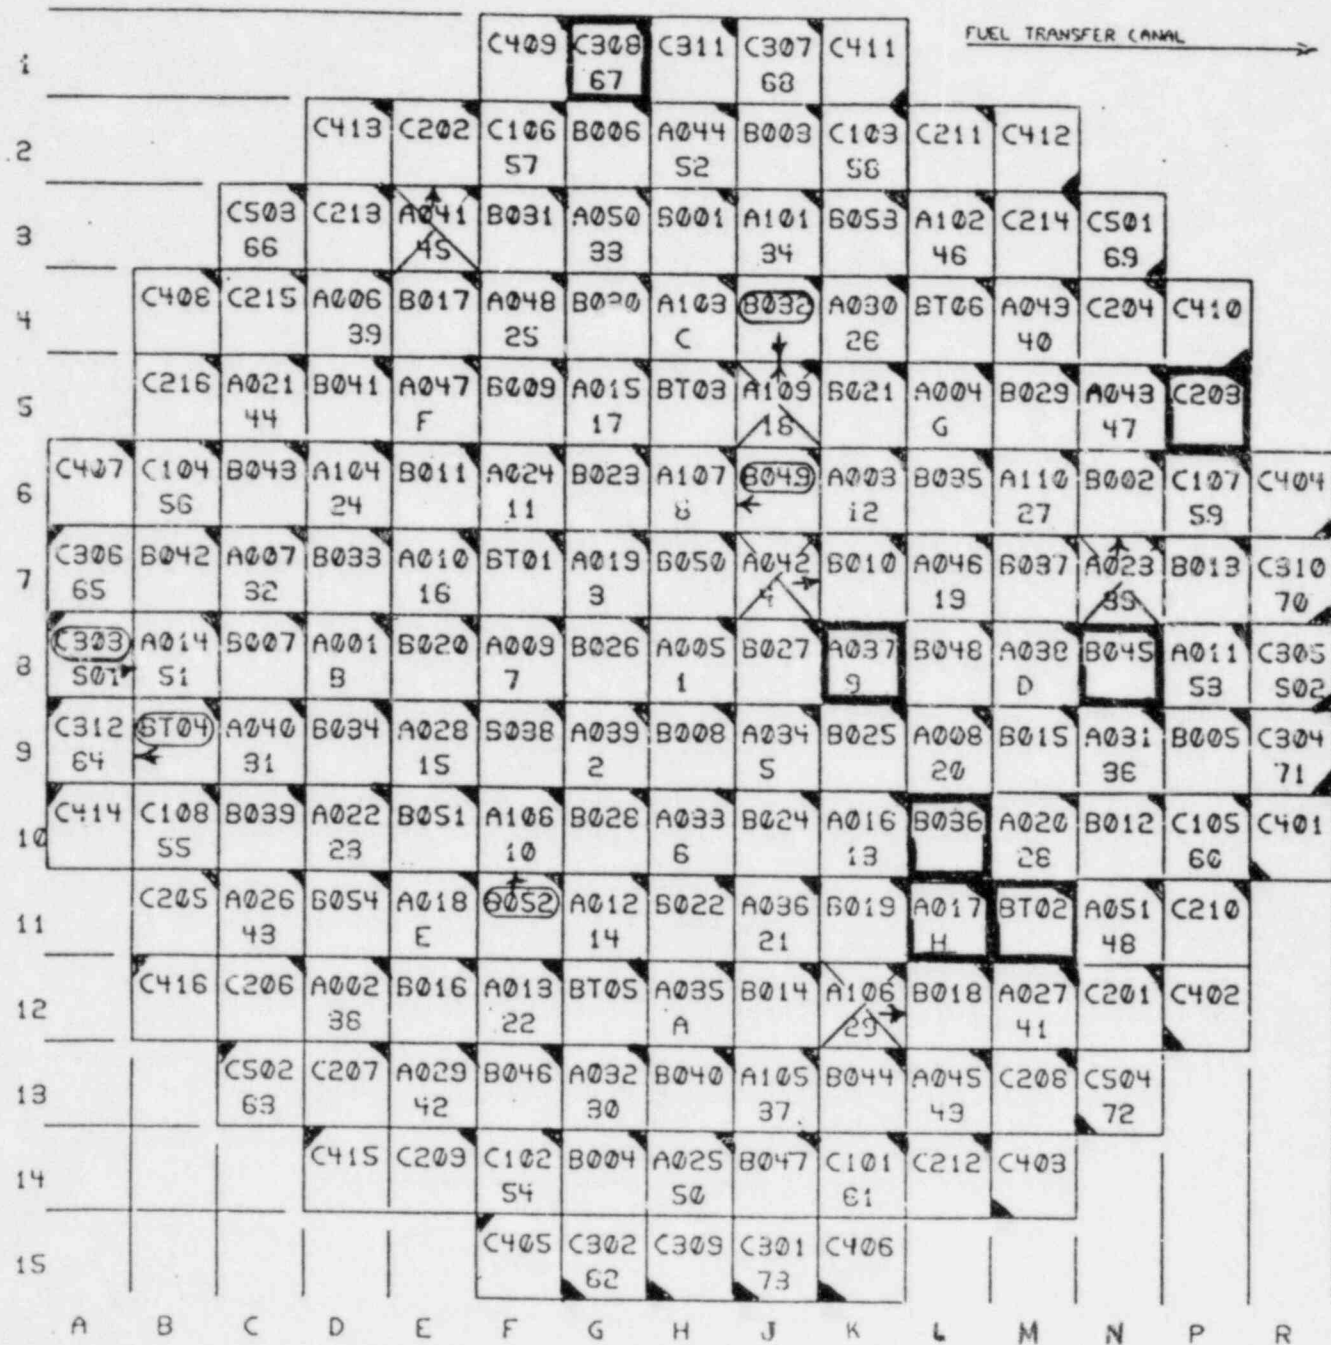
FIGURE 2

The core loadings for cycle 1 and cycle 2 are shown in Figures 2 and 3, respectively. The assemblies which were found to be leaking at the end of each cycle are identified by heavy outlines. In the case of cycle 1, two of the assemblies, AKC-308 and AKC-203, were located on the

periphery against the core shroud. However, the reason for failure of AKC-203, fretting from material trapped by the bottom grid, has already been noted. In addition, the failed rods in assembly AKC-308 were distributed throughout the assembly and could not be associated with shroud wear with the possible exception of a corner poison rod which had a perforation at grid 8. Furthermore, none of the leaking assemblies in cycle 2 were located on the core periphery. Therefore, although some grid to shroud wear has been observed, it has not been a significant cause of perforated rods. Although there were three out of seven leakers in cycle 1 in adjoining locations, none of the cycle 2 leakers shared a common face or even a corner. In the first two cycles, then, assembly location has not been a major factor in causing fuel rod perforations.

A concern still existed over what grid strap damage might have occurred on the unexamined assemblies and gone into cycle 2 core. As Table IV shows, grid damage was detected at EOC 2 on five assemblies: AKB-032, AKB-T04, AKB-049, AKB-052, and AKC-303. In the case of the last two assemblies, the damage was minor. Only one of the assemblies, AKB-032, contained a leaking fuel rod. No bright metal surfaces were detected at the tears and, due to the generally corroded condition, it was believed the damage probably took place during the cycle 1 outage. All of the assemblies with grid damage, both major and minor; are shown on the cycle 1 core map presented in Figure 2. The faces on which the damage was found are also indicated. In one case, between assemblies AKB-032 and AKA-109, damaged grid to damaged grid contact can be observed. As noted in Table I, the grid strip damage to AKB-032 may have contributed to a failed rod in this assembly during cycle 2. In the eight other cases of grid damage shown in Figure 2, six of the facing assemblies were visually inspected either after cycle 1 or cycle

2, and no damage was found. In general, then, damage to the grid of one assembly does not usually mean that the grid of the facing assembly also incurred damage.
