FINAL REPORT OF

GE TYPE AK-2-25
CIRCUIT BREAKER
S/N 228A4389-200-8MG

FLORIDA POWER & LIGHT COMPANY'S
ST. LUCIE NUCLEAR PLANT UNIT 1

GE NUCLEAR ENERGY
NORCROSS, GEORGIA

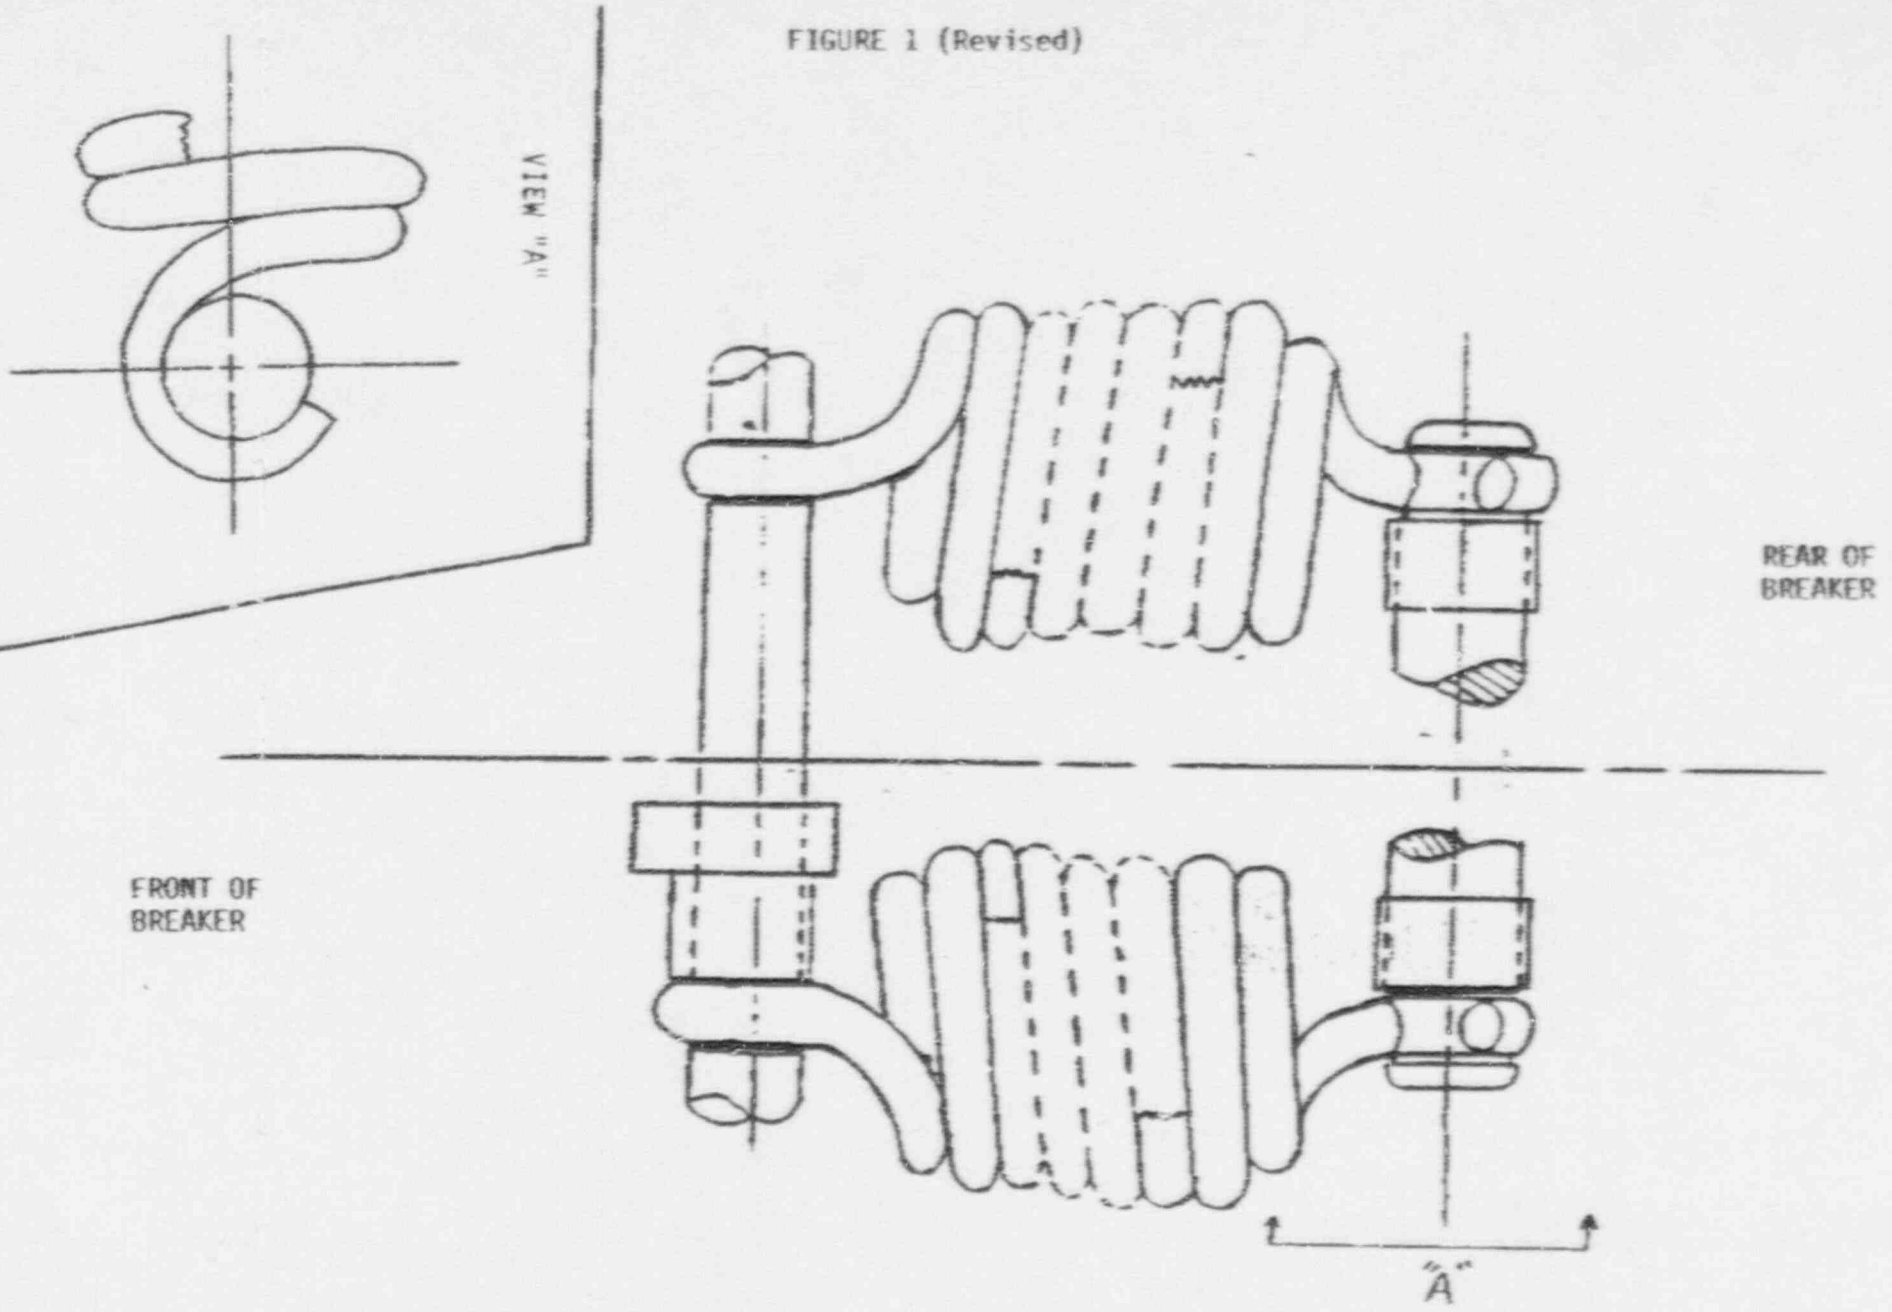
FIGURE 1 (Revised)

In the case of the circuit breaker operating springs, a drawing revision (Revision 6) was made in late 1985 to reflect in the drawing the preferred manufacturing installation orientation of springs during the manufacturing process. In essence, this change rolled each spring 180° longitudinally and, as a result of this roll, swapped the left hand spring to the right side of the breaker and the right hand spring to the left side of the breaker in order to retain the correct orientation and operation of the springs. This new spring orientation is shown in Figure 1 while the older orientation is shown in Figure 2.

In either orientation, the intent is for the curve between the spring hook and the first spring coil to curve away from the centerline of the circuit breaker.

4. The actual orientation of the springs is satisfactory if they are installed in accordance with either Figure 1 or Figure 2.
5. This failure occurrence points out a potential for a common cause error involving incorrect selection of the spring during breaker assembly. However, the consequent breaker failure appears to be random. The St. Lucie "failed" breaker in fact operated properly and passed all functional tests for a period of four (4) years prior to failure.

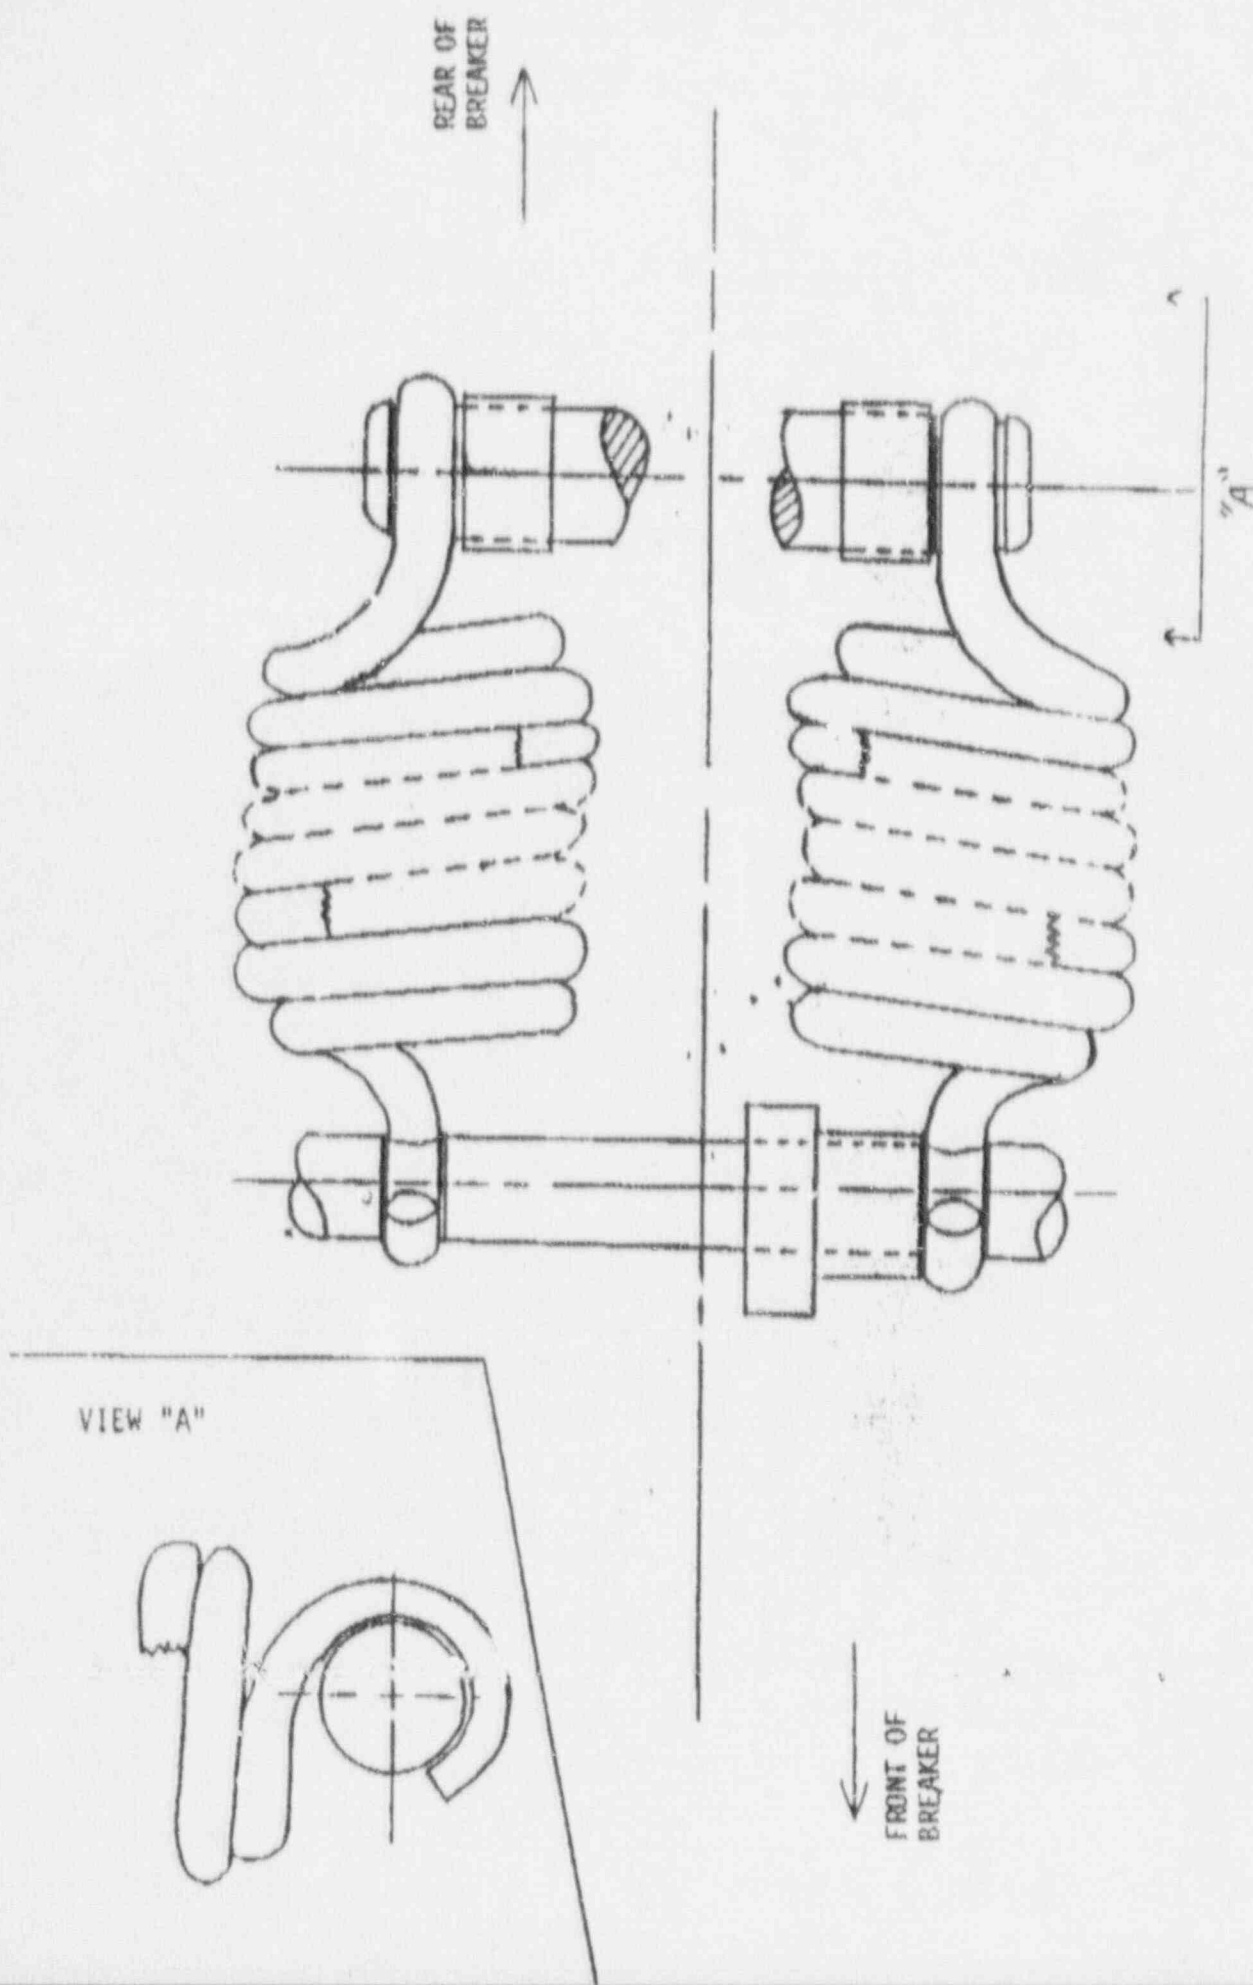
FIGURE 2 (Revised)

3. If a circuit breaker loses both operating springs, the breaker will not close.
4. The actual spring configuration appears to be one of the factors affecting whether the spring(s) disengages or not. While a spring orientation (as shown in Figure 2 attached) appears to be less likely to disengage, the disengagement is not repeatable; therefore, no firm conclusion can be reached. (This configuration did not fail during the evaluation testing.)
5. Since the spring disengagement cannot be reproduced with any certainty, the exact disengagement cause cannot be determined.
