CHARLES H. CRUSE  
Plant General Manager  
Calvert Cliffs Nuclear Power Plant

SUBJECT: Calvert Cliffs Nuclear Power Plant  
Unit No. 2; Docket No. 50-318; License No. DPR 69  
Licensee Event Report 94-004  
Unit 2 Reactor Trip Due to Main Generator Trip

Unit 2 Reactor Trip Due to Main Generator Trip

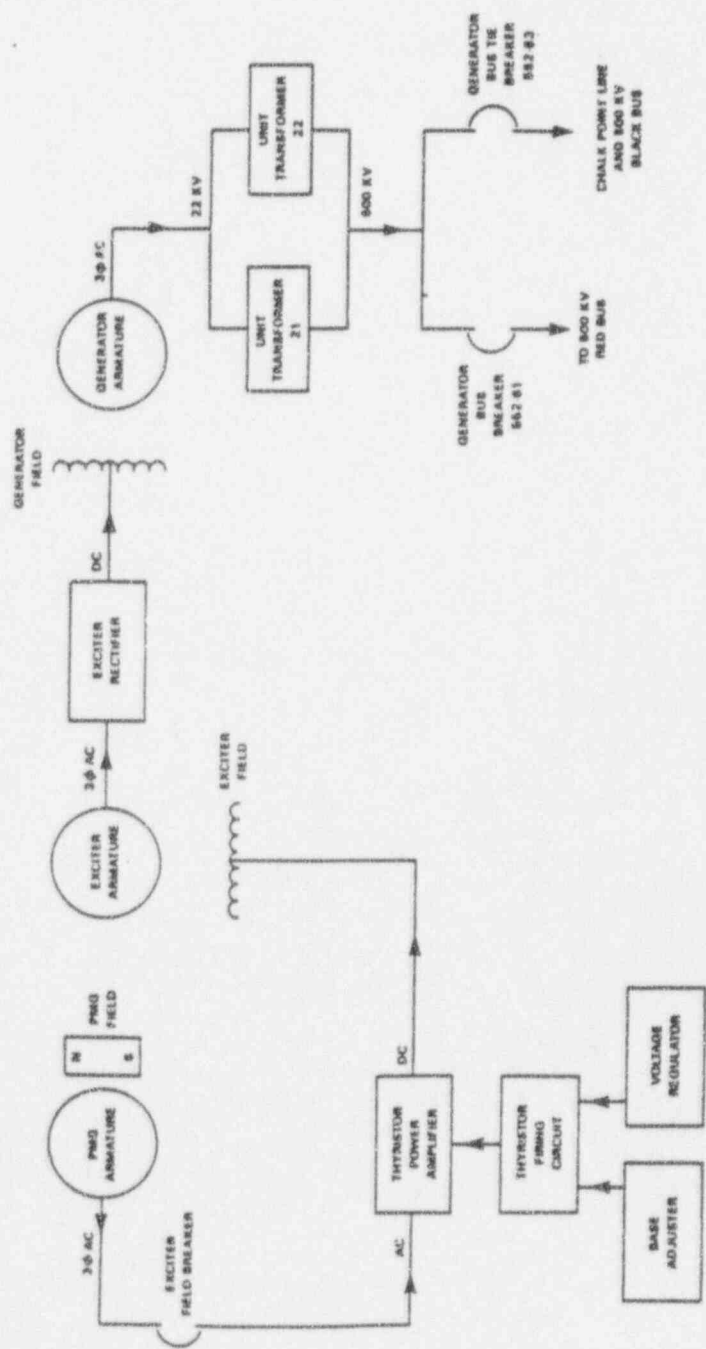
FIGURE 1  
CALVERT CLIFFS UNIT 2 -- MAIN GENERATOR

The main generator is a Westinghouse synchronous AC, three-phase, four-pole electrical generator. The generator's excitation system supplies DC excitation to the main generator field and adjusts excitation to maintain constant generator output voltage under changing load conditions. The excitation system consists of an exciter, exciter rectifier, a permanent magnet generator, a thyristor power amplifier, a thyristor firing circuit, a base adjuster, and a voltage regulator (Figure 1). The level of excitation supplied to the main generator rotor windings is controlled by a signal from the thyristor firing circuit.

The inputs to the thyristor firing circuit are from the base adjuster and voltage regulator. The base adjuster adjusts the exciter field to maintain a constant main generator field voltage. The voltage regulator adjusts the exciter field to maintain a constant main generator output voltage. When the voltage regulator is ON, main generator excitation is supplied by a combination of outputs from both the base adjuster and voltage regulator. In addition to other protection circuits that protect the generator from abnormal operating conditions, a minimum excitation limiting (MEL) circuit provides input to the voltage regulator to ensure a minimum value of generator field voltage is maintained.
