OYSTER CREEK CORE SPRAY SYSTEM
INSPECTION PROGRAM

TOPICAL REPORT NO. TR-080

Project No. 328203

OYSTER CREEK CORE SPRAY SPARGER SYSTEM
INSPECTION PROGRAM

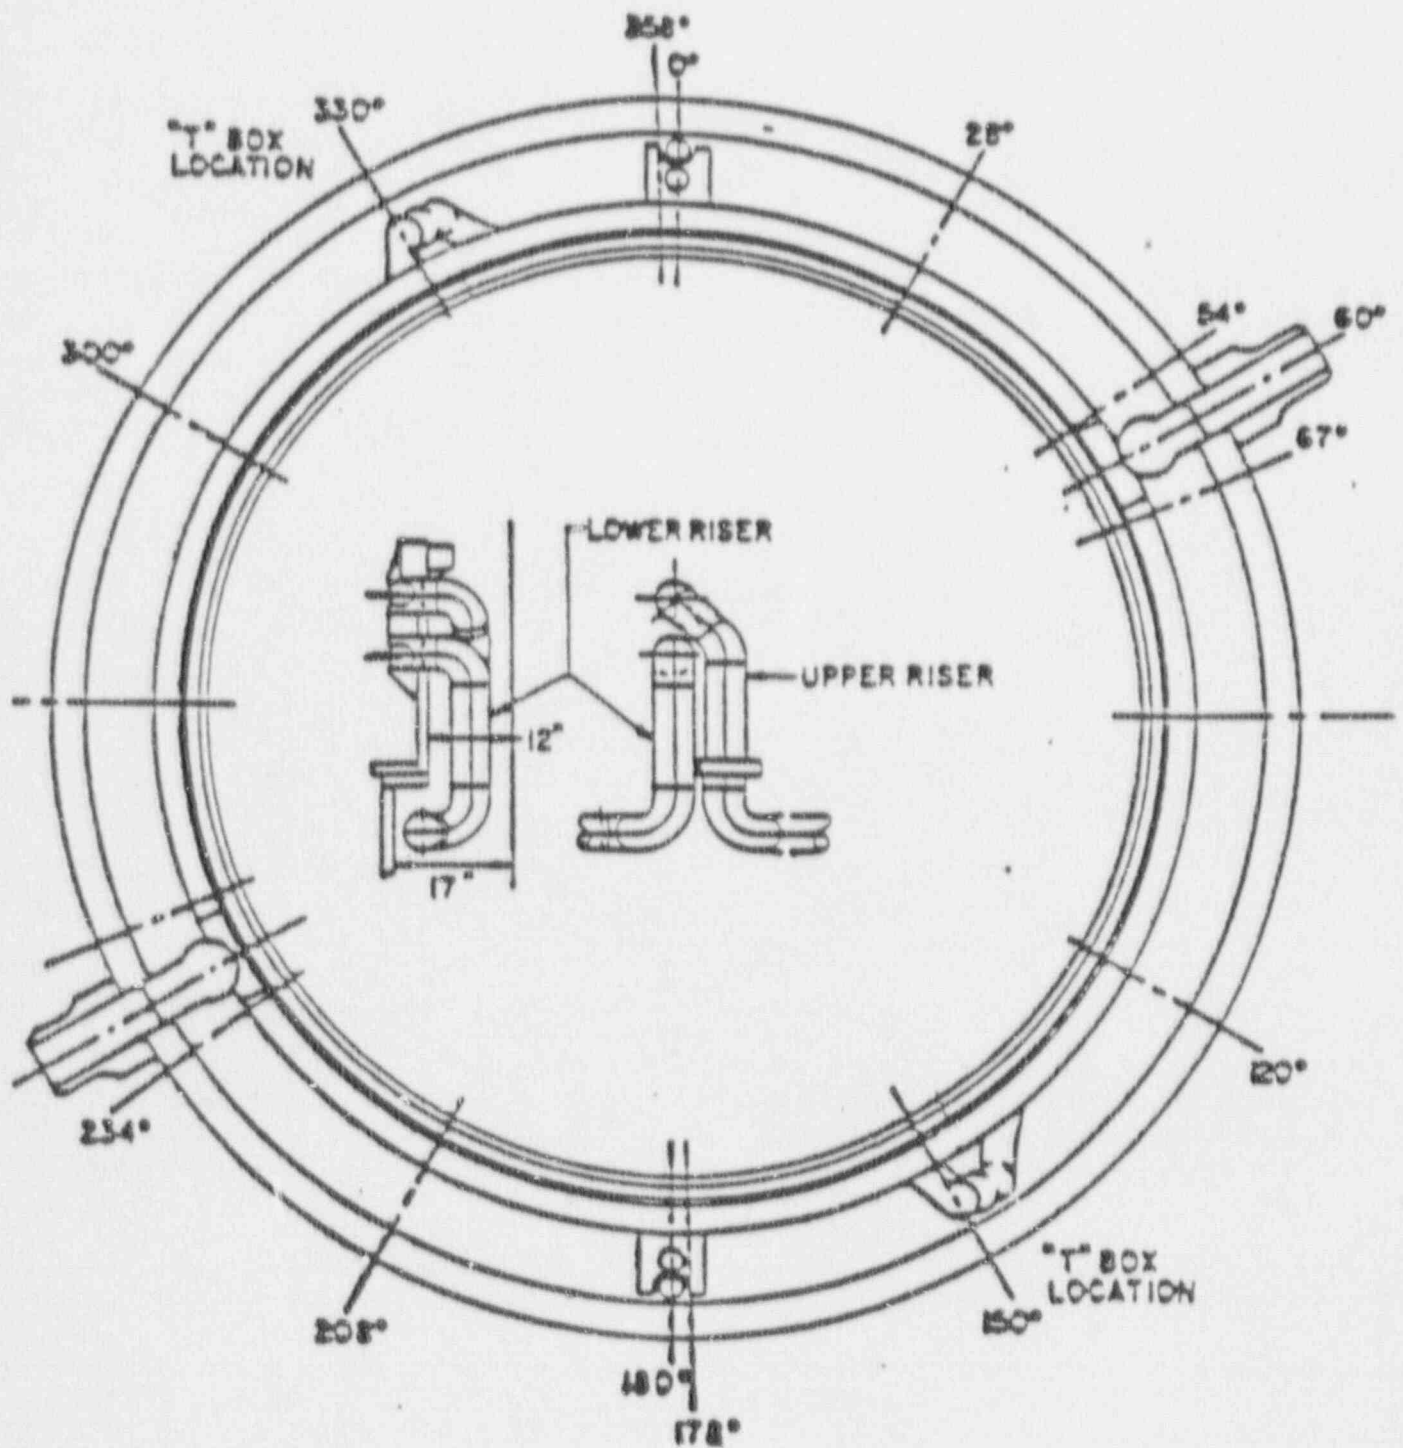
FIGURE NUMBER 1
OYSTER CREEK NUCLEAR GENERATING STATION

Visual inspection of the Core Spray System Annulus Piping was performed utilizing a Westinghouse Model ETV-1250 video camera with underwater auxiliary lighting. Due to access restrictions, a hand held camera technique was used to perform the examination. All accessible areas of the piping were inspected. Refer to figures 1 through 4. No relevant indications were noted during the inspection or subsequent review of video tapes.
