Subject: McGuire Nuclear Station Unit 1 and 2  
Docket No. 50-369  
Voluntary Special Report

## McGUIRE SAFETY REVIEW GROUP INPLANT REVIEW REPORT

1. REPORT NUMBER: 91-11
2. DATE OF REVIEW: February, 1991
3. SUBJECT DESCRIPTION: On February 15, 1991, Instrument and Electrical (IAE) personnel were performing Preventative Maintenance (PM) work request 08068C on inverter SKSS. In the process of performing this work, IAE Specialist A discovered a frequency detector board that had malfunctioned. This prevented the inverter from being returned to normal operation. After consultation with IAE Supervision, it was decided to replace the defective frequency board on February 21, 1991. To replace this board requires that SKSS be completely de-energized. At approximately 1230, a Nuclear Operations (OPS) Specialist (NLO) was dispatched to de-energize SKSS. The NLO opened the alternate feeder breaker to SKSS, located on Motor Control Center (MCC) SMXG at approximately 1250. This action resulted in a loss of power to power panel board KXS which supplies control power to the Standby Shutdown Facility (SSF) control panel. When the SSF control panel was de-energized, it caused all eight (four per u

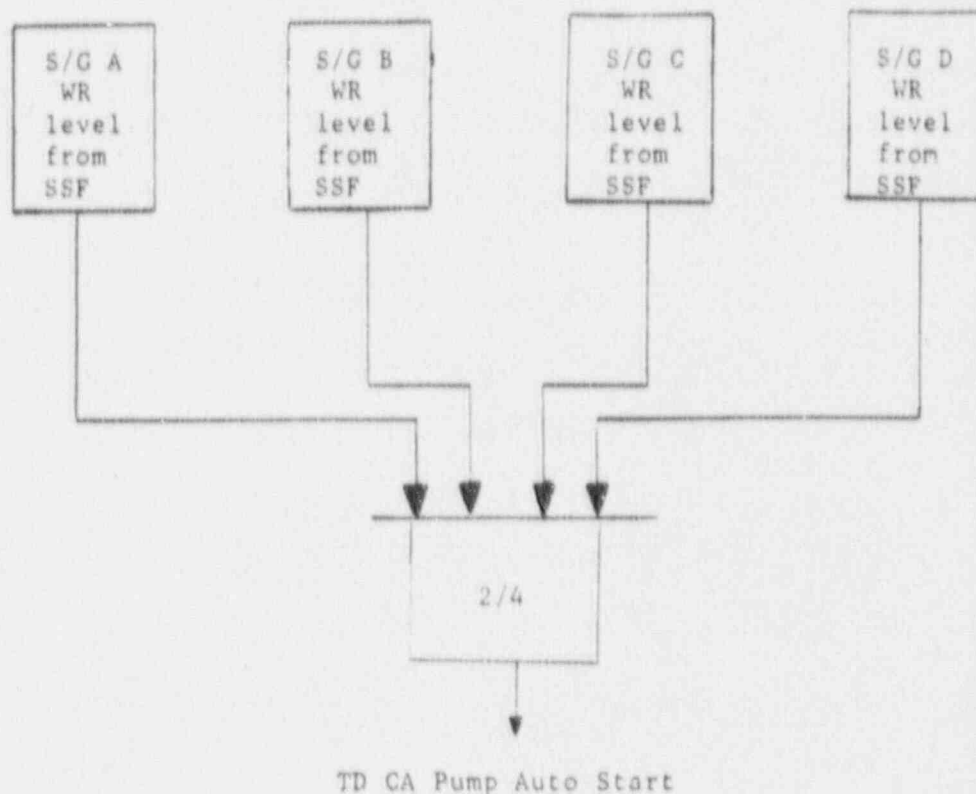
Turbine Driven Auxiliary Feedwater Auto Start  
Logic From The Standby Shutdown Facility

At approximately 1250, the NLO called IAE Specialist B and informed him that he was ready to de-energize SKSS inverter loads. The NLO then opened the SKSS inverter loads alternate power supply located on MCC SMXG. This action resulted in a loss of power to power panel board KXS which supplies power to the SSF control panel. When the SSF control panel was de-energized, all eight (four per unit) S/G wide range level indications failed in the low direction due to the loss of power. Units 1 and 2 T/D CA pumps automatically started when the one of one low level signal from two of four S/G logic from the SSF was satisfied.

- 7) The ESF logic for automatic start of the T/D CA pumps on S/G level is two out of four low-low level alarms in two S/G. The logic that actuates the T/D CA pumps from the SSF is one of one wide range level low alarm in two of four S/G.
- 8) The auto start signal from the SSF is not redundant as required for ESF signals.
