Houston Lighting & Power

South Texas Project Electric Generating Station
Unit 1
Docket No. STN 50-498
Licensee Event Report 91-009 and Special Report
Regarding Diesel Generator #12 and #13 Valid
Failures due to Cracked Fuel Injector Nozzle Tips

LICENSEE EVENT REPORT (LER)

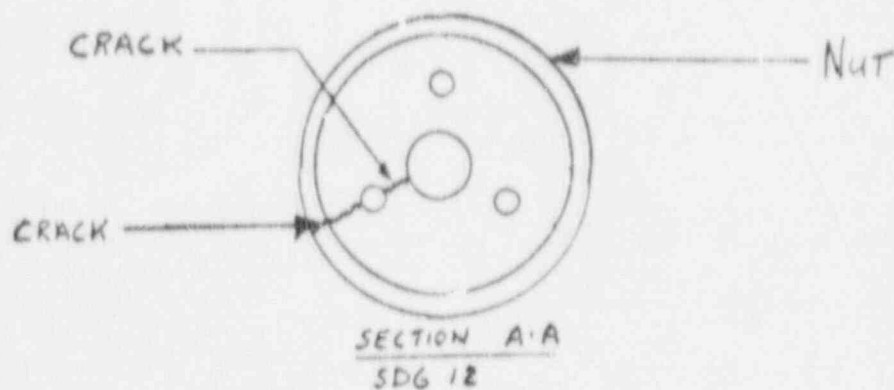
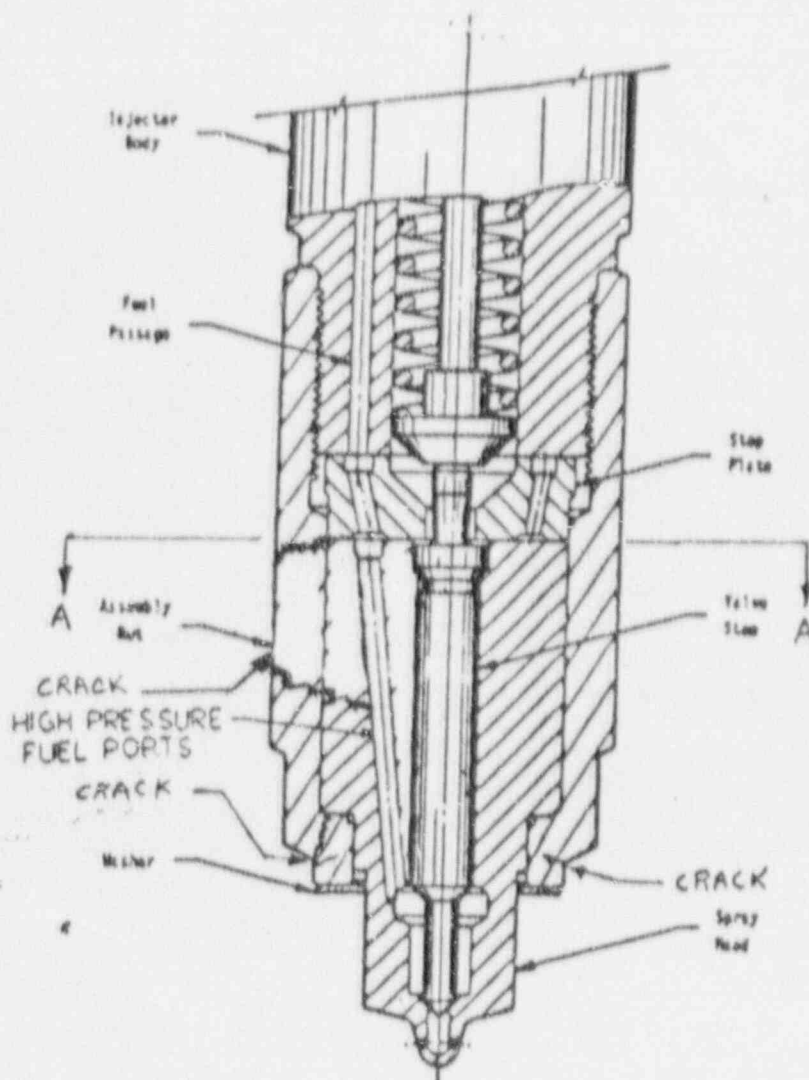
Figure 1
SDG 12 Fuel Injector Nozzle Crack

Fuel injectors 4L and 6R were removed and tested at the onsite machine shop. Fuel injector 4L was found to have cracks on both the nozzle tip (spray head) and the assembly tip nut (refer to Figure 1). The 4L nozzle tip was installed during the first Unit 1 refueling outage in the fall of 1989. A standard pressure test of the 6R injector was performed to establish its opening pressure. The injector leaked below the required opening pressure and was rejected, however, no cracking was noticed.

The lot number of the SDG 12 4L injector nozzle tip was identified as 150010. Three other nozzle tips from this lot were identified in SDG 12 and these injectors were also removed from the engine. Each of the corresponding engine cylinders were inspected with the aid of a boroscope and no evidence of damage was found. An inspection of the valve train on cylinder 4L also found no apparent damage. A lube oil sample analysis identified no significant decrease in lube oil viscosity. Following replacement of the injector nozzle tips from lot 150010, an engine balance run was performed on March 12th and SDG 12 tested satisfactory.

The specific cause(s) for the cracked fuel injector nozzle tips is (are) not known, however, the most probable cause(s) are manufacturing related and appear to be lot specific. The failure mode appears to be high-cycle fatigue related. Additional actions are planned to evaluate the cause(s) of the cracking.

1. For the March 10th SDG 12 event, fuel injector nozzle tips with lot 150010 were replaced and lube oil analysis was completed. Subsequently, an engine balance run on March 12th provided a satisfactory result.
2. Following the March 13th SDG 13 event, all twenty of the SDG's fuel injector nozzle tips were removed and replaced. Following lube oil analysis the lube oil was changed. A post maintenance test was completed and SDG 13 was declared operable on March 24th.

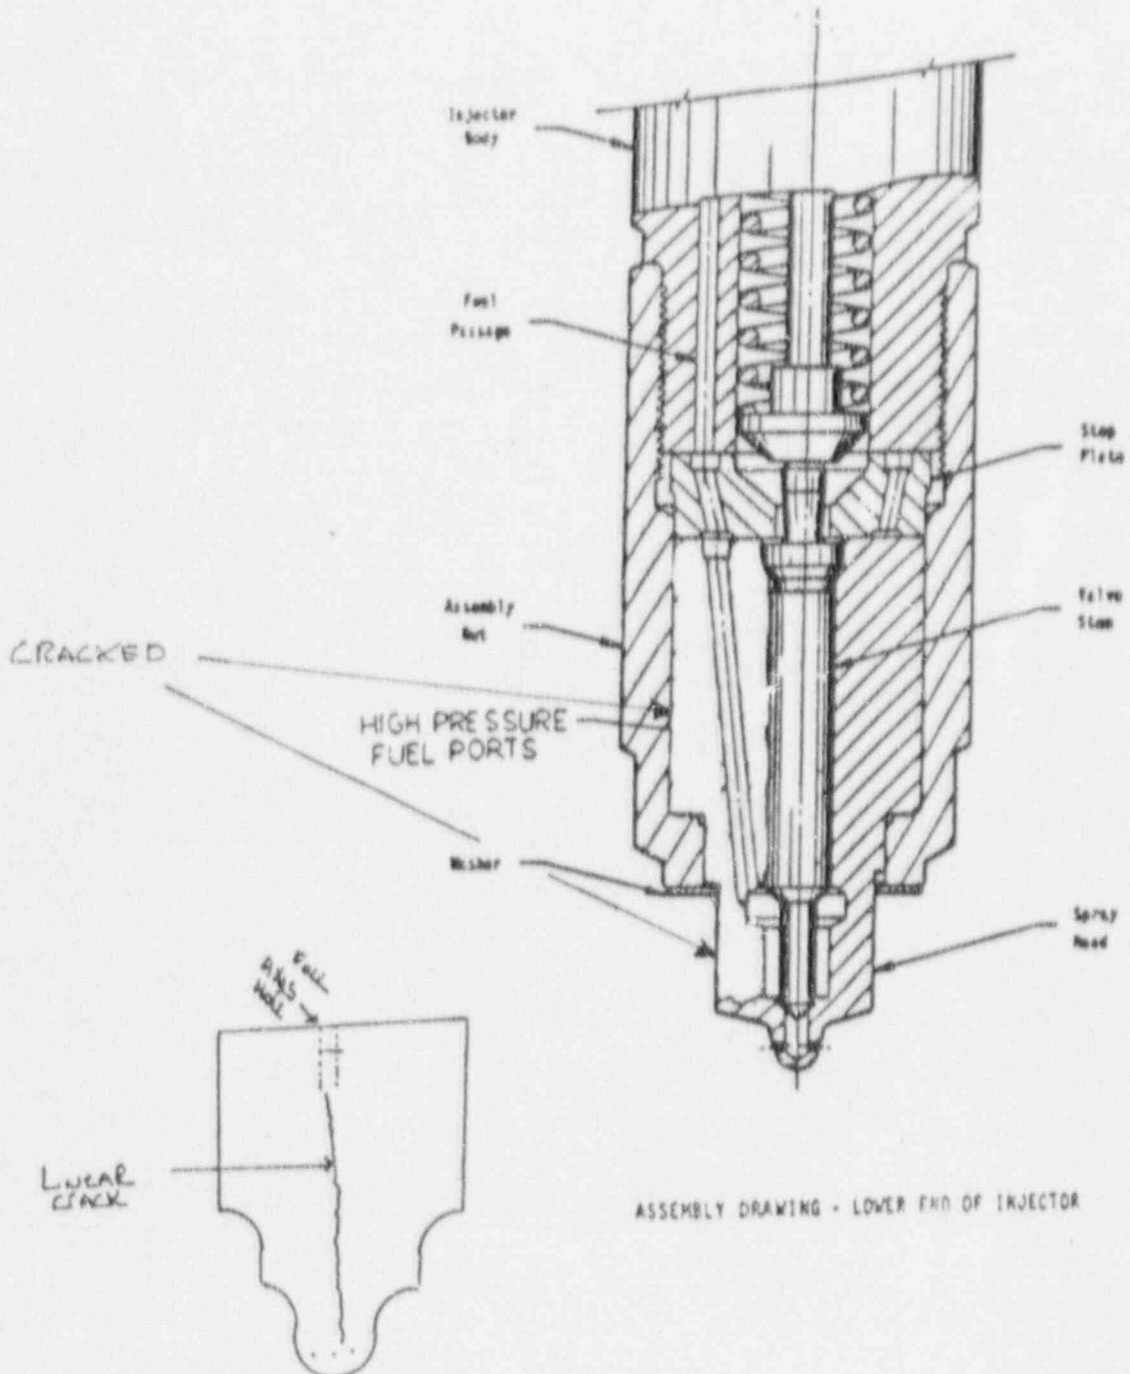
Figure 2
SDG 13 Fuel Injector Nozzle Crack

On March 13, 1991 during a performance run of SDG 13 (train C, Unit 1) a low combustion pressure was identified at cylinder 4L. The valve cover was removed and a fuel leak was observed on injector 4L. The run was terminated and SDG 13 was declared inoperable at 1419 hours.

The SDG 13 4L injector was removed and tested at the shop. The fuel injector would not pop open at the pre-determined design pressure of 3600 psi. A liquid penetrant examination on March 20th indicated a crack along the axis of the nozzle tip. (Refer to Figure 2.) This fuel injector was installed in SDG

The SDG 13 4L nozzle tip was identified as being from lot 150006. Lube oil samples and analysis resulted in identification of viscosity at the minimum allowed by the lube oil specification. The remaining nineteen fuel injectors from SDG 13 were removed, operability tested at the shop, and liquid penetrant examination of the tips was performed. All of the remaining nozzles were found satisfactory by both tests.

On March 22nd, all twenty fuel injector nozzle tips were replaced in SDG 13 and the lube oil was changed. A post maintenance surveillance test was performed successfully. SDG 13 was declared operable on March 24, 1991 at approximately 1525 hours.
