SAN ONOFRE NUCLEAR GENERATING STATION

Subject: Docket No. 50-362  
30-Day Report  
Licensee Event Report No. 91-001  
San Onofre Nuclear Generating Station, Unit 3

LICENSEE EVENT REPORT (LER)														
Facility Name (1) SAN ONOFRE NUCLEAR GENERATING STATION, UNIT 3										Docket Number (2) 0   5   0   0   0   3   6   2			Page (3) 1 of 0 7	
Title (4) UNIT 3 AUTOMATIC REACTOR TRIP DUE TO NON-1E UNINTERRUPTIBLE POWER SYSTEM FAILURE														
EVENT DATE (5)				LER NUMBER (6)				REPORT DATE (7)			OTHER FACILITIES INVOLVED (8)			
Month	Day	Year	Year	Sequential Number	Revision Number			Month	Day	Year	Facility Names		Docket Number(s)	
0   3	1   5	9   1	9   1	---	---			0   4	1   5	9   1	NONE		0   5   0   0   0   1   1	
OPERATING MODE (9) 1				THIS REPORT IS SUBMITTED PURSUANT TO THE REQUIREMENTS OF 10CFR (Check one or more of the following) (11)										
POWER LEVEL (10) 1   0   0				20.402(b)		20.405(c)		X 50.73(a)(2)(iv)		73.71(b)		Other (Specify in Abstract below and in text)

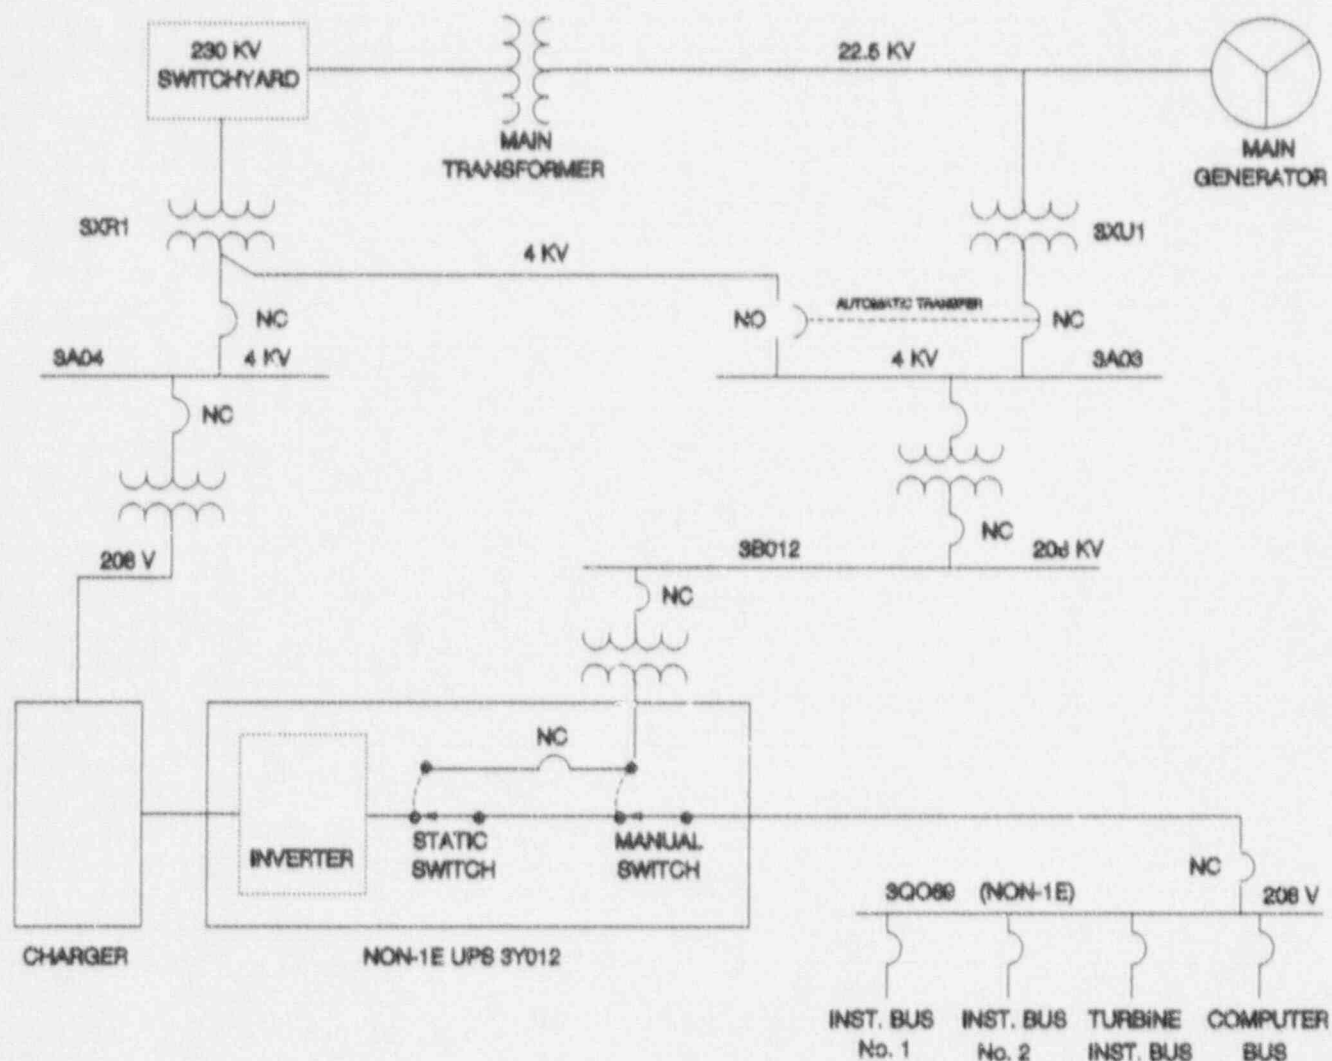
Figure 1 - Non-1E UPS, Power Sources and Loads

Unit 3 non-1E instruments and control systems are energized by non-1E instrument bus [BU] 3Q069. 3Q069 is supplied power from either the UPS inverter [INVT] 3Y012 (normal source) or 480 VAC load center 3B012 [EC, SWGR] (alternate source). Load center 3B012 is supplied power from 4.16 kV bus 3A03. On a loss of power from the inverter, the non-1E UPS static switch [ASU] automatically transfers bus 3Q069 to the alternate source without power interruption. 3Q069 can also be energized directly from 3B012 via a manual bypass switch [HS]. (See the following figure.)

During normal power operations, non-1E 4.16 kV bus 3A03 is supplied through the Unit Auxiliary Transformer (3XU1) from the Unit 3 Main Generator. Upon a unit trip, the power supply for 3A03 is transferred automatically to the Reserve Auxiliary Transformer (3XR1), which is supplied from offsite power. This automatic transfer occurs when the main generator output is at approximately eight megawatts. This happens less than one second after the turbine trip occurs. (See the following figure.)

An output capacitor [CAP] between phases "B" and "C" in the constant voltage transformer (CVT) [XFMR] section of the non-1E UPS inverter output failed, causing the internal inverter voltage to momentarily decrease and current to momentarily increase, initiating an automatic transfer of the non-1E UPS. Since the static switch overcurrent sensors measure only load currents (not internal fault currents), the static switch transfer was not initiated until a decrease in output voltage was detected. With the short circuit occurring directly at the CVT, the internal energy normally stored in the CVT was shunted and unavailable to sustain the loads during the transfer. This resulted in a brief power interruption before the static switch transferred to its alternate source. This power interruption was sensed by the main turbine electronic governor [TG], which initiated a turbine trip resulting in a LOL signal to the RPS.

- a. All capacitors in the Unit 2 and 3 non-1E inverters were replaced with an upgraded model.
- b. The Unit 3 instrument busses powered by the non-1E UPS were modified such that power will be maintained to critical component systems (i.e., feedwater, turbine governor, and control element drive mechanism control systems) in the event of similar failures.
