Subject: McGuire Nuclear Station Unit 2
Docket No. 50-370
Voluntary Special Report

McGUIRE SAFETY REVIEW GROUP INPLANT REVIEW REPORT

- 1.0 REPORT NUMBER: 91-10
- 2.0 DATE OF REVIEW: February 5 through March 5, 1991
- 3.0 SUBJECT DESCRIPTION: A review was conducted of the circumstances relating to the incident described on Problem Investigation Report (PIR) 2-M91-0025. The purpose of the review was to determine the cause of the incident and possible solutions to preclude the recurrence of problems of the type described by the PIR.
- 4.0 EVALUATION AND COMMENT: PIR 2-M91-0025 documented an incident in which placing the Unit 2 Boron Thermal Regeneration (NR) System in the recirculation mode resulted in a 300-350 gallon leak from the Unit 2 Chemical and Volume Control (NV) system.

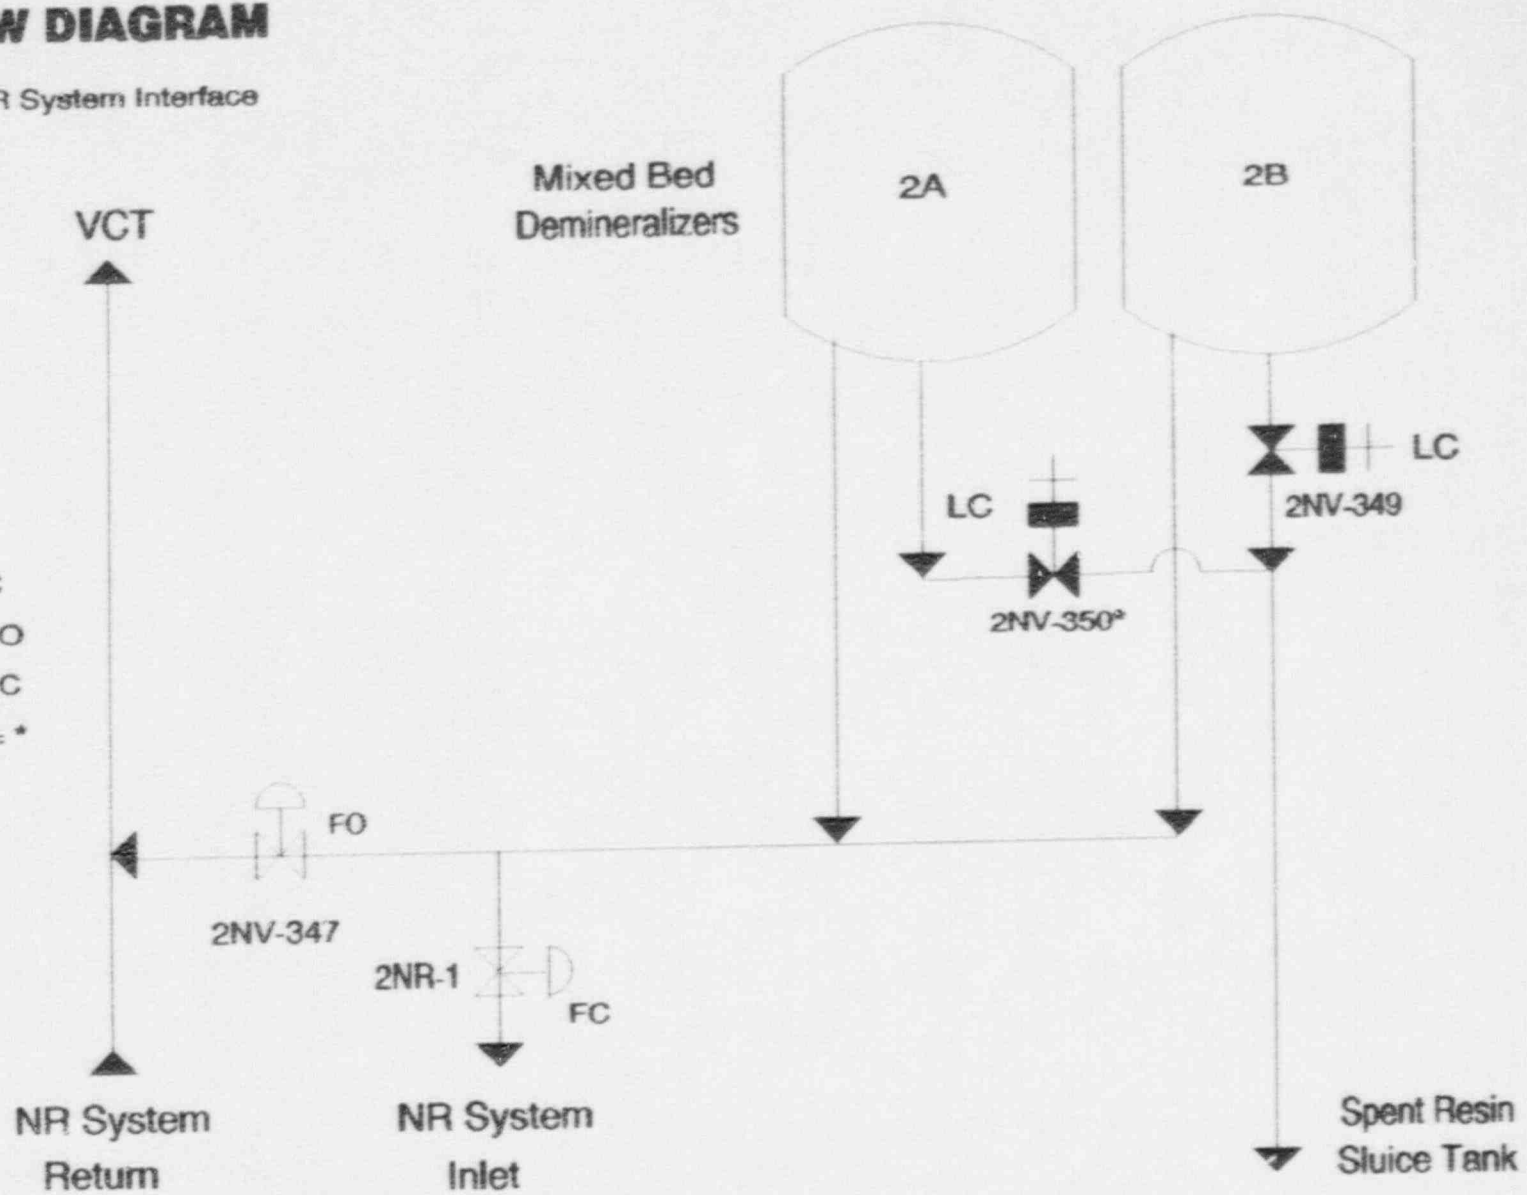
NV / NR System Interface

However, when the NR system recirculation was started, valve 2NV-347 cycled to an intermediate position due to an undetermined cause. Since there was no available NR system flowpath (with valve 2NR-1 closed), this resulted in increased pressure in the NV system piping upstream of valve 2NV-347. Based on the design setting for relief valve 2NV-156, Letdown Heat Exchanger Outlet Header Safety Relief, the pressure could have reached a maximum of 255 psig. This pressurization resulted in external leakage from valve 2NV-350, which is a diaphragm valve.

When the letdown piping upstream of valve 2NV-347 was pressurized by Chemistry personnel, using the Spent Resin Sluice Pump, the leak reappeared. The leak was identified by RP and MM personnel as valve 2NV-350. The bonnet bolts on valve 2NV-350 were retorqued and the leakage rate was reduced to approximately one drop every two seconds. The diaphragm for valve 2NV-350 was subsequently replaced.

OPS personnel issued procedure changes for procedure OP/2/A/6200/02, Enclosure 4.7, which requires the opening of valve 2NV-347 prior to placing the NR system in recirculation.

OPS and Projects personnel are evaluating the permanent isolation of the air supply to valve 2NV-347, to fail the valve to the open position. The NR system chilled waterloop has now been drained. Removal and Restoration (R&R) 01-193 was issued by OPS personnel on March 2, 1991 to remove from service the power supplies for the NR system pumps and compressors.
