# VERMONT YANKEE NUCLEAR POWER CORPORATION

September 16, 1994  
BVY 94 - 94

Subject: Temporary Non-Code Repair of Service Water Piping in the Intake Structure

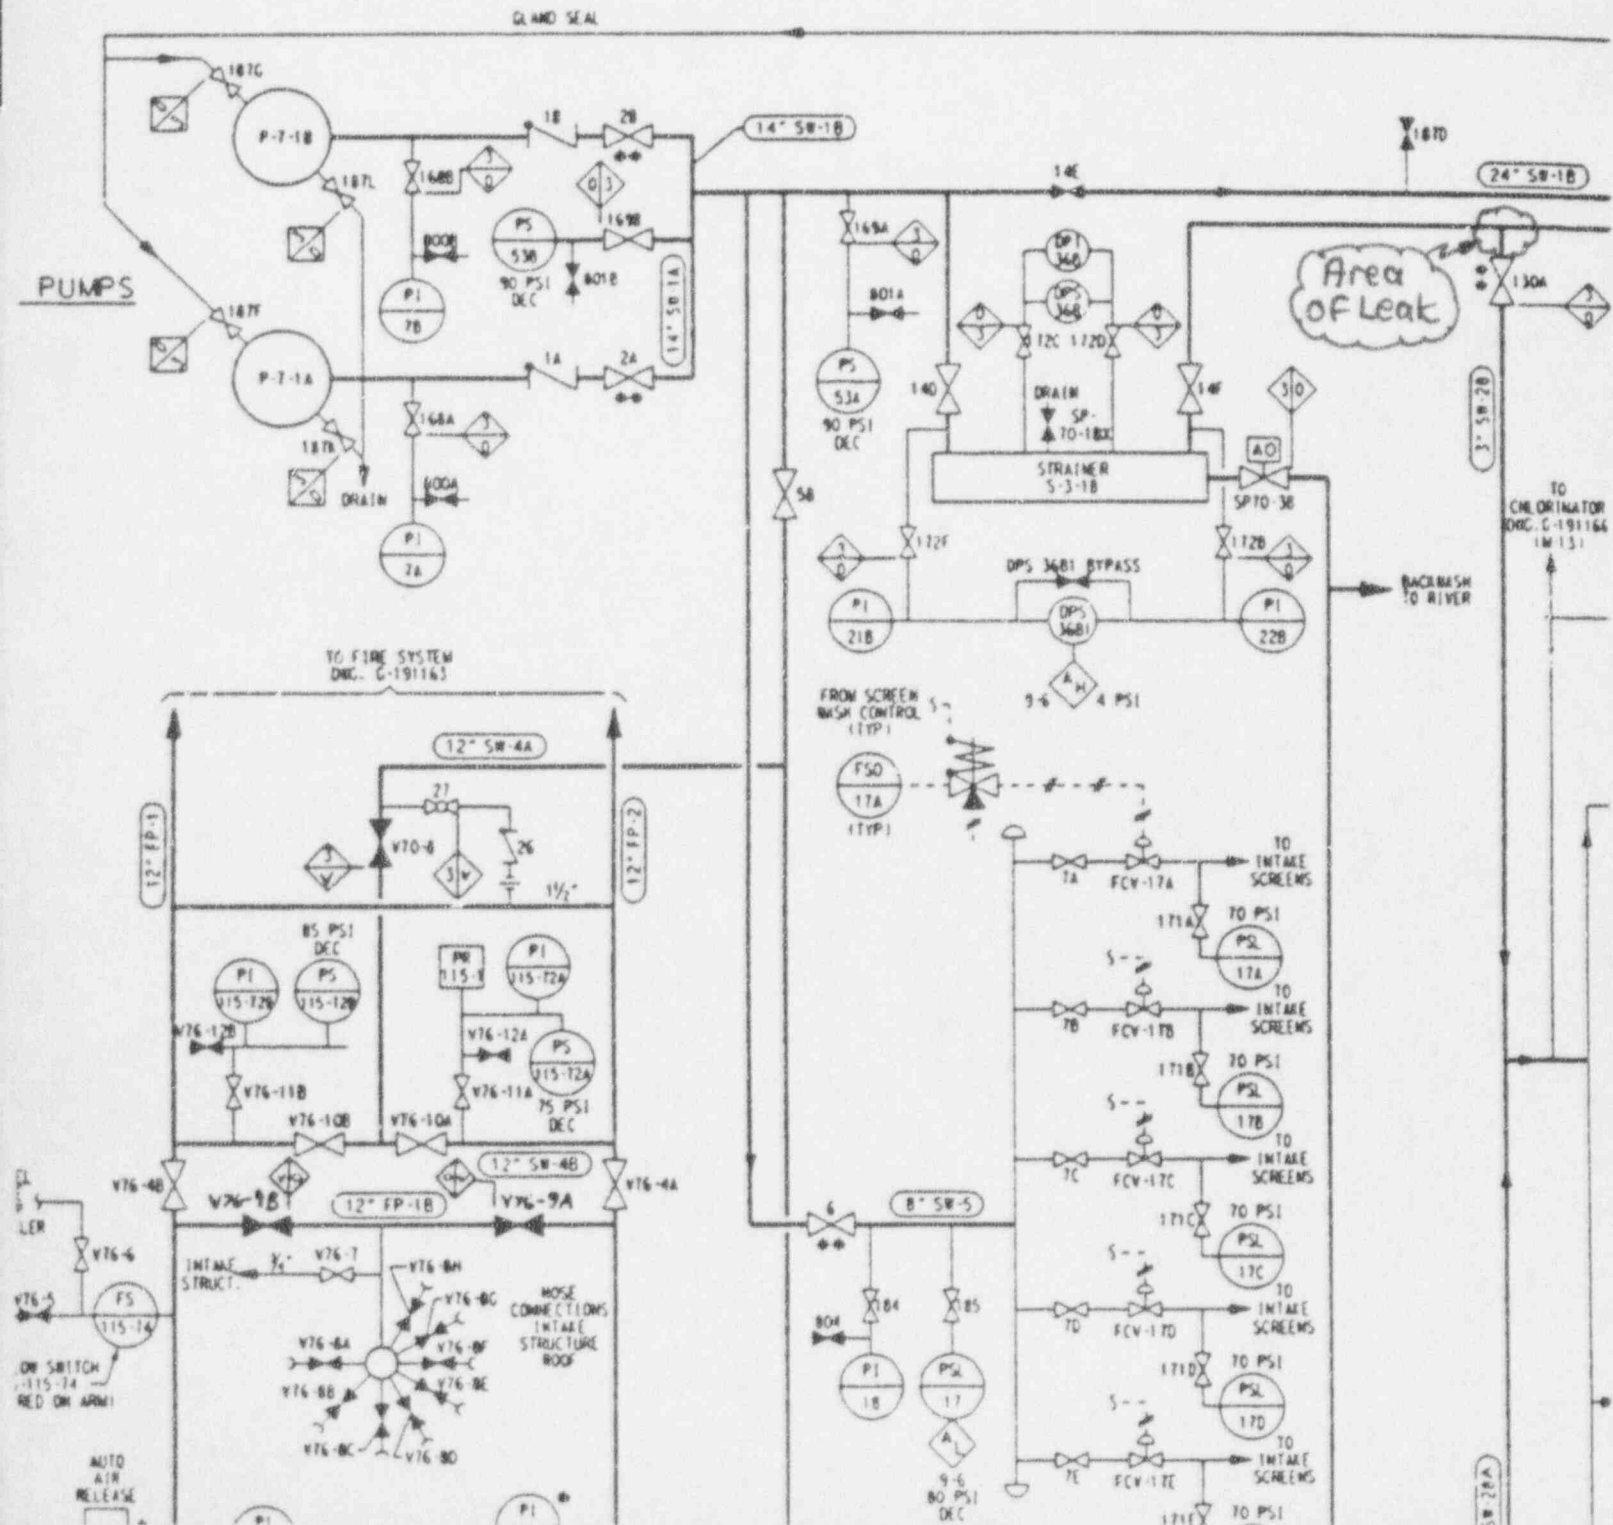
FIGURE 1

The Operations Department reported leakage from a three-inch Service Water (SW) branch line (3" SW-28) off the main Service Water header in the intake structure on August 31, 1994. The Service Water System is supplied water from the Connecticut River. The leak is located at a weld in a portion of the branch line to the chlorination system and circulating water pump cooling supply. The leak is located at the 9 o'clock position on the upstream side weld of valve V70-130A and results in approximately 1 drip every 5 minutes. See Figure 1 attached and FSAR Figure 10.6-1a for the flow diagram and arrangement of these components.
