SUBJECT: Calvert Cliffs Nuclear Power Plant
Unit No. 2; Docket No. 50-318; License No. DPR 69
Licensee Event Report 91-001, Revision 0C

LICENSEE EVENT REPORT (LER)

Reactor Coolant Inadvertently Drained Through Containment Spray Header Due to Operator Error

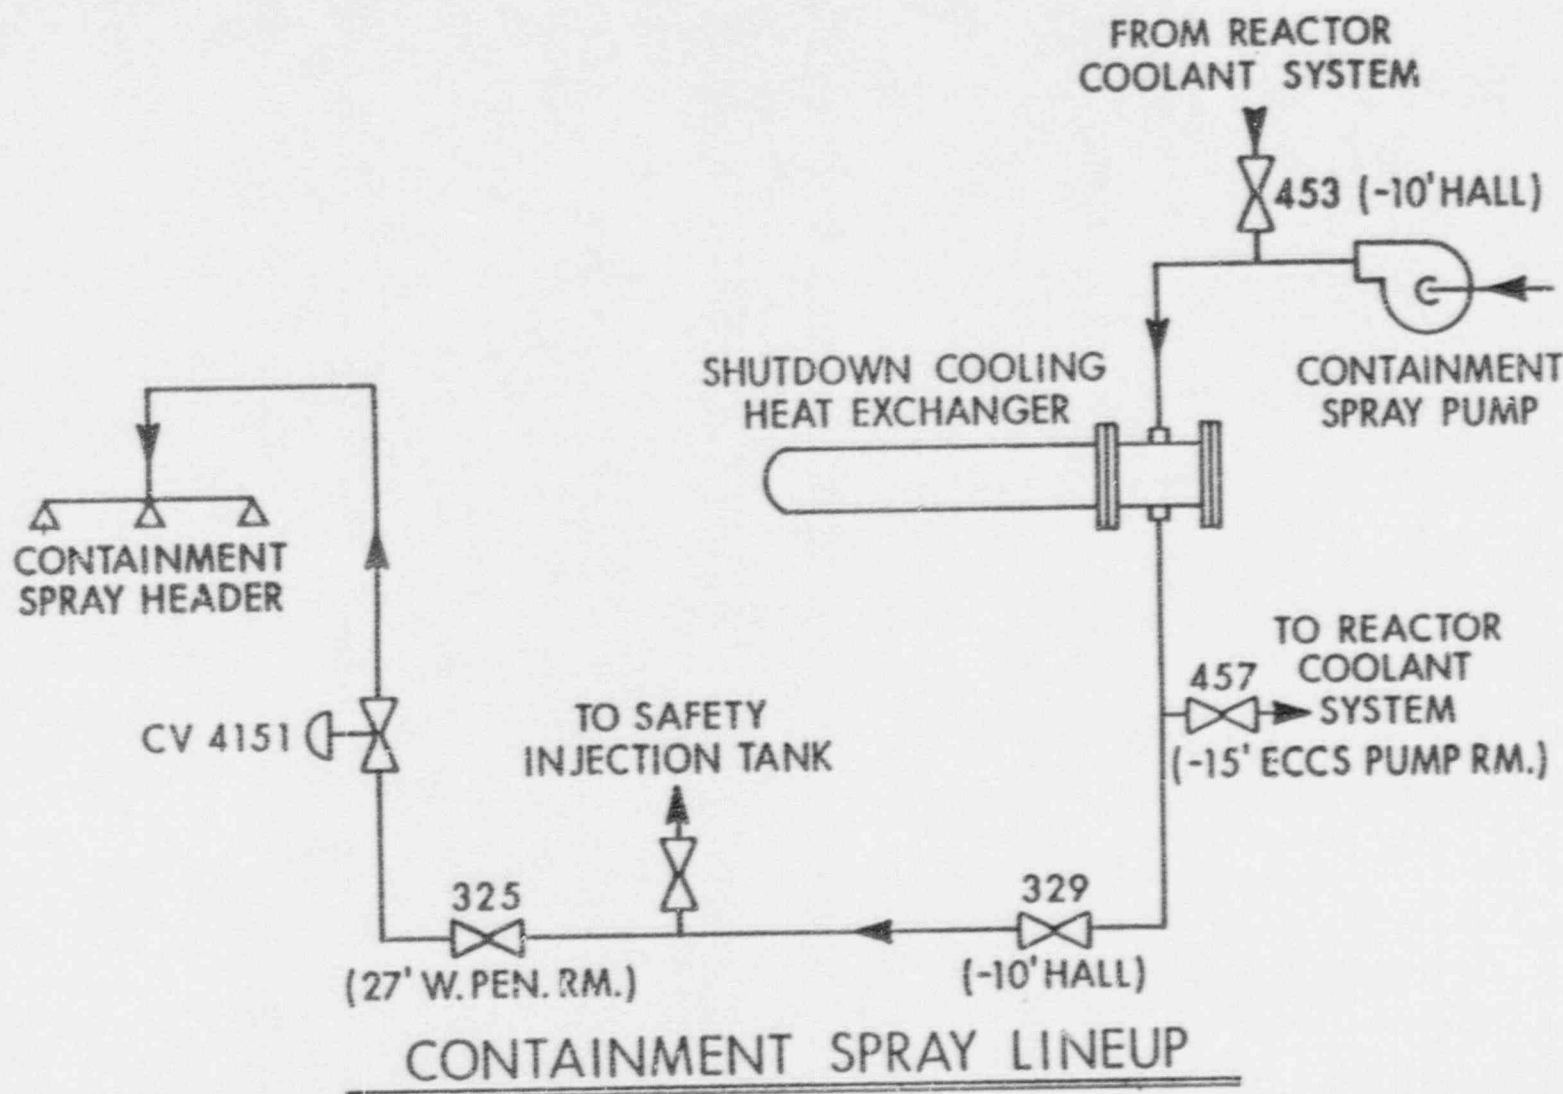
FIGURE 1

On March 12, 1991 at approximately midnight, the on-shift Plant Watch Supervisor (PWS), Unit 2 Auxiliary Building Operator (ABO) and three other operators were dispatched to line up containment spray piping for filling the SITs. Figure 1 shows the affected section of piping. At the time of this event, Operations Instruction OI-3A required valves SI-453 and SI-457 to be shut first to isolate containment spray piping from RCS. SI-325 was to be shut next and independently verified before SI-329 could be opened. The operators had a copy of the OI and the appropriate system drawing. Having reviewed the drawing, the PWS realized that, since the Containment Spray Pump was idle, there would be no driving head in the affected section of piping once SI-453 and SI-457 were shut. He concluded that SI-329 (which is physically located in the same general area as SI-453 and SI-457) could be opened at the same time SI-325 (which is located two floors above) was being shut.

Two of the operators shut SI-453. The ABO and another operator had partially shut SI-457 and were resting when the PWS, who had been in the hall, looked in the room in which they were working. The PWS, seeing that the stem of SI-457 was apparently down and the operators were no longer working on it, assumed the valve was shut and directed the first two operators to open SI-329. This opened a path for RCS flow through one Containment Spray Header. The operators heard flow and immediately shut the valve. The PWS contacted the Control Room and was told that pressurizer level had dipped slightly but was now okay. This was not considered significant since pressurizer level had been slowly decreasing all day. The PWS directed the operators to open SI-329 while he left to close SI-325.

Air operated Control Valve CV-4151, which was shut, did not stop the flow since its air pressure setpoint had previously been lowered from 60 psia to 25 psia in order to minimize excess forces on the control valve diaphragm. CV-4151 was lifted off its seat and RCS water entered one of Unit 2's two containment spray rings. Some of the water flowed into a drain line located upstream of the spray ring. The incorrect lineup was discovered in the field by flow noise and observed spray at about the same time as the drop in pressurizer level was seen in the Control Room. The operators in the field shut SI-329 and 457 simultaneously, ending the event. Roughly 1900 gallons of RCS inventory were drained in the approximately 10 minute duration of the event.

A contributing cause of this event was that the setpoint for air operated control valve CV-4151 had been lowered from 60 psia to 25 psia in March of 1990. This setpoint change had been made without adequate review or justification. This was caused by insufficient detail in the setpoint change review process procedure and by inattention to detail on the part of the engineer making the change and the personnel reviewing it. Had the setpoint not been changed, CV-4151 would have prevented the loss of RCS inventory.

The containment spray piping downstream of SI-325 was examined. The design pressure of this section of pipe is 225 psig. The maximum possible pressure that may have been exerted on the pipe during this event was 280 psig. While this is above the design rating of the pipe, it is well below the hydro test pressure of 325 psig. The total longitudinal pressure stress from this overpressurization is well below the maximum allowable seismic stress. It is unlikely that the design pressure of the pipe was exceeded since CV-4151, due to its low setpoint, probably lifted off of its seat when pressure reached approximately 77 psi.

4. The GS-NPO instructed all shift crews on management expectations concerning correct procedure interpretation, verbal communications, and appropriate lines of authority. Maintenance supervisors provided similar instruction.
5. The setpoint for CV-4151 was reset to its original value in both units and other setpoint changes were reviewed for similar errors. Setpoints were revised as appropriate. None were safety significant.
