SUBJECT: Calvert Cliffs Nuclear Power Plant
Unit No. 1; Docket No. 50-317
Request for Relief from ASME Requirements

BRANCH CONNECTION CALVERT CLIFFS UNIT 1 NO. 12 SALTWATER SYSTEM HEADER

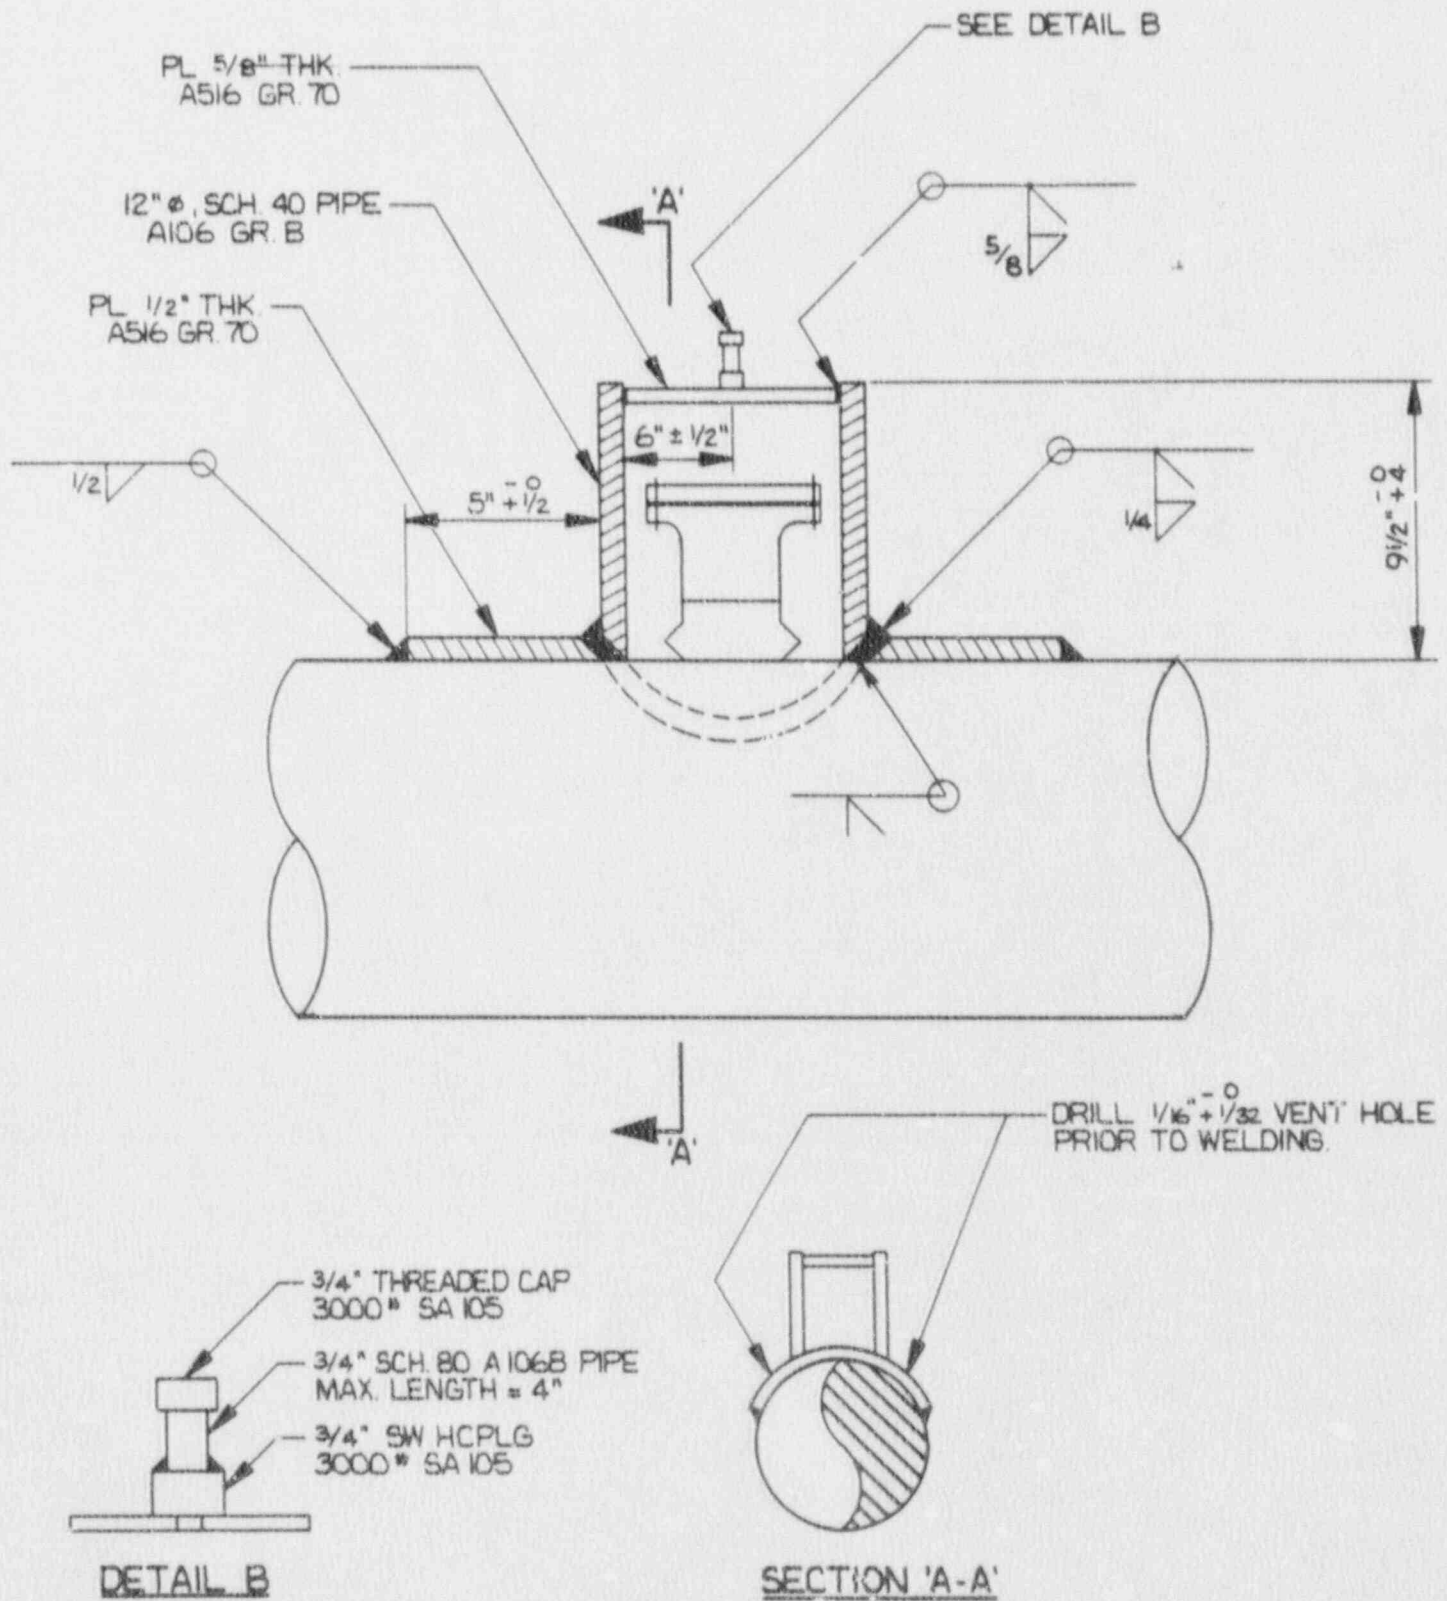
A small through-wall flaw (hole) exists in the weld attaching a six-inch weld-on inspection port to the 30-inch Unit 1 Saltwater System header just downstream of No. 12 Service Water/Saltwater heat exchanger. This piping is classified as Class 3 for Inservice Inspection purposes. The hole is approximately one-quarter-inch diameter and was caused by corrosion.

An evaluation of the hole in the six-inch weld-o-let weld was performed to determine whether the flaw was stable or likely to propagate. The configuration was modeled using significant conservatism. The resultant stress due to a combination of deadweight, pressure, thermal expansion, and seismic was determined to be less than 500 psi. The Code allowable stress is 12,750 psi. It is concluded that stress levels are too low to cause an increase in the size of the existing hole.

We have installed a branch connection to provide a pressure boundary replacement around the six-inch weld-o-let. The branch connection was designed in accordance with the original construction code ANSI B31.1 - 1967. The requirements of ASME Section XI IWA - 7200 were met.

A drawing is attached showing the details of the branch connection. Calculations were performed to support the design. The branch was evaluated for deadweight, pressure, thermal expansion, and seismic stresses. A conservative corrosion rate was incorporated into the analysis. The stress analysis demonstrated that the branch connection stresses are well below the Code allowable values.
