50.55(e) Report

Subject: Interim Report - DER 83-11
A 50.55(e) Potentially Reportable Deficiency Relating to Exide
Batteries May Leak or Corrode at Terminals Due to Cracking of
Plastic Seals/Covers
File: 83-019-026; D.4.33.2

INTERIM REPORT - DER 83-11
POTENTIAL REPORTABLE DEFICIENCY
ARIZONA PUBLIC SERVICE COMPANY (APS)
PVNGS UNIT

NOTICE TO OPERATORS OF EXIDE GN CLASS 1E BATTERIES

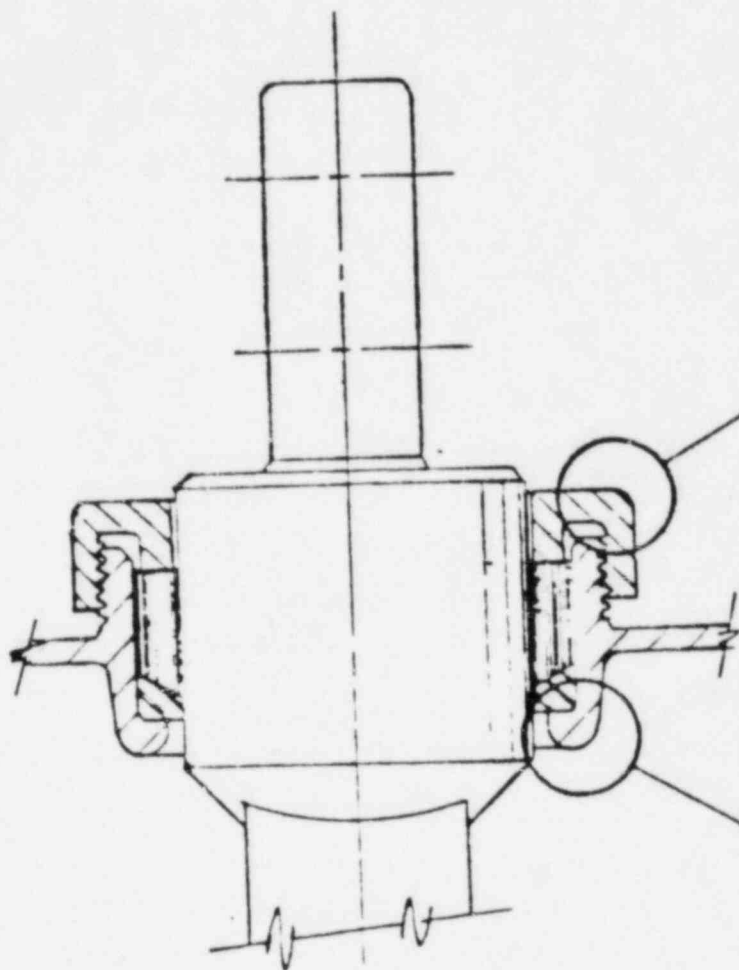
FIG. 1

The design of the seal (see Fig. 1) involves the compression of a rubber sleeve, or gland, against the lead terminal post. The gland is held in compression by the cover and the seal nut.

Unfortunately, the stress on these plastic components, over a period of years, can cause them to crack. The plastic boss at the base of the seal can crack as shown in Fig. 2, or the seal nut can crack as shown in Fig. 3.

The effect of either type of cracking is the same in that it relieves the pressure on the gland, thereby allowing the seal to "leak", that is, to allow acid to migrate slowly up the posts. Given that the intercell connectors are tight, as they should be, this leakage should cause no problems.

A procedure has been developed for permanent repair, which is now being refined, and submitted for qualification, for reducing the rate of the leakage. This can be carried out on site by EXIDE personnel, and should be implemented during your next planned shutdown.

It is based on the principle of eliminating all stresses on the plastic parts, and creating a new seal, of stress-free design, above the old seal location.

1. Back off all red and black nuts to eliminate any remaining gasket compression of the post seals.
2. Retorque intercell connector bolts to 250 in. lbs.
3. Ensure that terminals are fully coated with No-oxide grease.
4. Repair any cracks in the covers with approved cement, after appropriate cleaning and neutralizing.
5. Conduct micro-ohmometer check on all intercell connections and arrange for this check to be repeated quarterly by EXIDE personnel or until permanent repairs have been completed. Connectors must also be retorqued quarterly to 250 in. lbs. as well as a thorough and detailed examination of the cell covers for further cracks.

1. Disconnect and remove all intercell, intertier and terminal connectors.
2. Remove all red and black terminal seal plastic nuts.
3. Remove rubber glands from inside the seals.
4. Rebuild the seals using "O" rings with liquid sealing compound and new red and black caps.
5. Clean connectors and terminal posts and reassemble hardware in accordance with instructions including micro-ohmometer readings.
6. Return the battery to service.

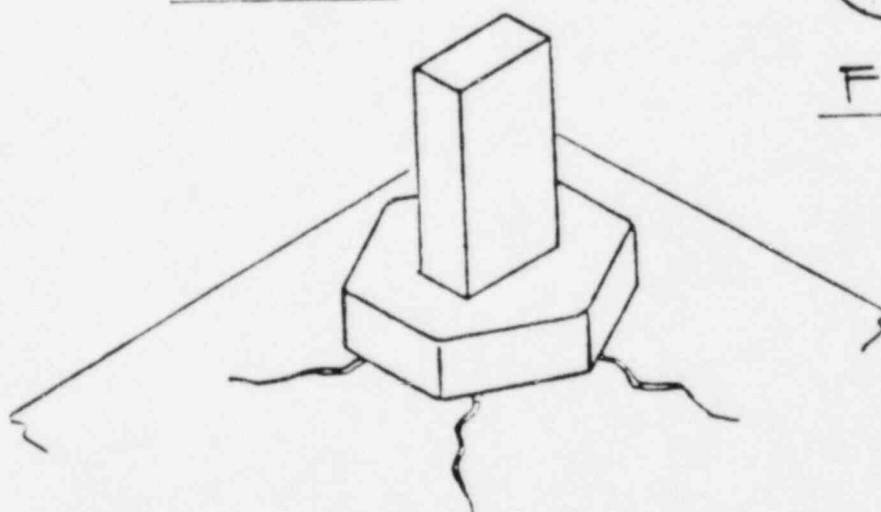
FIG. 4

The cracking of the plastic boss or nut, if complete, causes nothing more than leakage, which, as stated, can be reduced by other means. If the cracking is only partial, or the compression of the gland is marginal to begin with, then a secondary fault, called "nodular corrosion" of the lead post can occur. This corrosion takes place in the crevice of a partially tight seal and causes a growth to take place on the surface of the lead.

The consequence of nodular corrosion is to create additional stress on the plastic components, this time in a radial direction. This stress can lead to radial cracks in the cell cover (Fig. 4). A small number of cells have been reported with this condition.

A final corrective action, necessary only for the few units which have radial cracks in the covers, is a "flood-pour" cover repair. This relatively simple technique creates an all-enveloping secondary cover above the old one, sealing off any cracks. The flood pour technique should be used only if many cracks are present. For small, isolated cracks, individual repair is preferable.
