Hope Creek Generating Station

HOPE CREEK GENERATING STATION
DOCKET NO. 50-354
UNIT NO. 1
LICENSEE EVENT REPORT 94-012-00

TITLE (4): Reactor Protection System and Engineered Safety System
 Actuation - Safety Auxiliaries Cooling System isolation actuation and
 subsequent reactor scram.

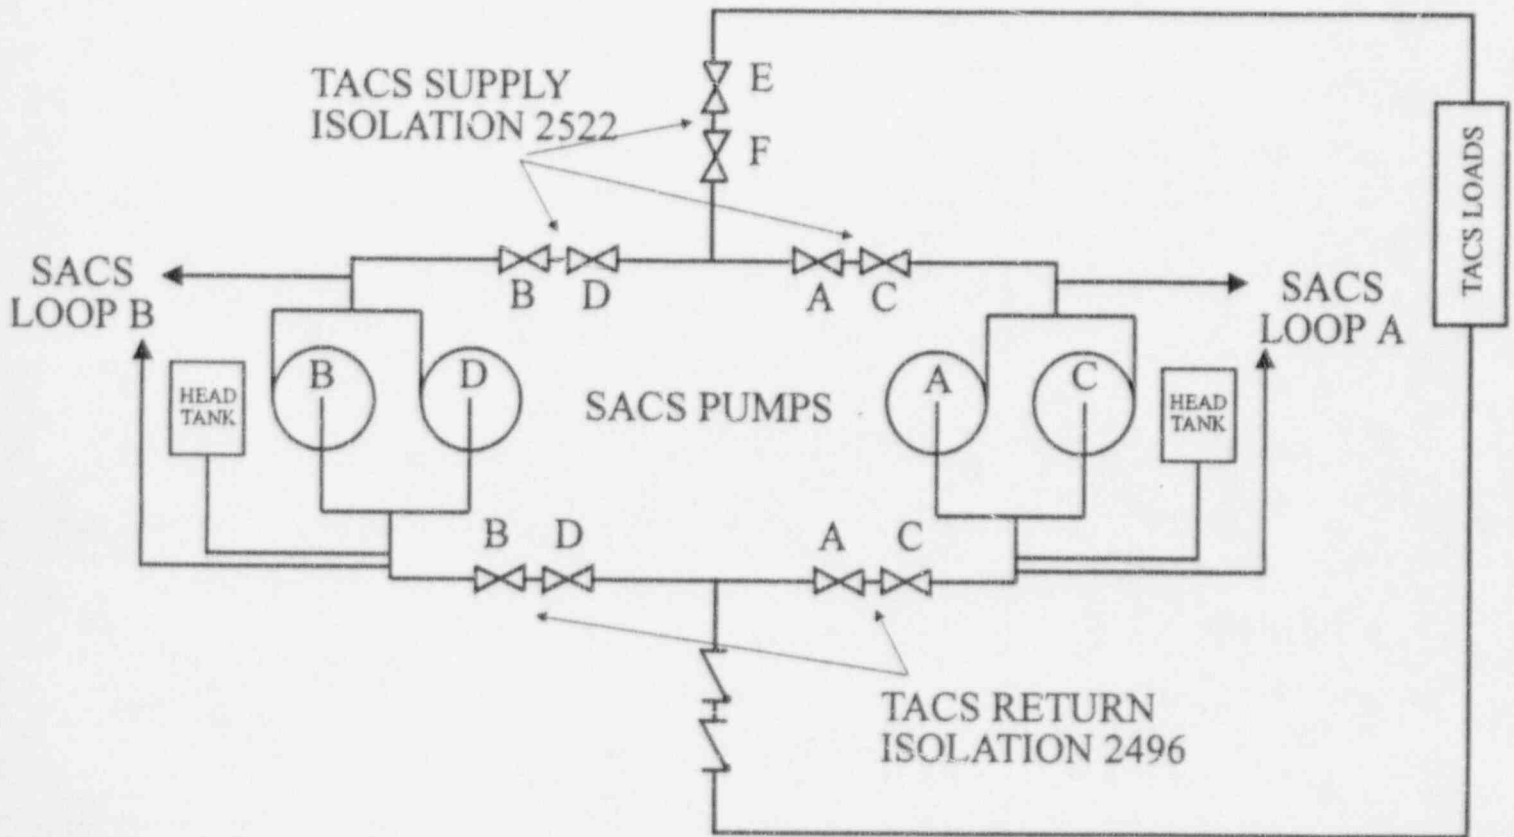
SACS/TACS FLOW DIAGRAM

A partial isolation of the "A" SACS loop resulted when the logic cabinet lost power. The hydraulically operated TACS supply valve for the "A" SACS channel failed closed, however, the motor operated return isolation valves remained open (fail as is per design on loss of logic power). This allowed the two SACS loops to be cross connected via the common TACS return header. The "A" channel SACS pump continued to operate, but as a result of the "A" valve isolating, a cooling water low flow to TACS was sensed and the B SACS loop auto started. The "B" SACS loop started and the TACS supply isolation valves opened; however, the "B" SACS loop return isolation valves from TACS do not reposition as quickly and the return water began flowing to the unisolated "A" loop. The "B" SACS loop head tank level decreased to the TACS isolation setpoint and isolated TACS. Operators maximized make-up flow to the head tank. When head tank level was seen to be recovering, the operators attempted to restore TACS from the "B" SACS loop by manually jacking the supply isolation valves open. As the "A" SACS loop was only partially isolated, the "B" SACS head tank level decreased. Seeing this response, the SNSS ordered the TACS isolation valves closed terminating the level decrease. The SACS to TACS subsystem isolation valves will isolate on low head tank level, Loss of Coolant Accident signals, or when their associated SACS pump trips. As none of these conditions existed, water from the "B" SACS loop transferred to the "A" SACS loop through the unisolated return isolation valves.
