PERRY NUCLEAR POWER PLANT

Perry Nuclear Power Plant
Docket No. 50-440
LER 94-015-01

Enclosed is Licensee Event Report 94-015-01 concerning Potential Loss of
Emergency Service Water System Due to Loss of Keepfill.

Potential Loss of Emergency Service Water System Due to Loss of Keepfill

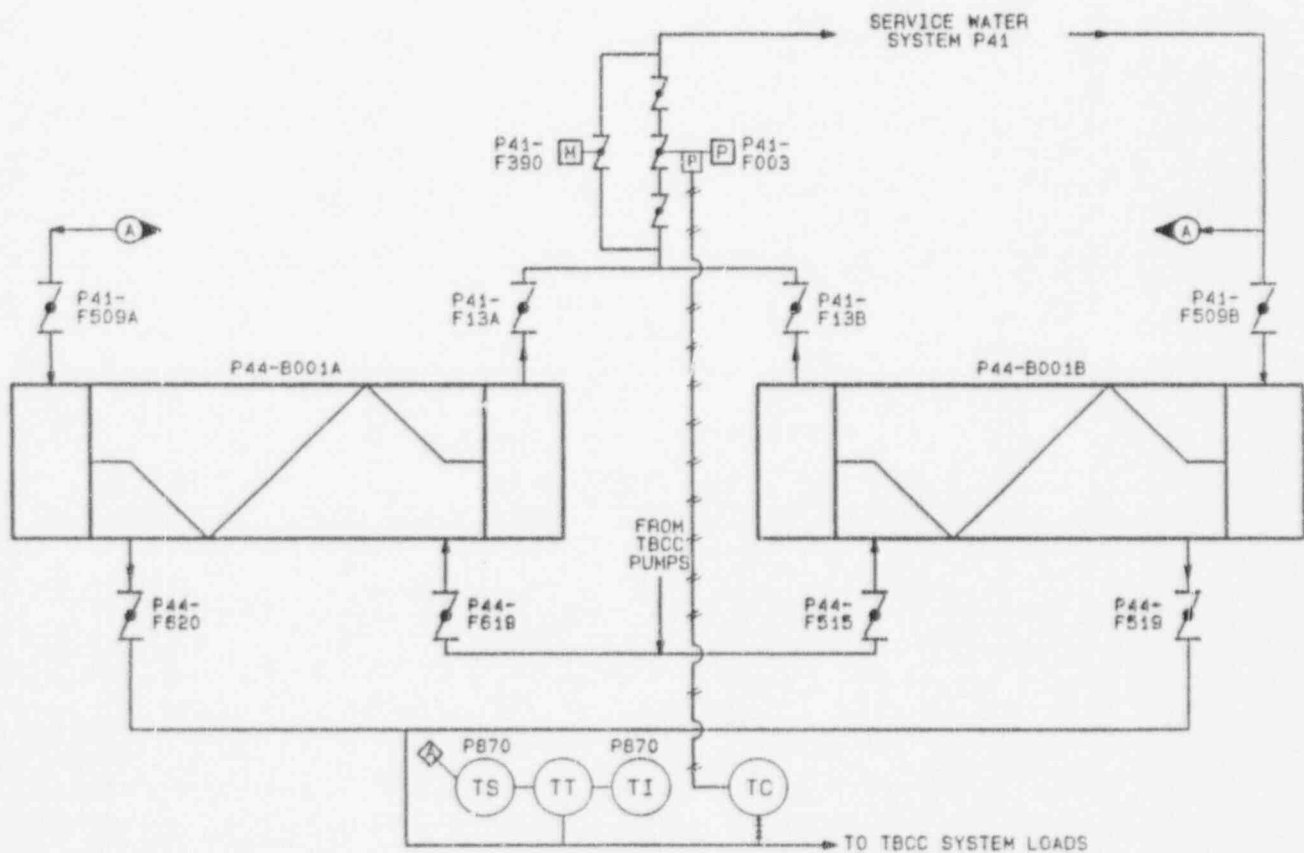
TBCC SYSTEM HEAT EXCHANGER SERVICE WATER FLOW CONTROL

Lake temperature data records indicate that a Lake Erie temperature inversion occurred overnight between June 8 and June 9, 1994 which reduced lake temperature from 62 degrees F to 54 degrees F. This condition would result in a closing of the valve P41-F003 thereby decreasing keepfill supply pressure.

The cause of this event was inadequate design. The design of the restricting orifice installed downstream of the TBCC heat exchangers was based on maximum system operational flow and did not consider minimum flow conditions or the ESW keepfill line located upstream.

Engineering has conducted SW system testing to determine ESW keepfill pressures. System operating parameters were recorded at various TBCC temperature control valve and bypass valve positions to evaluate SW system performance and provide data for determination of permanent corrective actions. A design change is being developed to provide a new keepfill supply from the SW system and will be completed prior to startup from the fifth refuel outage.
