North Atlantic Energy Service Corporation  
P.O. Box 300  
Seabrook, NH 03874  
(603) 474-9521, Fax (603) 474-2987

NYN- 94111

Subject: Service Water System Pump Bolt Degradation

## Basis for Operability of Service Water System Pumps

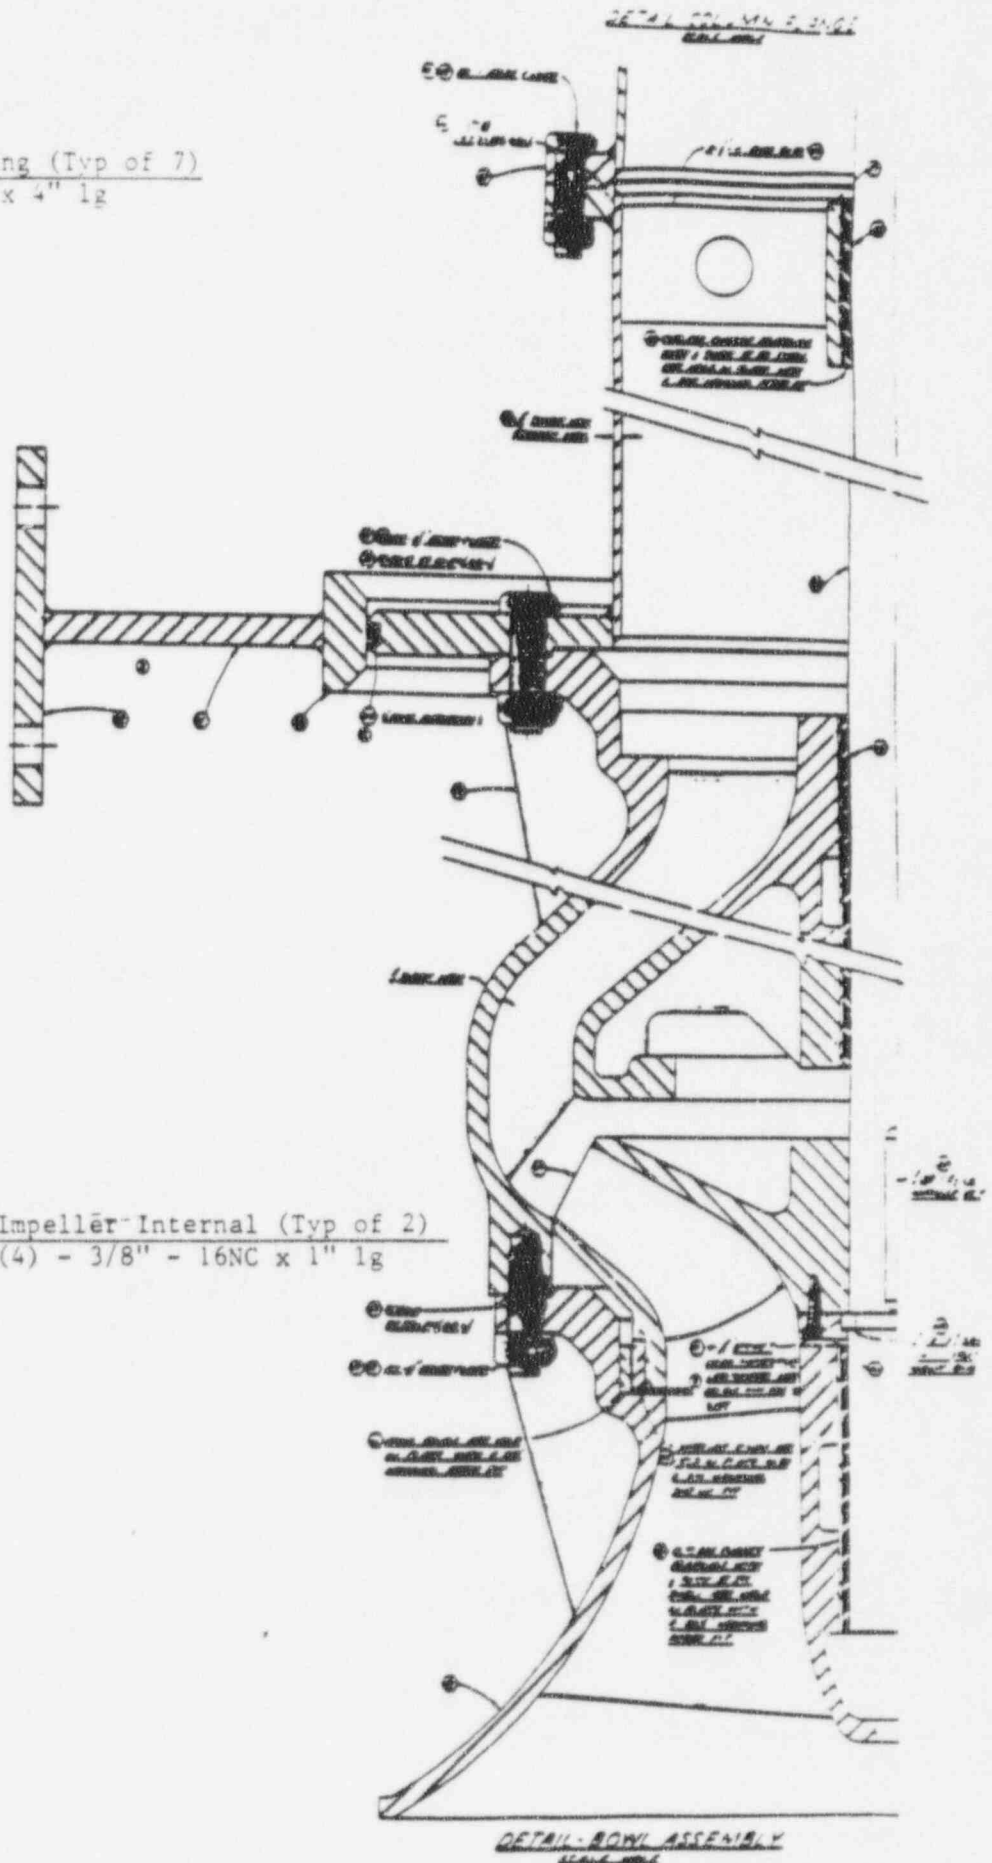
- A. SERVICE WATER PUMPS (1-SW-P-41A THRU 41D) - PROVIDE HEAT SINK FOR NORMAL AND ACCIDENT LOADS (2 REQUIRED). 2 STAGE VERTICAL PUMP CONSISTING OF 7 COLUMN SECTIONS

- TWENTY 1" CAP SCREWS PER COLUMN FLANGE (140 PER PUMP)
  - TWENTY FOUR 1-1/8" CAP SCREWS THAT ATTACH (24 PER PUMP) THE LAST COLUMN TO THE BOWL ASSEMBLY

- TWENTY FOUR 1-1/8" STUDS PER BOWL (48 PER PUMP)
  - FOUR 3/8" SOCKET HEAD CAP SCREWS PER (8 PER PUMP) IMPELLER (IMPELLER RETAINER CAP SCREWS) - INTERNAL

Column Flg Bolting (Typ of 7)  
(20) - 1" - 8NC x 4" lg

Column - Bowl Bolting  
(Typ of 1)  
(24) - 1 1/8" - 8NC x 4 1/2" lg

Impeller Internal (Typ of 2)  
(4) - 3/8" - 16NC x 1" lg

Bowl Studs (Typ of 2)  
(24) - 1 1/8" - 8NC x 4 1/2" lg

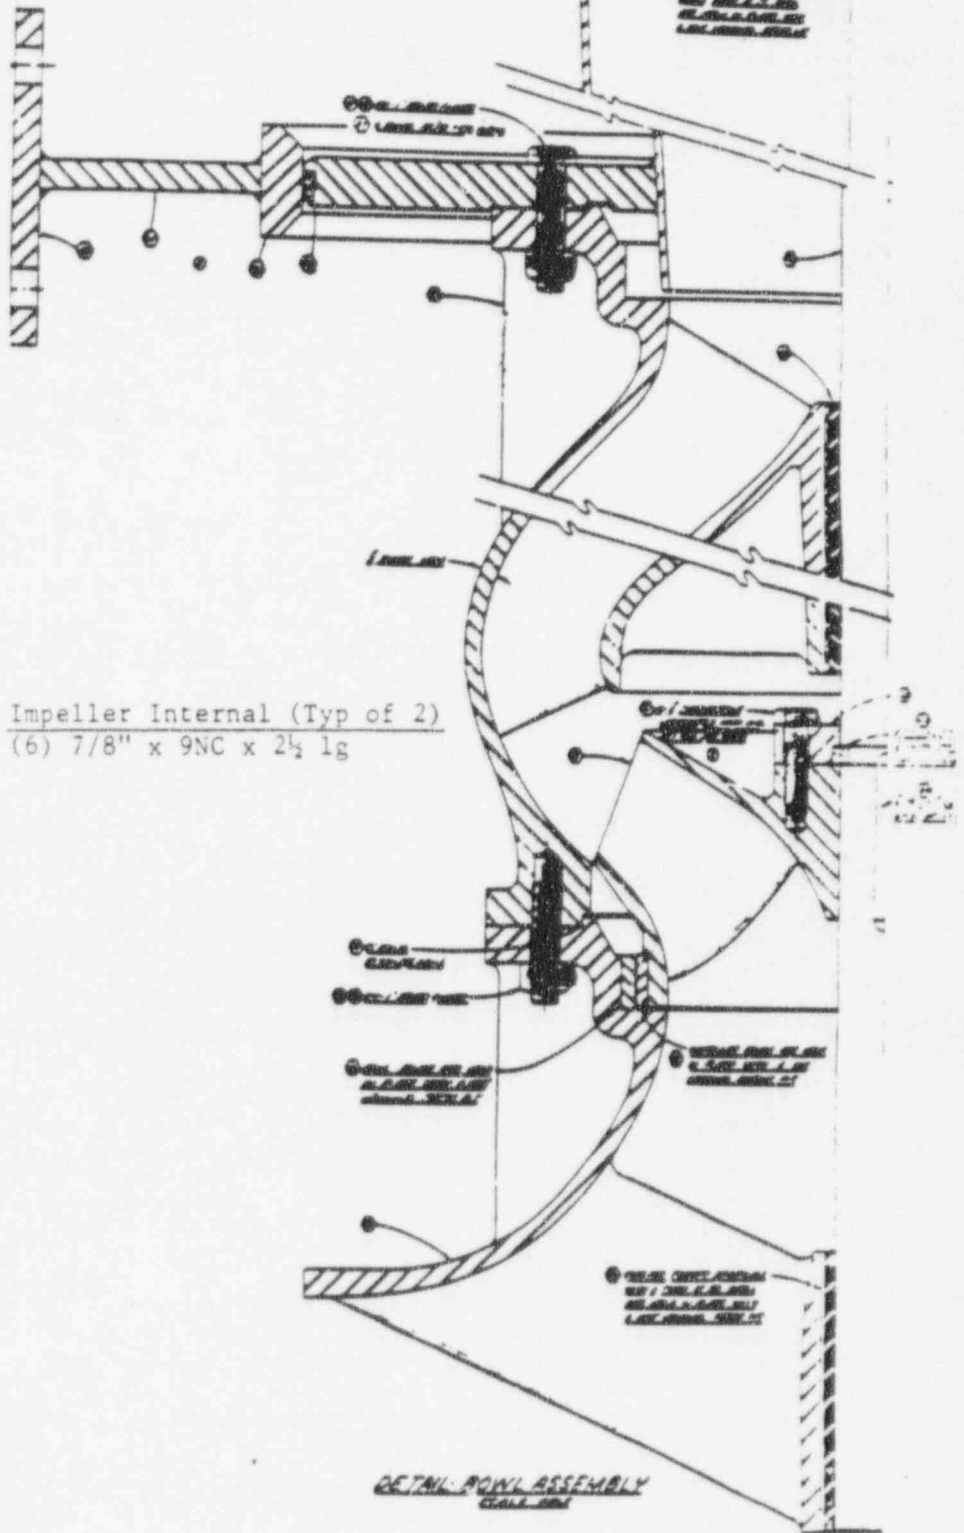
- B. COOLING TOWER PUMPS (1-SW-P-110A AND 110B) - PROVIDES HEAT SINK ONLY UPON LOSS OF OCEAN HEAT SINK TUNNELS. TWO STAGE VERTICAL PUMPS CONSISTING OF SIX COLUMN SECTIONS

- TWENTY FOUR 1" CAP SCREWS PER COLUMN (144 PER PUMP) FLANGE
  - TWENTY FOUR 1" CAP SCREWS THAT ATTACH (24 PER PUMP) THE LAST COLUMN TO THE BOWL ASSEMBLY

- TWENTY FOUR 1" STUDS PER BOWL (48 PER PUMP)
  - SIX 7/8" CAP SCREWS PER IMPELLER (12 PER PUMP) (IMPELLER RETAINER CAP SCREWS) - INTERNAL

Column Flg Bolting (Typ of 6)  
(24) - 1" x 8NC x 4" lg

Column - Bowl Bolting (Typ of 1)  
(24) - 1" x 8NC x 4½" lg

Bowl Studs (Typ of 2)  
(24) 1" - 8NC x 4½" lg

Impeller Internal (Typ of 2)  
(6) 7/8" x 9NC x 2 1/2 lg
